Silicon Cracking in Plated c-Si Solar Cells

Luca Pavani, Adrian Turner, Oliver Schultz-Wittmann
TetraSun Inc.
1551 McCarty Blvd. Milpitas – CA, USA
Phone: +1 (408) 375 6328; e-mail: luca.pavani@tetrasun.com

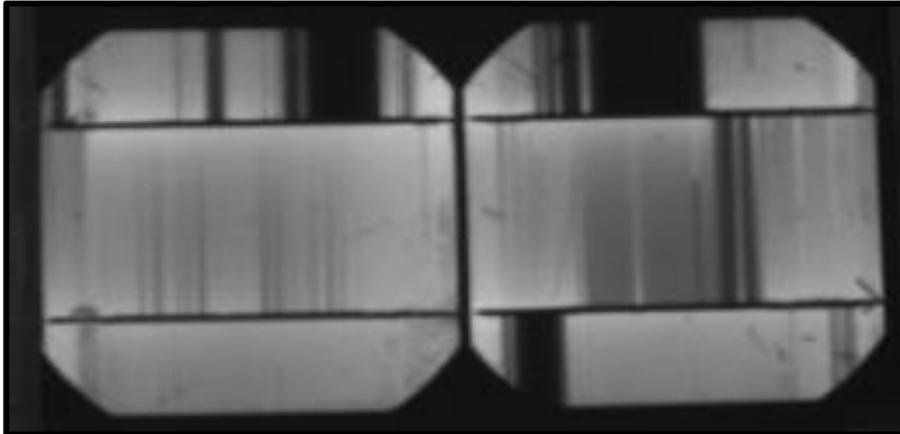
EL imaging of the tabbed solar cells shows that some portions of the device are electrically disconnected. This is leading to a severe reduction of the expected module output power (Figure 1).

Figure 1: EL image of two tabbed solar cells showing electrically disconnected areas within the device

Though this failure mode can be reduced by adjusted parameters of the soldering process, the physical mechanism that leads to the silicon fracturing is not yet entirely understood [1], [2].

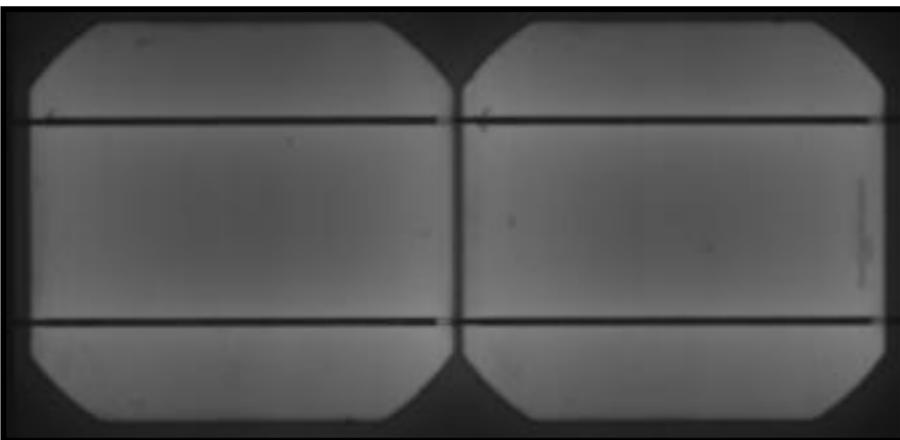
Figure 2: EL images of two tabbed solar cells free from soldering defects

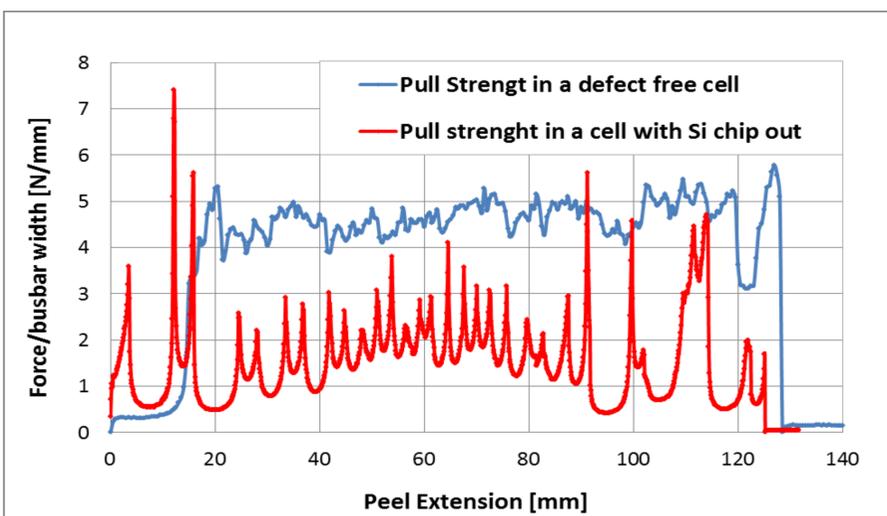
Graph1: Pull test comparison of defected cells and defect free cells

TetraSun c-Si cells with plated bus bars and finger grids show a very good pull strength around 5 N/mm. A reduced pull force approaching the ≥ 1 N/mm criteria is directly correlated to defected solar cell that show electrically disconnected areas under EL inspection.

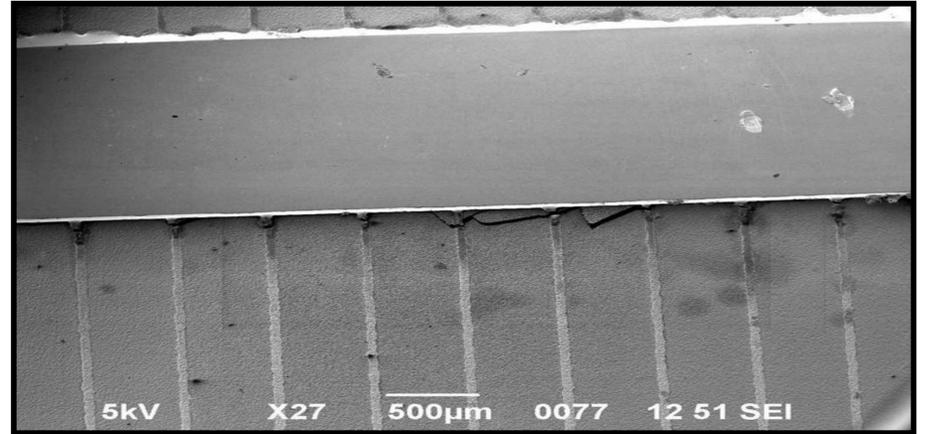
In these areas the silicon is clearly cracking at the edges of the bus bar (Figure 3). The cracking can be so severe to induce dislocation or chip out of the silicon which eventually results in cut metal fingers. (Fig 4). This is the reason for the electrical discontinuity observed in the device with the EL inspection.

Figure 3: SEM image of cracked silicon along the bus bar

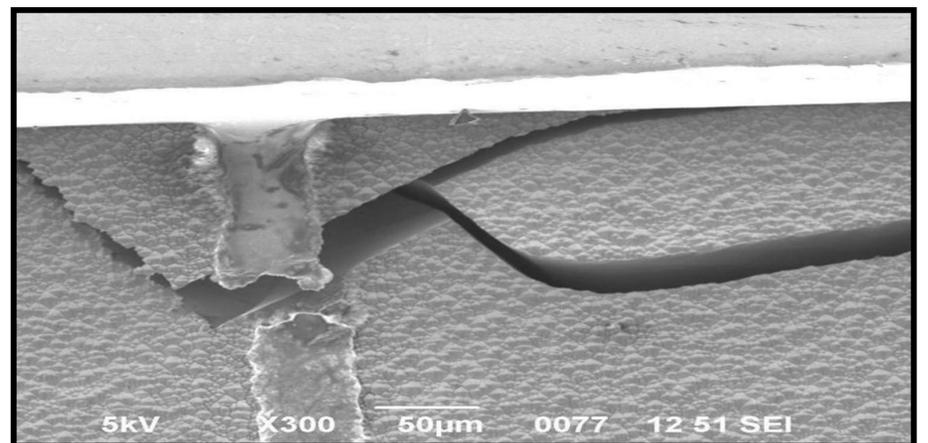
Figure 4: SEM image of cut metal finger due to Silicon chip out

SEM analysis confirms that the periodically reduced pull strength is not a failure related to the metallization but is physically correlated to a cracking of the silicon itself. The cracking can be so severe that occasionally it leads to break the metal fingers detaching them from the bus bar. This results in electrical disconnect of section of the solar cell from the rest of the device.
