PV Module Failures Observed in the Field

Kazuhiko Kato

Research Center for Photovoltaic Technologies (RCPVT)

Many failures have been found in PV modules!

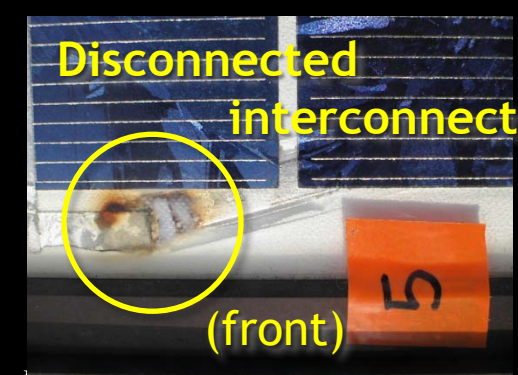
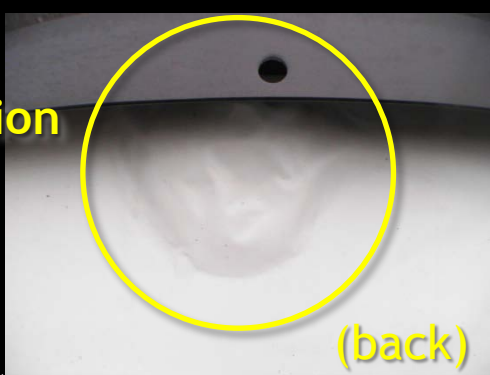
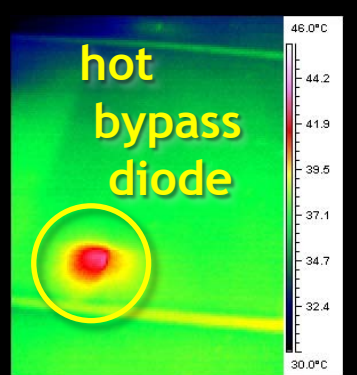
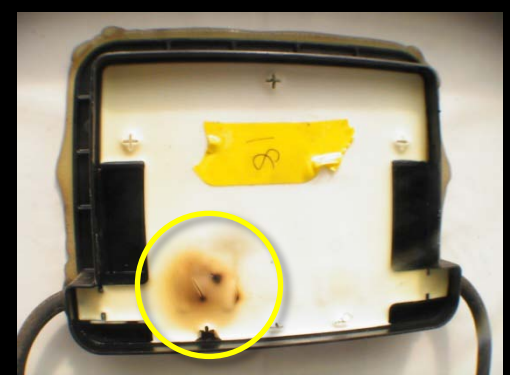
Case #1

2.9kW residential PV system with 20 poly-Si PV modules located in the suburbs of Tokyo (installed in 1998, Mitsubishi)

- Inspection by the installer reported **“No roblem”**.
- The survey by PVResQ! Judged that 10 of 20 PV modules had **serious failures**.
- The **10 modules were replaced** by the manufacturer with no charge in the end.
- The others were not (the manufacturer said they would never have any problems.)

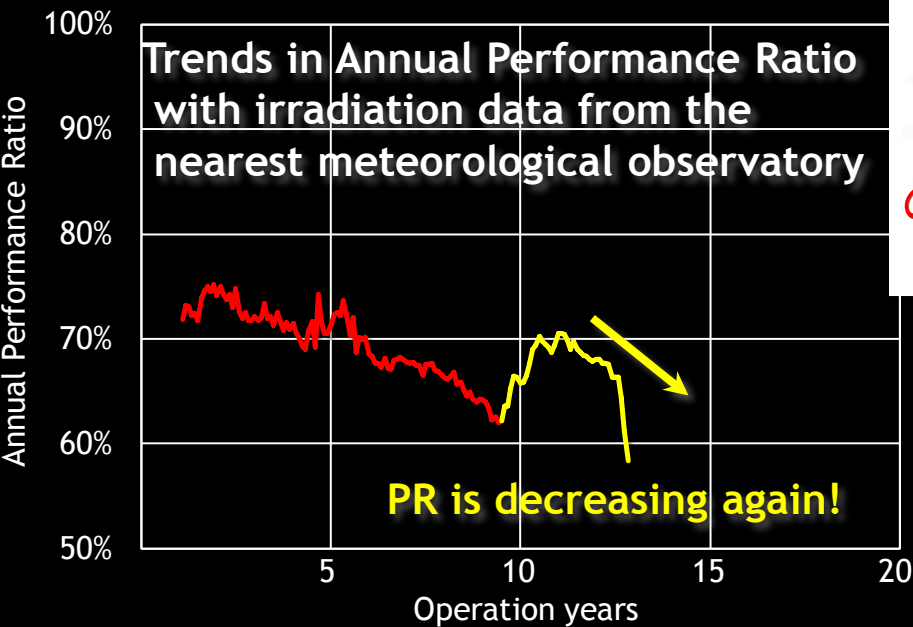
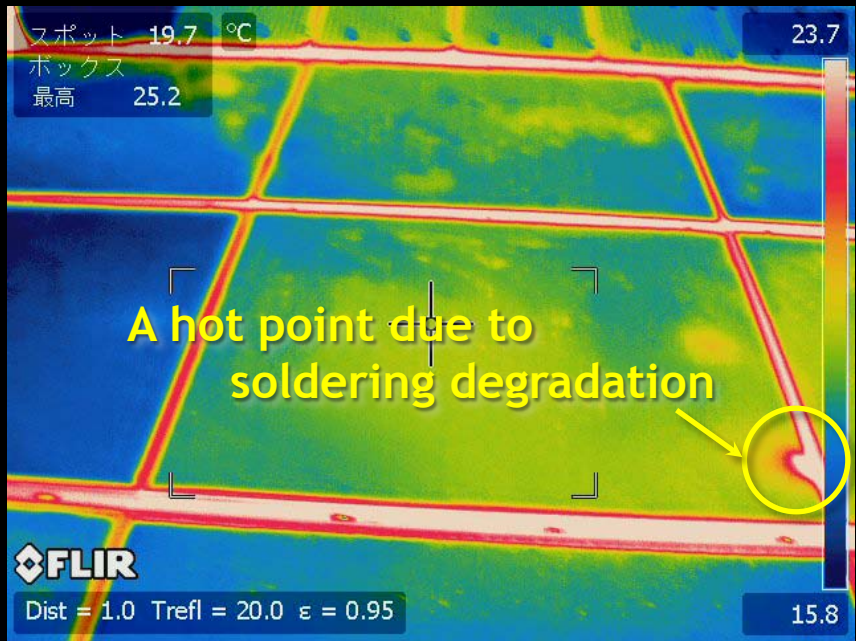
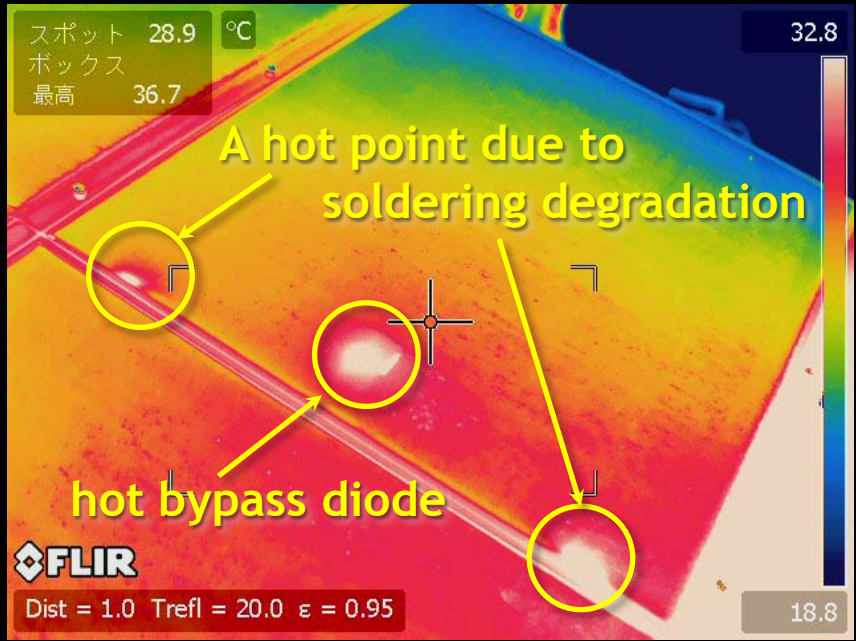
...and three years later

- The same kind of failure as before was found in old 5 modules.
- One of them could not generate voltage due to disconnection of internal circuit.
- The manufacturer replaced all the old modules with no charge, though their warranty period (10 years) was over

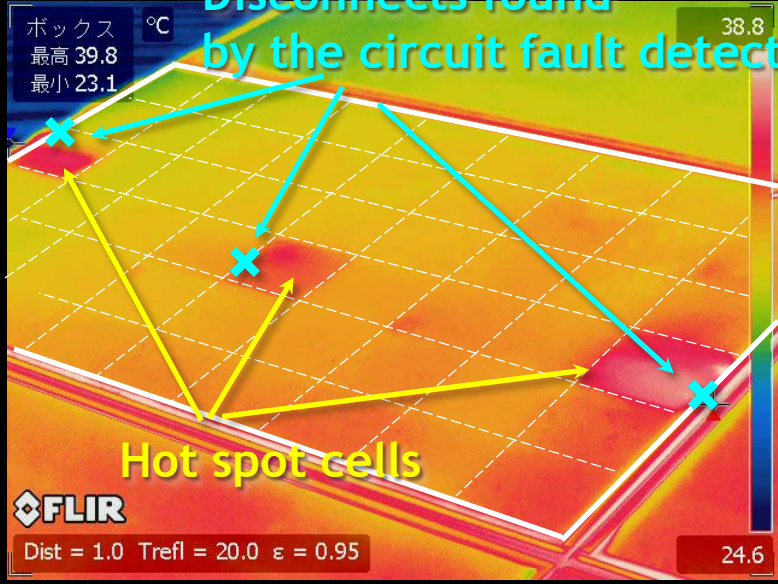
Disconnects found by the circuit fault detector

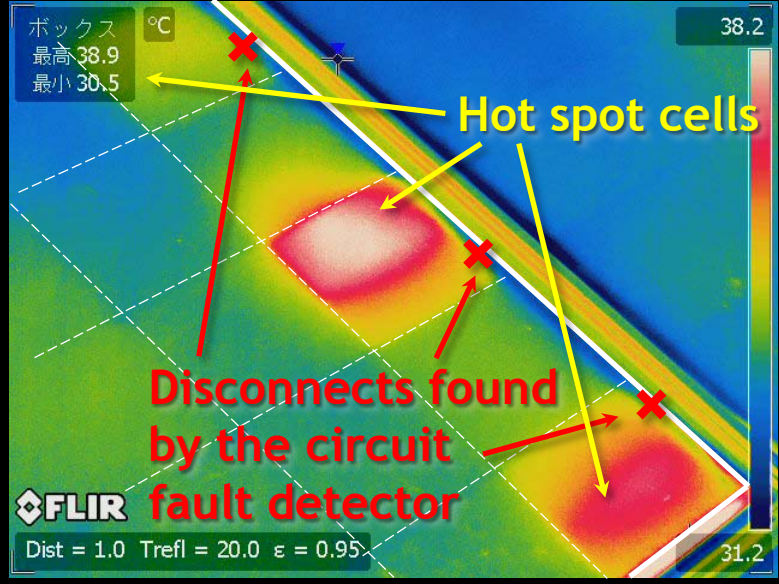
Hot spot cells

Disconnects found by the circuit fault detector

- PV RessaQ! survey found failures in many PV modules.
- Discussion about module replacement is in preparation.

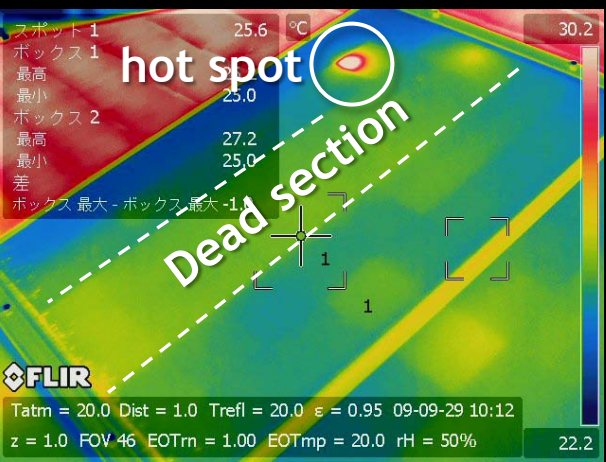
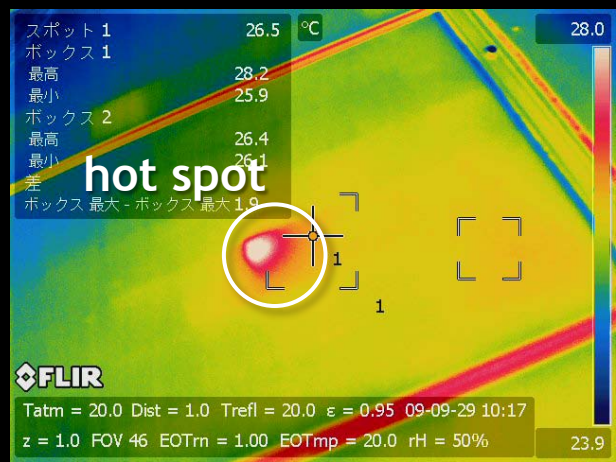
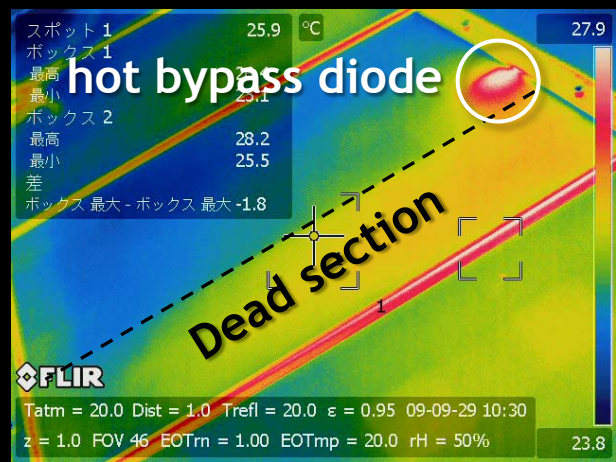
Case #3

3.84kW residential PV system
With 32 poly-Si PV modules
located in the suburbs of Tokyo
(installed in 1998, Mitsubishi)

PR had been decreasing!

- PVResQ! survey found **15 PV modules had serious failures.**
- Though the warranty period (10 years) was over, all the PV modules were replaced with no charge.

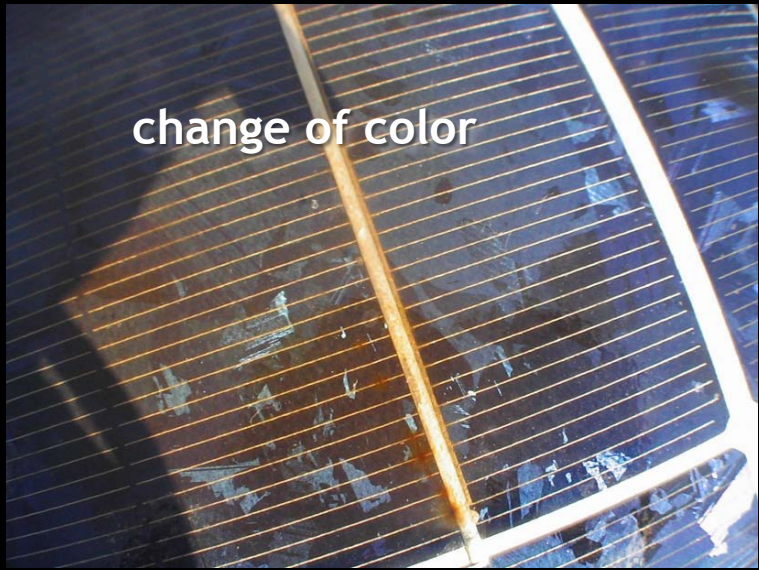
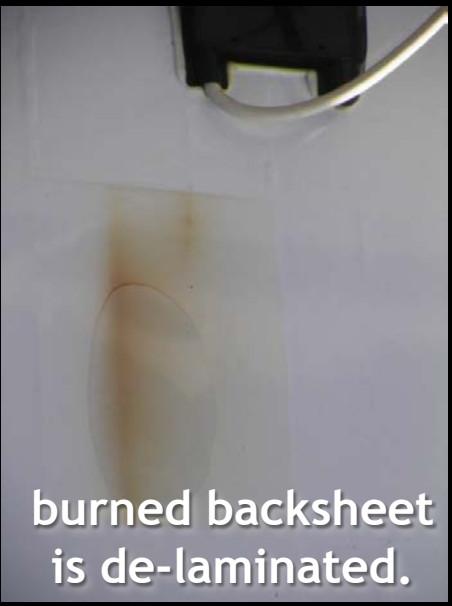
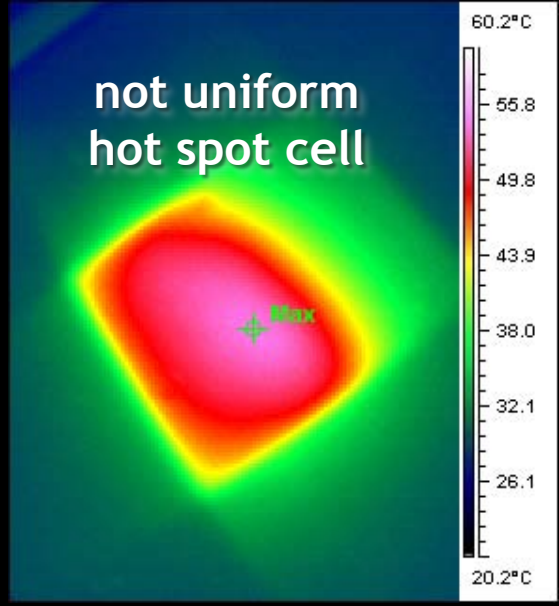
Case #4 "Sharp ND-150AM"

Four PV modules were replaced,
though high performance ratio and short operation years.

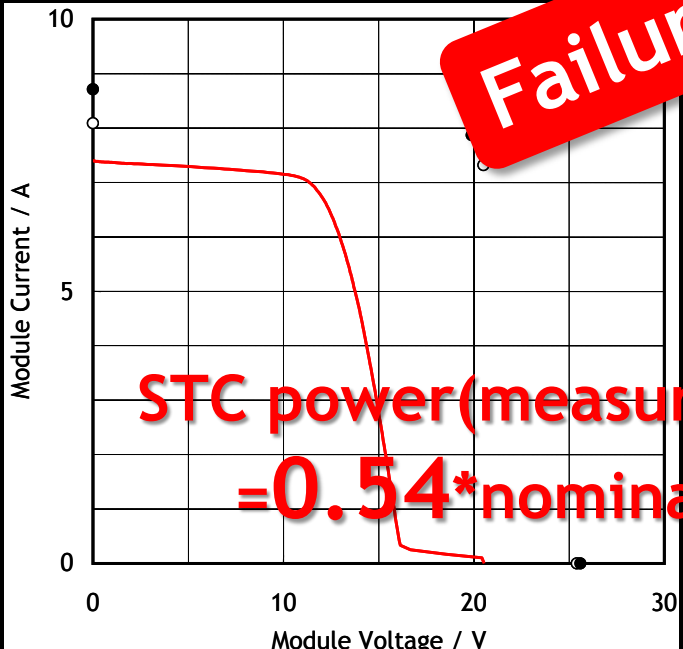
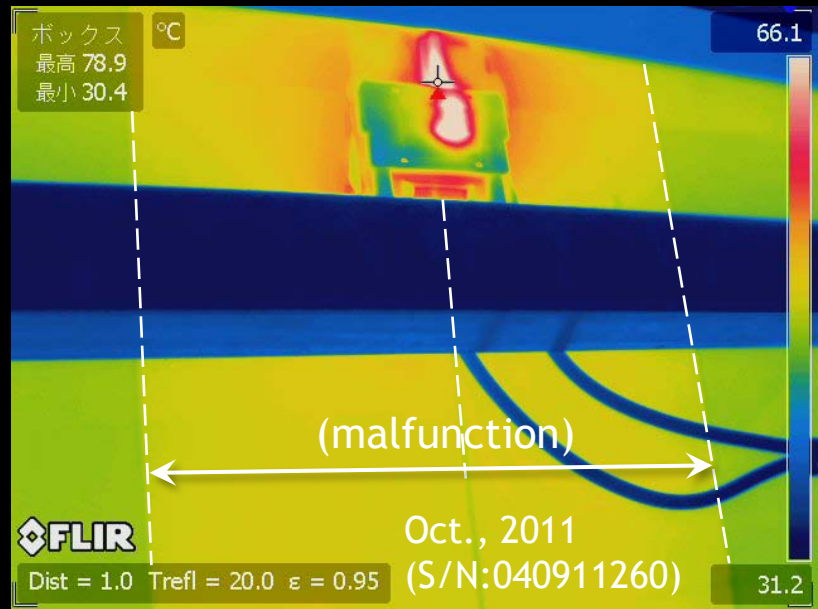
Failure Step #2

**STC power(measured)
=0.54*nominal value**

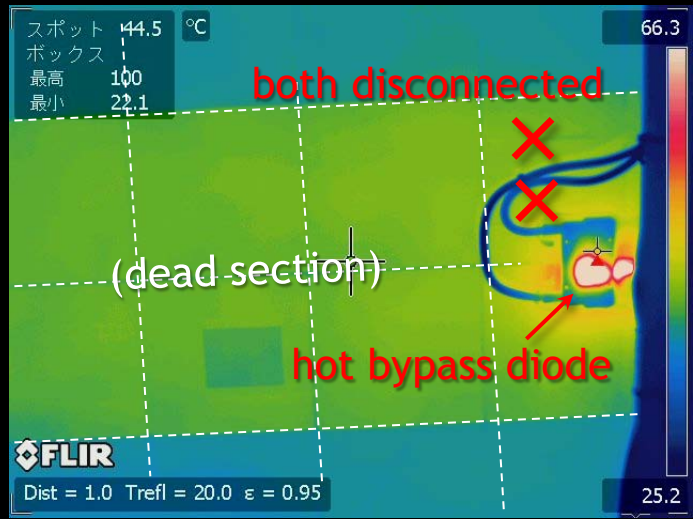
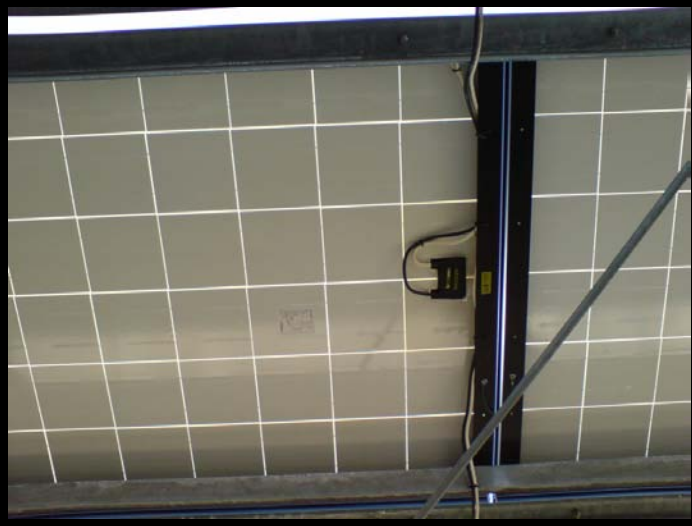
“Step 2”

Observed
in March 2010

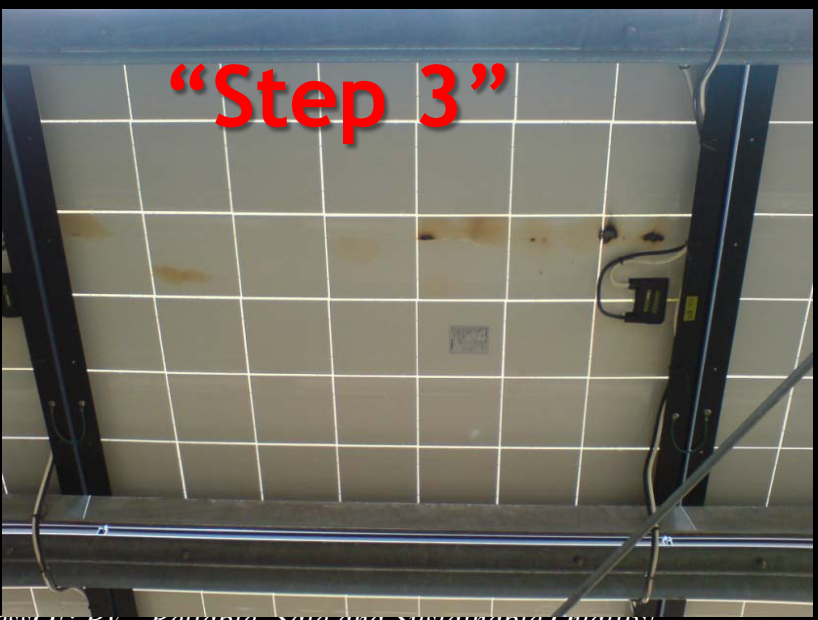
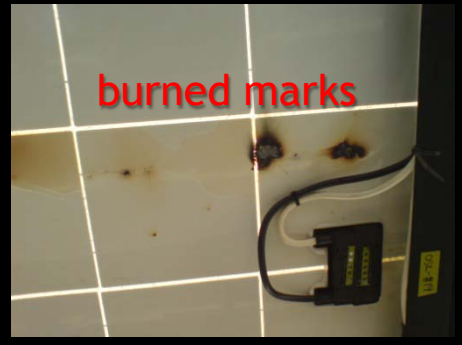
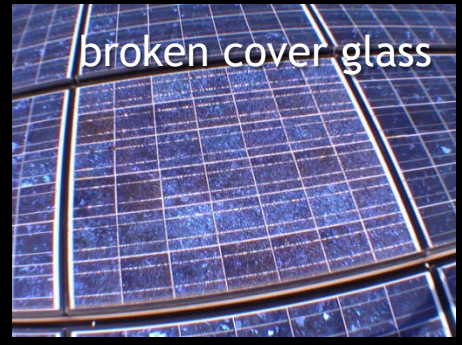
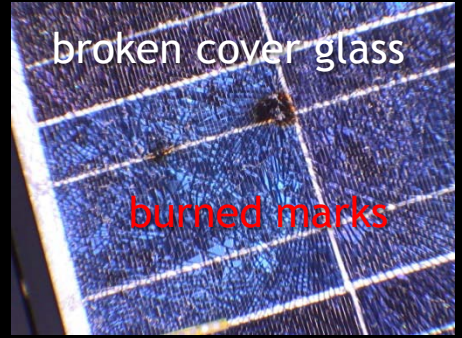
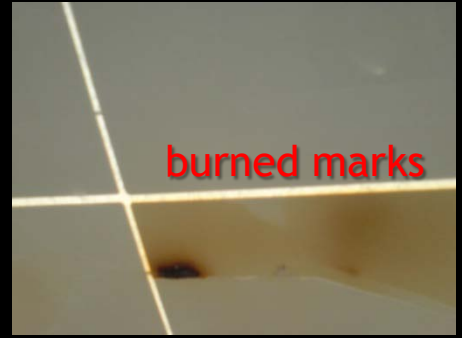
“Step 3”

New situation observed in June 2010

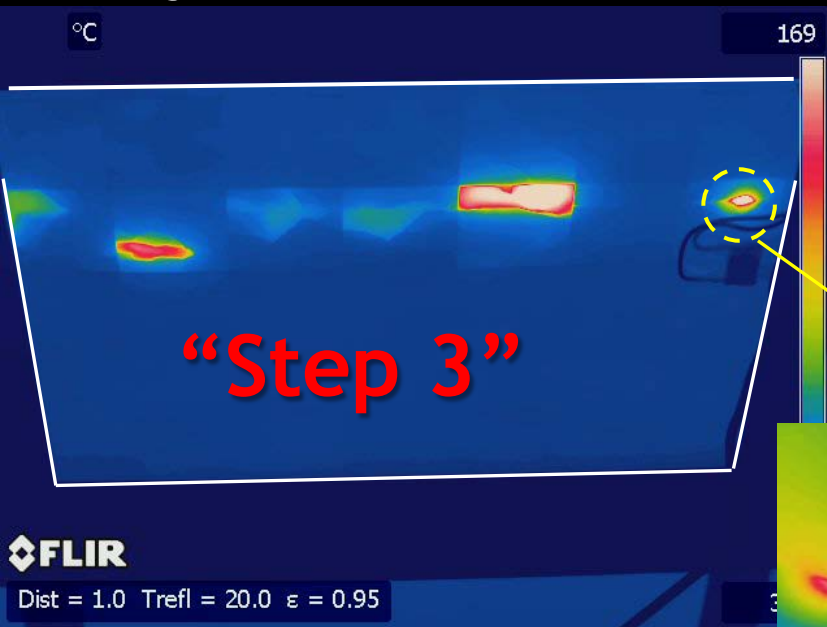
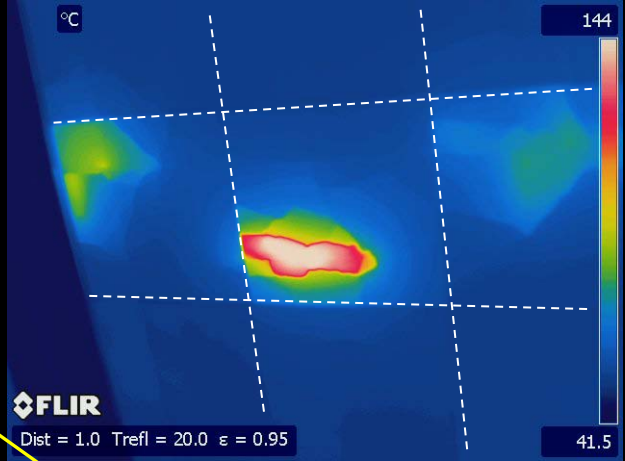
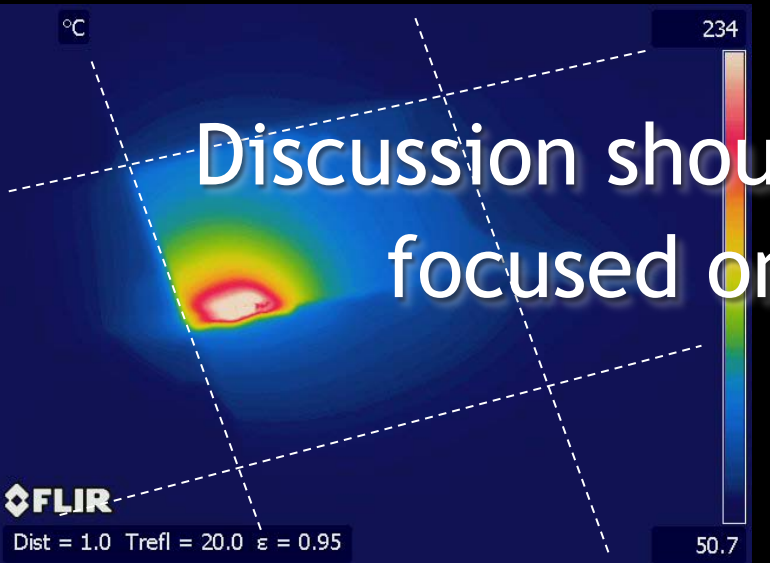
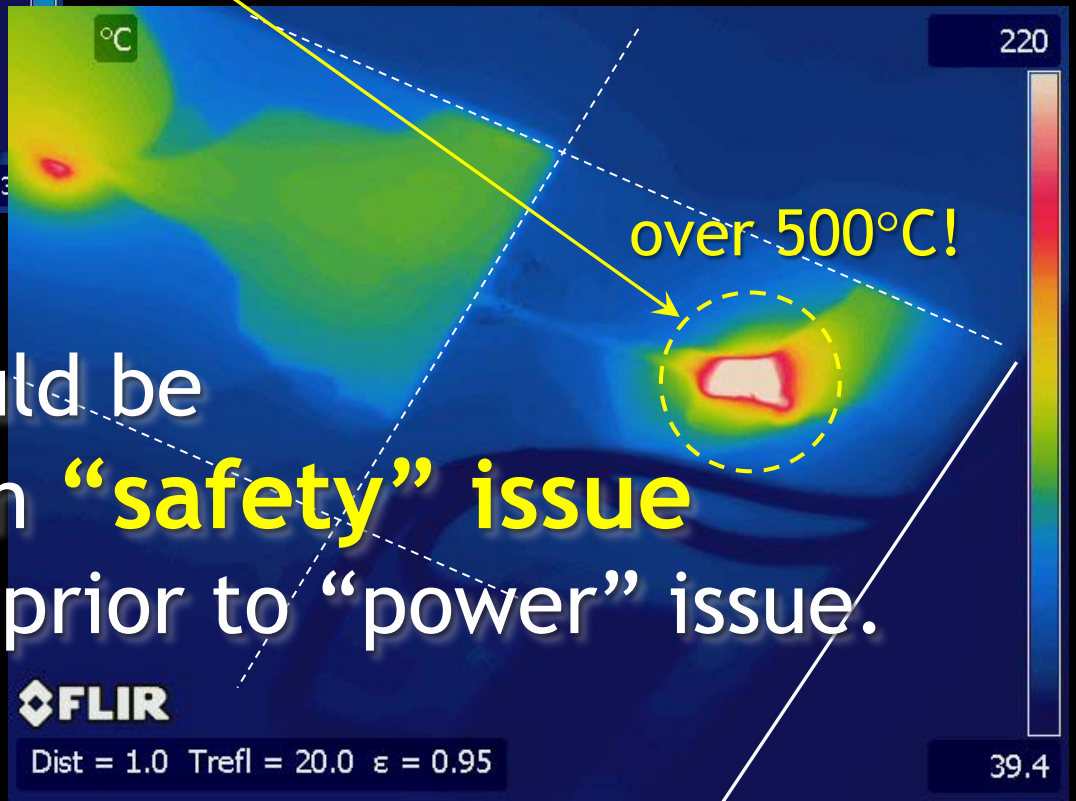
IR images from back side

Discussion should be focused on **“safety”** issue prior to **“power”** issue.

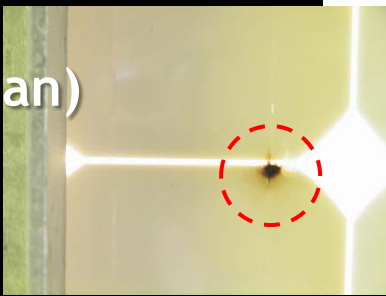
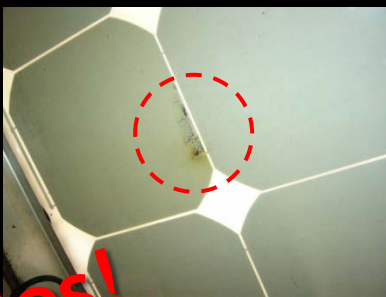
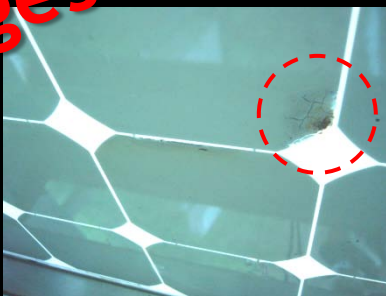
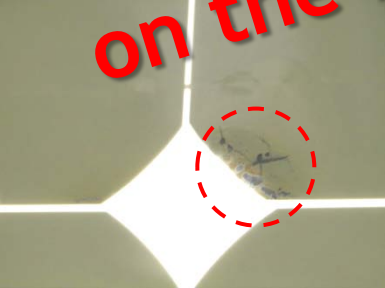
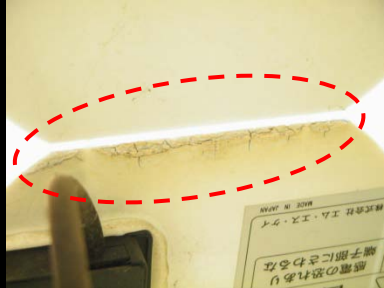
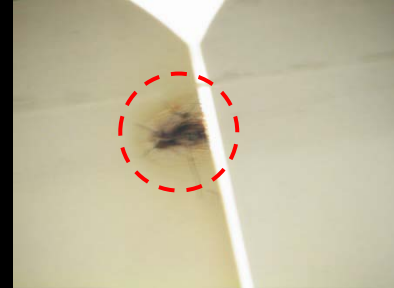
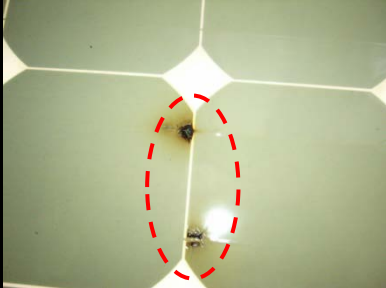
1,272 pieces of mono-Si PV module manufactured by MSK (now Suntech Power Japan)

Many burned marks on the backsheet along cell edges!

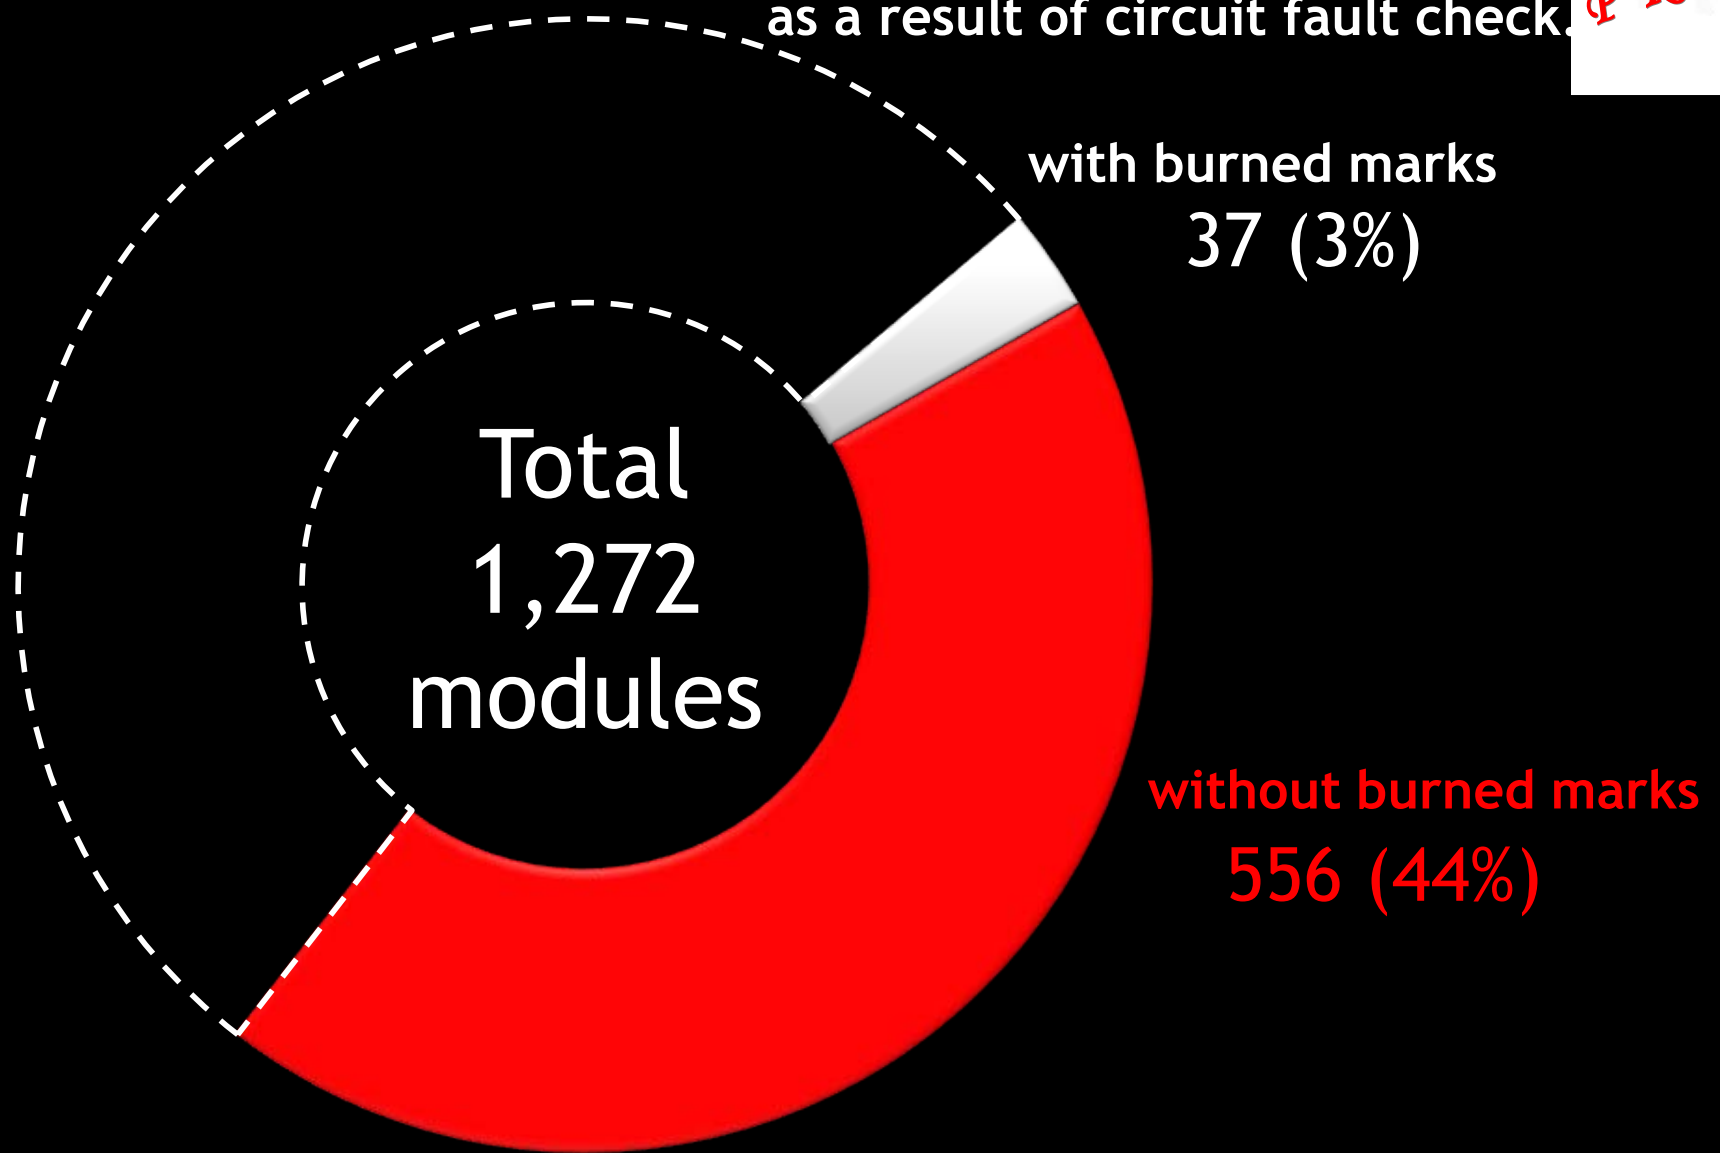
Fraction of PV modules in which bypass diodes do not work as a result of circuit fault check.
