## Failure Modes of CPV Modules and How to Test for Them

19-Feb-10

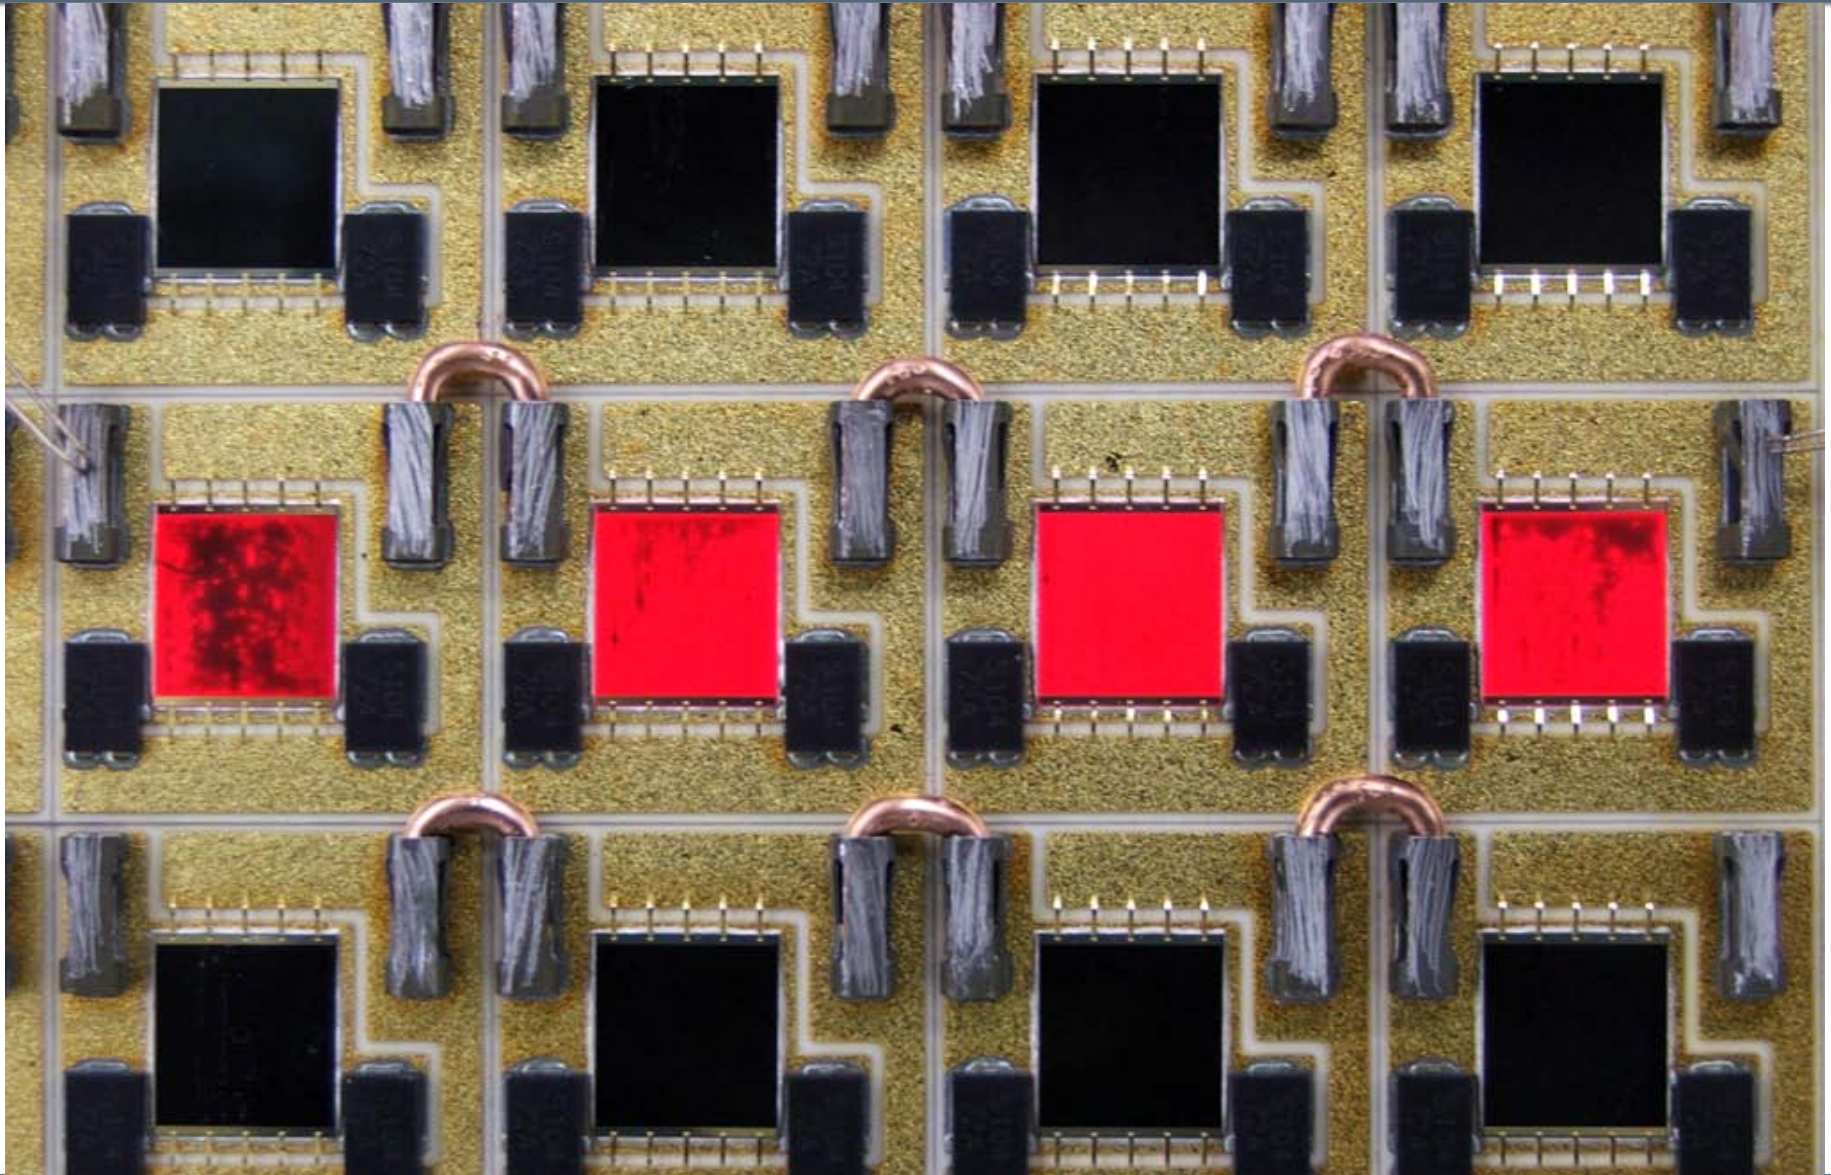
# TC EL After Damp Heat Exposure

- **Grid Finger Delamination.**
  - Dark areas appear to be aligned along GFs.
- **Degradation of Anti-Reflective Coating (ARC).**
- **Top cell shunting.**
- **Accumulation of opaque surface contamination.**

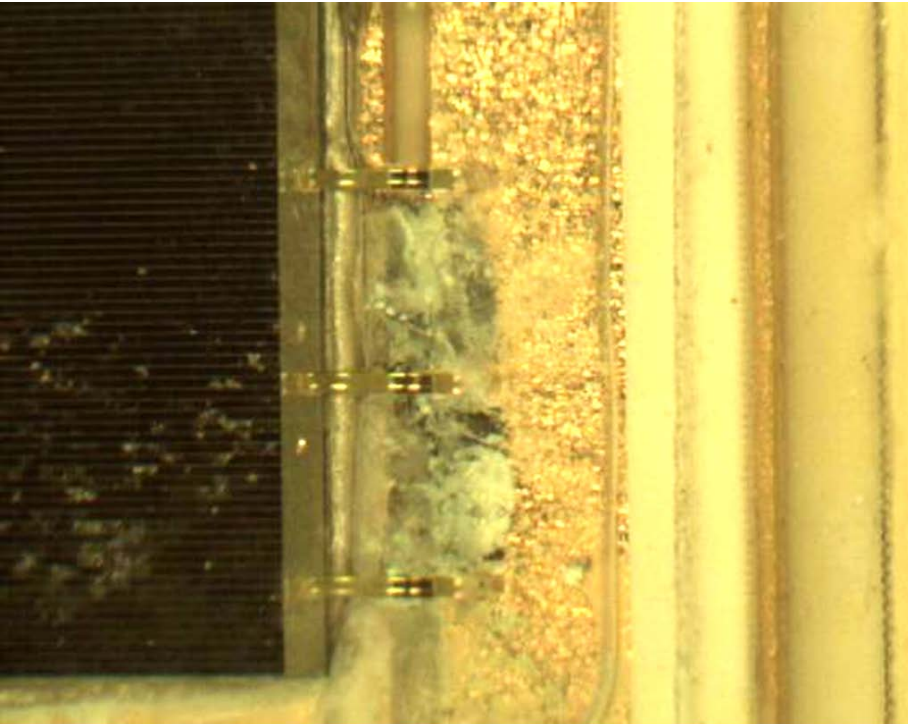
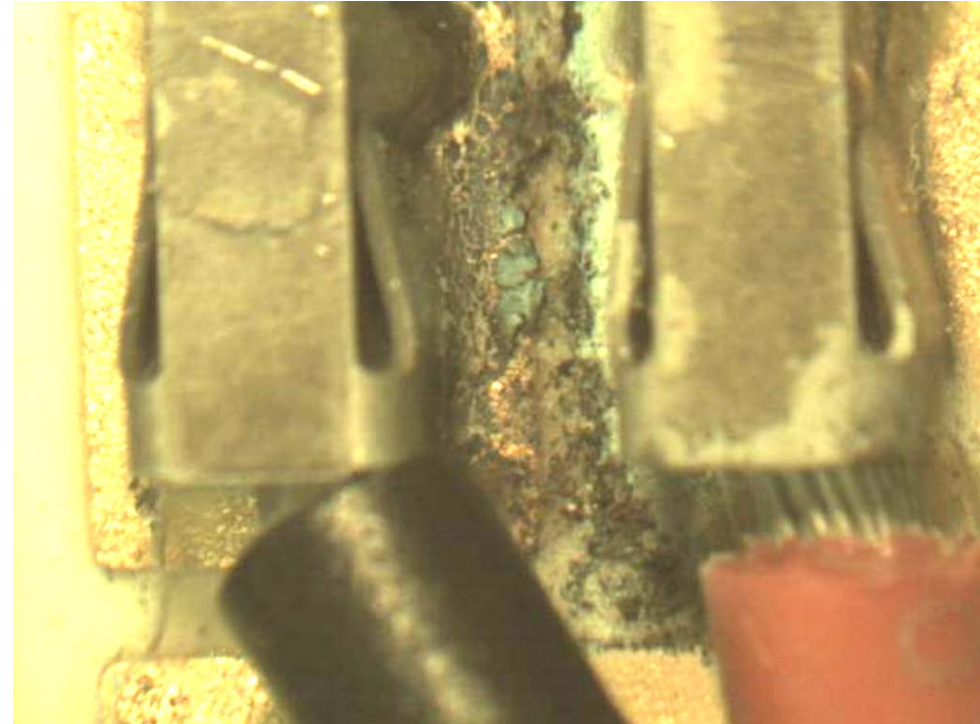
# Robust Encapsulation is Critical

- It appears that this type of failure mode requires both moisture incursion as well as bias.
- For this reason we now add light bias to all our damp heat product reliability testing.
- Moisture incursion also makes it difficult to pass the IEC wet insulation test.

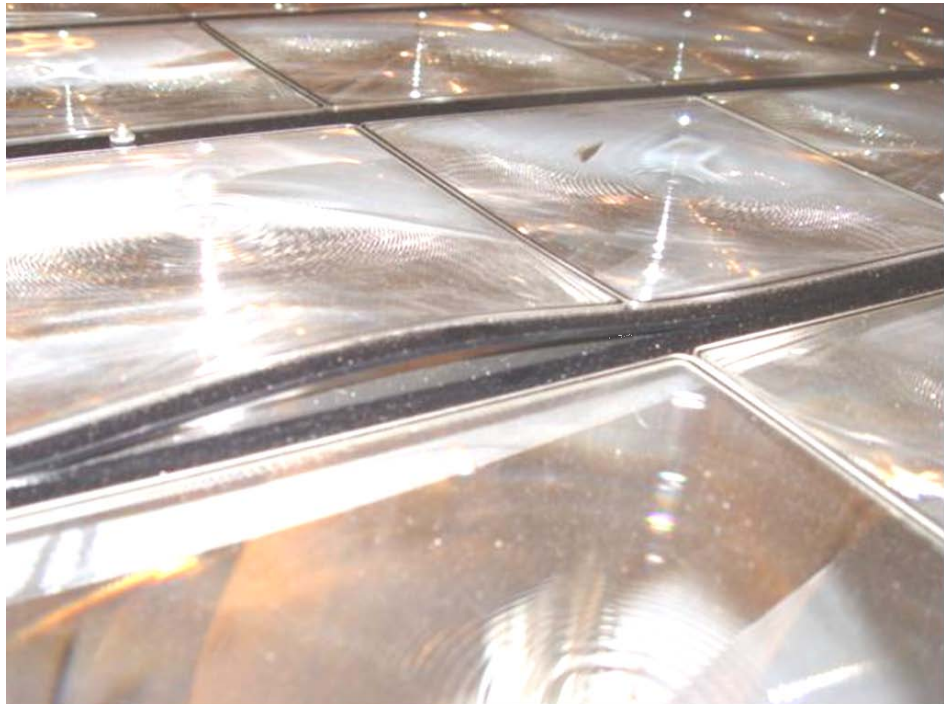
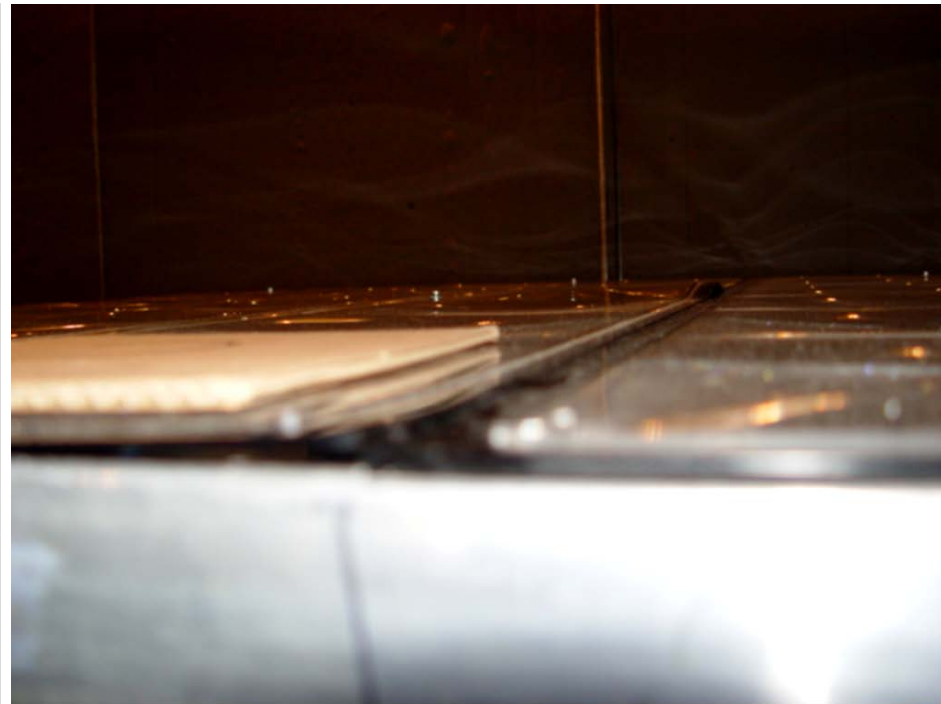
- We have also seen Acrylic lenses deform during damp heat testing.
- Besides the obvious impact to the optical performance of the module, in damp climates this further reduces the chances of passing the wet insulation test when the receiver in the bottom of the module finds itself under water from time to time.

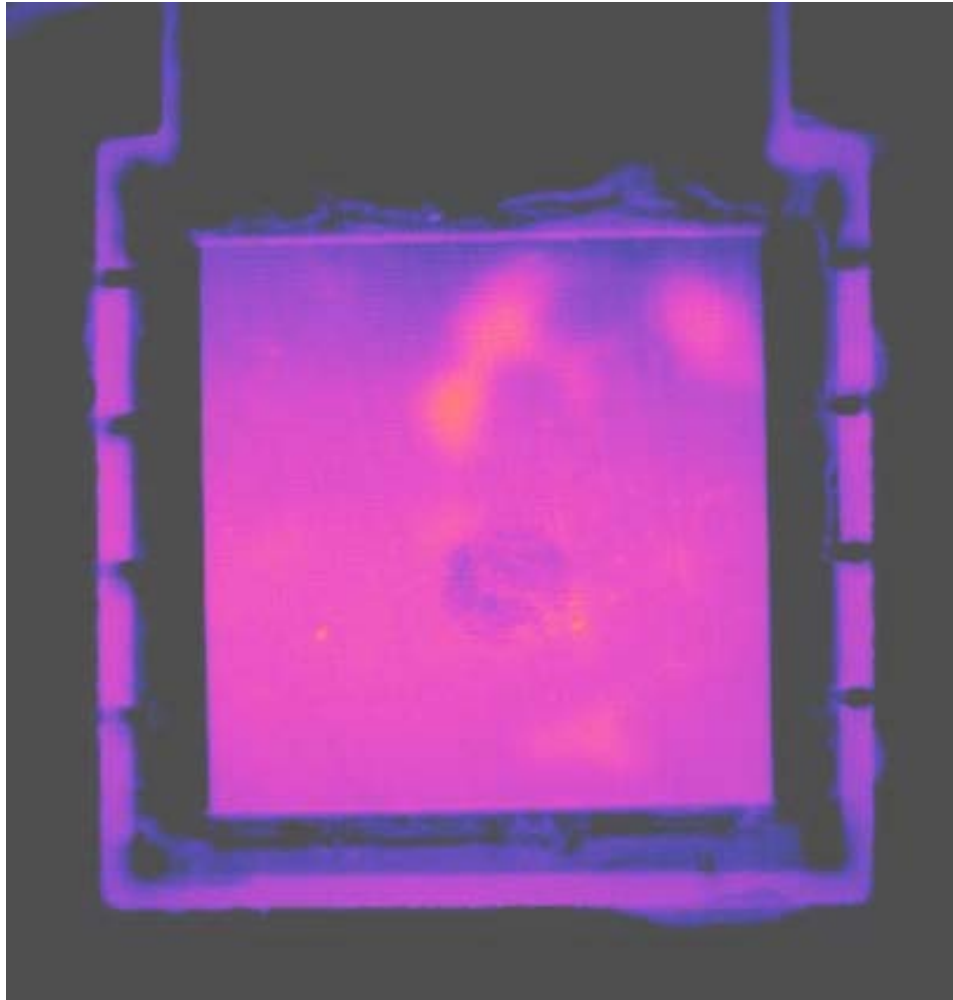
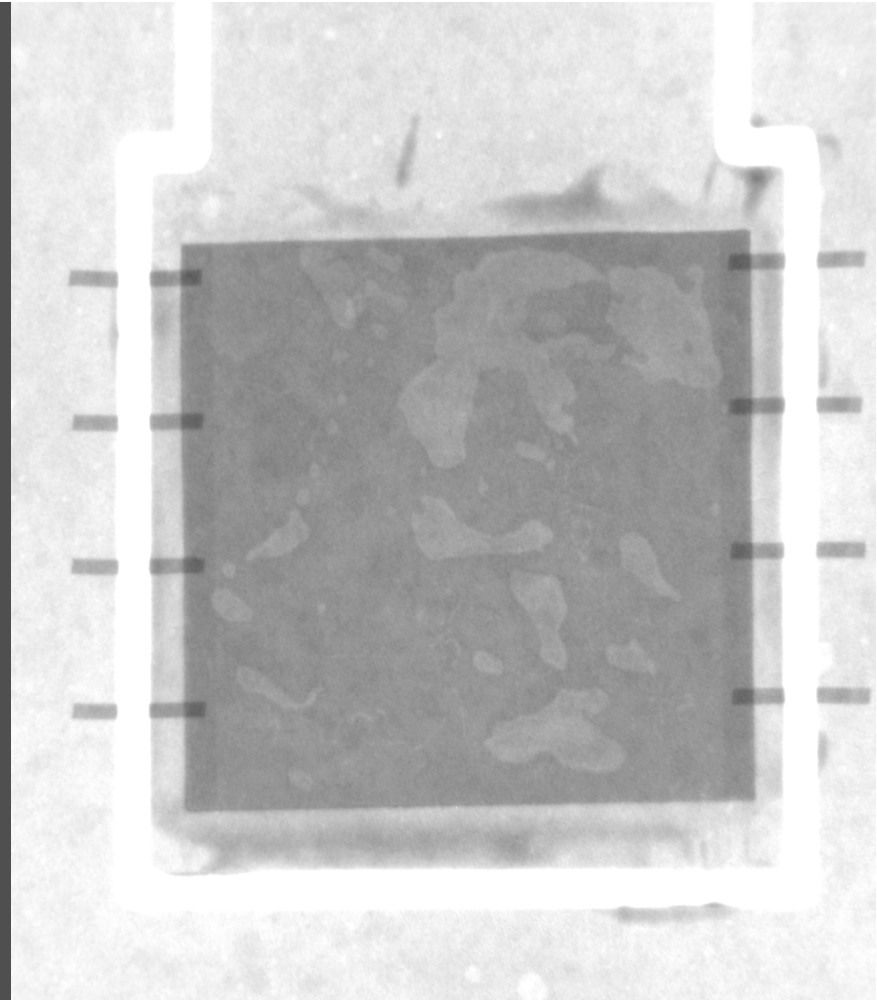
# Die Attach Voids

- **Thermal Impedance Variations**
  - Voids and other non-uniformities in the die attach
  - One corner of a rectangular cell is always higher than the other three
- **Current crowding in forward bias**
  - Under buss-bars
  - Near ribbon bonds
- **Localized shunt current paths**
  - Intrinsic crystalline defects
  - Edge shunts
  - EOS/ESD

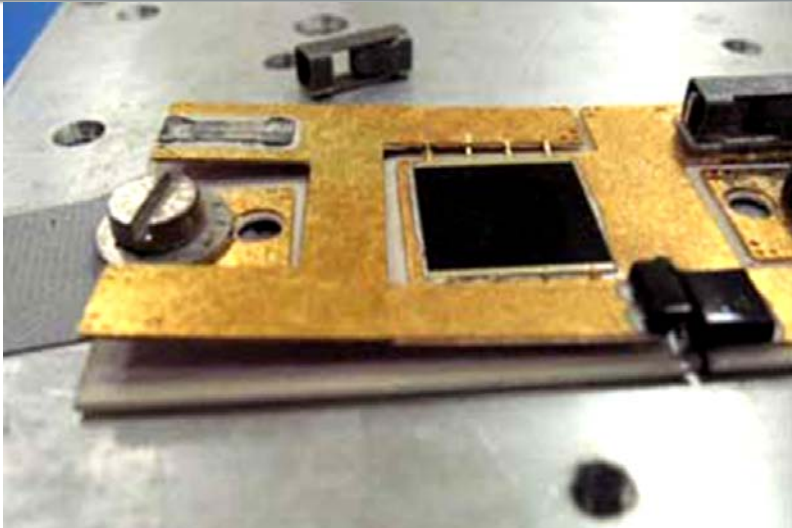
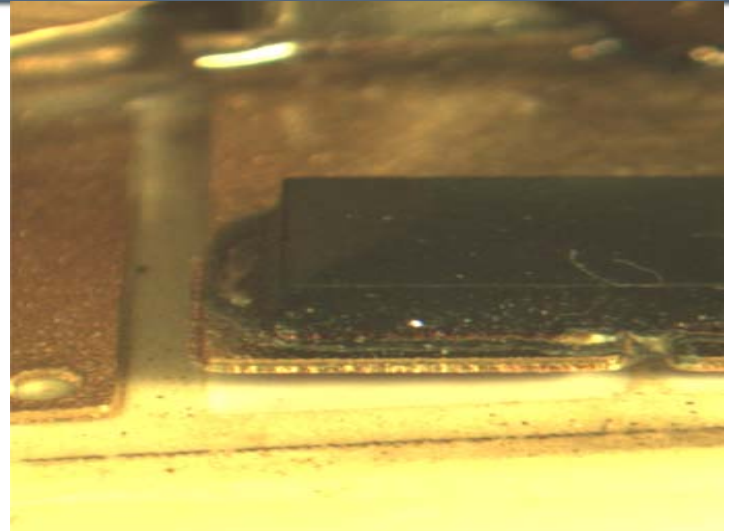
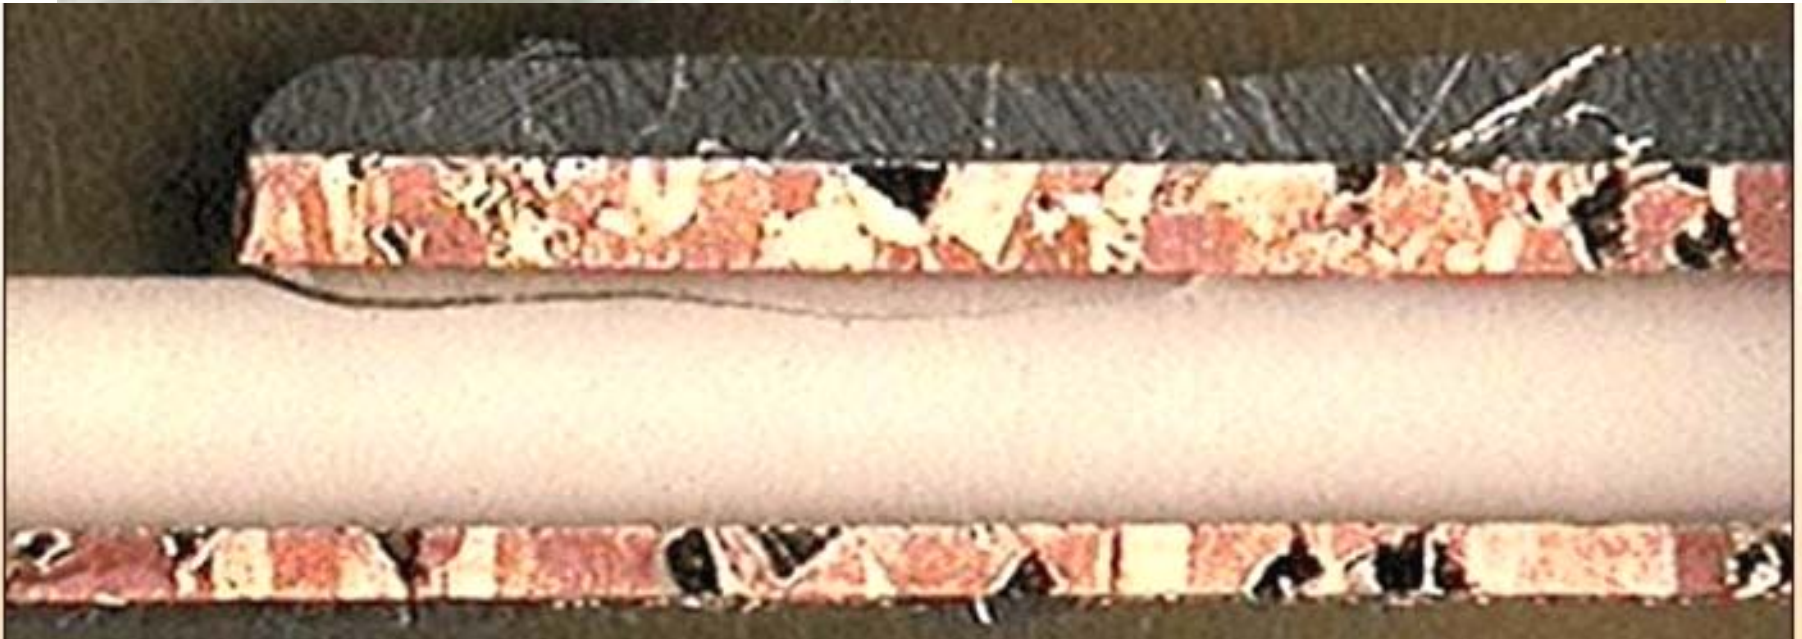
# Ceramic Conchoidal Failures in PTC

At  $1.25 \times I_{SC}$  the temperature of this cell is at least  $120^{\circ}\text{C}$  above ambient (heat sink).

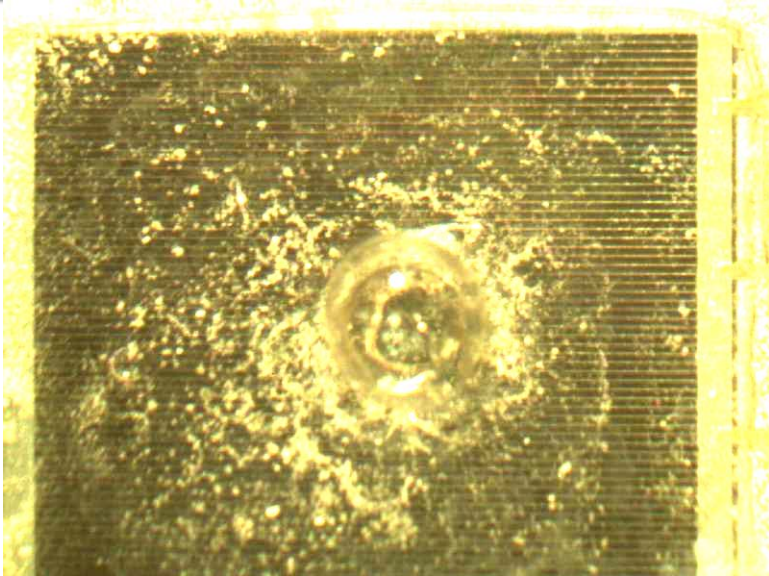
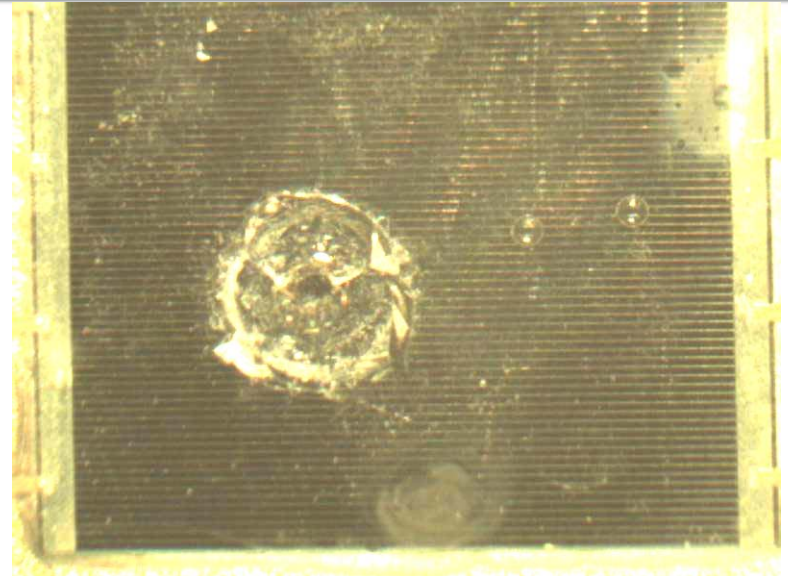
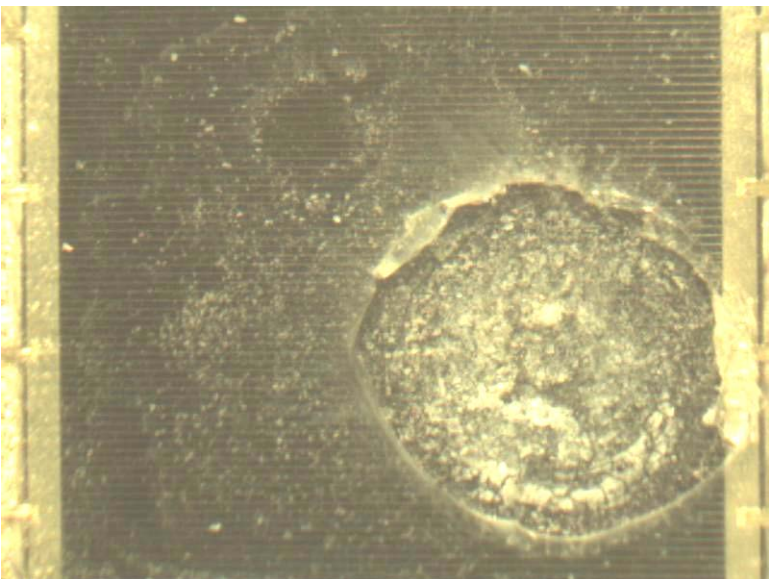
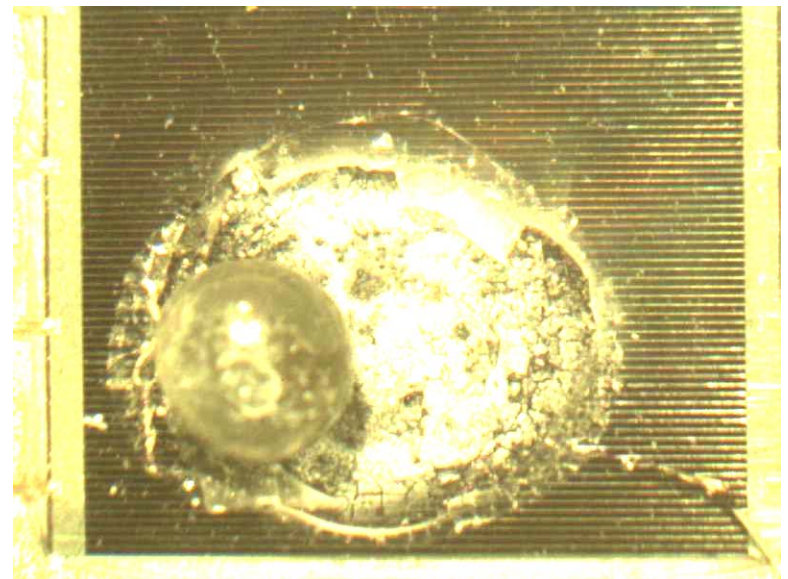
# Coverglass Failures

- **Silicone beneath coverglass too thick**
  - Thinner silicone (1 – 2 mils) under coverglass has not exhibited the failure mode.
  - Silicone is not a good thermal conductor, but why is it absorbing?
- **Particulates trapped in silicone during fabrication**
  - Tools shedding metal particles.
  - Dust or lint particles.
- **Coverglass quality**
  - Inclusions.
  - Incorrect glass formulation.
- **Various “Greenhouse” effects**
  - Coverglass reflects IR emitted by cell.
  - Structure concentrates and preferentially absorbs energy re-radiated at the middle cell band-edge wavelength.
- **Misalignment of lens relative to cell**
  - Higher concentration (2000X?) if light pushed into corner of SOE.
  - Doesn't explain failures near center of cell, or provide root cause.
- **Thermal impedance**
  - Better heat sinking reduces incidence of failure.

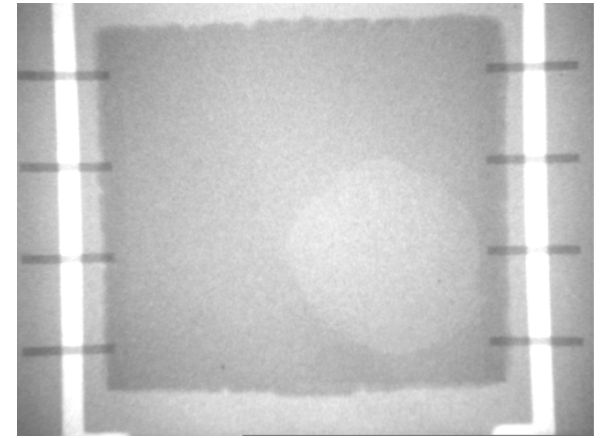
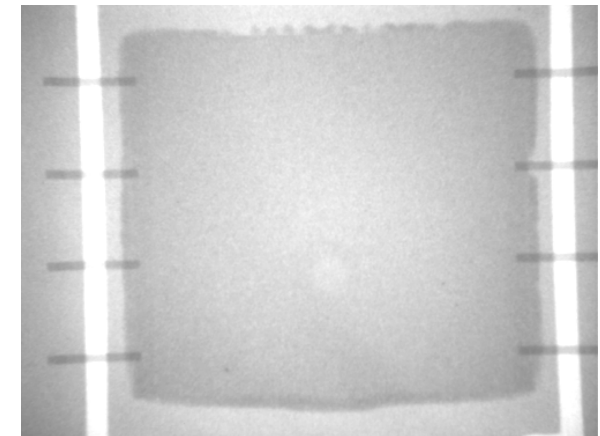
**Xray**

No apparent damage to cell

Xray contrast due to glass

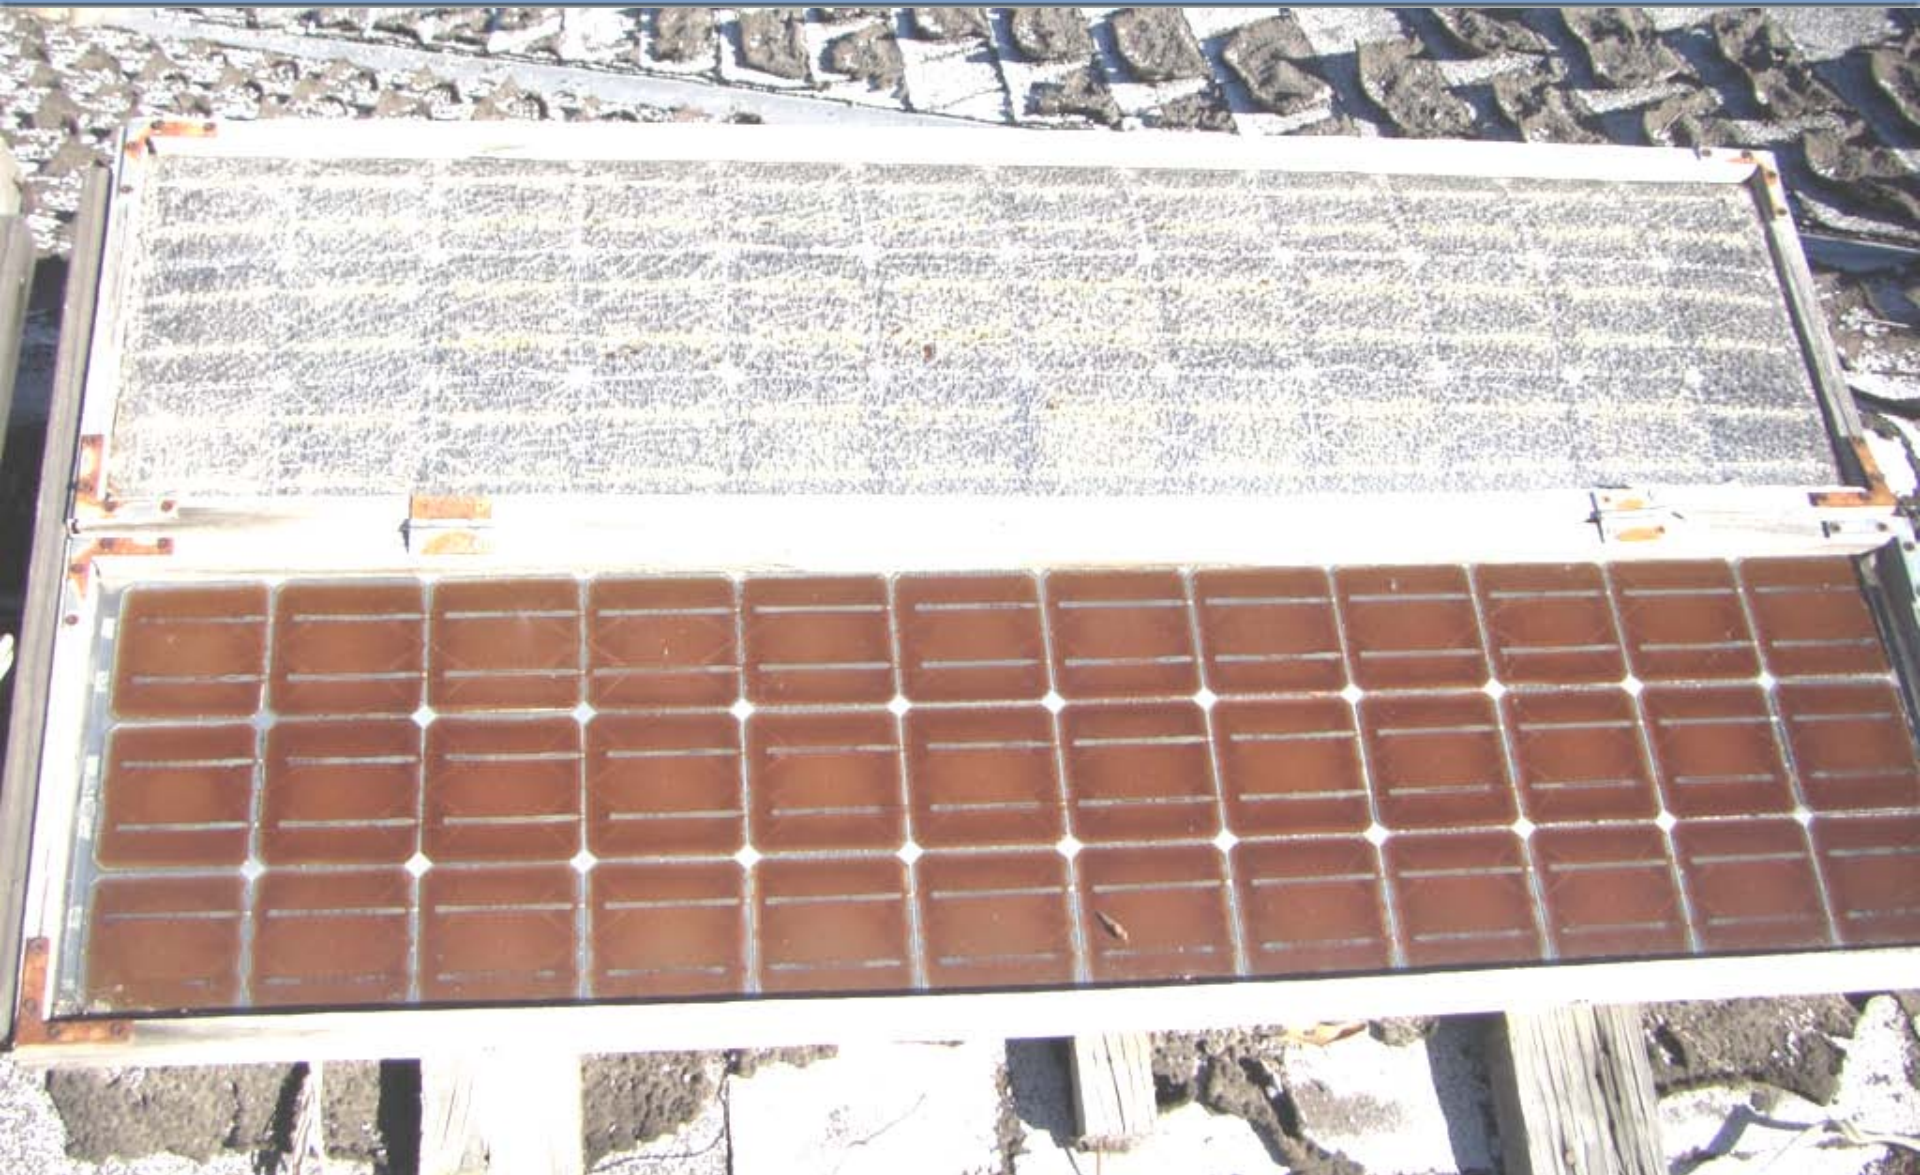
Still Going

- Many people in the room probably know a lot more about the pedigree and jaded history of these panels than I do, but these are the essential facts:
  - The panels were originally taken out of service after the encapsulation yellowed and reduced the output power by about 15%.

- At the time they were reinstalled a misguided drywall screw shattered the tempered face glass on the upper panel.
  - Since then the both panels have been in continuous service powering a 12V DC service in an artist's studio.

- Both have yellowed considerably more than when reinstalled but even the shattered panel is still generating power.
- I don't have hard numbers, but the main point is that at the time these panels were built, I am guessing that there were not many predictions that they would fail prematurely due to yellowing of the encapsulate and even fewer that they would still be generating power after thirty + years in service and a shattered coverglass.
