E. NDE Development for Valve-Train Components for Diesel Engines

Jiangang Sun

Argonne National Laboratory

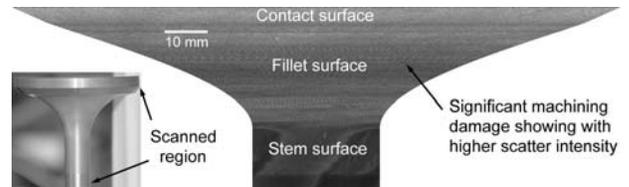
Figures 2 and 3 show, respectively, laser-scatter images of SN235P natural-gas intake valve No. 8 at before and after the finish machining. Spatial resolution in both scan directions was ~10 μm. In Figure 2, significant machining damage can be found on the entire valve head surface except the stem surface near the bottom of the image. These damages are seen as bright lines (of higher scattering intensities) along the machining direction, as shown in the detailed image in Figure 4(a). The lengths of the machining damage are typically near 1 mm. In

Figure 2. Laser-scatter scan image of SN235P valve 8 after initial rough machining.

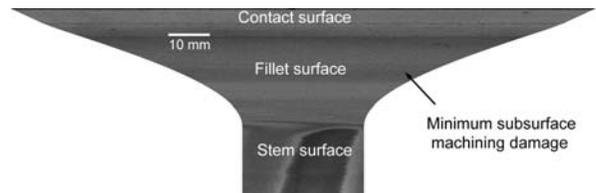
Figure 3. Laser-scatter scan image of SN235P valve 8 after finish machining.

addition, the overall optical scatter intensity of the valve-head surface is high, indicating a higher level of overall damage. In comparison, the finish-machined surface shows minimum machining-damage indications as seen in Figure 3 and the detailed image in Figure 4(b). The higher scatter-intensity spots in Figures 4(a-b) come from material inherent defects such as porosities with sizes typically smaller than 50 μm . Therefore, it is apparent that the finish machining essentially removed all machining damages induced in the initial rough machining of these SN235P valves.

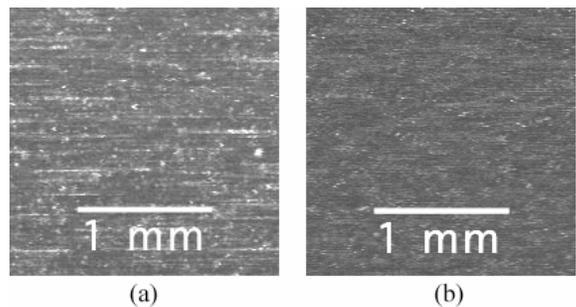
Figure 4. Detailed laser-scatter images in contact surface of SN235P valve 8 after (a) initial rough machining and (b) finish machining.

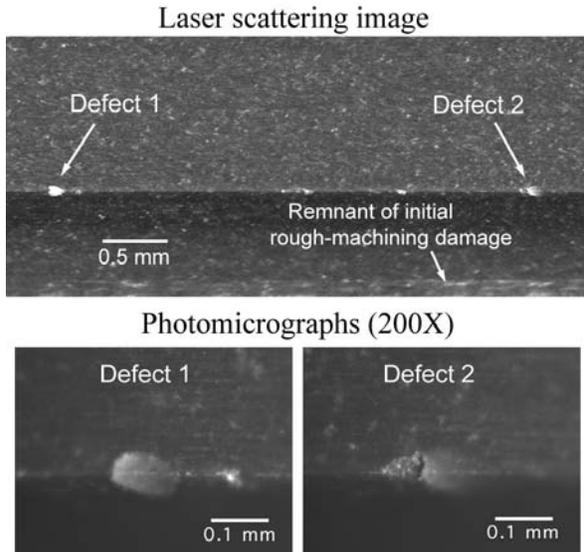
Laser scattering scan was also conducted in the keeper groove region of the SN235P valves. Before the finish machining, a severe machining damage was found around the entire circumference of the keeper-groove edge, which caused premature failure of a SN235P valve in a rig test.² In the finish-machined valves, this damage was also removed. However, because the edges are still sharp, some chip damage can be detected along the keeper-groove edges. Figure 5 shows detected edge chips in a laser-scatter image and photomicrographs.

Figure 5. Detailed laser-scatter image and photomicrographs of chip flaws at keeper groove edge of a SN235P valve.

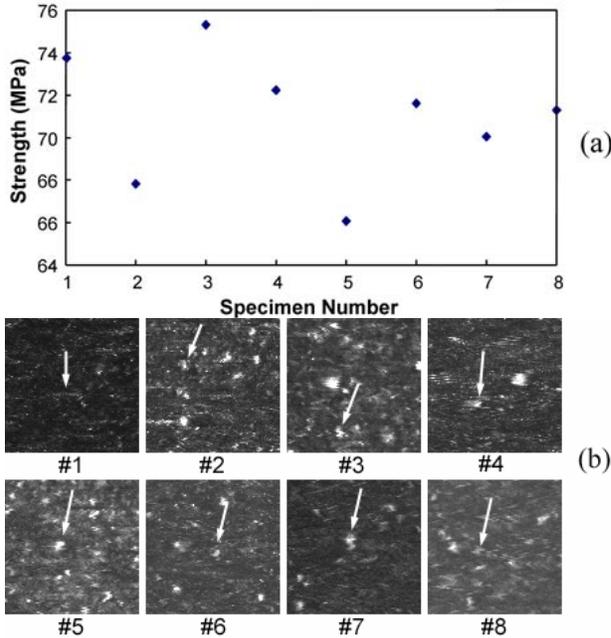
Figure 8. (a) Fracture strength and (b) corresponding fracture origins in scattering images (image size is 0.5 mm × 0.5 mm) of eight ground rods.

origin in the scanning image. It is clear that all specimens fractured from inherent material flaws (high-porosity defects), except specimen 1, which fractured from a machining damage (likely a lateral machining crack). The lowest fracture strength occurred in specimens 2 and 5. For specimen 2, there are a group of material flaws along the fracture line, which may explain its low fracture strength. As for specimen 5, its fracture origin is more intensive (likely deeper flaw) and slightly bigger (~35 μm) than those of the other specimens (~25 μm); therefore, its strength is lower.

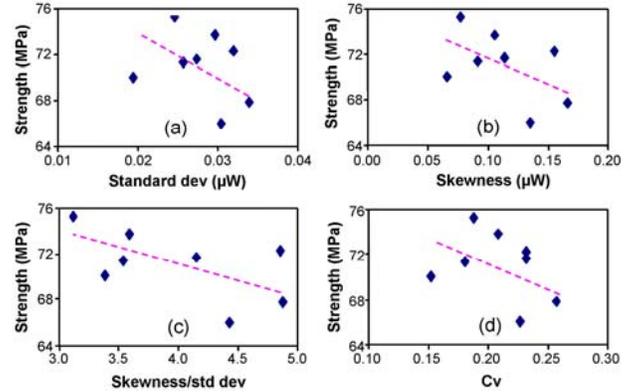
Statistical parameters of laser scatter data were correlated with fracture strength. These statistical parameters include standard deviation, skewness, skewness/standard deviation, and coefficient of variance Cv (standard deviation/mean). Figure 9 shows fracture strength as functions of statistical parameters for the eight specimens. The standard deviation and skewness in Figures 9(a–b) generally correlate well with the fracture strength. Both show a similar trend, that is, strength decreases with the increase of standard deviation or skewness. These results are physically reasonable. Because standard deviation represents the second-order and skewness the third-order difference of local scatter intensity from the

Figure 9. Correlation of fracture strength with statistical parameters processed from laser-scatter data around fracture regions.

background, a higher standard deviation or skewness indicates the presence of severe subsurface damages/defects that generate higher scattered light intensity above the background. Note that the nondimensional parameters skewness/standard-deviation and Cv in Figures 9(c–d) also show the same trend. These nondimensional parameters can be good candidates for predicting the fracture strength.
