Materials Issues Associated with EGR Systems

Michael J. Lance and C. Scott Sluder
Oak Ridge National Laboratory
June 10th, 2010

PM009

Project Objective: Provide information to industry specialists about fouling deposit properties

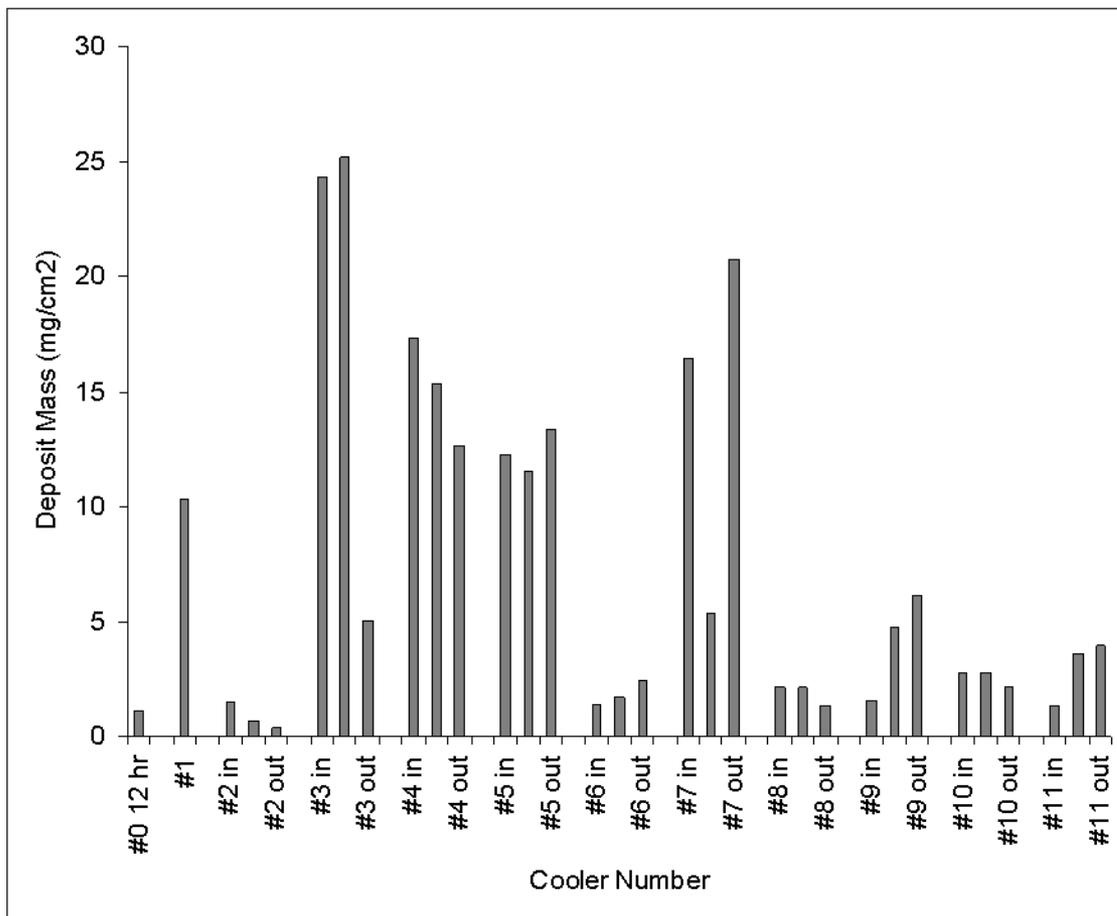
Deposit Mass per Unit Area (mg/cm²)

<i>Cooler #</i>	<i>Miles</i>	<i>Hours</i>	<i>Condition</i>
1	280000		
2			Dyno-cell
3			
4			
5	89478		Field Aged
6	113764		Field Aged
7	249128		
8		315	Dyno-cell
9		1389	Field Aged
10a	140000		Dyno-cell
10b	140000		Dyno-cell

- **There was no consistent trend between all of the coolers in the change in deposit mass along the length.**

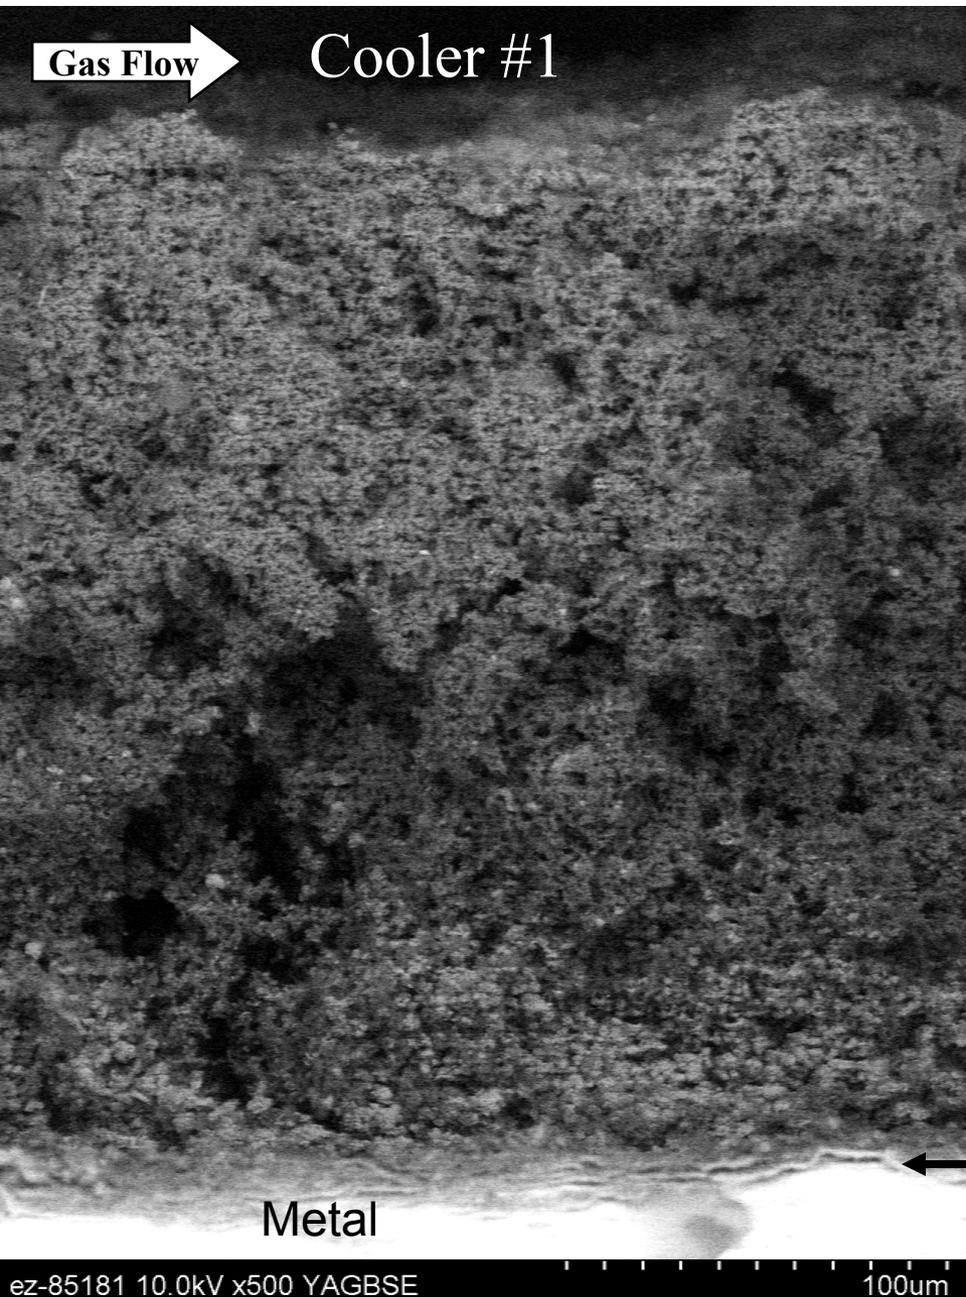
Imaging Method: Fracture Surface

- Metal is milled to the thickness of Al-foil and then broken open revealing the deposit fracture surface.
- Here, Cooler #1 has FeSO₄ particles embedded within carbonaceous material near the metal.
- There is also a corrosion layer on the metal itself.

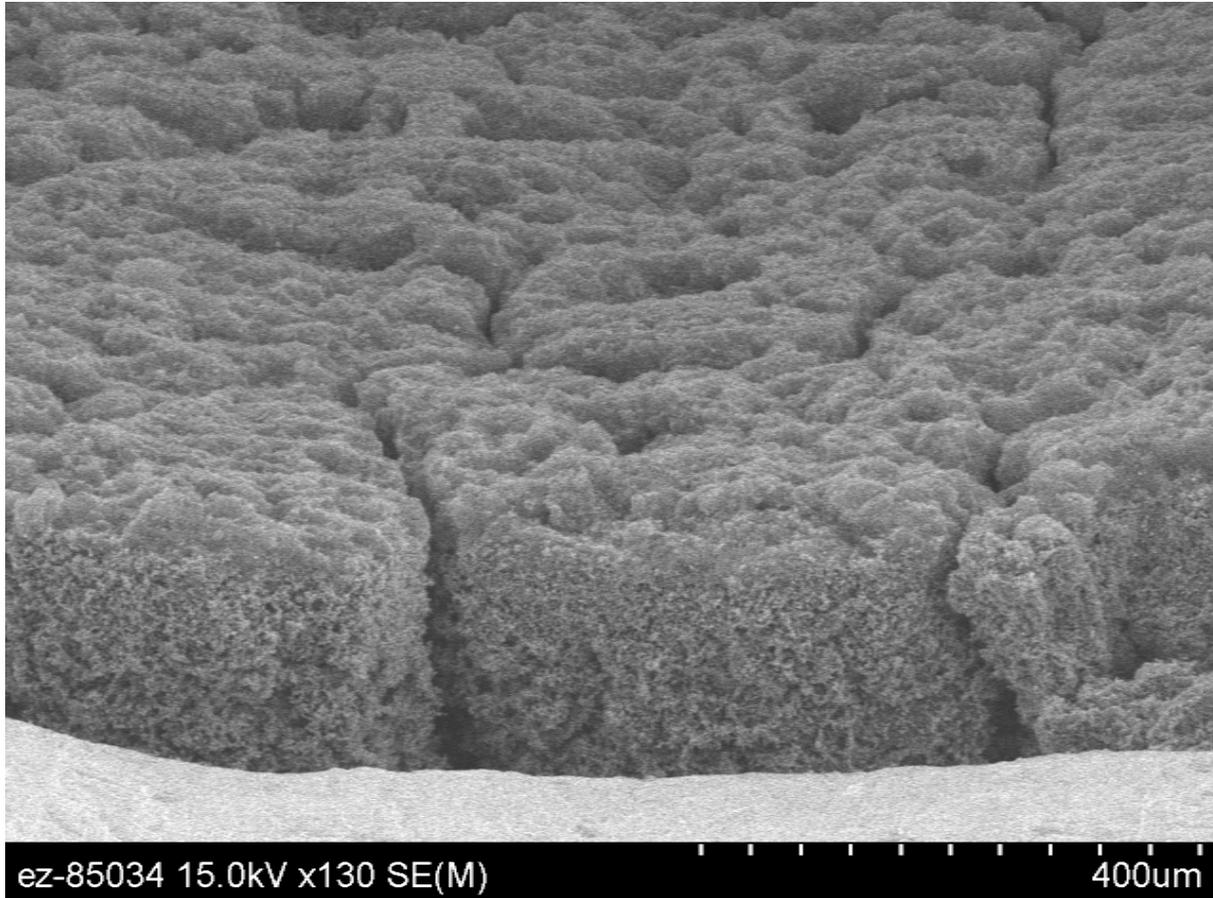
Mud-cracking is Observed in Many Coolers

- **Mud-cracking and subsequent spallation of the deposit may be a significant regeneration mechanism.**
- **Spallation has been observed near turbulators on many of the coolers.**
- **Spontaneous regeneration of the EGR cooler has been reported.**

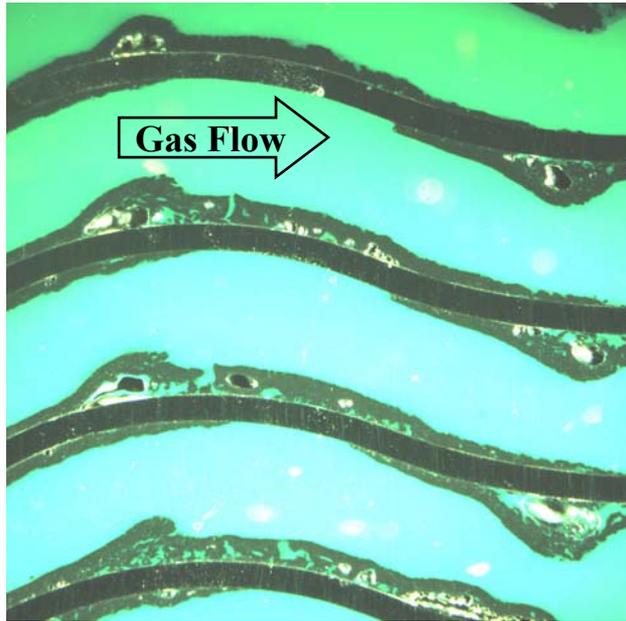
Cooler #2

- Epoxy mixed with a fluorescent dye is poured over a $\frac{3}{4}$ " section of tube without a vacuum. Mount is then ground on one side until the outer tube is gone. A second epoxy infiltration, this time with vacuum, is then done. The sample is then ground and polished.
- The technique is useful for seeing the interaction between the tube geometry and the deposit (above left) and seeing where the HC is distributed throughout the deposit cross-section (above right).
- As the black soot is covered in HC, its reflectivity increases, providing contrast when using optical microscopy.
- This technique is NOT useful for determining deposit thickness since the epoxy tends to collapse the soot microstructure.

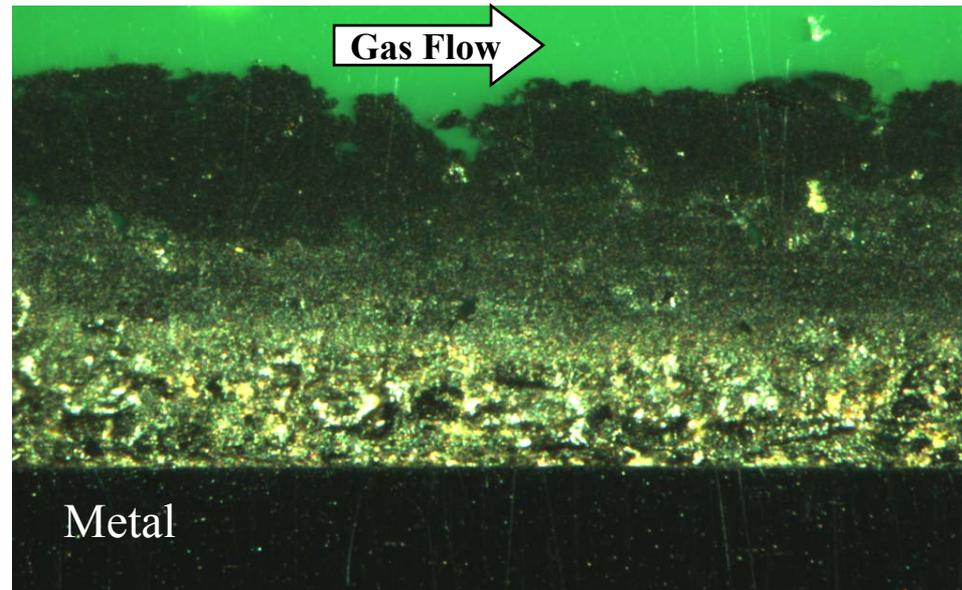
Hydrocarbon Condensation

- **A common feature of most of the coolers is the higher HC concentration at the metal. This is seen here by the increasing reflectivity near the metal.**
- **This is caused by a thermal gradient across the deposit with lower temperatures near the metal which allows heavy HC species to condense.**
- **More deposit is often seen at the sides of the tube as opposed to the finned center, presumably because it is more effectively cooled there.**
- **HC may be beneficial in low amounts by causing the deposit to be denser.**

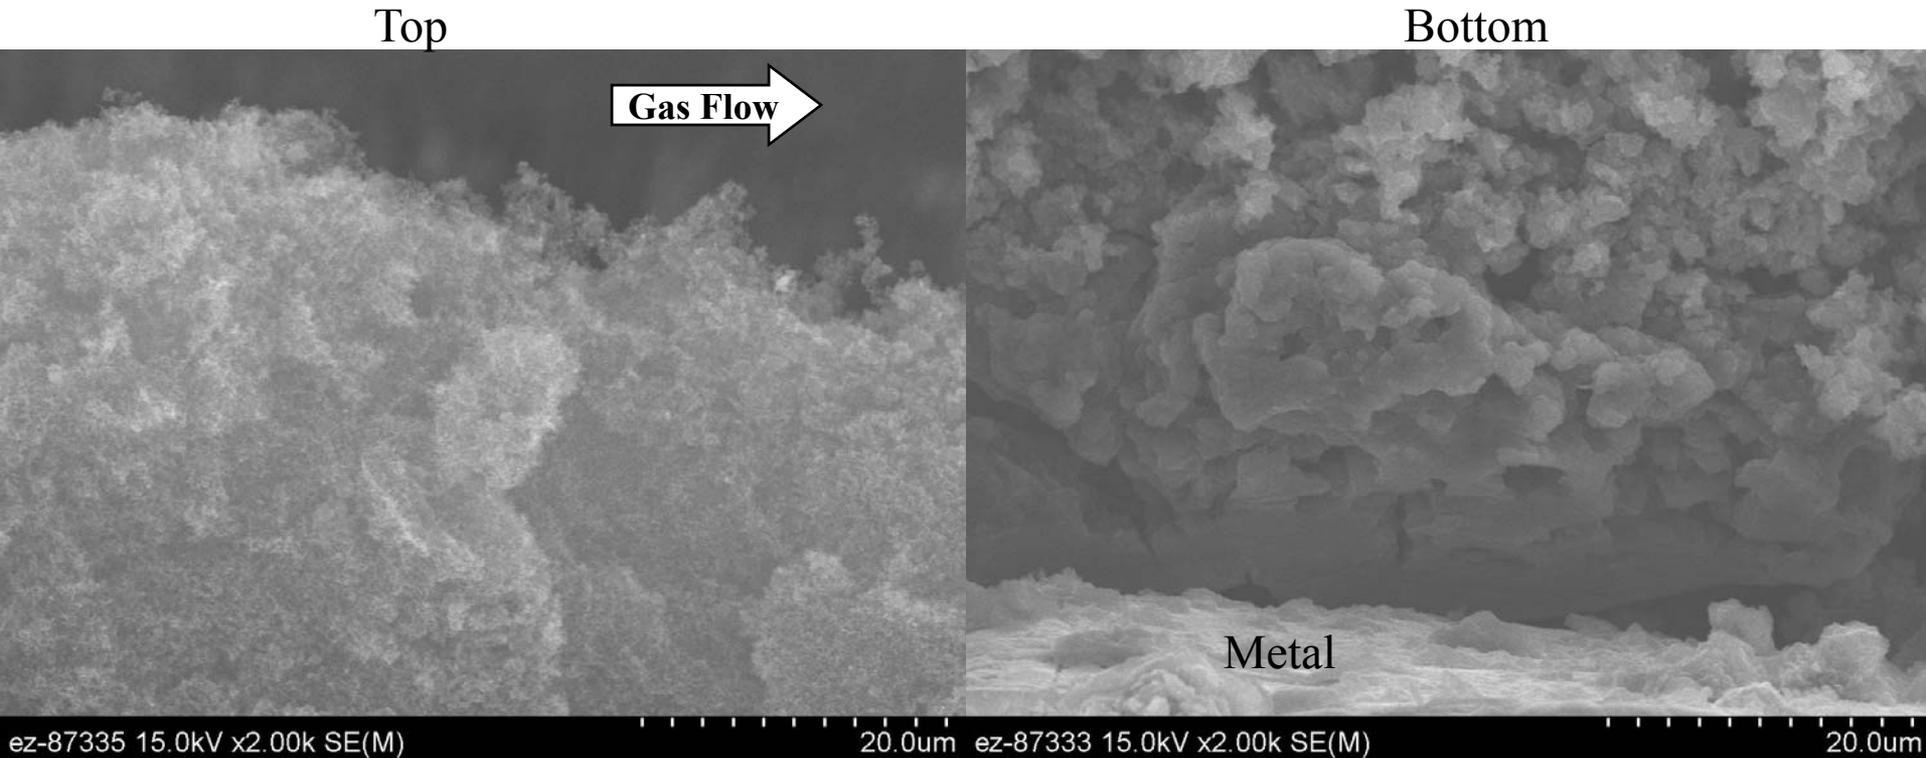
Comparing Top to Bottom of Deposit

- **Fine particulate matter (PM) can be seen on the top surface of the deposit (left).**
- **The bottom surface near the metal appears much coarser and the fine PM is hard to find.**
- **The density of the dry PM-composed deposit has been measured at ORNL to be ~2%. The condensing of HC on the PM appears to collapse the porous structure of the deposit causing it to be denser and therefore more thermally-conductive.**
- **Since HC will be concentrated at the metal surface, it will greatly influence the adhesion of the deposit.**

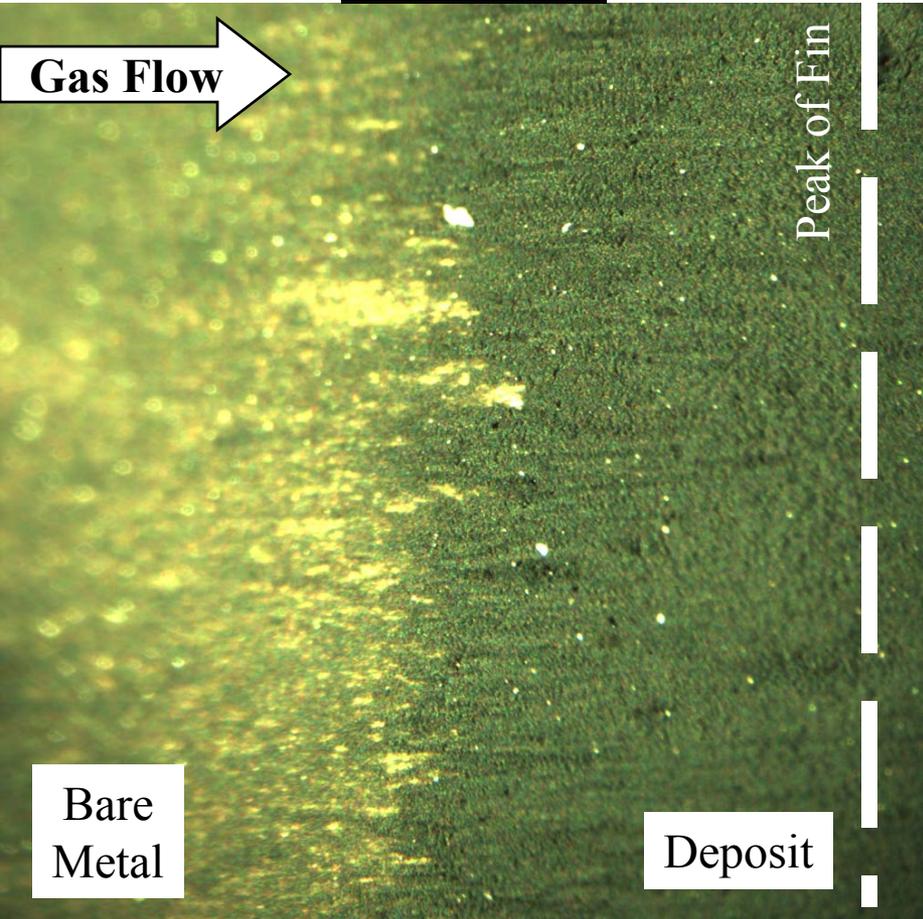
Cooler #6

- The deposit is being eroded on the leading edge of the sinusoidal peak of each fin.
- The erosion is uneven and forms channels or grooves in the deposit, presumably from the action of the flowing exhaust gas and/or snowballing.
- This microstructure has been observed on most of the coolers.

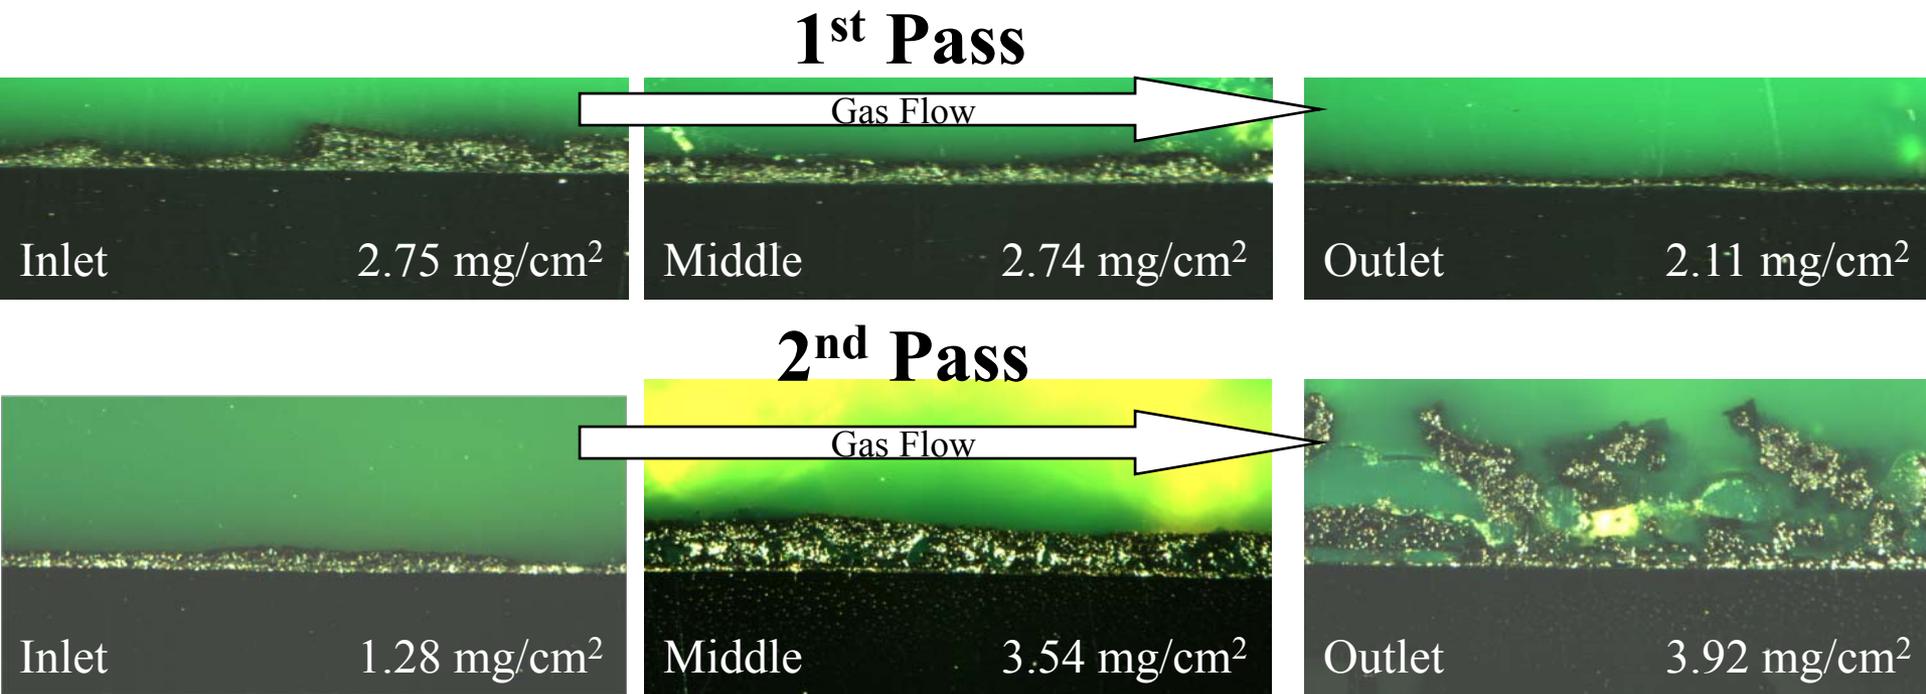
Variation in Deposit Thickness (Cooler #10a & b)

- **Deposit gets thinner and lighter down the length of the 1st pass.**
- **However, it gets thicker and heavier down the length of the 2nd pass.**
- **Fouling will be determined by multiple interacting processes including both deposition and removal phenomena.**

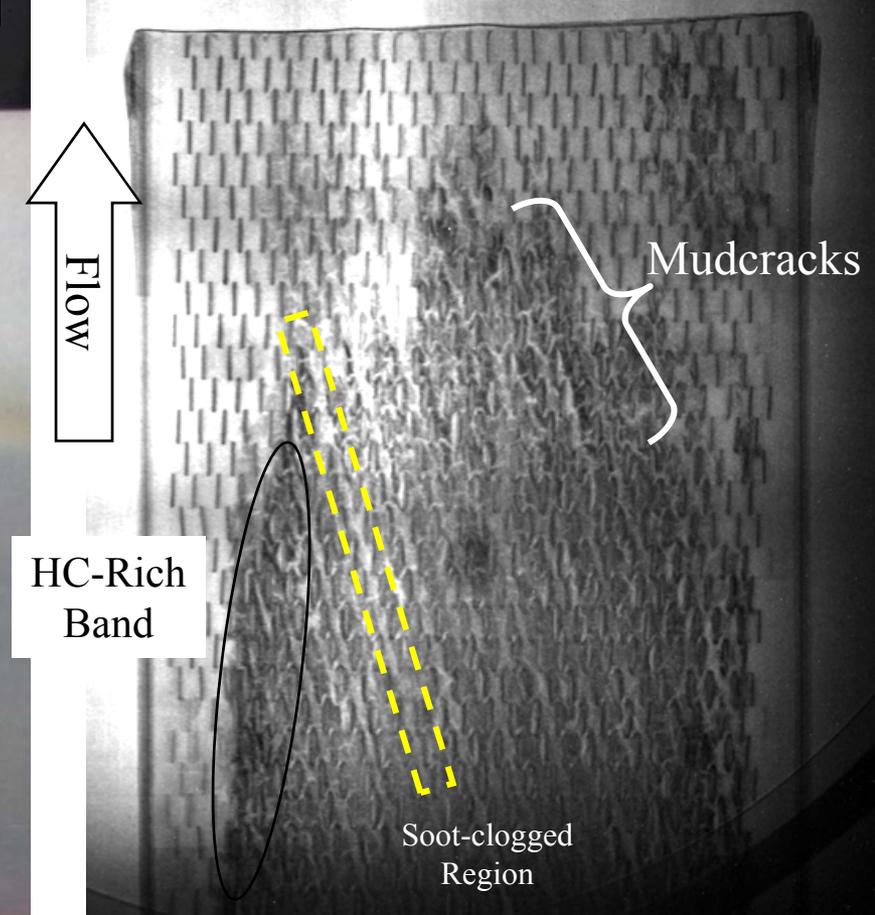
Neutron Radiograph (2-D)

- This is an image of one tube which shows the soot distribution (as the dark areas) in the cooler.
 - The exhaust gas can still pass on the right and left of the tube where there is no deposit.
 - Diagonal channels (e.g., within yellow box) seem to be forming in the clogged regions which apparently allow the exhaust gas to move through these regions.
 - The darker band on the left side of the clogged region may indicate more hydrocarbon loading in this region.
 - There appears to be breaks (mudcracks?) in the deposit that form orthogonal to the gas flow.

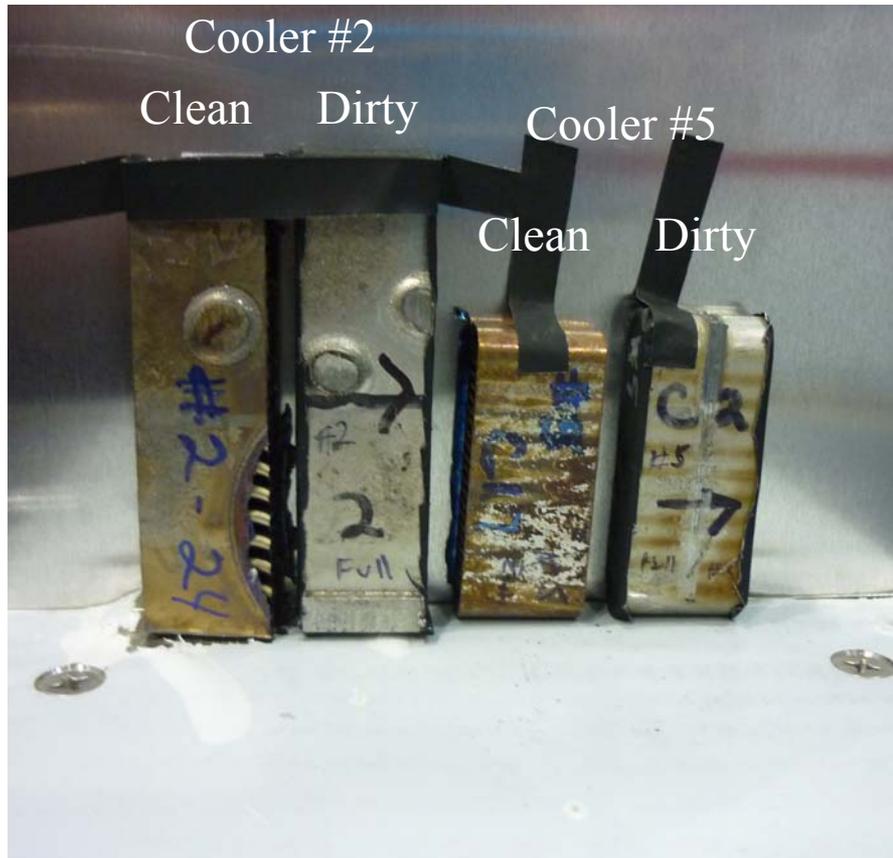
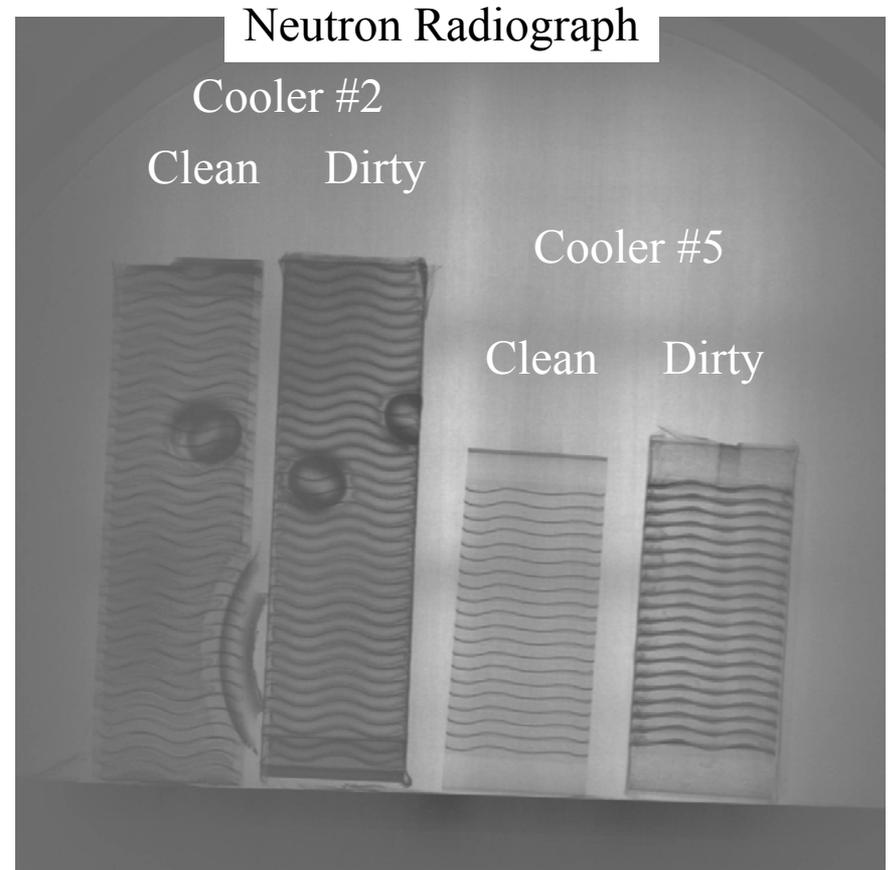
Clean and Deposit-Loaded Cooler Sections

- Cooler #2 and #5 had the lowest and highest percent hydrocarbon, respectively.
- The attenuation of neutrons is dependent on the hydrogen density in the deposit and the deposit thickness.
- The clean cooler #2 sample appears lighter than the deposit-loaded sample in the neutron radiograph because it was slightly tilted against the scintillator plate.
- Cooler #5 shows a clear darkening due to the presence of the deposit.
