# Yakama Nation Housing Authority, Adams View: System Retrofit Research Report and Case Study Summary

February 23, 2004–January 15, 2005

**CARB (Consortium for Advanced Residential Buildings)**  
*Norwalk, Connecticut*

*Subcontract Report*  
NREL/SR-550-38263  
November 2005

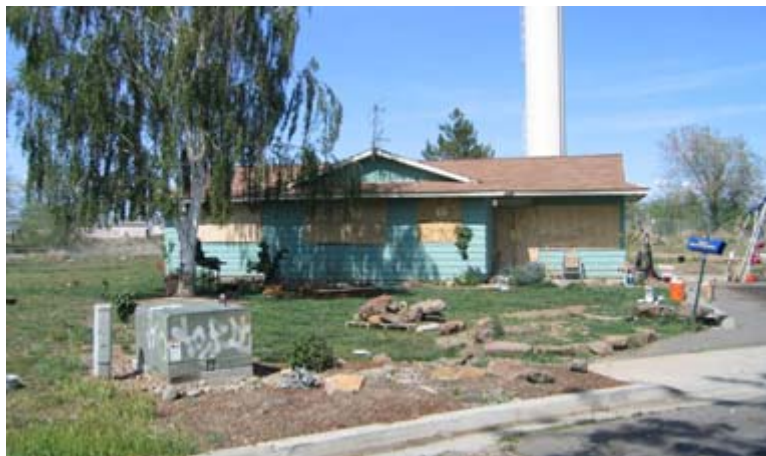
The Yakama Nation Housing Authority (YNHA) is working to rehabilitate single family homes (two to four bedrooms) in its Adams View project using public and tax credit financing. Named for the spectacular 12,307-ft Mount Adams, the Adams View project was constructed in the early 1980s under the HUD 1937 Housing Act. It is in need of a major rehabilitation as a result of wear and tear after many years of use and overcrowding (Figures 1 and 2).

**Figure 1. One of the boarded-up homes at Adam's View scheduled for rehabilitation**

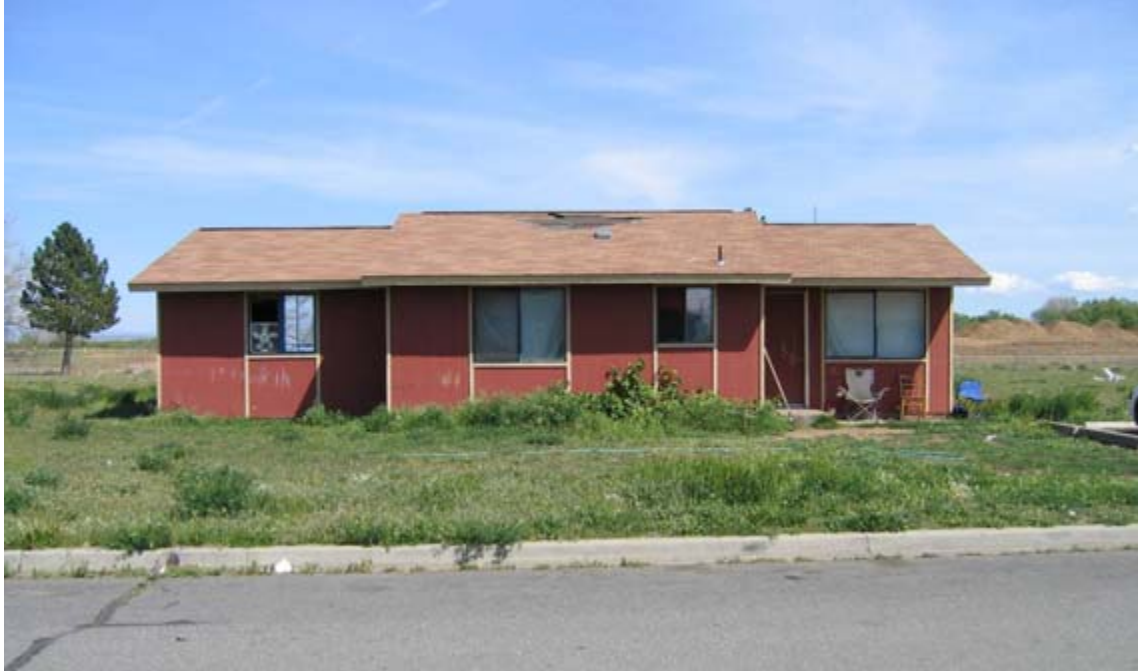
**Figure 2. Another of the homes at Adam's View (shingles blown off roof)**

Energy-efficient low-e glazing replaced the old windows, which were mostly broken and boarded up. Metal roofing material was recommended to replace the old shingles that were being damaged (pulled off) by strong winds that occur occasionally in the valley.

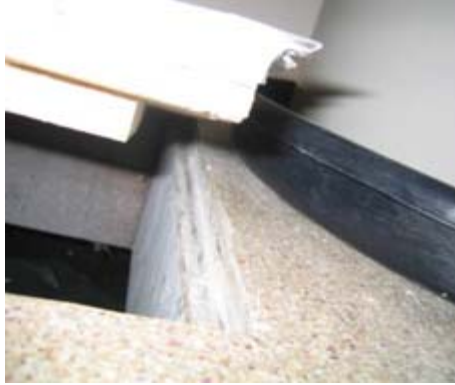
**Figure 6. Crawlspace hatch**

Placing a strip of weather-sealing foam on the rim of the crawlspace and attic hatches will provide a tighter seal of the hatch (Figure 6). The hole cut-out for the dryer exhaust should also be properly sealed to minimize leakage to the crawlspace. The holes through which the supply and return ducts penetrate the exterior wall should be properly sealed. In some cases this was done, but in others (unit #303, in particular) it wasn't.

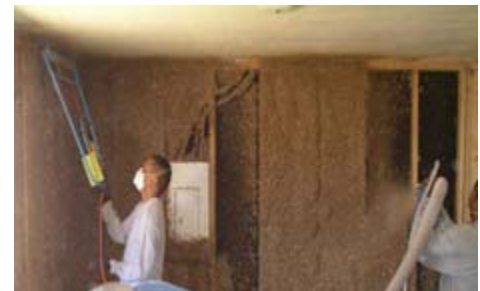
The YNHA have recently purchased a blower and have a trained crew for the installation of blown cellulose (Figure 8). Since our last visit, they have switched to blown cellulose for the wall insulation. This switch from fiberglass batts to blown cellulose could tighten the building envelope by as much as 20% as was shown to be the case in a recent Conservation Services Group study<sup>2</sup>. In addition, the blown cellulose will provide a slightly higher R-value to the building envelope (R-13) versus the R-11 fiberglass batts that are currently being used in the wall cavity. This would bring the overall wall R-value to R-15 when accounting for the insulated siding.

**Figure 8. Blown Cellulose Insulation**

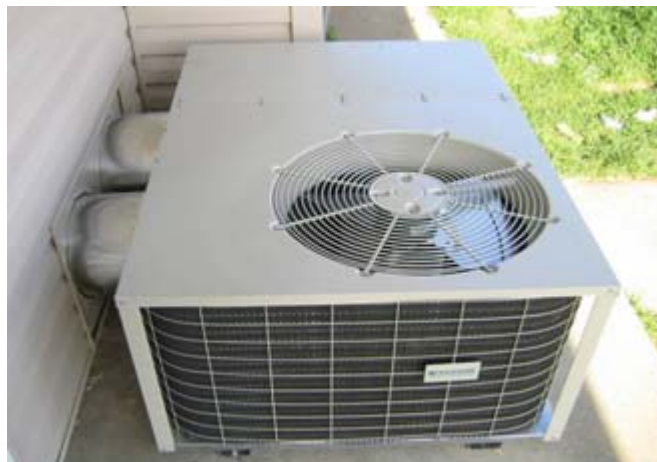
There are inherent problems with an external heat pump; for example, uninsulated ductwork might be a concern (Figure 9). However, the supply duct is actually insulated and has an external metal sleeve to protect the insulation from rain and snow. One issue that was mentioned previously was concerns of vandalism. The heat pump in Figure 9 is actually the second heat pump installed at house #303. The first one was stolen from the site a few days before CARB's testing. The units are typically bolted down to the concrete pad, but the stolen unit had not been. In addition, the testing revealed higher duct leakage to the outside values than we initially anticipated with an internal air handler. Performance testing (Table 4) resulted in duct leakage to the outside of 55.5 cfm25 (7%; with a 2-ton heat pump and assuming 400 cfm/ton).

**Figure 9. Packaged heat pump unit for house #303**

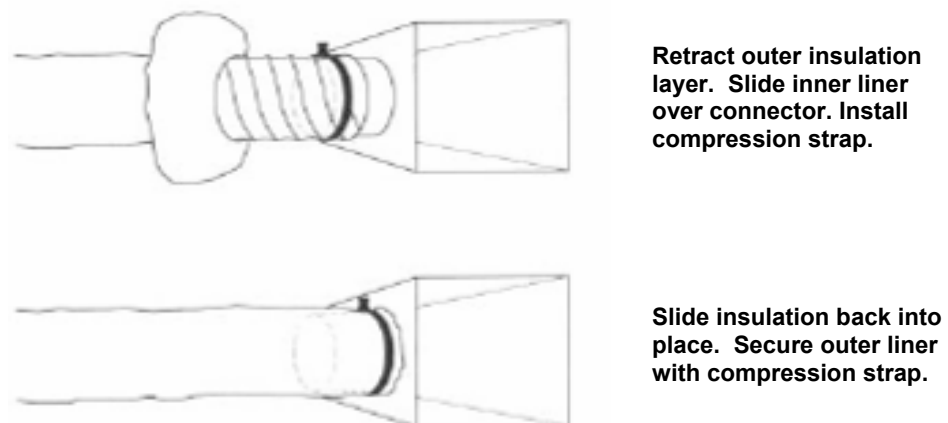
**Figure 10. Recommended procedure for connecting flexduct <sup>3</sup>**

It is difficult to minimize duct leakage to the outside when your air handler is located on the exterior, but use of mastic on the main supply and return sheet metal ducts would help. The circular supply registers are one-size-fits all, meaning that they have a multi-sized collar to allow for various supply duct diameters. As standard practice, a single compression strap/wire-tie is used to attach the flexduct to the boot. For the connection of the flexduct to the supply registers, CARB recommends the procedure illustrated in Figure 10 to improve duct tightness.

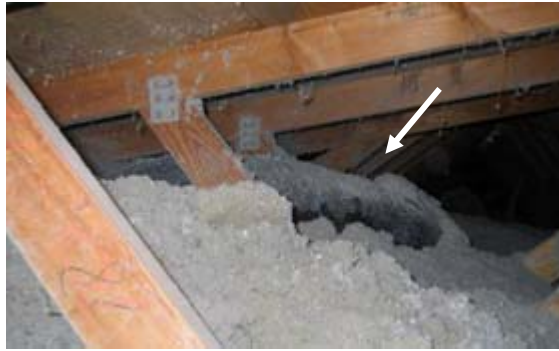
**Figure 11. Ductwork partially buried in attic**

CARB also recommends that the flexduct in the attic be buried under the cellulose insulation (Figure 11). Burying the flexduct in the cellulose, decreases heat loss and gains between the ducts and the attic space. This was successfully implemented except where the flexduct needed to cross the ceiling joists to get to the outer rooms.

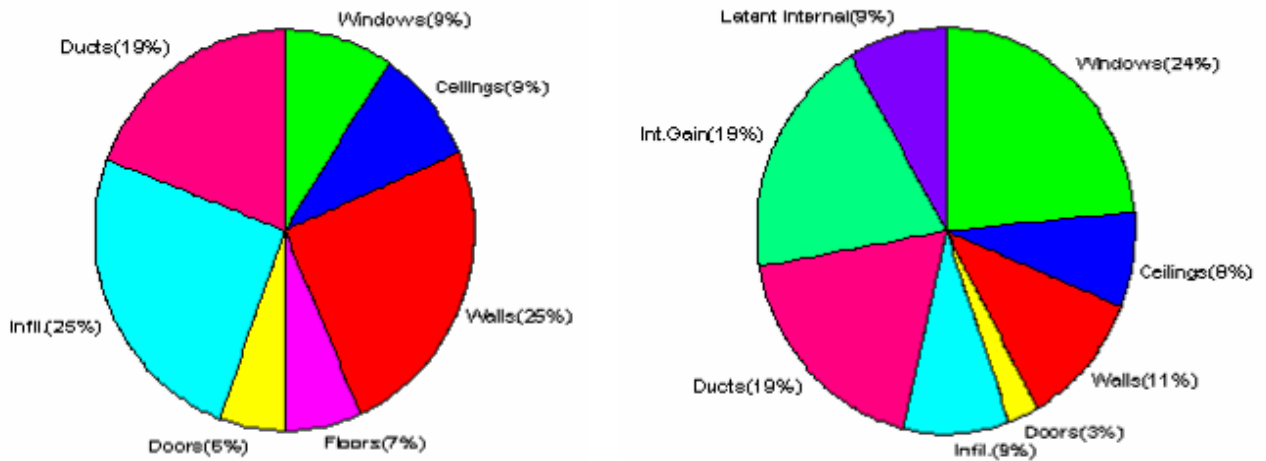
From CARB’s evaluation of the Adam’s View project, it is evident there are additional opportunities to increase performance of these units through further air sealing and the installation of tight ductwork. The test values for air infiltration and duct leakage were inputted into the energy modeling software to assess the impact of air and duct sealing on the design loads for these homes. The pie charts (Figure 12) show that air leakage (through the building envelope and ductwork) still accounts for 44% (25% infiltration + 19% ducts) of the winter heating design load and 28% (9% infiltration + 19% ducts) of the summer cooling design load.

**Figure 12. Air leakage in winter and summer**

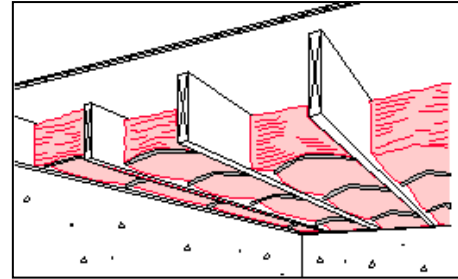
CARB has some concerns with the quality control of the floor truss insulation installation. It was observed in several of the crawlspaces that batt insulation placed in the floor is falling out in various places. This will allow for greater heat transfer through the floor and will derate the overall U-value of the floor. During the winter months, this poor installation will be more noticeable as homeowners will likely have comfort issues because of the cold spots and potential condensation problems.

**Figure 13. Spring rod installation** <sup>4</sup>

Either greater care needs to be taken in placing these batts or something like spring rods/batt hangers should be used during the installation (Figure 13). In addition, the PEX piping should have continuous insulation wrap on it. Exposed piping in the crawlspace will greatly increase hot water distribution losses (Figure 14).

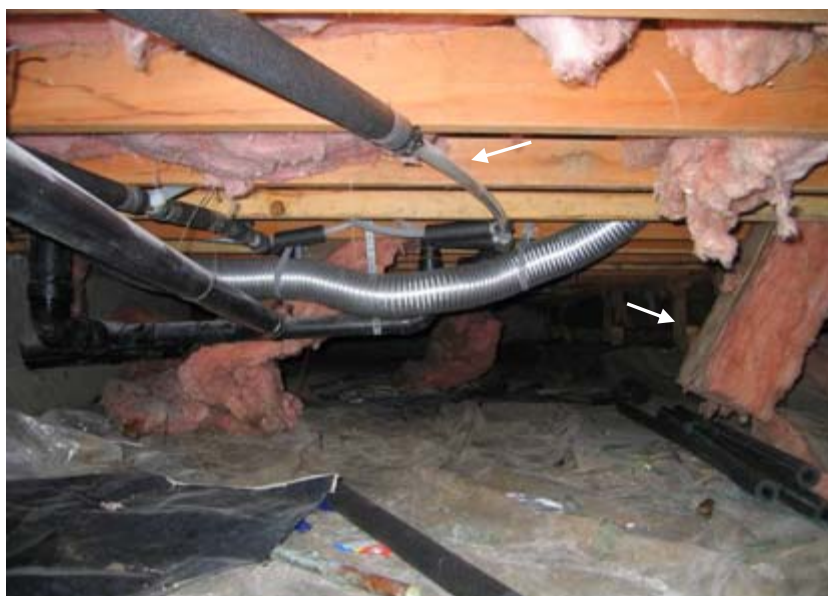
**Figure 14. Crawlspace of Unit #303**
