Balancing Hydronic Systems in Multifamily Buildings

Russell Ruch, Peter Ludwig, and
Tessa Maurer

Partnership for Advanced Residential Retrofit

July 2014

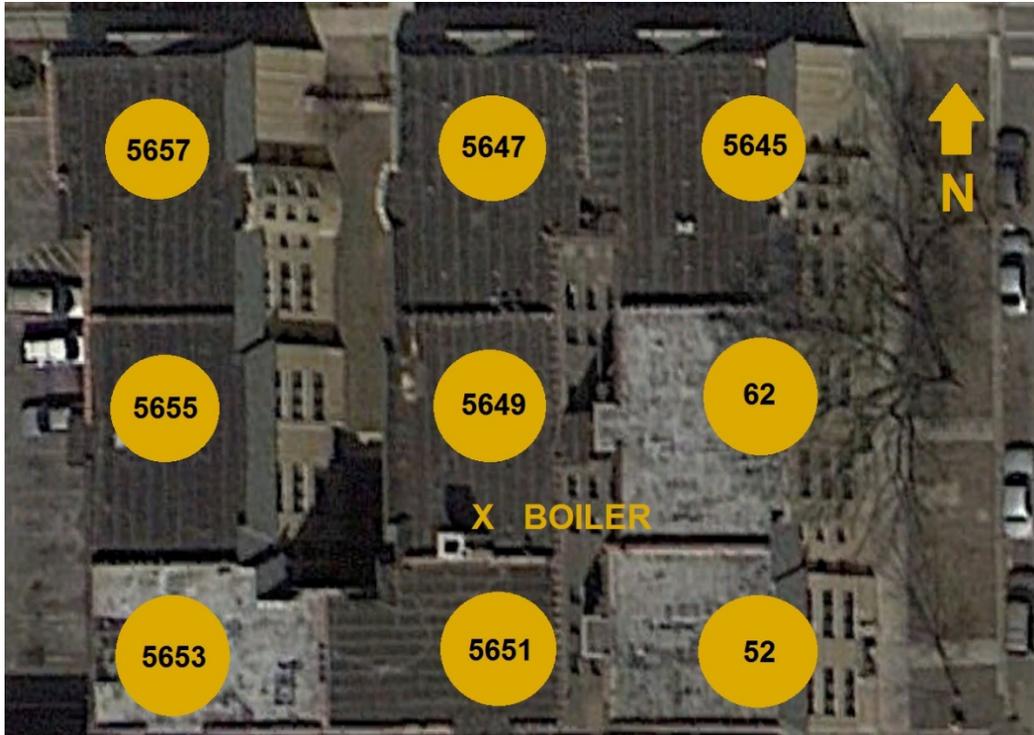
Figure 9. Aerial view of Building A; note position of boiler in southeast corner

Building A (Figure 8) was built in 1920 in an “S” shape typical of Chicago multifamily buildings of that era. Originally outfitted for a steam boiler, the building was converted in the late 1990s to a centrally metered hydronic system with baseboard radiators and multiple sequenced boilers.⁵ This new system was piped for only two zones, west and east, and the distribution piping was undersized. This resulted in chronic underheating issues in the north and west units, which were located furthest away from the boiler room (Figure 9).

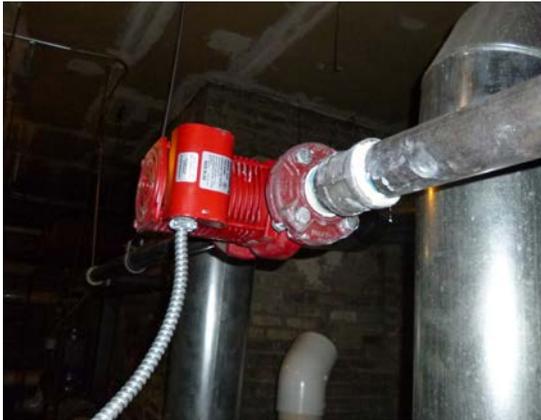
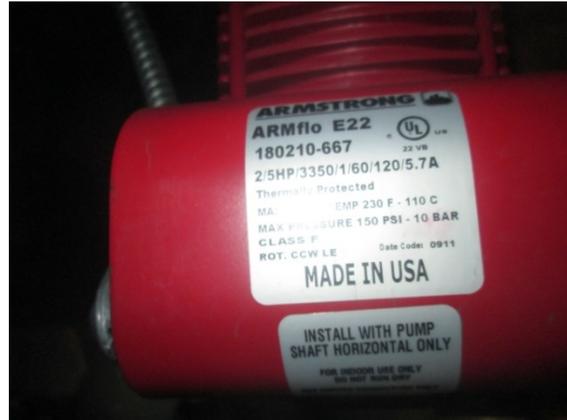
Figure 10. Circulator added to west loop at Building A

In July 2013, building management expressed concerns that despite the new temperature controls the building still had underheating issues in the north and, especially, west units. They noted that uneven heat distribution caused many tenants to open windows or supplement heat with their oven ranges. These temperature-altering actions interfered with the averaging controls to the extent that the cut-in set point had to be set at 79°F in order for the boiler to consistently heat all units to at least 65°F. The high set point resulted in severe overheating of some units, causing significant tenant discomfort and unnecessary gas usage. Ultimately building management decided to bypass the new temperature averaging controls altogether and use only the outdoor reset as the primary firing control.

In August 2013, PARR’s heating contractor submitted a proposal for a retrofit to address the imbalance issue. Since replacing the undersized piping would be prohibitively expensive, he recommended adding a booster pump to increase flow to the west loop (Figure 10). This retrofit was expected to address underheating of the furthest units, while allowing maintenance to return to using the temperature averaging controls, ideally at a lower set point temperature. Building management agreed to this proposal and signed a contract on October 1, 2013.

In October 2013 the contractor drained the system and installed isolating valves on the west loop so the pump could be installed in the middle of the heating season (for data comparison purposes) with minimal disruption. Eighteen data loggers were installed throughout the building, comprising a sample of about 50% of units. In November 2013 the contractor installed a boiler gas meter.

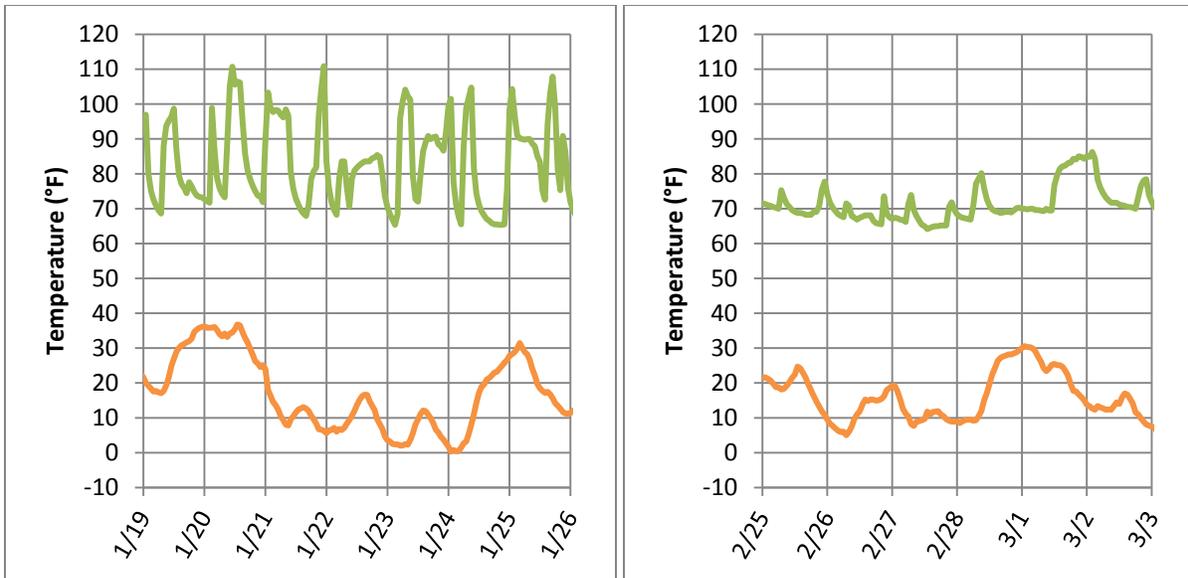
Figure 12. Two weeks of readings at unit 5651-1: pre-retrofit (left); post-retrofit (right)

Temperature in the pre-retrofit week oscillates widely within a range of 66°–111°F, cycling one to three times a day. Temperature in the post-retrofit week rises and falls within a relatively narrower range of 66°–86°F, and only rises above 81°F during a single cycle. Outdoor temperatures during these weeks were comparable.

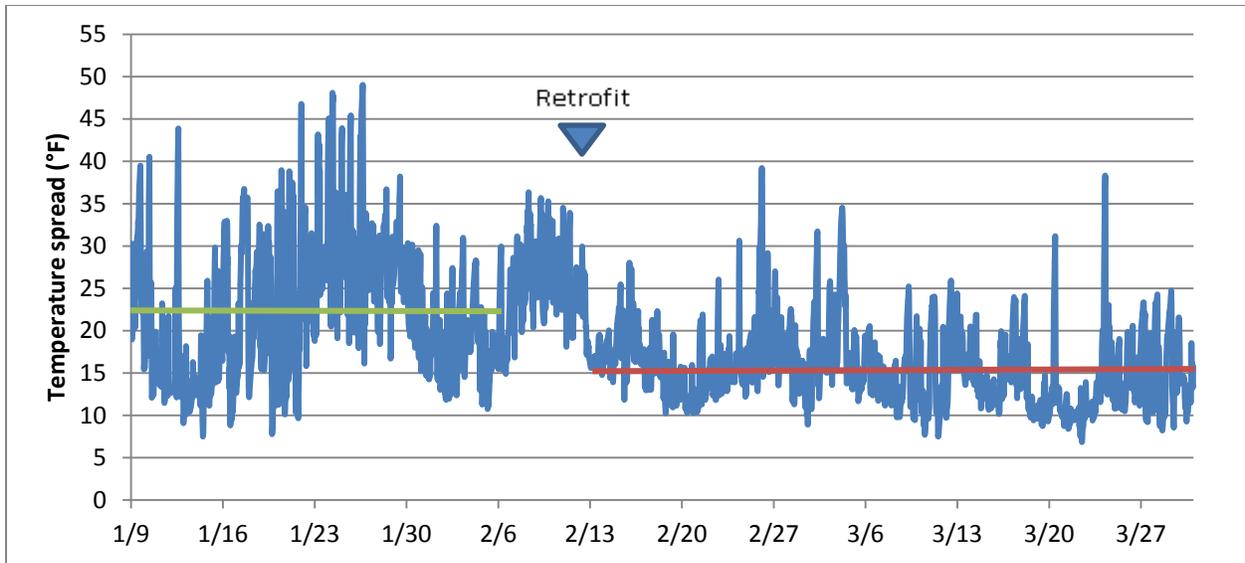
Figure 14. Difference between highest and coldest unit temperatures at 30-minute intervals

Mean differentials for the pre-retrofit and post-retrofit periods showed an improvement in temperature spread from 22.1°F to 15.5°F. This measure of temperature spread is plotted over time in Figure 14. Pre- and post-retrofit averages are shown in green and red.

As Figure 14 visually depicts, not only did the temperature spread across units generally improve after retrofit, but the incidence of temperature differences likely caused by supplemental heating also significantly decreased. This is shown by the relatively few “spikes” in temperature spread after retrofit. Though some tenants likely continued to supplement the baseboard heat, they seem to have been compelled to do so less often.

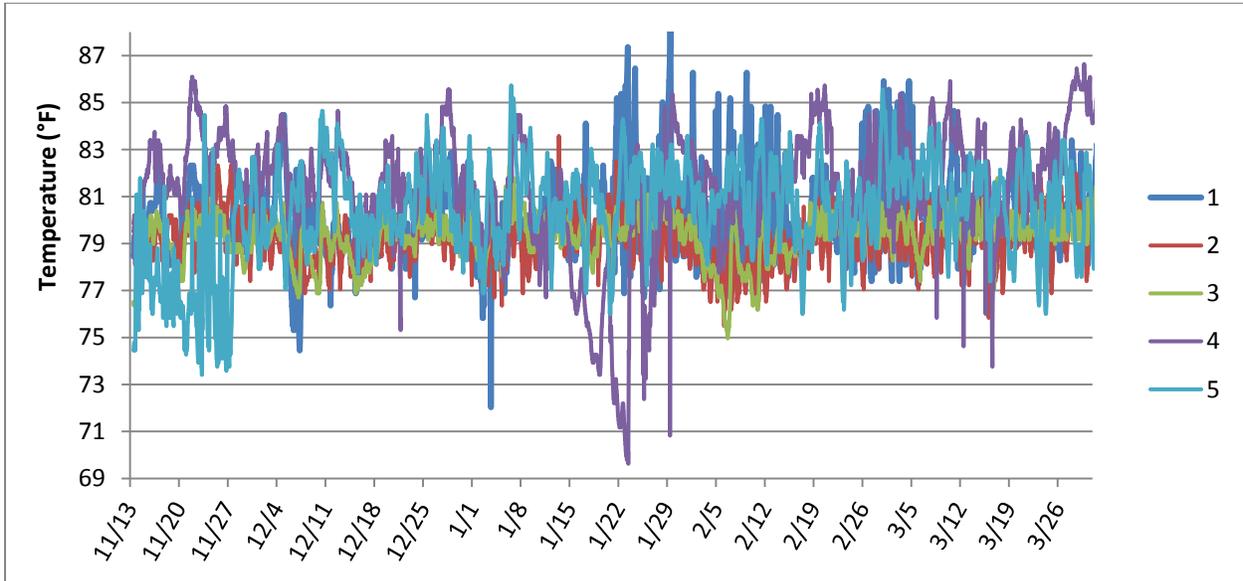
Figure 18. Temperatures in first floor units of Building B

In line with the owner’s concern, the first floor did regularly experience higher temperatures than the second floor during the sample period. First floor unit readings were generally ranged between 76°F and 85°F (Figure 18), while on the second floor temperature tended to oscillate between 72°F and 82°F (Figure 19). Note that second floor unit #8 read especially low because the tenant there preferred to set the thermostat at 60°F.
