Chamberlain Heights Redevelopment: A Large Scale, Cold Climate Study of Affordable Housing Retrofits

K. Donnelly and M. Mahle
*Consortium for Advanced Residential Buildings
(CARB)*

March 2012

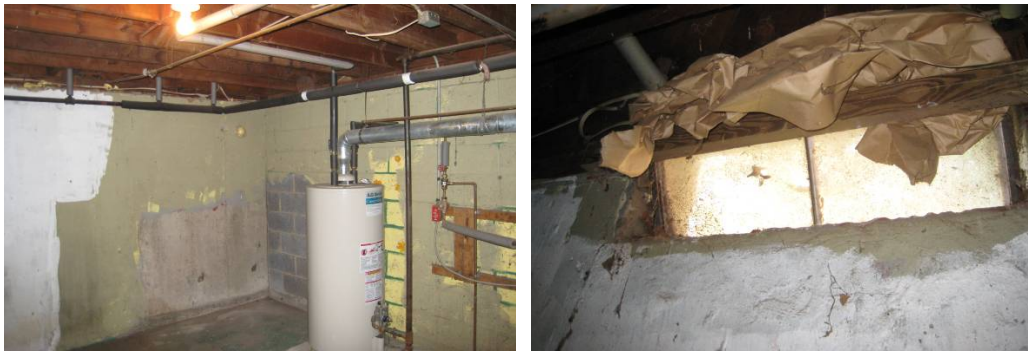
The existing foundations were uninsulated poured concrete walls measuring 7 ft in height and 8 in. in thickness. Concrete block walls divided the basements of adjoining units. Mechanical equipment was housed in the basements and some tenants used the area as additional living space. Windows in foundation walls were uninsulated, leaky, and often broken, as shown in Figure 7.

Figure 7. Basement prior to retrofit

The basement was brought into the thermal boundary with the addition of 1½-in. polyisocyanurate boards (R-10) directly adhered to the interior surface of the poured concrete foundations. The contractor installed ledger boards at the top and bottom of the concrete walls, installed the rigid insulation in between, and covered with ½-in. painted oriented strand board to provide a durable surface for tenants. For units with mudroom additions, crawlspaces were constructed of poured concrete and also insulated with 12½-in. polyisocyanurate. The crawlspaces communicate directly with the full basements without access doors. Basement windows were reframed, air sealed, and replaced (see Figure 8).

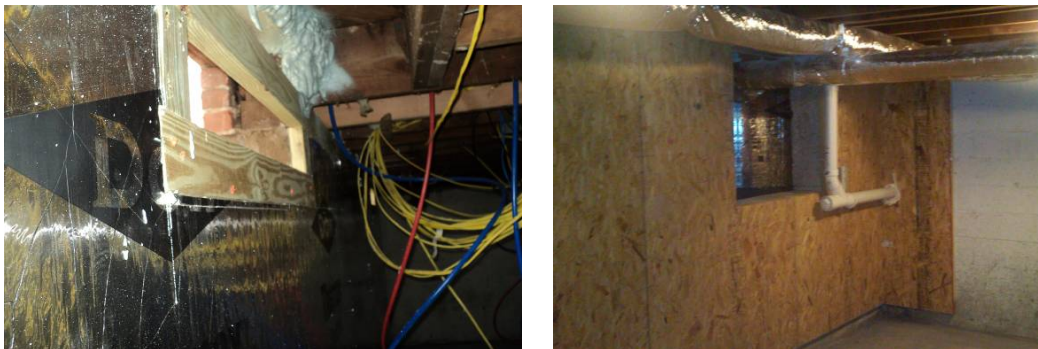
Figure 8. Basement after retrofit

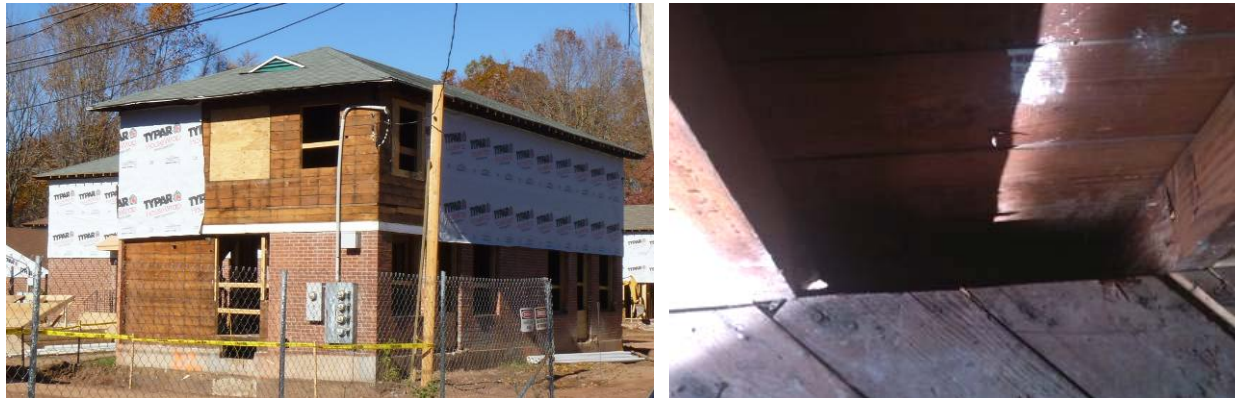
The existing 2×4 wood frame studs are 16 in. o.c. with spaced board sheathing, and most first floor units were balloon framed (see Figure 9). First floor brick veneer was preserved but second story siding was replaced. Concerns about the vapor barrier and drainage plane behind brick veneer led the team to consider a combined thermal and vapor barrier application (closed cell foam).

Figure 9. Above-grade wall prior to retrofit and balloon framing

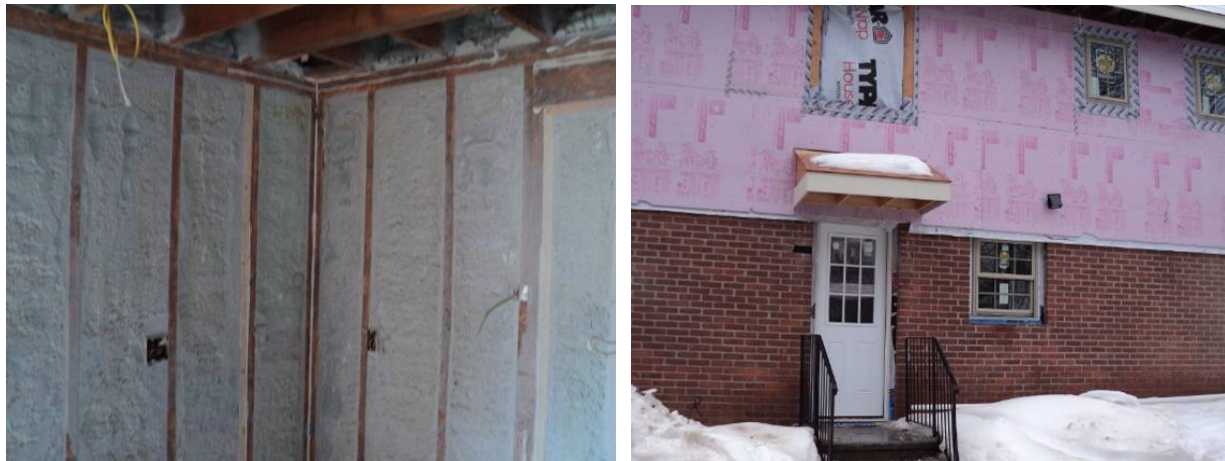
Figure 10. Above-grade walls after retrofit

Late concerns about spatial limitations associated with proposed furring led the team to proceed with the first option. Therefore $3\frac{1}{2}$ -in. ccSPF was applied in existing studs (R-5.7/in.) and $5\frac{1}{2}$ -in. ccSPF in the new mudroom additions. The ccSPF was trimmed flush. Where there was no brick veneer, an additional $\frac{3}{4}$ -in. (R-4) XPS was adhered to exterior. Code officials insisted on replacing XPS with DensGlass (R-1) in conditions where common walls intersected exterior walls on the upper floors as a fire-rated barrier. The second floor framing is cantilevered out over the brick so the siding drains to the exterior surface of the brick in a flush detail (no ledge) (see Figure 10 and Table 9).

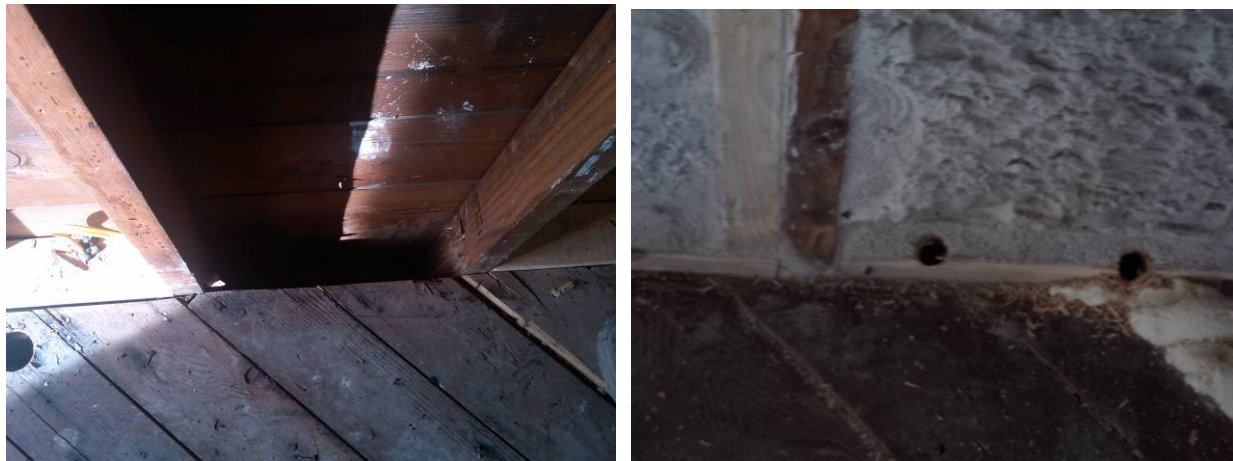
Figure 11. Balloon framing after retrofit

First floor rim joists were sprayed with closed cell foam and, where balloon framing existed, the bays were blocked and drilled, then sprayed full with foam (see Figure 11).

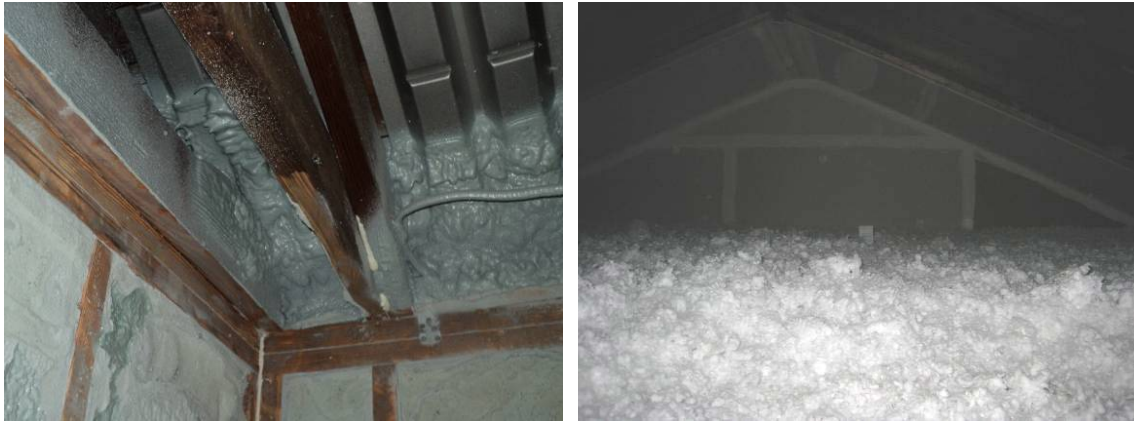
Pre-retrofit, vented attics were accessible to tenants and insulated with mineral wool batts (R-19 approximate). Ceiling penetrations were not air sealed and baffles at soffit vents were not secured into place. Based on the pre-retrofit conditions, it was assumed that a significant amount of air infiltration traveled from the attic through wall cavities and out floor, ceiling, or wall penetrations.

Figure 12. Baffles foamed in place and blown fiberglass in attics

Consideration was given to spraying the rafters with ccSPF to create unvented attics and R-50 blown cellulose at the attic floor. The more cost-effective alternative was to blow 18 in. of fiberglass insulation at the ceiling joists (R-44) and spray foam baffles into place to maintain a vented attic. Prior to fiberglass, effective air sealing was to be accomplished at the ceiling plane at all through-ceiling penetrations (smoke/carbon monoxide detectors, surface-mounted fixtures) and gypsum-board-to-top-plate intersections using ccSPF. Similar air sealing and blown-in fiberglass (R-44) was achieved in mudroom addition attics. CARB recommended against using hat channels on the top floor to attach gypsum board, but a late change saw the channels re-introduced and blower door testing revealed infiltration on the top floor. Attic access panels were insulated and gasketed with key access to discourage tenant use (see Figure 12).

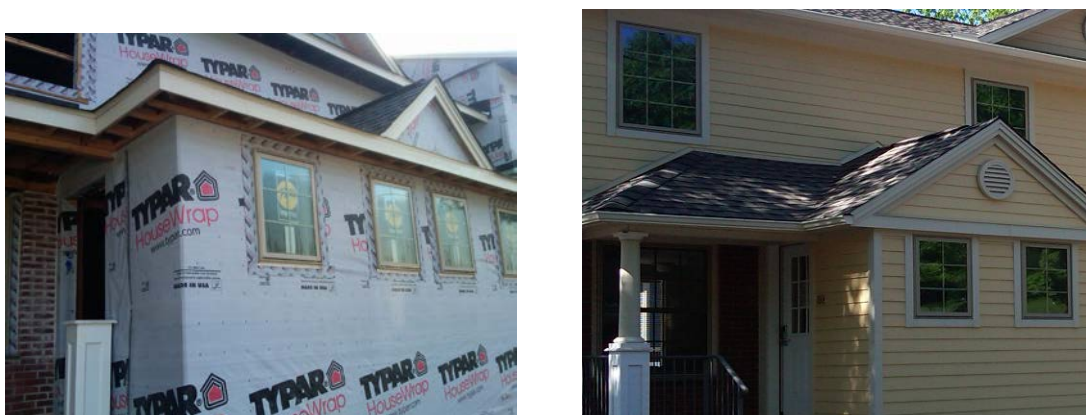
Existing windows were clear uninsulated aluminum with U-value 0.60 and SHGC 0.65. The cost-effective solution that met the aesthetic and durability requirements was to replace windows with aluminum clad low-E argon-filled units. The new ENERGY STAR qualified windows are U-value 0.32, SHGC 0.25 (see Figure 13).

Figure 13. Windows during and after retrofit

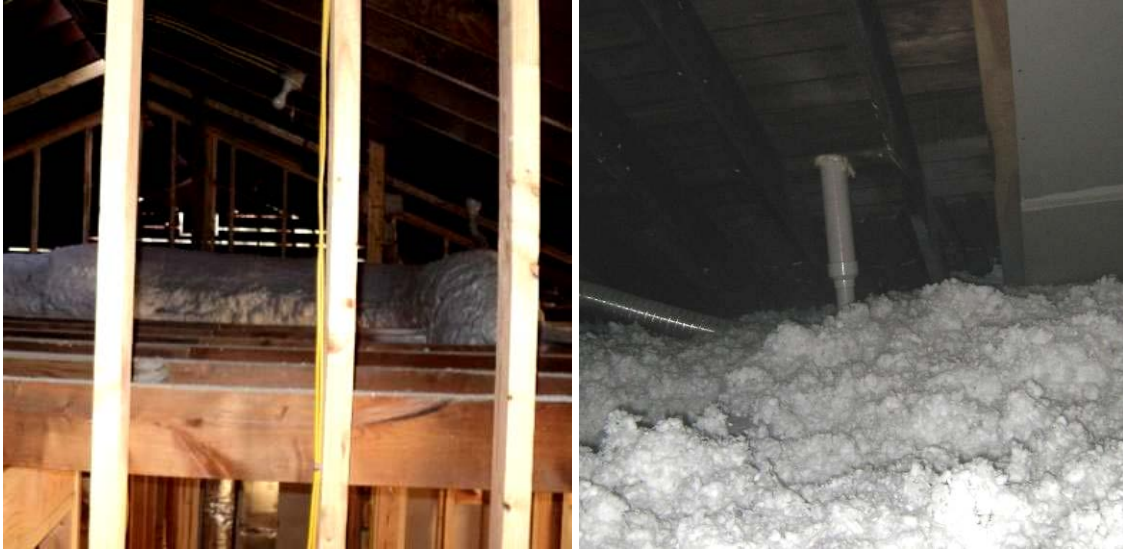
Figure 15. Attic ducts sprayed with ccSPF and buried in blown fiberglass

Most of the newly installed ductwork was run from the basement air handler throughout the first floor, keeping them in conditioned space. However, the first floor ceiling height restrictions (7 ft, 6 in.) limited space for second floor runs so the horizontal supplies were located in the attic. The return riser is within the second floor conditioned space. The attic ducts were sealed with mastic at joints and seams, sprayed with 2 in. ccSPF, and buried in the blown-in fiberglass (see Figure 15). CARB has successfully implemented this foam-encapsulated, buried duct technique on other projects to mimic inside-conditioned-space distribution performance. This approach achieves a thermal equivalent of R-25 and duct blaster tests typically result in negligible leakage to the unconditioned attic.

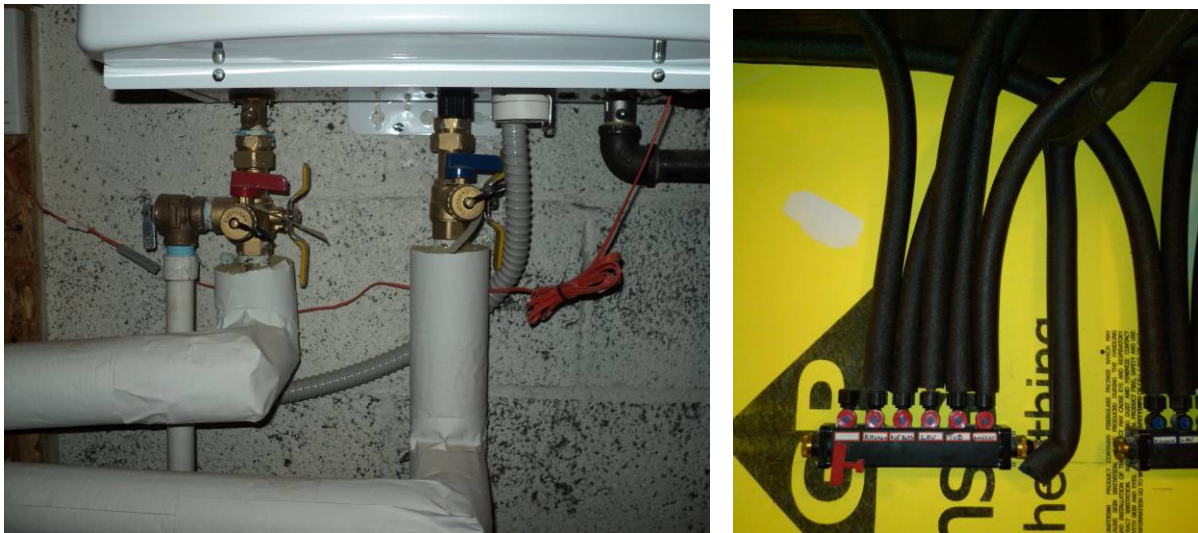
Figure 16. Insulated copper at tankless unit and insulated PEX at branch runs

The installed hot water system eliminates standby losses by replacing the indirect tank off the existing boiler with a tankless water heater (0.94 EF). Additionally, all pipes were insulated with a R-5 minimum, and PEX branch runs were no longer 22 in. from source to fixture. Additional water savings features installed are: (1) 1.75-gpm low-flow showerheads, (2) 1.5-gpm low-flow lavatory faucets, and (3) efficient dishwashers that use less than 6 gallons per cycle (see Figure 16).

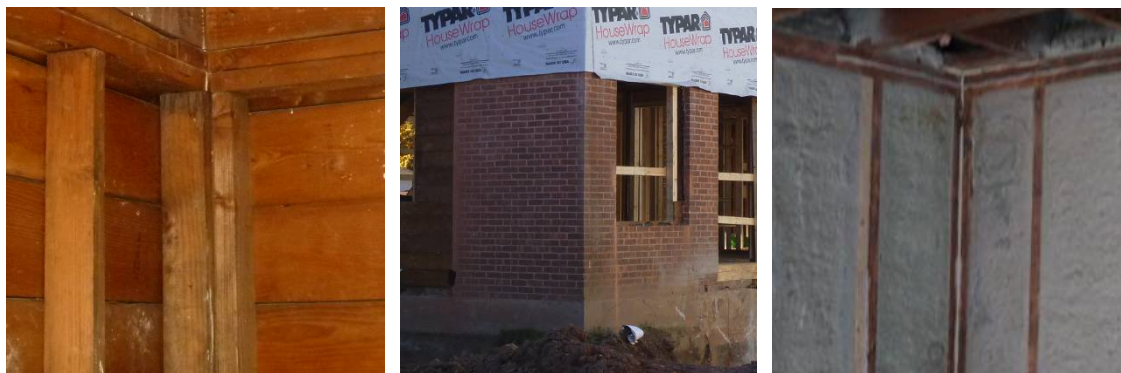
First floor corners were framed to accommodate the brick returns; the two stud ends meet at the interior corner, leaving an open space to the outside (see Figure 18). CARB recommended drilling the corner studs to spray ccSPF in the open cavity. The project team rejected this technique due to time and cost constraints, so corner studs were air sealed with foam or caulk at the interior joint. During intermediate inspections and air infiltration testing, infrared images show temperature differences at the corners and air infiltration with the blower door operating (see Figure 19). Based on the infrared analysis, CARB confirmed that the uninsulated corners represent still a significant source of energy loss/gain and potentially lead to occupant discomfort.

Figure 18. Corner framing, uninsulated space, air-sealed joint

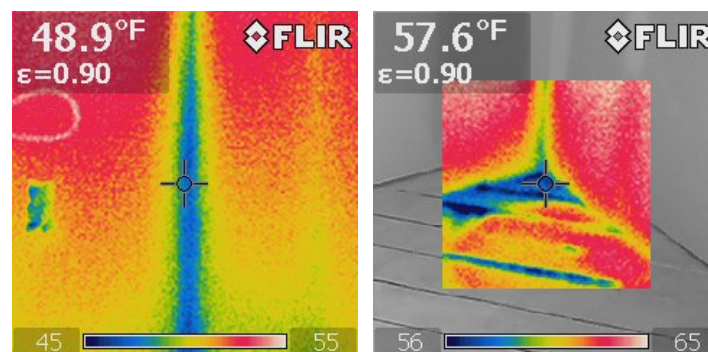
Figure 19. Infrared of cold corner and blower door pulling across the floor

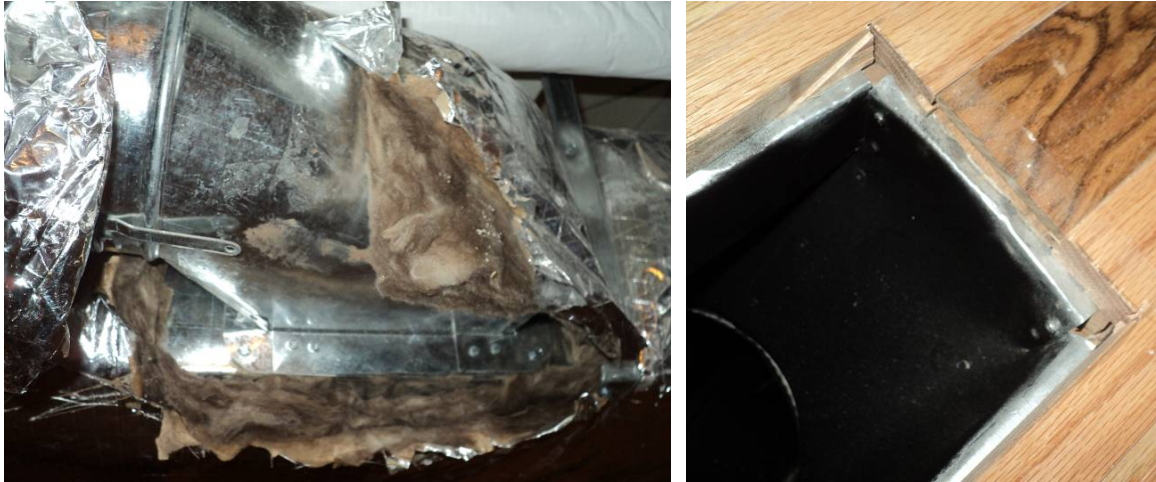
The HVAC contractors diligently implemented the duct sealing specifications for distribution runs in the attic and above-grade conditioned spaces, but were remiss with ducts in the basement. SWA raters visually inspected installed ducts during intermediate site inspections but basement ducts were not installed until final stages of construction, therefore, they were not assessed until final testing. Final duct blaster results showed significant duct leakage. Although the air infiltration numbers were somewhat high (3.7–8.2 ACH50), the duct leakage seemed very high given the sealing strategies specified. After investigative testing, SWA identified conditions contributing to the duct leakage: (1) air handler cabinets and filter housings; (2) unsealed

basement duct work; and (3) unsealed registers (see Figure 21). Generally speaking, the air handler cabinets were very leaky so HVAC foil tape was used to seal the joints. Apparently time constraints caused the HVAC installer to neglect to seal basement ducts before covering them with insulation. The problems were identified after the first five units were completed. Corrections were made to these sample homes, and the practices were successfully carried through to future units. One CARB recommendation that was not implemented was use of rigid filter racks. The team used sheet metal chambers to save cost, which remain a point of leakage because sealing would inhibit changing of filters in the future. Table 12 shows the improvement in duct leakage numbers after the issues described above were addressed.

Figure 21. Basement ducts were unsealed in initial units

Tested Unit 30 Hollis Drive	Tested Leakage to Outside cfm at 25 Pa	Leakage to Outside per 100 ft² (cfm at 25 Pa)
Before Corrections	178	21.2
After Corrections	30	3.57
