Field Testing of Compartmentalization Methods for Multifamily Construction

K. Ueno and J.W. Lstiburek
Building Science Corporation

March 2015

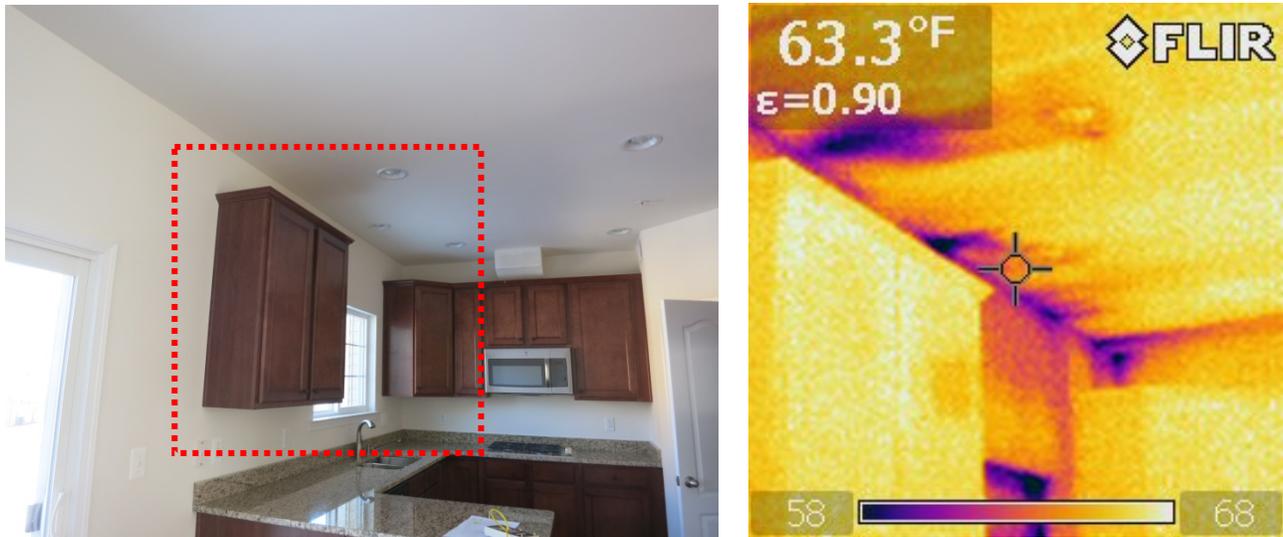
One consistent issue arose at the second- to third-floor ceiling/floor assembly (across several units); this is shown at a rear second-floor kitchen in Unit 6704 (conventional construction) in Figure 24 and Figure 25 (keyed to “A” in Figure 23). Air is entering the floor framing cavity from the exterior at the third-floor overhang detail.

Figure 24. Rear second-floor kitchen, Unit 6704 (middle)

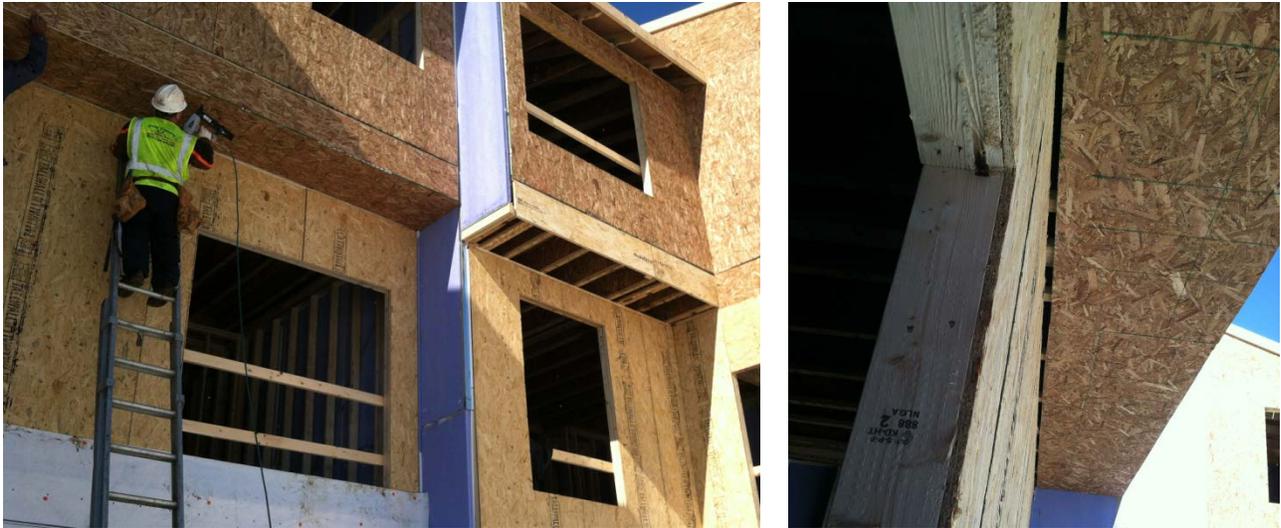
Figure 26 shows the construction of this detail on the adjacent building in frame. The underside of the overhang was sheathed with OSB, but large sheathing gaps were common. No visible blocking detail separated the overhang floor cavity from the main floor cavity.

Figure 26. Overhang detail in framed building, showing gap in sheathing at inside corner

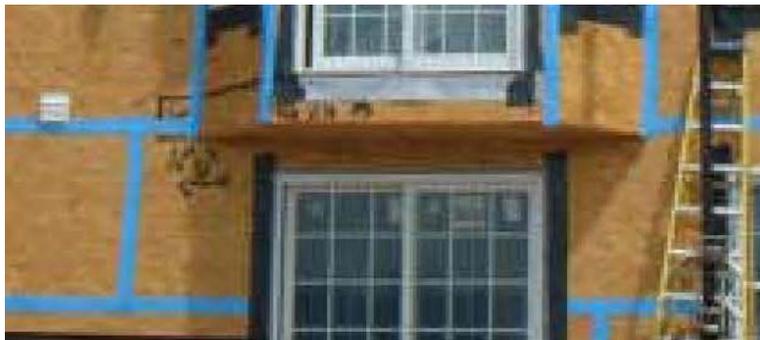
Surprisingly, this leakage was even seen in one of the two taped sheathing units (6700), albeit in a much reduced form. A possible explanation is shown in Figure 27: although the flat sheathing seams were taped, the inside and outside corners of the overhanging bay were left untaped.

Figure 27. Overhang detail at taped sheathing condition

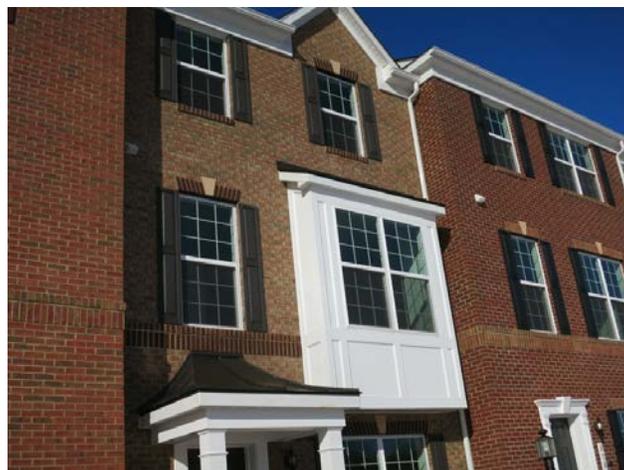
The projecting bay at the front of Unit 6702 (middle, improved, and taped) had significant air leakage at the ceiling, visible at the framing (Figure 29; keyed to “B” in Figure 23). An exterior view of the bay is seen in Figure 30. The metal roof of the bay does not appear to be vented; no further investigation or disassembly was done.

Figure 30. Front bump out bay detail at unit 6702

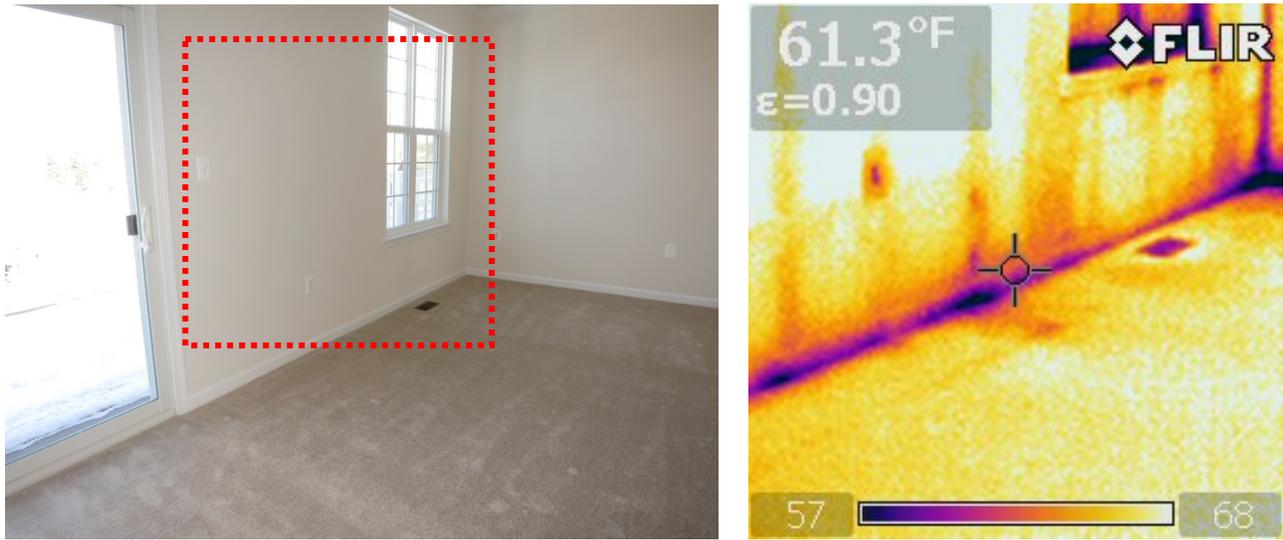
Air leakage was seen in multiple units at the baseboard at exterior walls (Figure 31).

Figure 31. Air leakage at first-second floor/ceiling assembly, Unit 6702

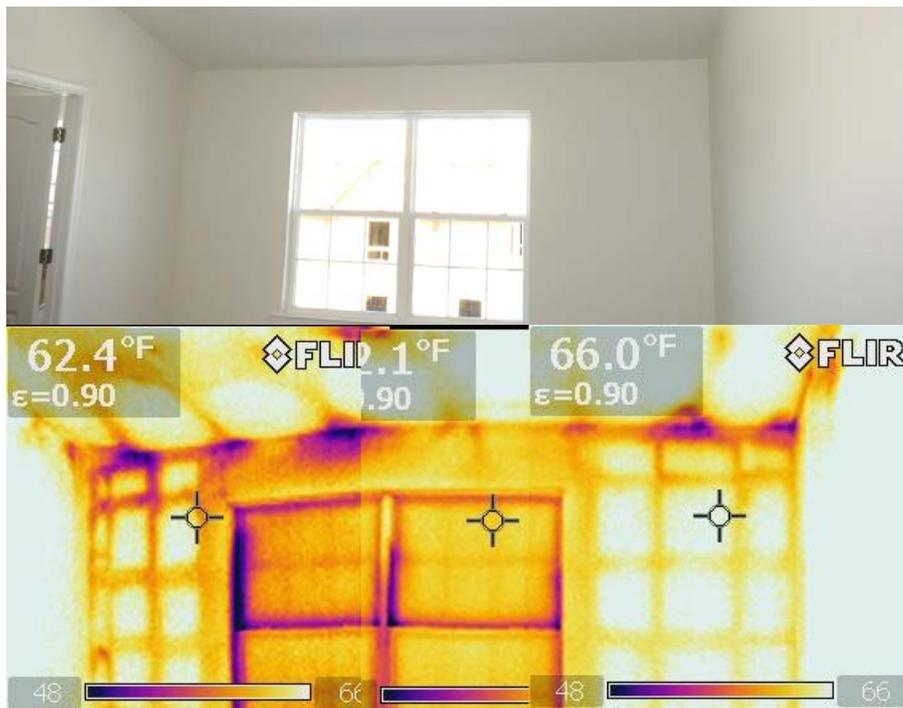
Leakage was consistently seen at the top (third)-floor roof-wall connection, often at the rear of the units (keyed to “C” in Figure 23). The rear of the building has some type of cross-framing detail (possibly horizontal strapping or resilient channel); the leakage might be due to insufficient sealing of the top of the cavity. The fact that the leaks coincide with the roof trusses (where access and visibility would be limited) is consistent with this theory.

Figure 32. Rear wall/vaulted ceiling leakage, Unit 6706

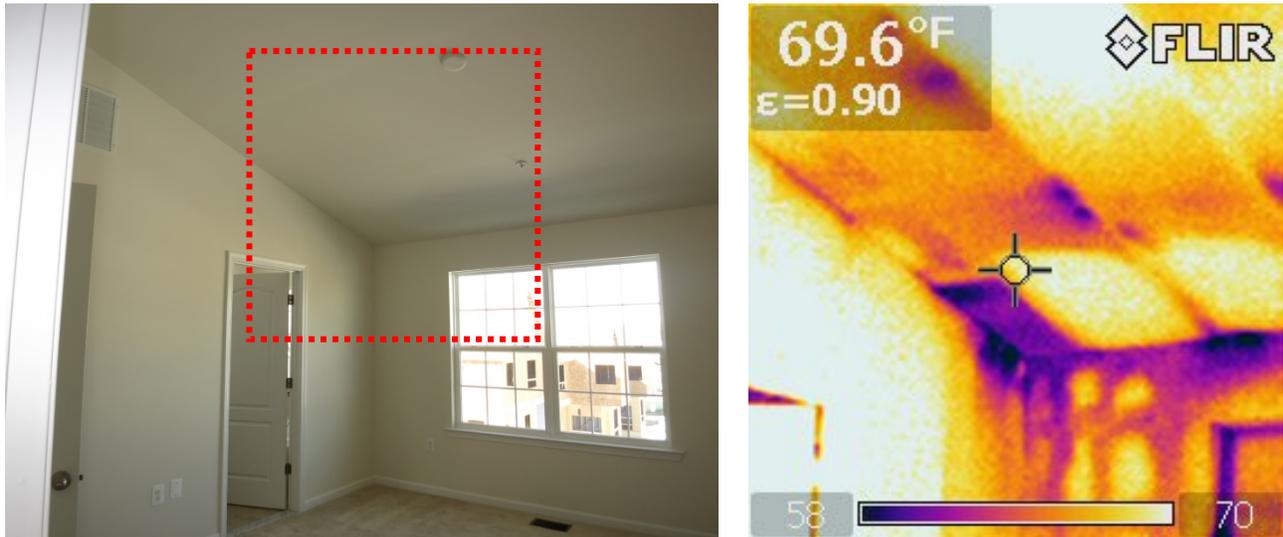
Issues were also seen in the vaulted ceiling (Figure 33).

Figure 33. Vaulted ceiling air leakage, Unit 6706

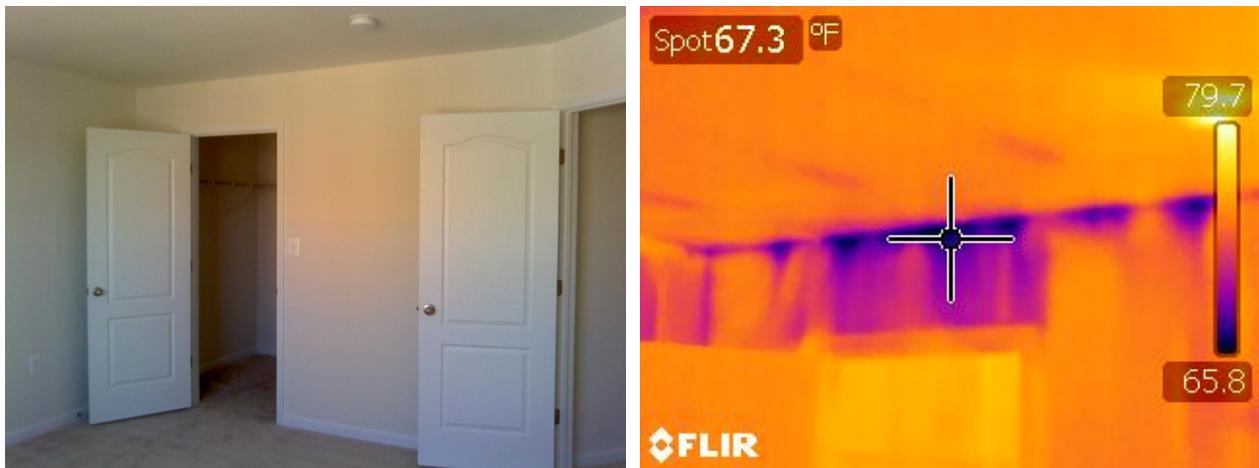
At several interior walls under the vented/unconditioned attic, noticeable air leakage was visible at the top plate (Figure 34 and Figure 35, keyed to “D” in Figure 23). Unfortunately, this indicates that the interior top plate detail (Figure 8) was not executed correctly or consistently.

Figure 34. Interior wall under attic (third floor), Unit 6702

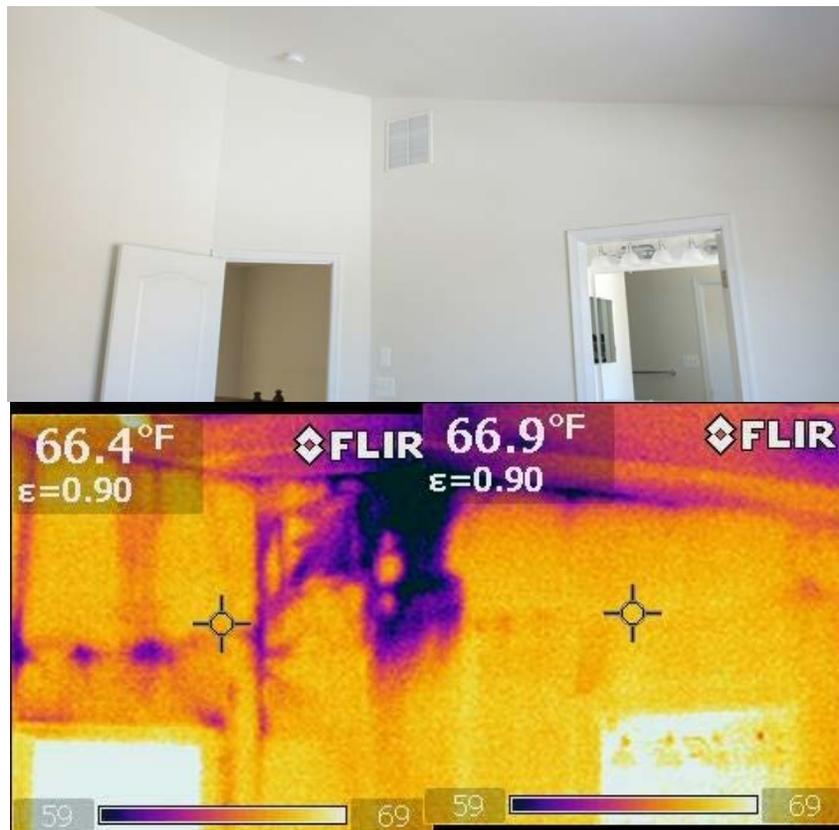
The transitions from vaulted ceilings to flat attics were good in some cases, but poor in other cases (Figure 36; keyed to “E” in Figure 23). The attic sides of the knee walls were sheathed with thin profile sheathing (Figure 37), but apparently, some air sealing details were not executed correctly.

Figure 36. Return duct air leakage and attic knee wall leakage (Unit 6704)

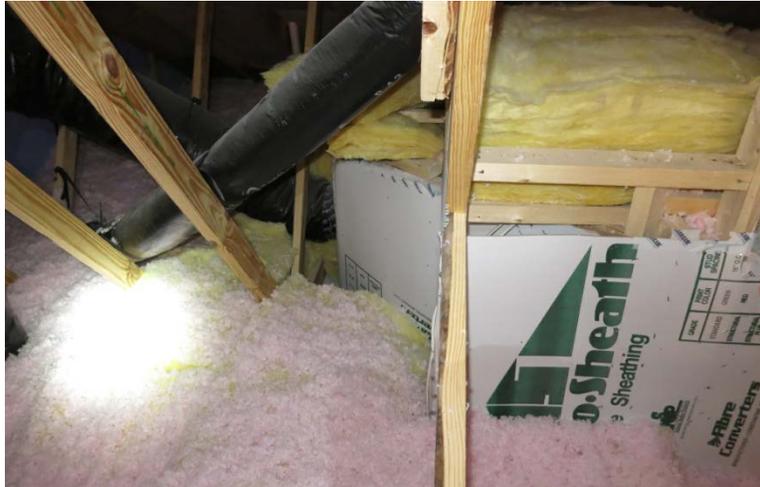
Figure 37. Attic knee wall condition and sheathing (Unit 6704)

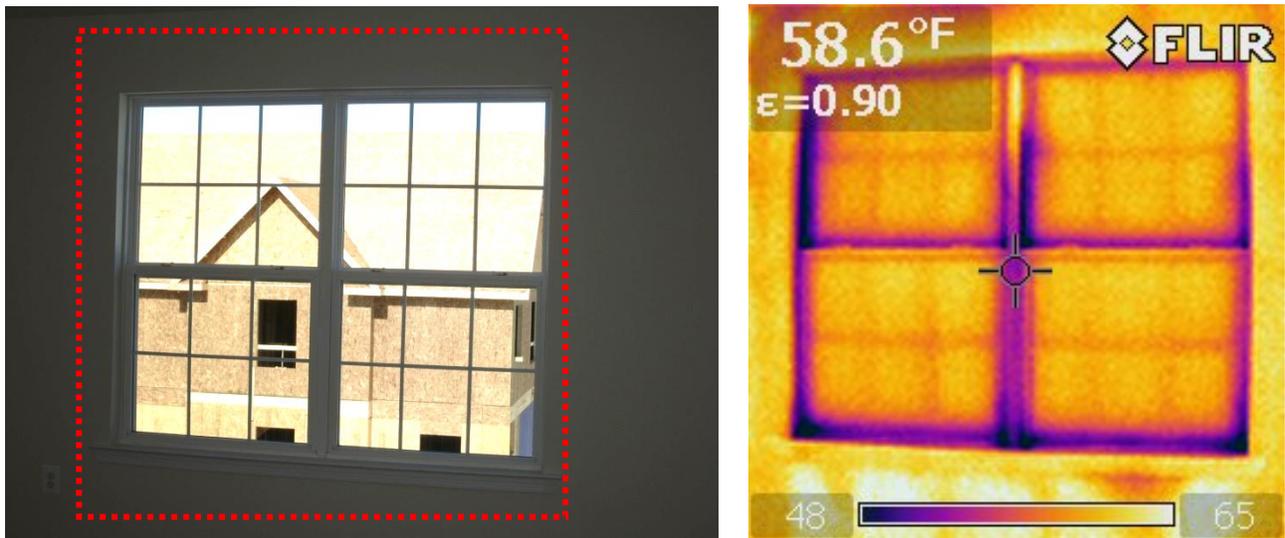
Figure 38. Window air leakage (window unit, sash-to-frame)

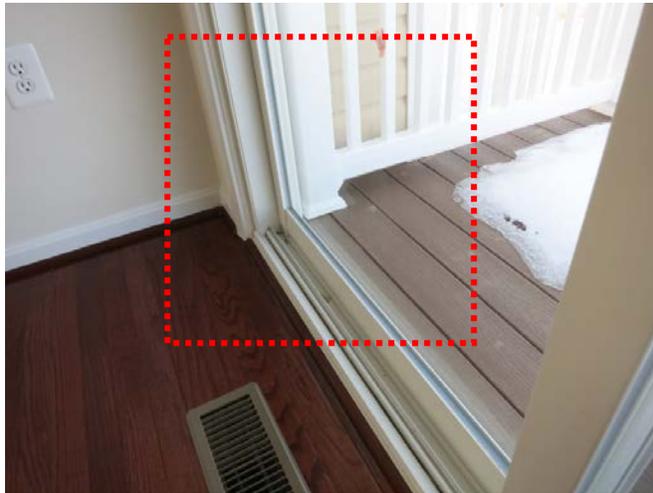
Figure 39. Sliding glass door air leakage at weep hole (door unit)

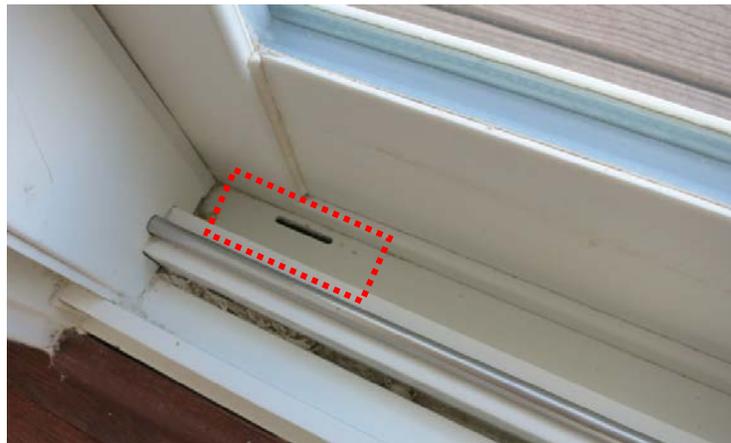
Figure 40. Sliding glass door air leakage at weep hole (door unit)

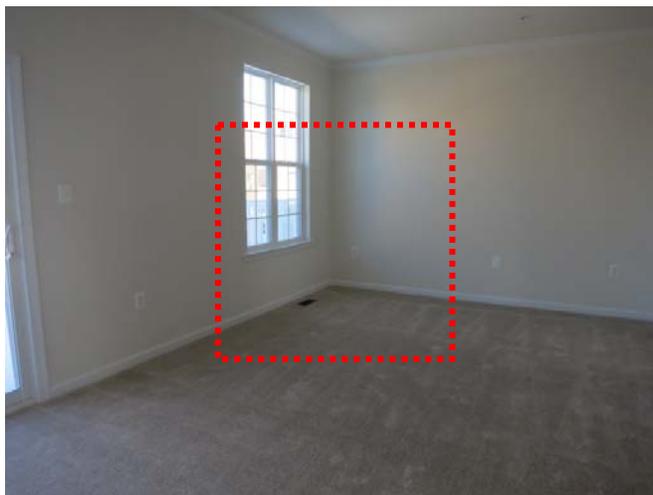
Figure 41. Window air leakage (window-to-wall connection at sill), Unit 6706

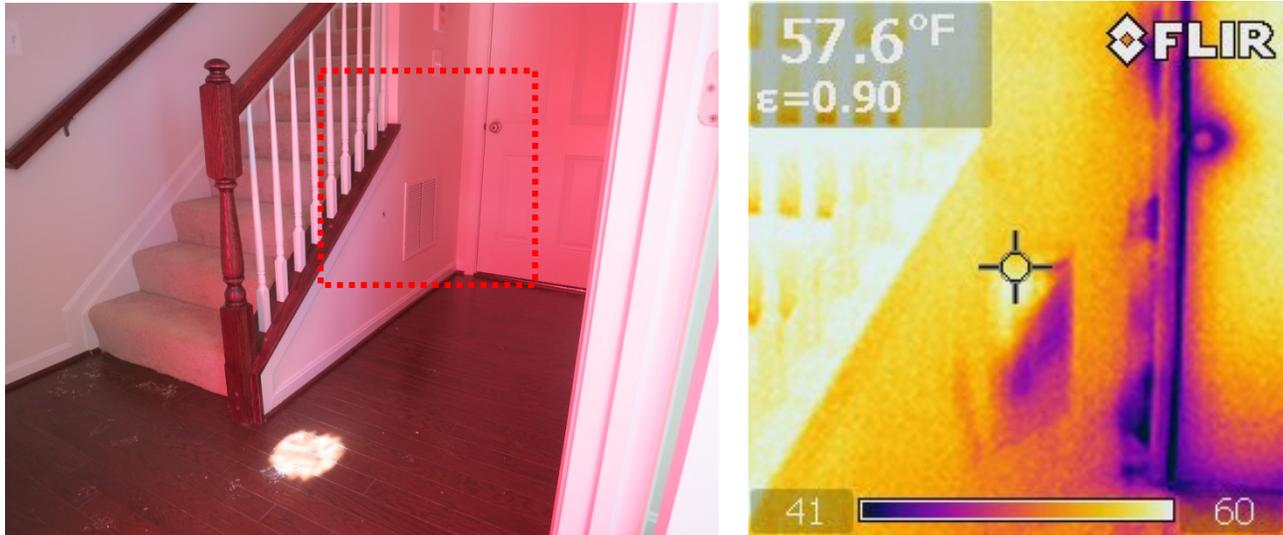
Similarly, the door to the garage showed air leakage at both the unit (door jamb gasket) and at the frame-to-wall connection (Figure 42).

Figure 42. Air leakage at door (door jamb gasket and frame-to-wall connection)

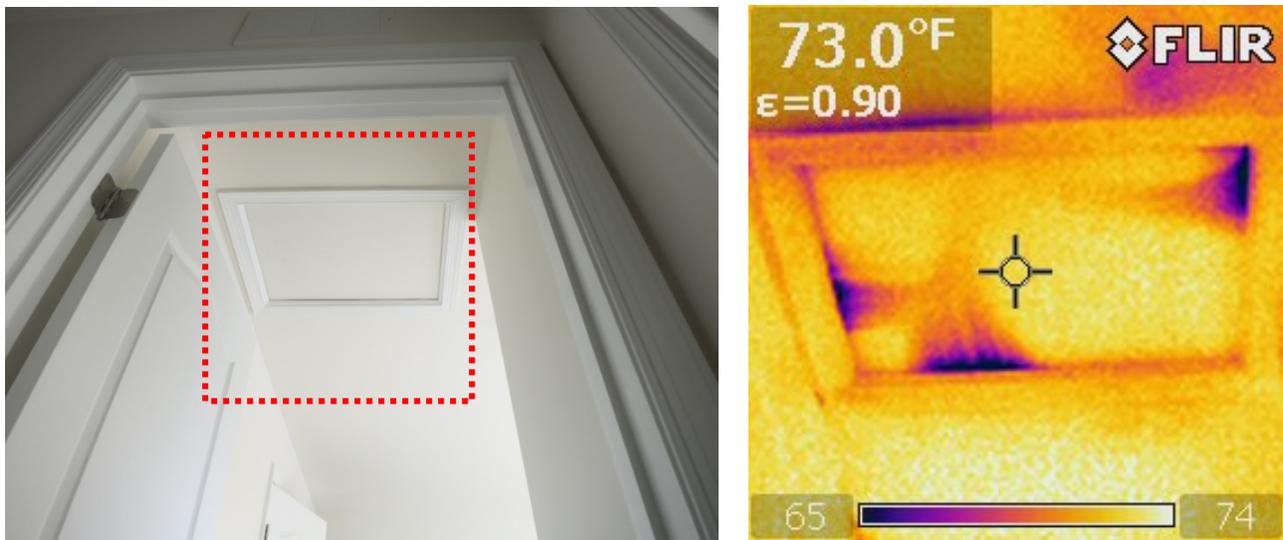
The attic hatch showed air leakage plumes (Figure 43, keyed to “F” in Figure 23), despite the presence of a bulb gasket. The hatch was insulated with a 10-in. block of expanded polystyrene foam (~R-40); however, it was evidently not sufficient to compress the gasket fully. The units were depressurized in this test, which would tend to pull the hatch downward. Apparently, some type of mechanical clamping may be required for a good seal.

Figure 43. Attic hatch air leakage

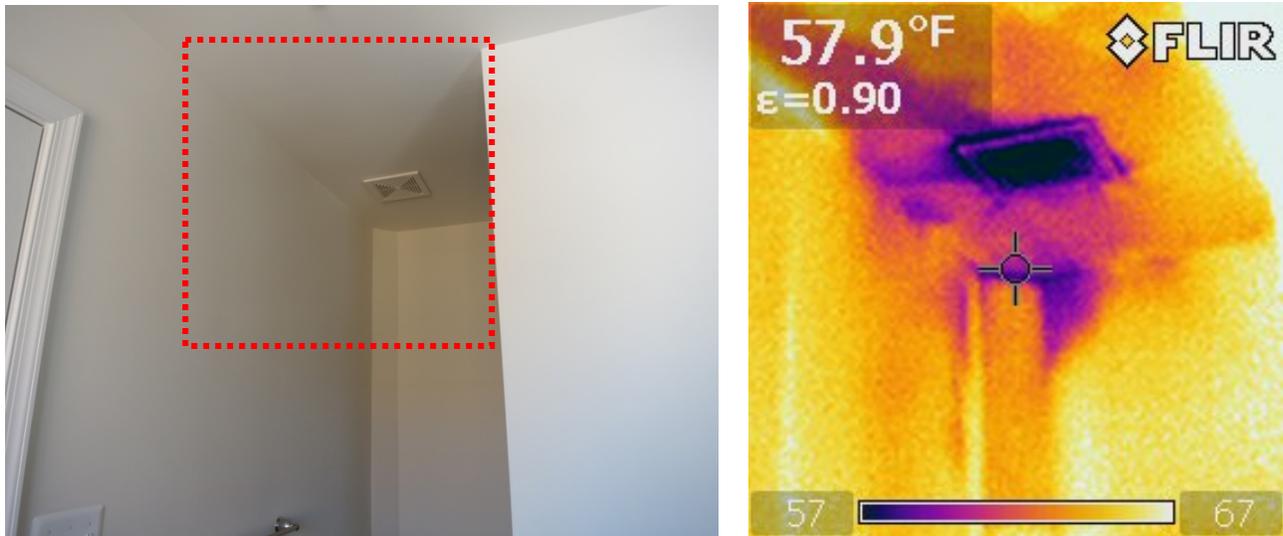
The bathroom exhaust fans were also leakage sources, both through the fan (i.e., flapper not sealing correctly), and around the fan unit (gaps between the fan body and ceiling gypsum board).

Figure 44. Exhaust fan air leakage (through unit and around unit)

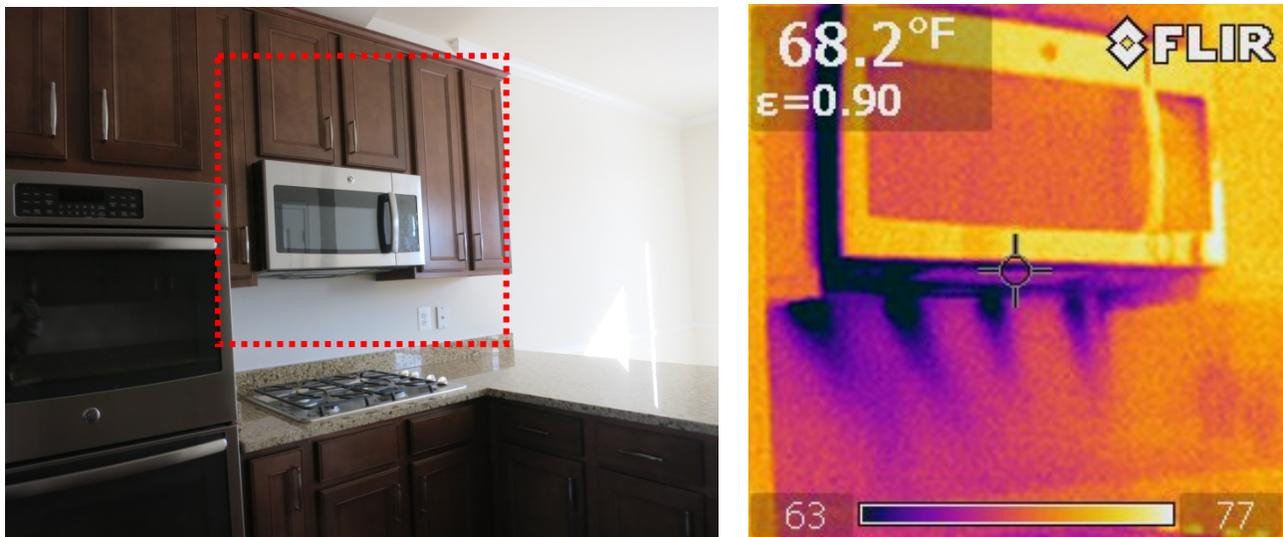
Similarly, the microwave oven/range hood was a source of leakage in some cases (Figure 45).

Figure 45. Microwave/range hood air leakage (through unit and around unit)

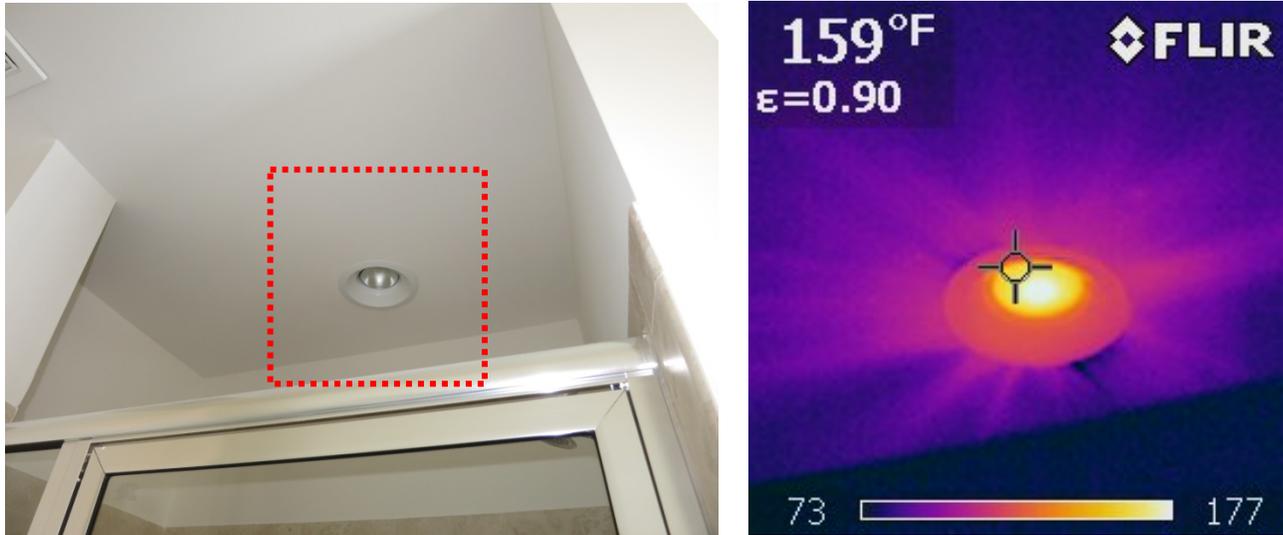
Leakage was observed around recessed lighting below the unconditioned attic (Figure 46). Similarly, electrical fixtures and box covers had similar leakage issues (see Figure 33, showing vaulted ceiling).

Figure 46. Bathroom recessed light air leakage (around unit/trim ring)

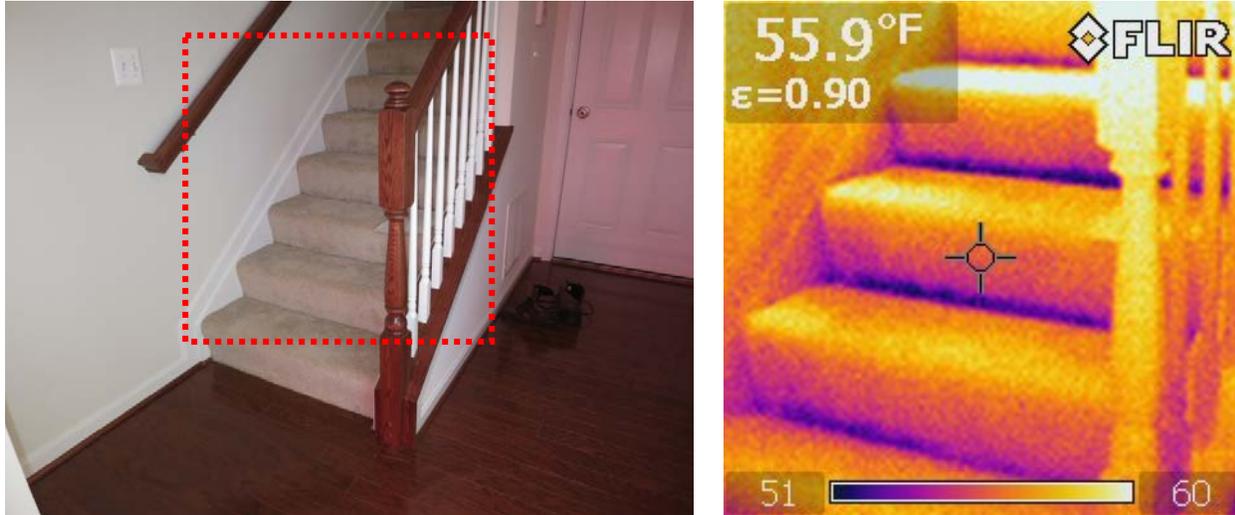
During depressurization, noticeable amounts of leakage came out of the stair carpeting joints (location A), at the tread-to-riser connection (Figure 48). Given the geometry, this is due to leakage at the area separation wall, the garage mechanical room (and systems), or interactions between these two details.

Figure 48. Air leakage at stair tread-to-riser joints, location (A)

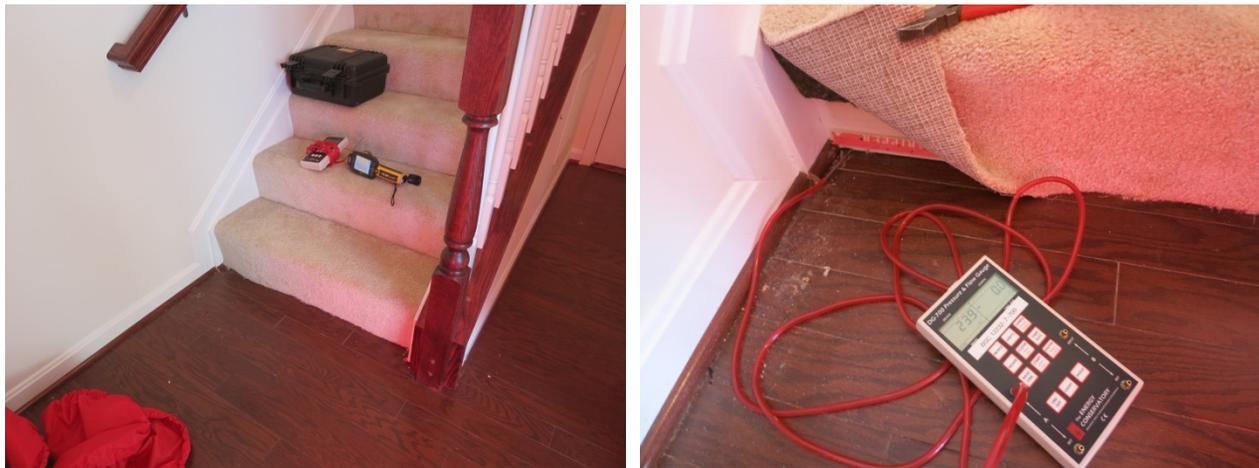
A pressure measurement was taken at the space under the stairs; when the unit was depressurized to 50 Pa, the stairs were at 24 Pa with respect to the interior. In other words, the area under the stairs is 50% interior and 50% exterior, indicating significant leakage to the exterior.

Figure 49. Measurement of pressure difference under stairs, location A

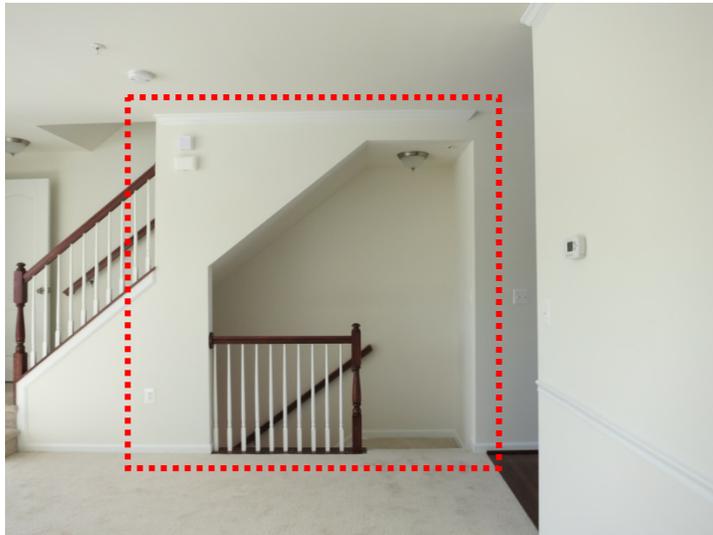
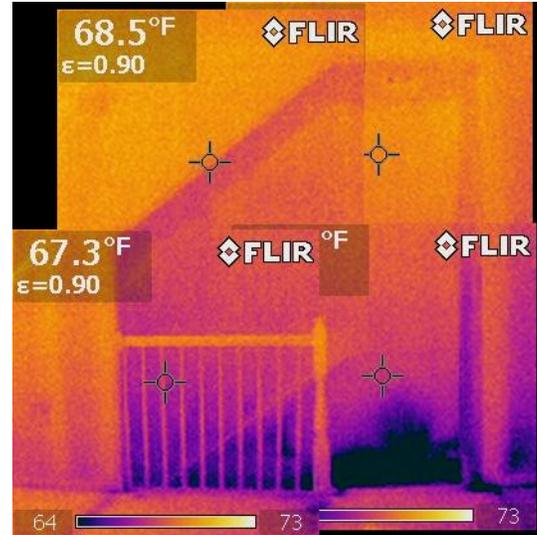
Similar issues were seen at the top of the stairs, at the landing between the first and second floors (Figure 50).

Figure 50. Air leakage at stair landing (first-to-second floor)

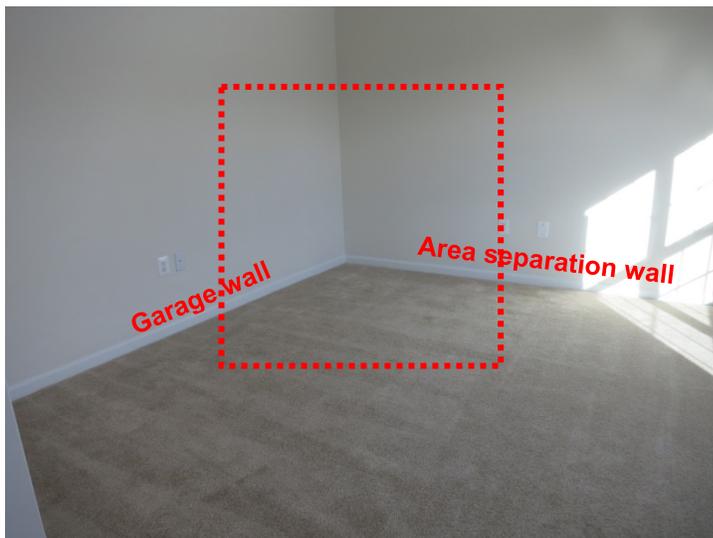
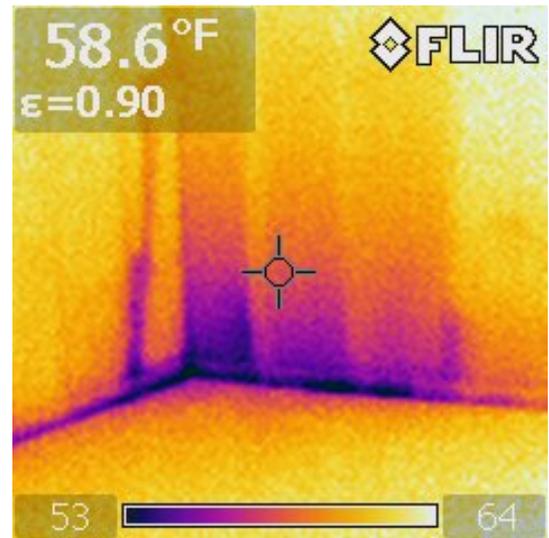
Figure 51. Garage tee wall intersection, Unit 6700, location B

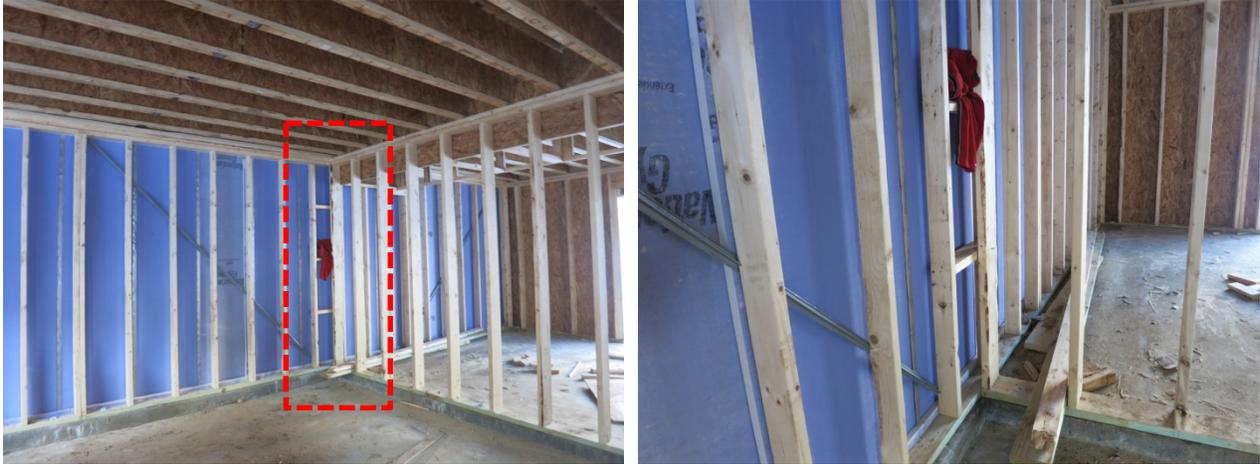
Figure 52. Garage tee wall intersection, showing ladder blocking

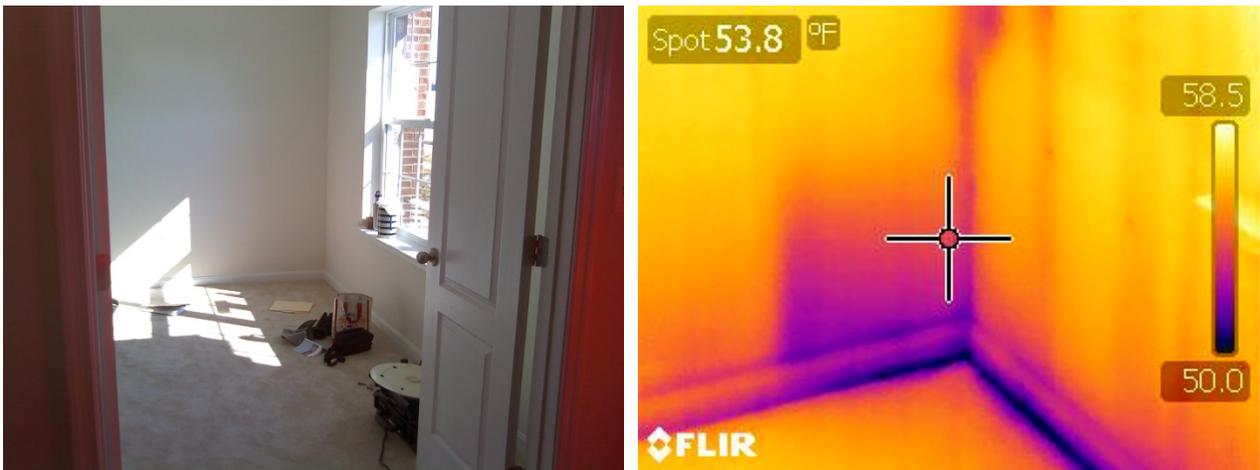
Figure 53. Area separation wall “jog” at exterior, location C

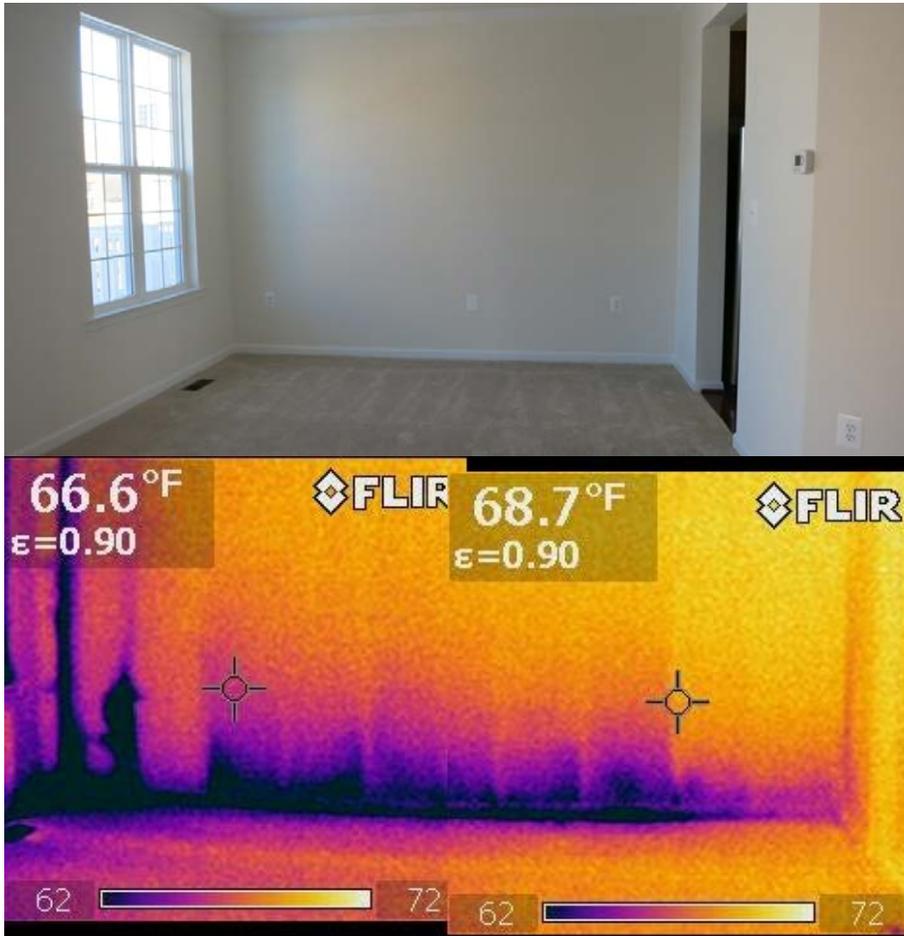
Figure 54. Second-floor living room leakage pattern over garage, Unit 6706, location D

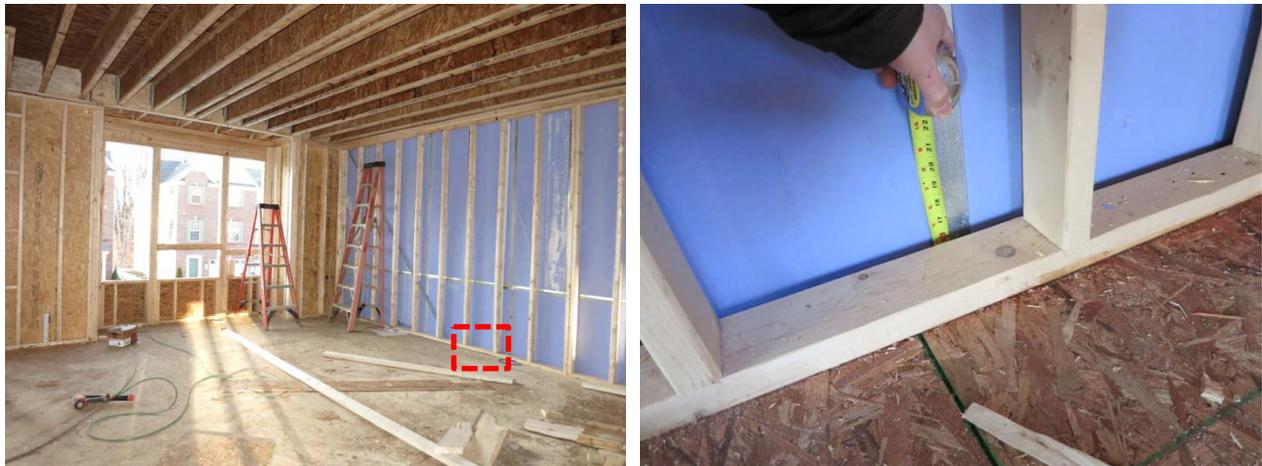
Figure 55. Missing gypsum fireblocking at garage ceiling rim joist area

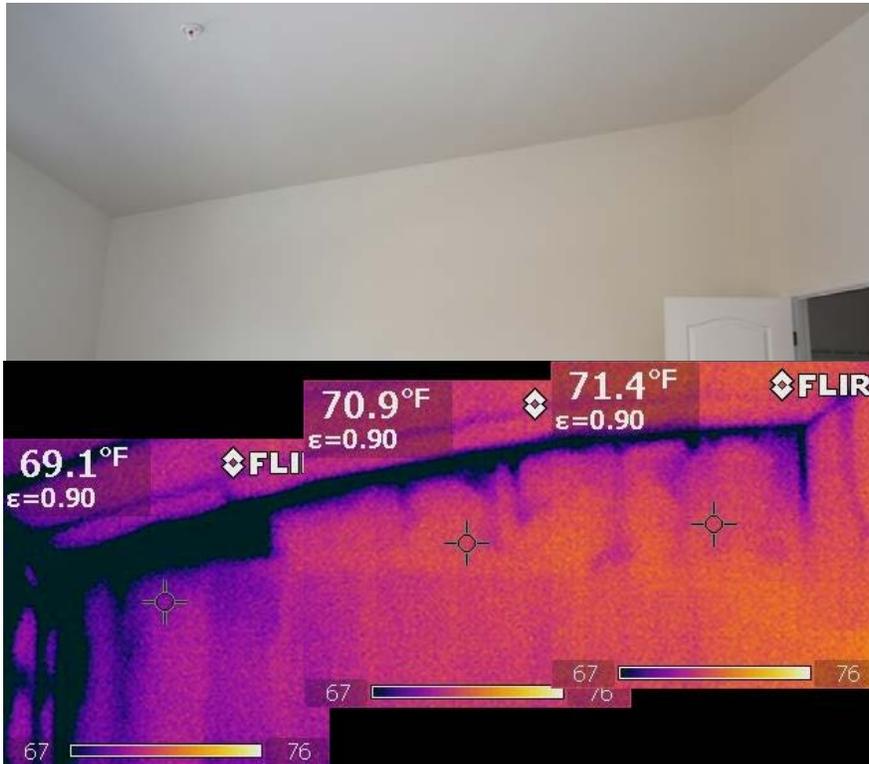
Figure 56. Leakage at vaulted ceiling connection to separation wall, Unit 6706

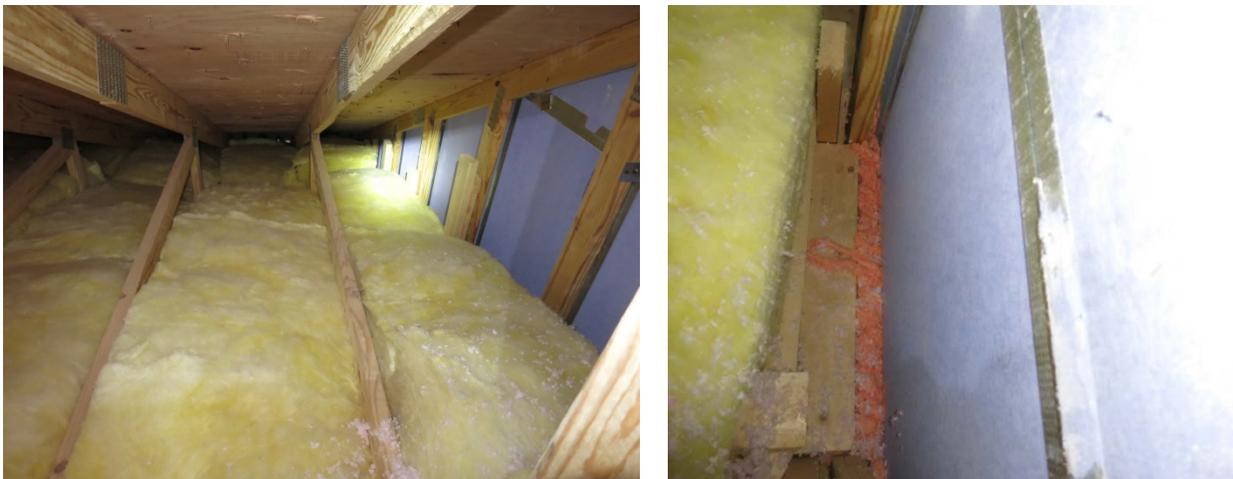
Figure 57. Vaulted attic and separation wall conditions, Unit 6704

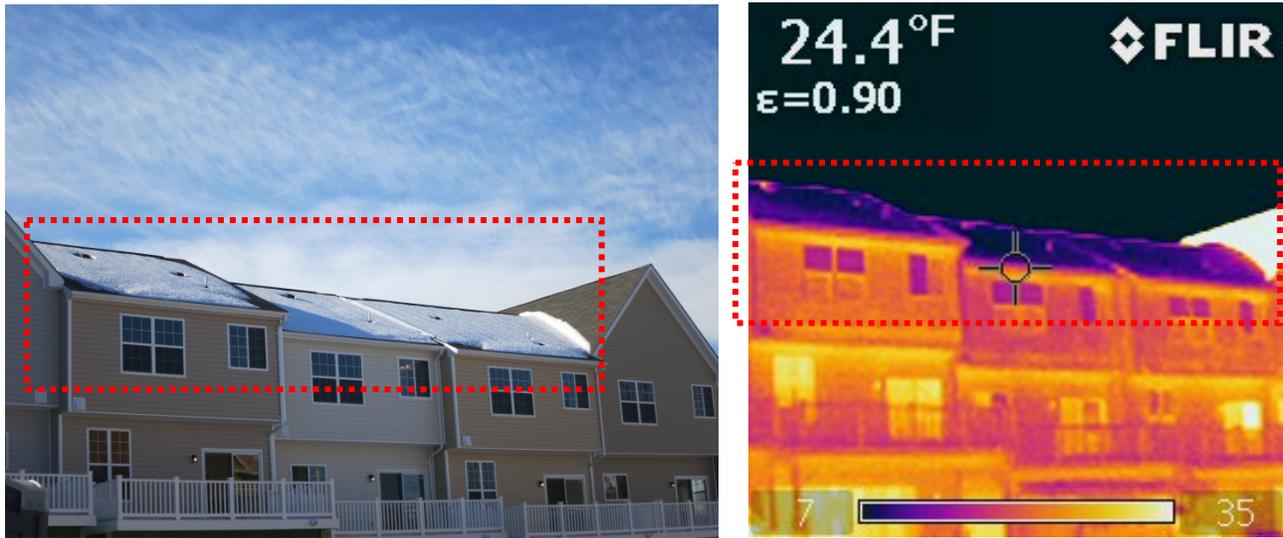
Figure 58. Exterior infrared of three middle unit attic demising walls

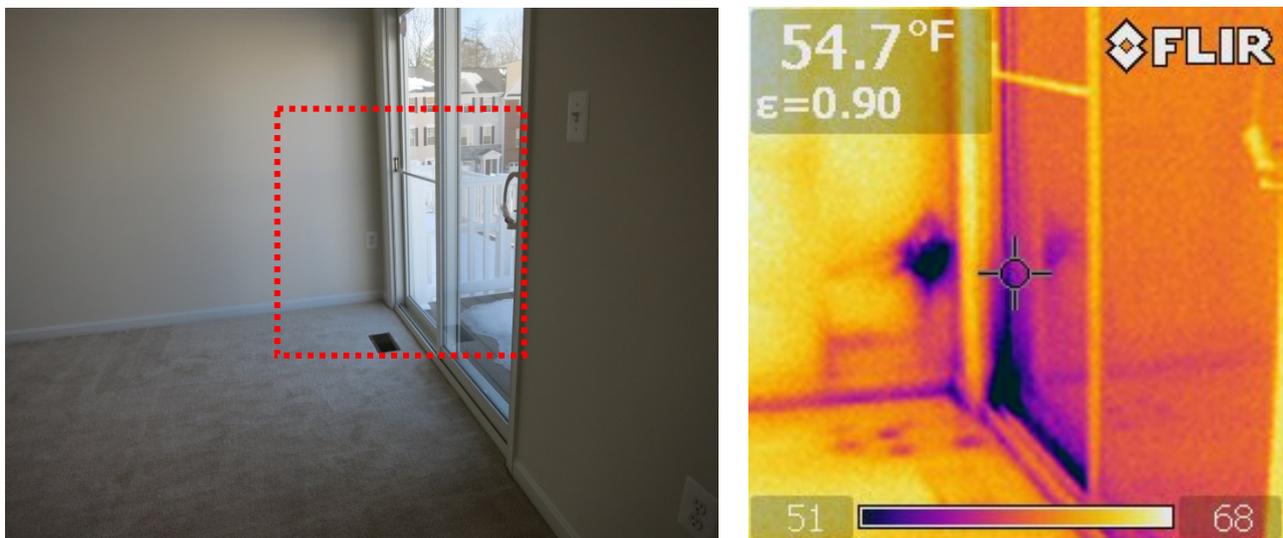
Figure 59. Area separation wall leakage at exterior “jog,” Unit 6706

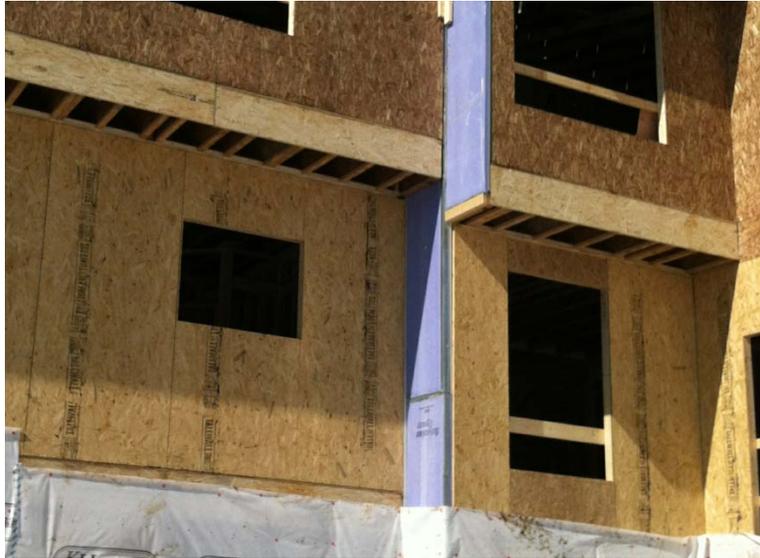
Figure 60. Separation wall “jog” at second and third floors, frame building

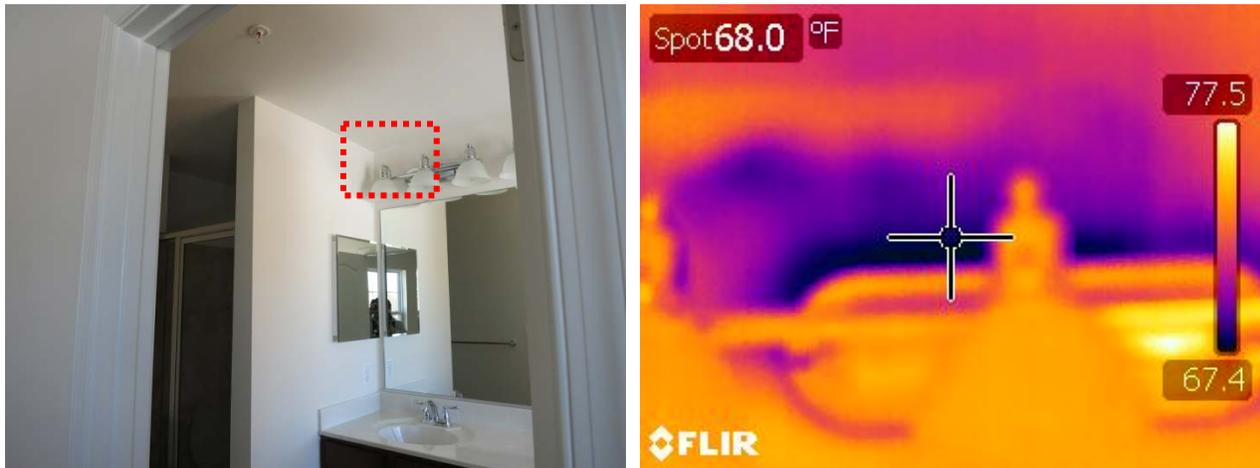
Figure 61. Air leakage at light mounted on area separation wall

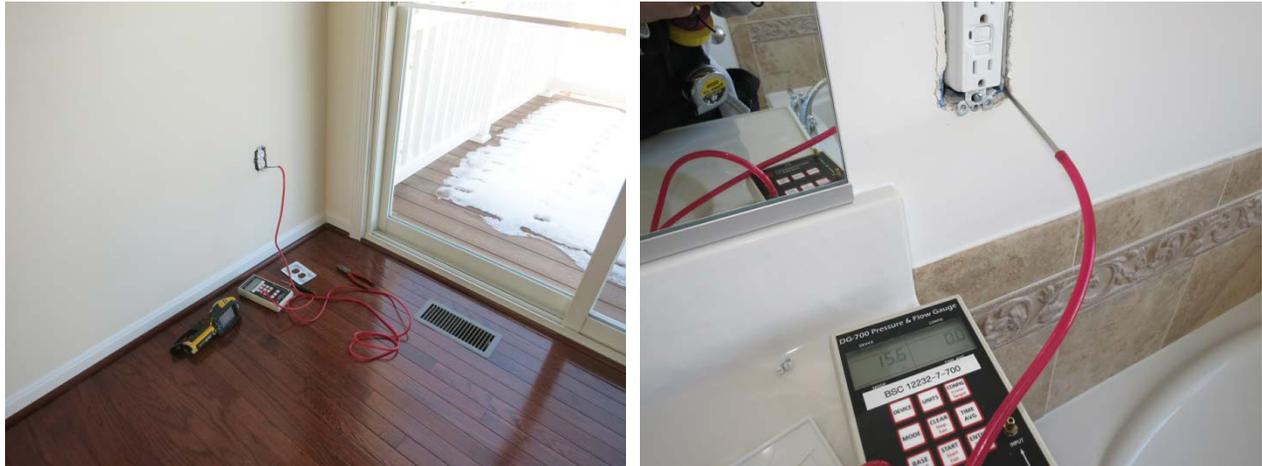
Figure 62. Pressure difference measurements at electrical box penetrations

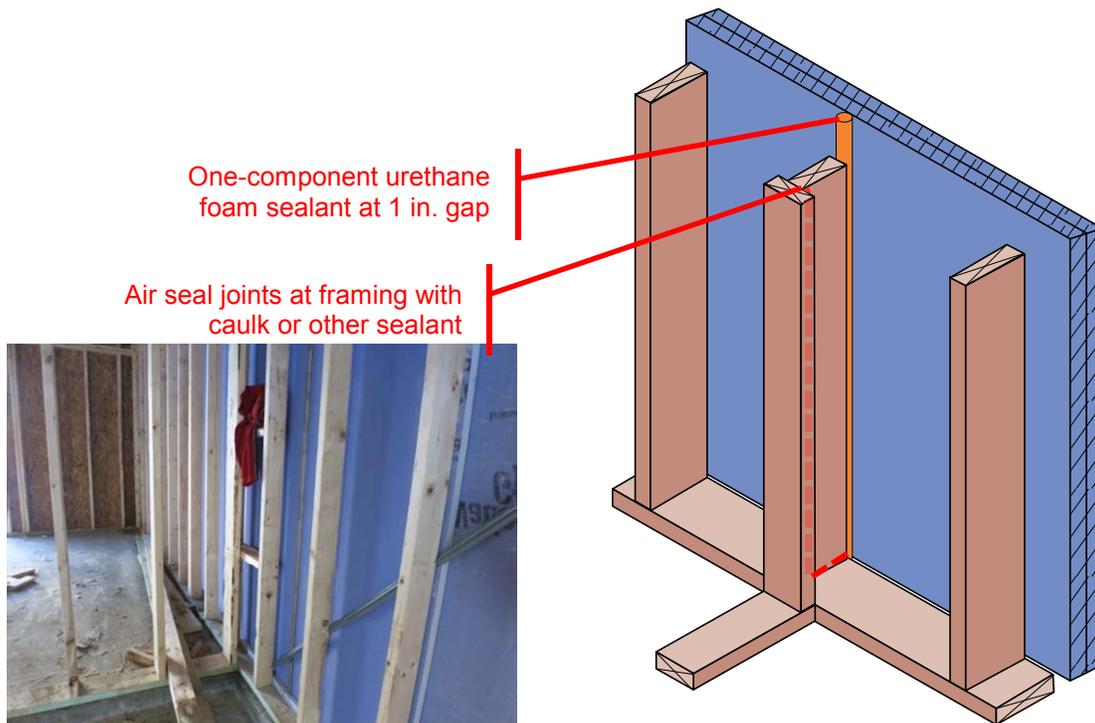
Figure 76. Garage tee wall intersection, current (L) and proposed air sealing details (R)
