# Energy Retrofit Field Study and Best Practices in a Hot-Humid Climate

J. McIlvaine, K. Sutherland, and E. Martin  
*Building America Partnership for Improved  
Residential Construction*

March 2013

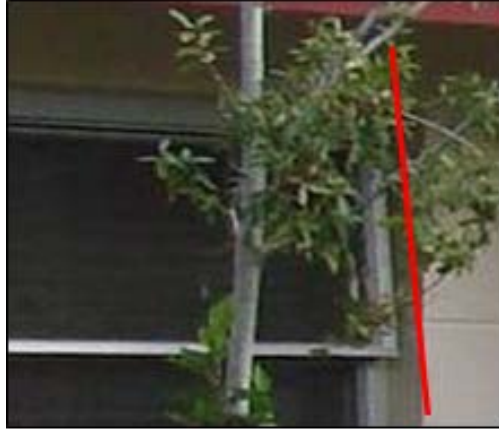
As a final note on window replacements, the window type sometimes had great impact on whole-house airtightness. Jalousie and awning windows often did not close completely at pre-retrofit, creating extensive air infiltration paths (see Figure 10). The window in its most closed position is still slightly open. The red line indicates the pitch of the closed pane. If the window closed completely, the frame edge and red line would be vertical rather than pitched. In addition to efficiency gains from reducing solar heat gain and thermal conductance, replacing such poorly closing windows has the added benefit of large infiltration reductions. Air sealing between the window frame and rough opening likewise enhances the infiltration reduction. This third airtightening benefit of window replacement is reflected in the whole-house airtightness testing at the test-out audit (see Section 2.3); however, it is not accounted for in the cost associated with the infiltration reduction measure.

**Figure 10. Pre-retrofit awning window in its most closed position is still slightly open, as indicated by the pitch of the red line.**

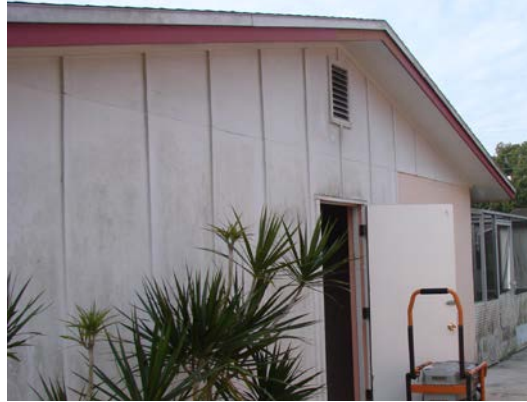
**Figure 12. Typical shallow roof pitch of Florida homes built before 1980**

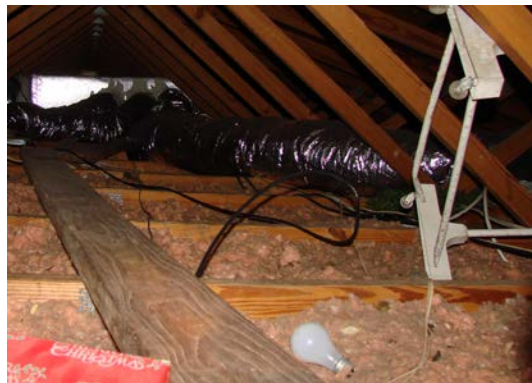
With few exceptions, homes had vented attics with some level of batt or blown insulation (Figure 13) applied to the attic floor, except in two cases that had no insulation. The pre-retrofit R-value was not precisely known and had to be estimated based on visual inspection. Typically, a section of the ceiling insulation depth could be measured. Researchers’ estimates of pre-retrofit ceiling insulation values ranged from R-0 to R-34 (average R-16), with about 75% between R-9 and R-25. Improving the ceiling insulation level was among the most common retrofit measures included in 58 retrofits (83%) (Table 8).

Figure 13. Typical pre-retrofit ceiling insulation condition

Typically, ceiling insulation retrofit consisted of blown-in fiberglass on top of existing insulation of various types to achieve the total desired insulation value, rather than removal of existing insulation. Often, researchers observed forced-air ductwork that was not strapped in place above the insulation and was partially buried after insulation was blown into the attic. Although strapping is required by the Florida Residential Mechanical Code for new construction, it is not required for mechanical system change-outs. Where ducts are partially or completely buried under insulation (Figure 14), moisture may condense on the outer surface of the duct if the insulation causes the surface temperature to drop below the dew point of the humid attic air. Duct leakage can increase this risk. Based on these durability concerns, researchers included the mechanical code guidelines for supporting flexible ducts above attic insulation that are required for new construction in the best practices. In other research, the Building America program is investigating the effects and benefits of covering attic-mounted ducts with insulation.

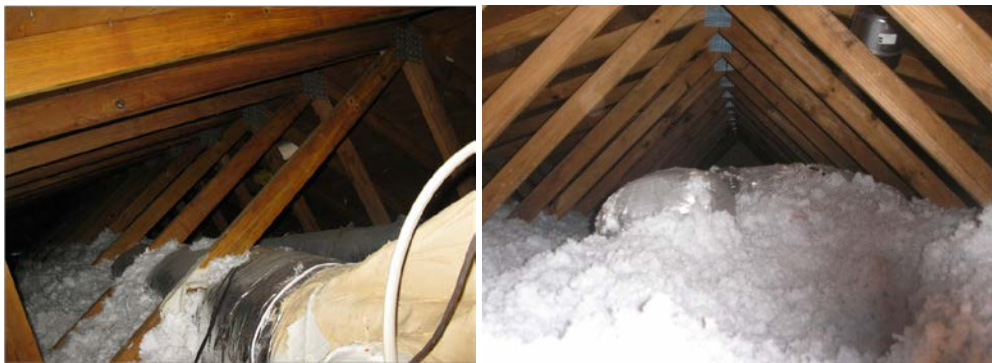
**Figure 14. Post-retrofit ducts buried by blown-in fiberglass**

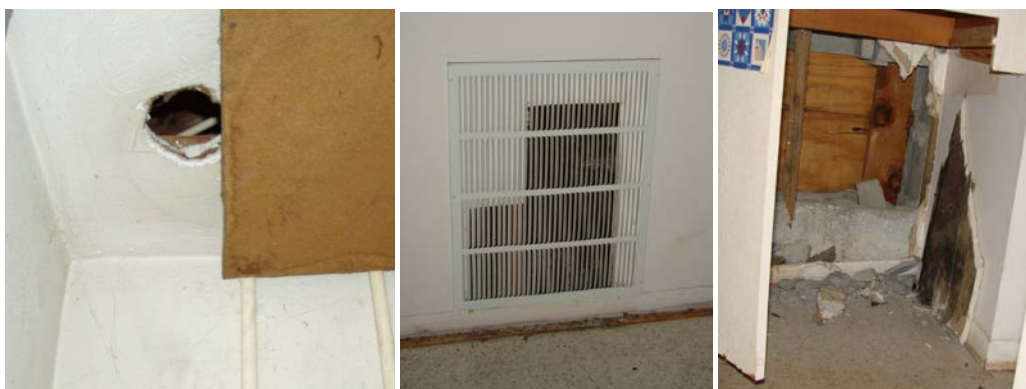
For the 59 homes, pre-retrofit ACH50 ranged from 3.6 to 41.8 with an average of 10.5. All but one home had ACH50 < 25. When test-in results were high, auditors identified airflow pathways and provided that information to the partner. In Florida’s hot-humid climate, high infiltration rates are less detrimental than they are in climates with larger temperature differentials between outside and conditioned spaces. It is less beneficial and less cost effective to expend labor on *extensive* air sealing efforts in the hot-humid climate. Air sealing efforts necessary to achieve the target ACH50 test result include sealing around drywall penetrations (for supply and return registers, dryer vents, wiring, lighting and fan fixtures, and plumbing), replacing missing plumbing access panels, correcting poor window and door closure, eliminating recessed lighting, and installing gaskets at attic access panels in the conditioned space (Figure 10 and Figure 16).

**Figure 16. Pre-retrofit drywall penetrations: The ceiling fixture was removed, but penetration to the attic was unsealed (left); plumbing access in the wall covered with a return grille rather than a solid cover or patch (center); large opening beneath the bathroom vanity where block and drywall were removed as part of an incomplete renovation (right).**

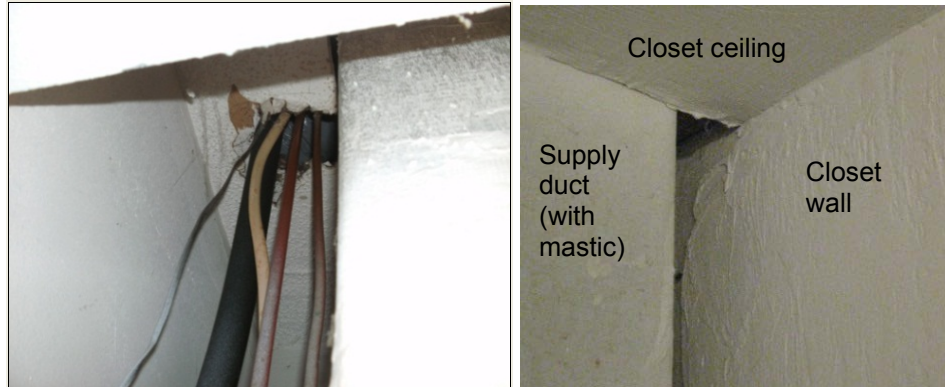
A common infiltration path that sometimes remained post-retrofit was located at the ceiling of the air handler unit (AHU) closet (Figure 17). Contractors often did not seal the gap around the supply plenum at the ceiling drywall. Access to this gap is complicated by closets that were designed for smaller AHUs.

**Figure 17. Gaps or holes at ceiling of AHU closet**

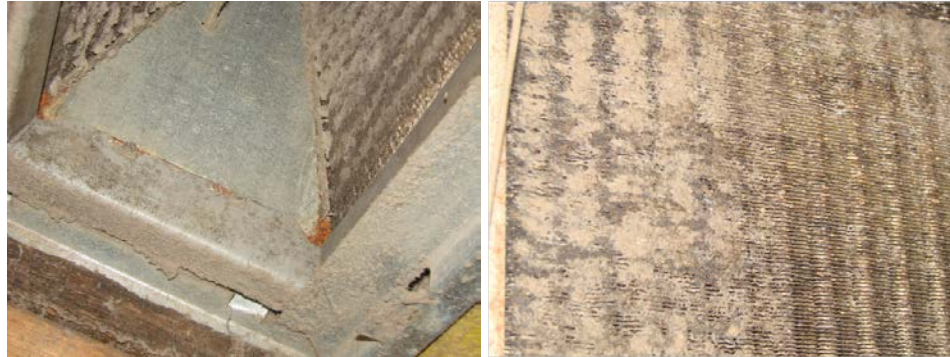
**Figure 19. Looking up at pre-retrofit clogged, dirty cooling coils in the AHU (left); corroded and clogged cooling coil (right)**

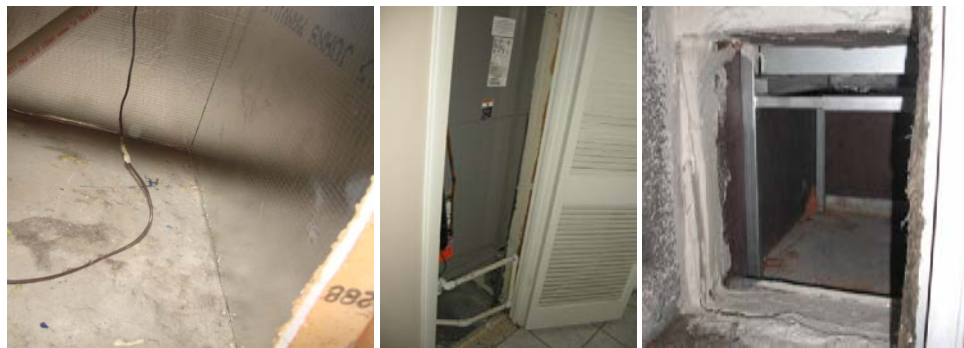
Of the 53 houses tested before and after retrofit, duct leakage was reduced in 42 (79%) and stayed the same in one (2%). In 10 homes, ducts were leakier after renovation. In three of those, new ductwork had been installed. Six had a noticeable lack of return plenum sealing (Figure 30, left). Five had no dedicated return plenum; rather, the whole AHU closet with a louvered door (Figure 30, center) or door-mounted return grille served as the return plenum surrounding an AHU mounted on a metal stand (Figure 30, right).

**Figure 30. Return air plenum lined with duct board without sealant at edges and seams (left). Narrow AHU closet functioning as return with uncontrolled airflow (center). Attempt to make a sealed return plenum around a metal AHU stand (right), with noticeable unsealed gap at bottom edge of duct board.**

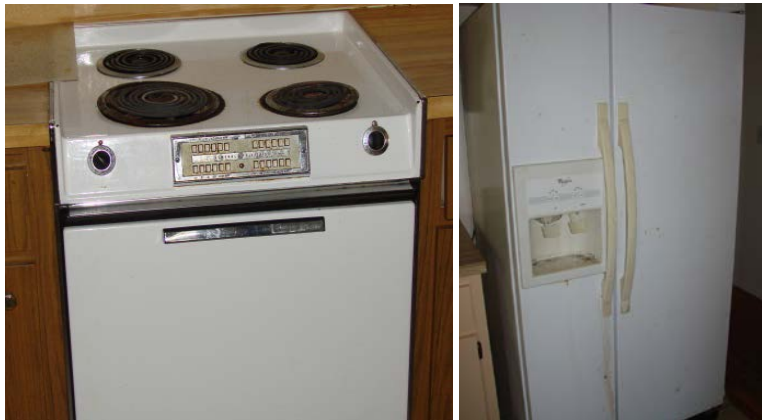
Before renovation, appliances were typically missing, old, or in poor condition (Figure 32). Many of the homes were not equipped with dishwashers. Researchers attempted to use manufacturers’ rated efficiencies; however, often model numbers were illegible or the equipment had been removed before the pre-retrofit audit. Thus, to define efficiencies for the appliances at pre-retrofit, researchers relied almost exclusively on estimates which likely overestimated the efficiencies, making improvement projections conservative.

**Figure 32. Typical pre-retrofit appliance condition for range (left) and refrigerator (right)**

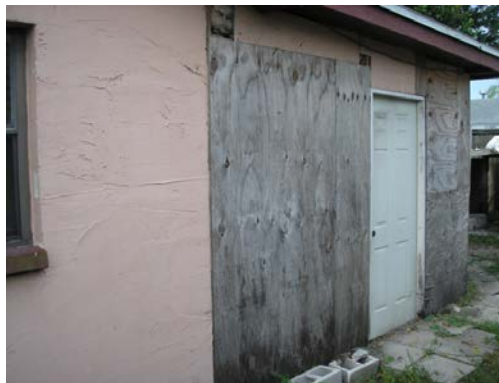
During pre-retrofit audits, researchers found that many homes had porches and garages enclosed and made part of the conditioned space (Figure 33). These were retained as part of the conditioned space in all but five homes. Returning those spaces to their original use reduced conditioned floor area, volume, and thermal envelope area. Conditioned floor area reductions ranged from 140 ft<sup>2</sup> to 696 ft<sup>2</sup> and were, with one exception, coincident with a reduced window area (Table 14). Rather than include this envelope change in every energy-saving measure, researchers adjusted the pre-retrofit simulation model to reflect the change. This effectively focuses savings on efficiency improvements rather than on size adjustments that are relevant to a small number of renovations. The analysis reflects the savings from the package of improvements if the house had been the same size at pre-retrofit. From a homeowner perspective, though, reducing the size of a home would likely produce annual savings.

**Figure 33. Pre-retrofit exterior wall of porch converted into conditioned space**
