Evaluation of Crawlspace Retrofits in Multifamily Buildings

Armin Rudd

Building Science Corporation

September 2014

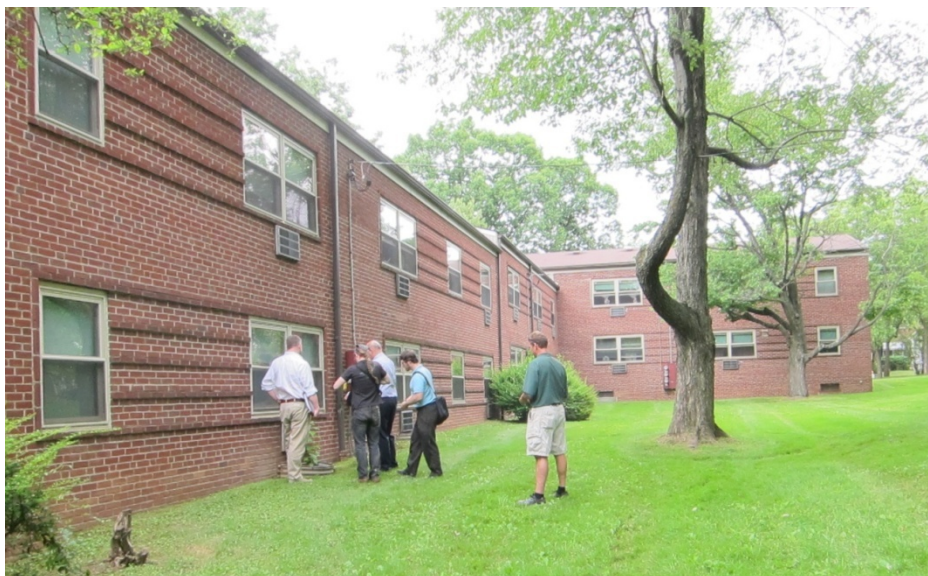
Figure 10. Project team discussions near a window well behind Buildings B and A; the at-grade crawlspace inside was wet and muddy

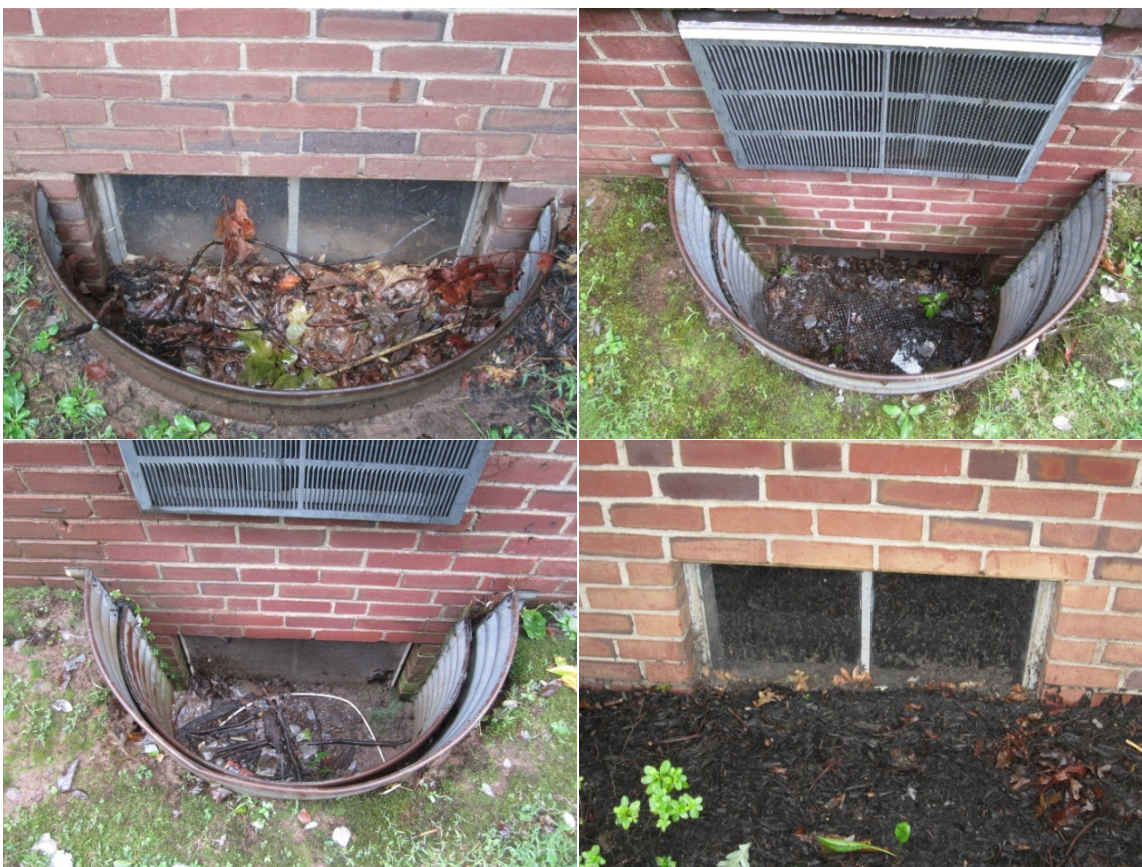
Figure 11. Evidence indicating bulk water intrusion through the crawlspace windows

After evaluating the condition of some of the crawlspaces and the site, BSC recommended that the crawlspace windows and window wells be sealed against bulk water intrusion and air leakage (Figure 11). The crawlspaces ranged from wet to mostly dry, going from a shallow at-grade to a deeper crawlspace with about 3 ft of above-grade wall, respectively. All crawlspaces had concrete slab floors, but wet mud and some standing water were prevalent in some. Wet or damp slabs and concrete block walls were evident in others. For financial reasons, a major foundation drainage upgrade was not an option. Considering the mud on top of the concrete slab in the crawlspace, the condition of the window wells, and the site drainage conditions, BSC believed that blocking water intrusion through the window wells was the first best affordable option for trying to manage the crawlspace water/moisture problem.

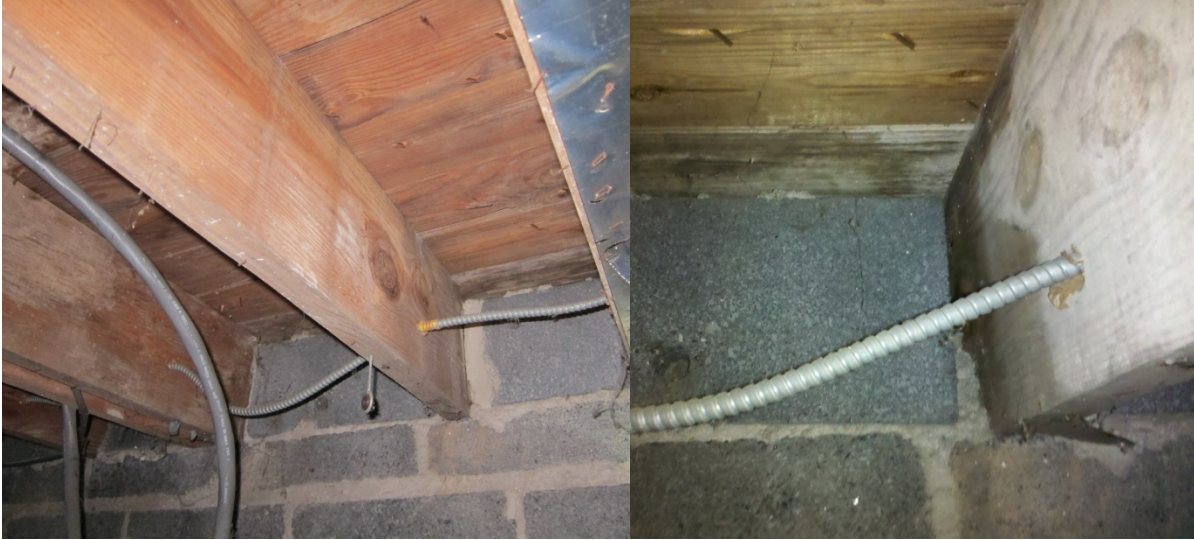
Figure 16. Water-sensitive wood joists embedded into water-absorptive concrete block

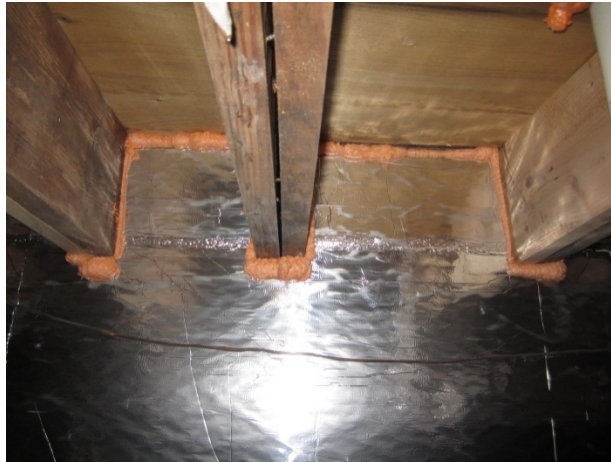
Figure 19. Example of air leakage to unit above but well-sealed foundation wall

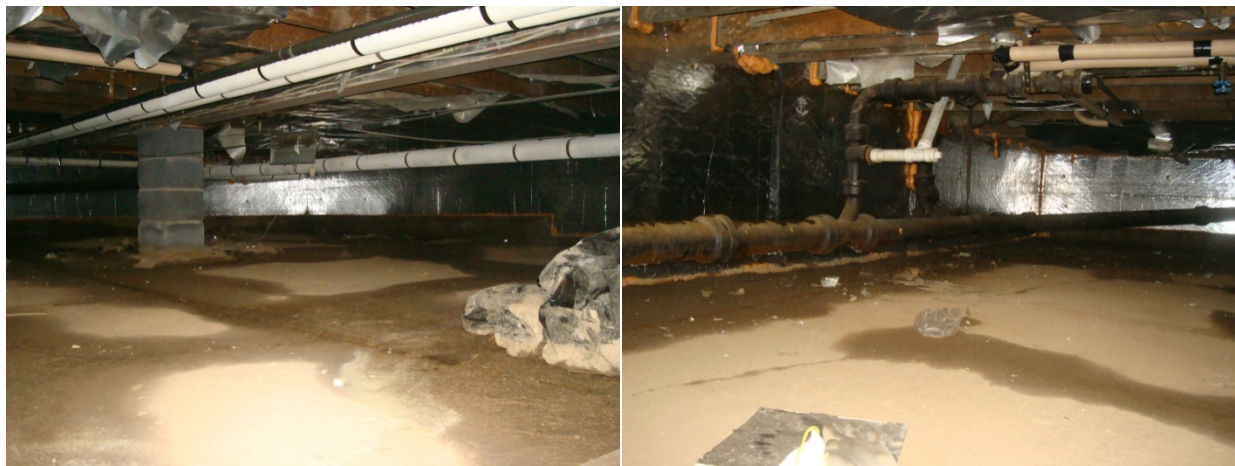
Figure 20. Crawlspace photo showing wetness at seams in the concrete slab (L) and (R), and floor drain backup (L)

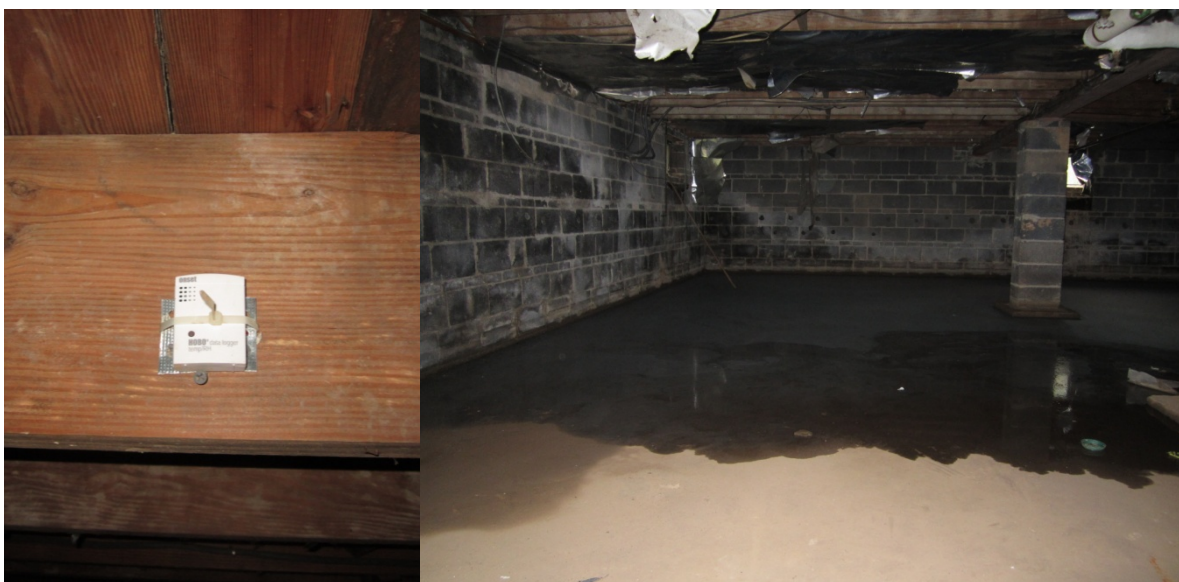
During a rainy period BSC researchers arrived to download the pre-retrofit temperature and RH data in the crawlspaces, and found that both were flooded (Figure 22). Conditions were such that the data loggers in the crawlspace of Building B could not be accessed (Figure 23). The data loggers were accessible in the crawlspace of Building E, and plots of the conditions are shown in Figures 25 to 27.

Figure 22. Temperature and RH data logger (L); standing water in crawlspace (R)

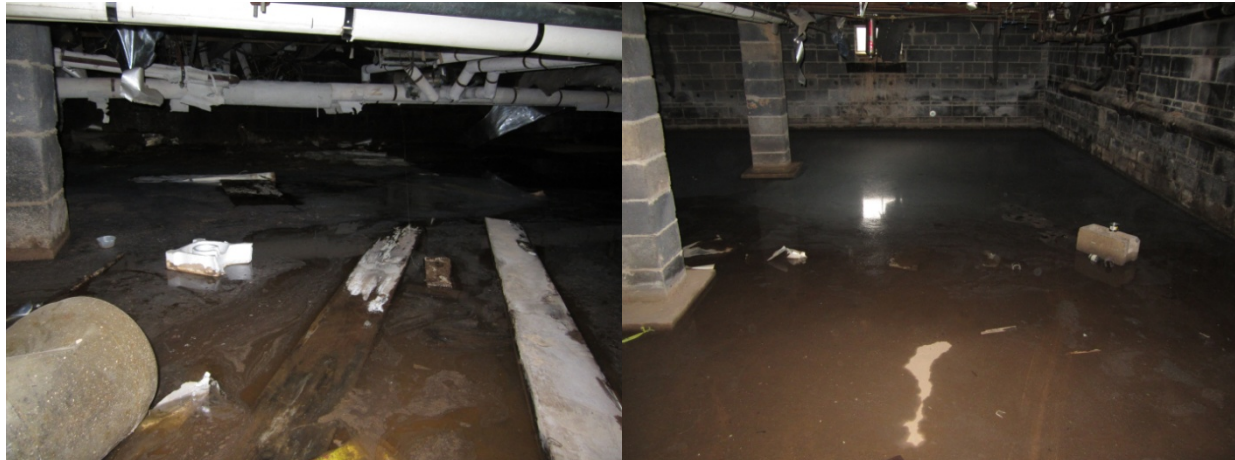
Figure 23. Inaccessible Building B crawlspace (L), and Building E crawlspace (R) with standing water during a rainy period

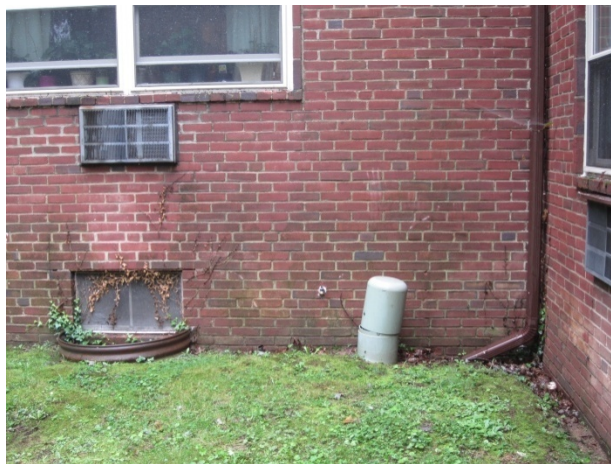
Figure 24. Roof gutter downspout not piped to storm drain system allowing water intrusion to crawlspace

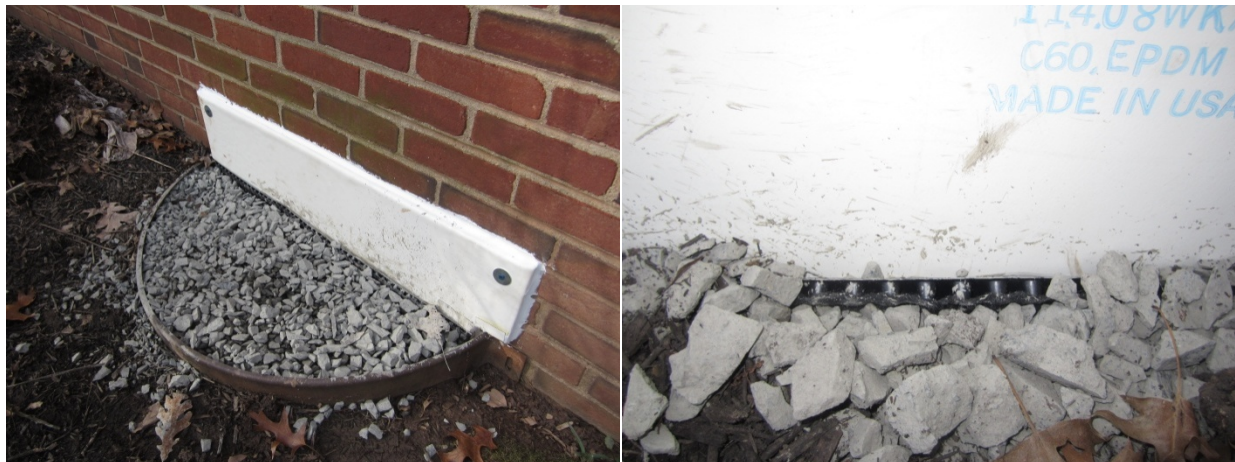
Figure 29. Finished view of the crawlspace window blocking retrofit to eliminate that bulk water intrusion (L); note the foundation drainage mat protecting the waterproof membrane (R)

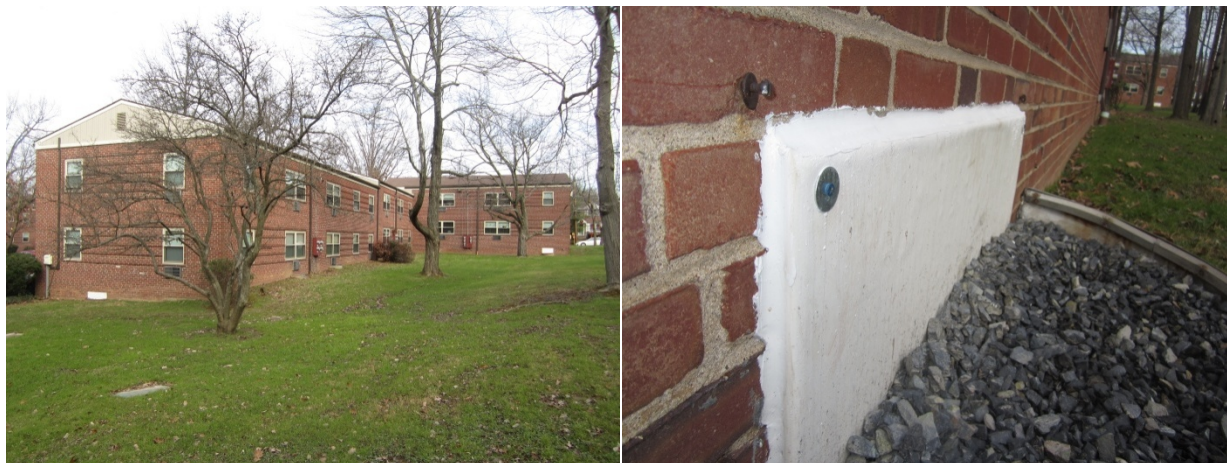
Figure 30. Crawlspace window well blocking and sealing on the back sides of Buildings A and B (L); note the sloped sealant to shed water at the top of the blocking panel (R)

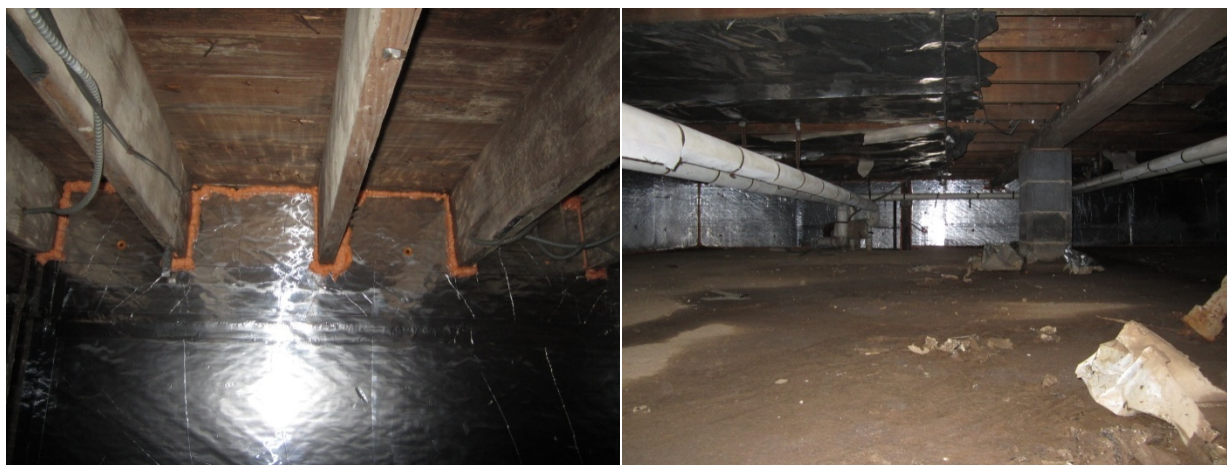
Figure 31. Crawlspace foundation wall insulation fit well and sealed at edges and penetrations (L); some crawlspace conditions remained wet but drying, with exhaust ventilation throughout and sump pumps in critical locations (R)

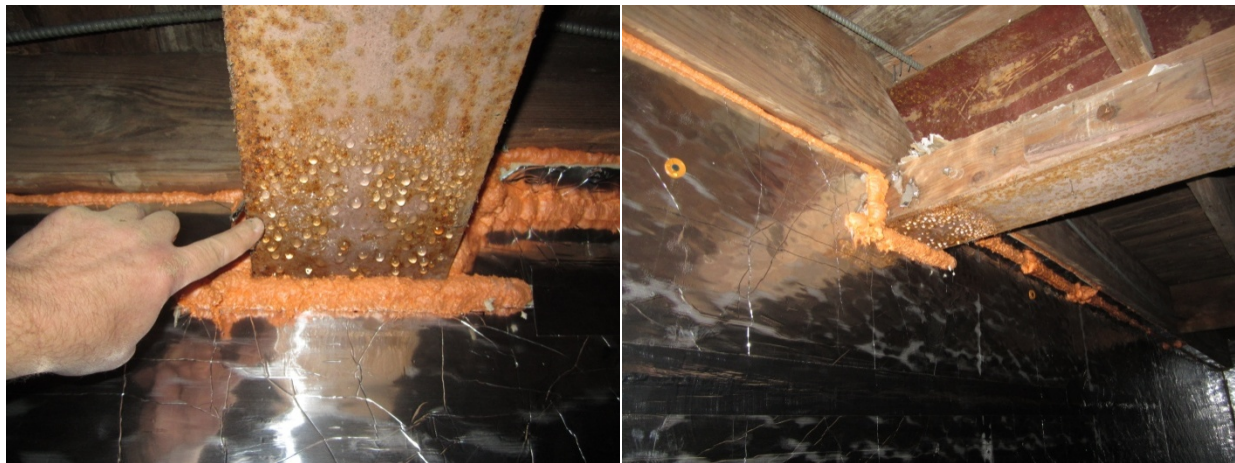
Figure 32. Condensation showing on cold I-beam at exterior wall of humid (70% RH) crawlspace (December 2011)

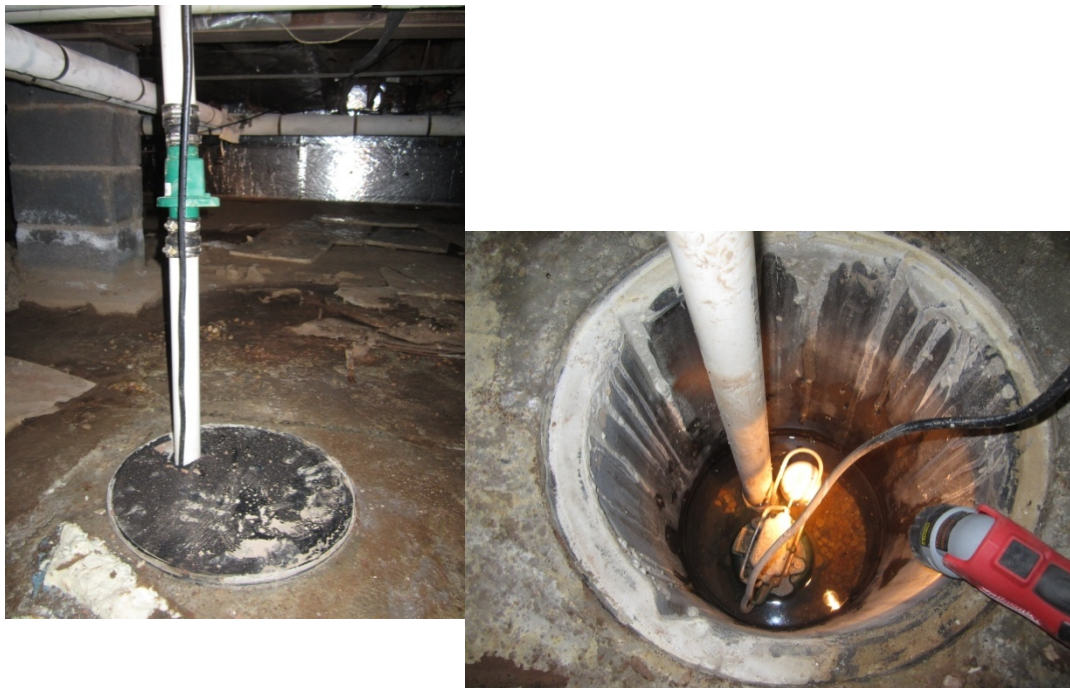
Figure 34. Sump pump installation; sides of sump pit are perforated with drilled holes, but perforating the bottom would be better; concrete debris and mud left in sump should be cleaned out to allow pump impeller to work freely.

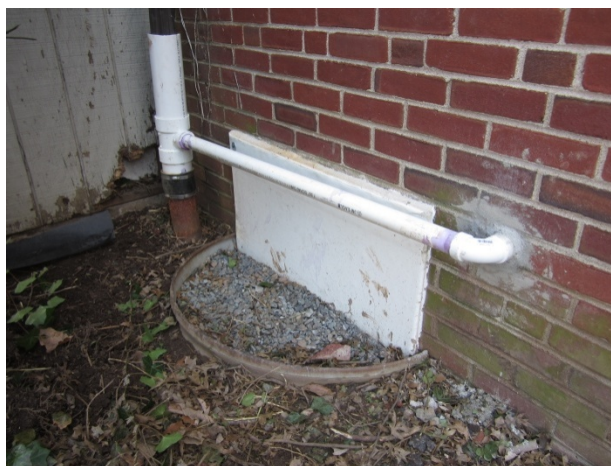
Figure 35. Sump pump water discharged into the roof drain water system

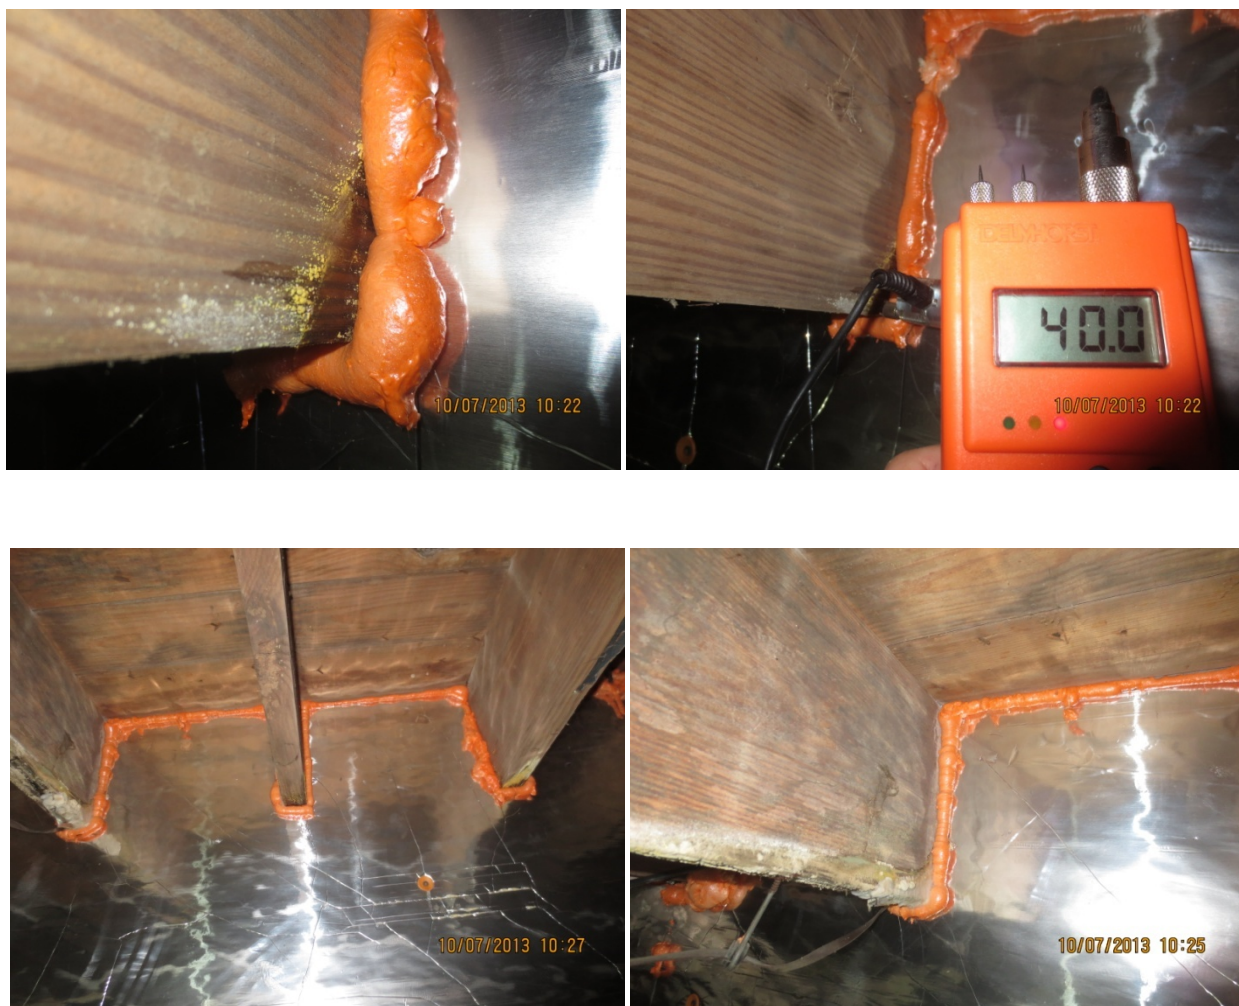
While the unvented crawlspace retrofit was effective in reducing heat loss, and the majority of the bulk water drainage problems had been resolved, the important finding was that some of the wood joists embedded in masonry pockets behind the brick veneer were showing signs of moisture damage. The earlier recommended small airspace between the insulation and the joist was needed to allow the joist to adequately dry when it got wet from water passing through the brick veneer or from capillary uptake from the masonry unit. Since it would not be possible to reliably determine which joists may become moisture damaged over time, a recommendation was made that the foam insulation be cut back $\frac{1}{2}$ in. from around all the joists in all of the crawlspaces to increase drying of the joist ends. It was apparent that the risk of moisture damage to the wood joist ends far outweighed the energy penalty of the small area of uninsulated wall around the joists.

Figure 36. Wet floor joists coming out of insulated masonry wall, measuring 40% moisture content and showing fungi growth and decay

pockets behind the brick veneer were showing signs of moisture damage. A small airspace between the insulation and the joist was needed to allow the joist to adequately dry when it got wet from water passing through the brick veneer or from capillary uptake from the masonry unit. Brick leaks water, masonry units draw and hold water, and wood is both water absorptive and water sensitive. An airspace around the wood joists would keep the wood warmer and allow it to dry when it got wet, as it had for the last 40 years. This drying requirement reasoning was also influenced by having seen some pre-retrofit water staining at the ends of some wood joists, which indicated that the joists had been getting wet and drying, and tolerating that. Since it would not be possible to reliably determine which joists may become moisture damaged over time, a recommendation was made that the foam insulation be cut back $\frac{1}{2}$ in. from around all the joists in all of the crawlspaces to increase drying of the joist ends. It was apparent that the risk of moisture damage to the wood joist ends far outweighed the energy penalty of the small area of uninsulated wall around the joists.

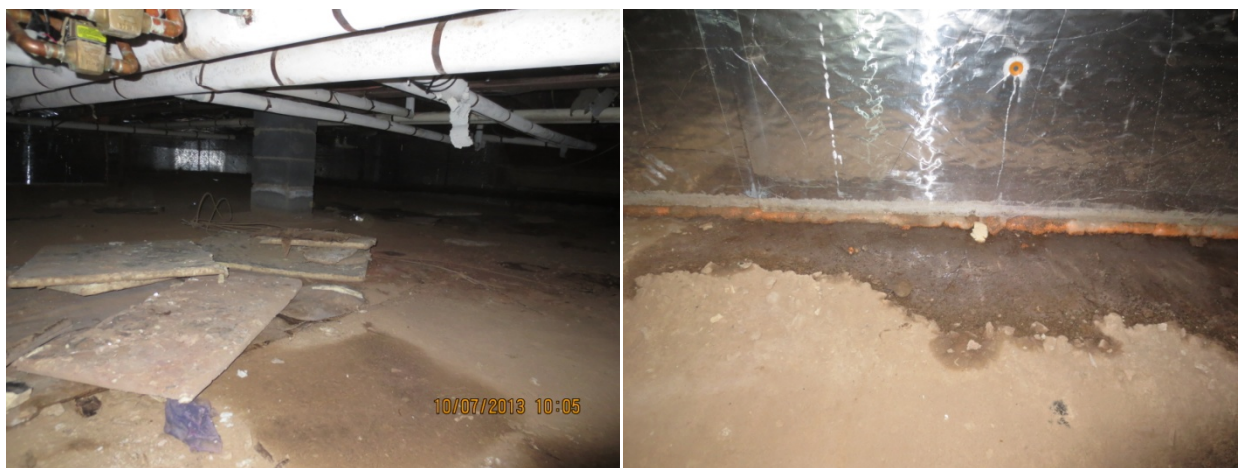
Figure 37. Example of debris and mud, holding moisture in crawlspace (L); example of small area of standing water at slab edge and foundation wall (R)
