# Retrofitting a 1960s Split-Level, Cold-Climate Home

Srikanth Puttagunta

*Consortium for Advanced Residential Buildings*

July 2015

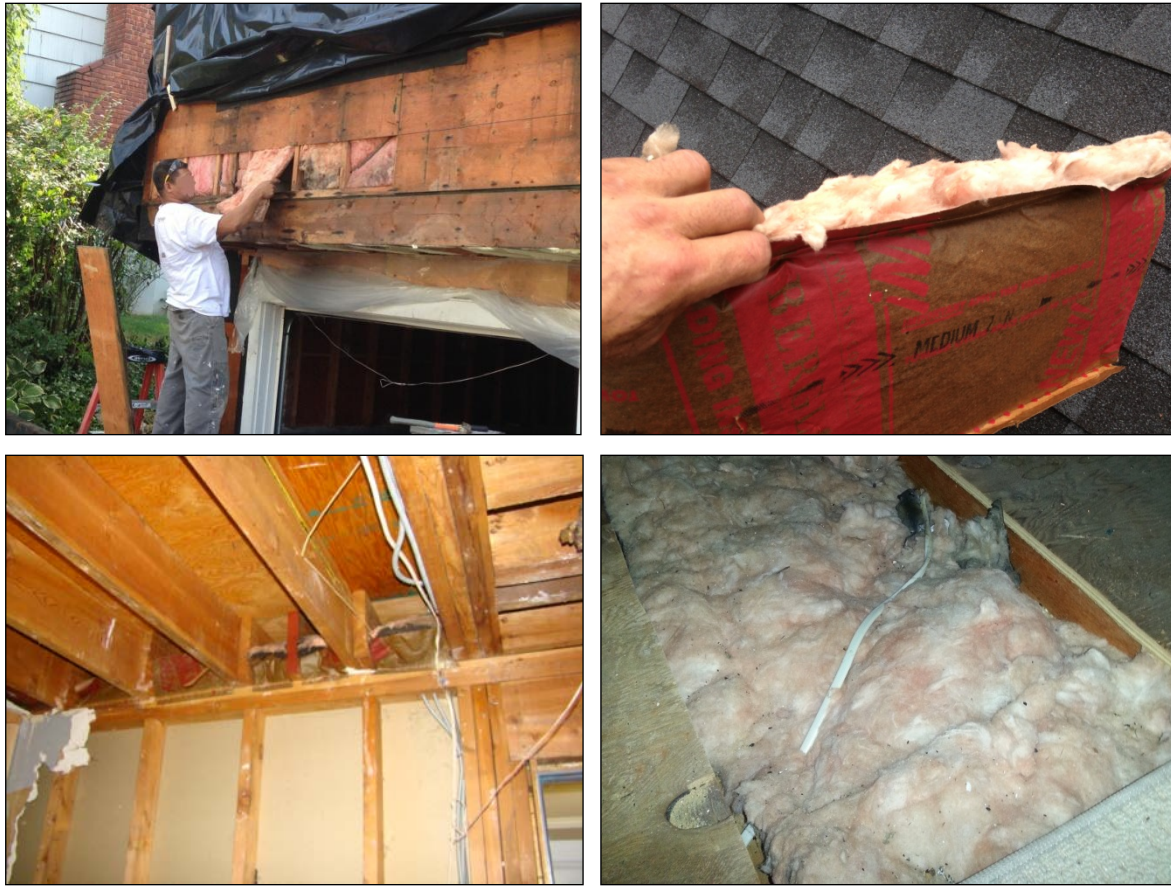
- Ways to improve the exterior wall insulation (the insulation was poorly installed and deteriorated R-11 fiberglass batts) without damaging the interior drywall.

- Ways to improve the ceiling and roof assembly (the assembly was poorly installed and deteriorated R-19 fiberglass batts were in the ceiling of the vented attic and in vaulted parts of the ceiling).

**Figure 2. Pre-retrofit insulation conditions: exterior wall insulation being pulled from exterior (upper left); wall insulation thickness (upper right); attic insulation (dead rodents were a major issue during this retrofit) (lower right); garage ceiling insulation (no air blocking between conditioned parts of home) (lower left).**

Dense-packed cellulose and ccSPF were used to provide the thermal barrier for the home. The siding needed to be replaced; thus, the walls could be properly insulated when the old siding was removed. A strip of sheathing was removed along the perimeter of the home to allow the old batt insulation to be removed. Once the sheathing was repaired, holes were made to blow cellulose

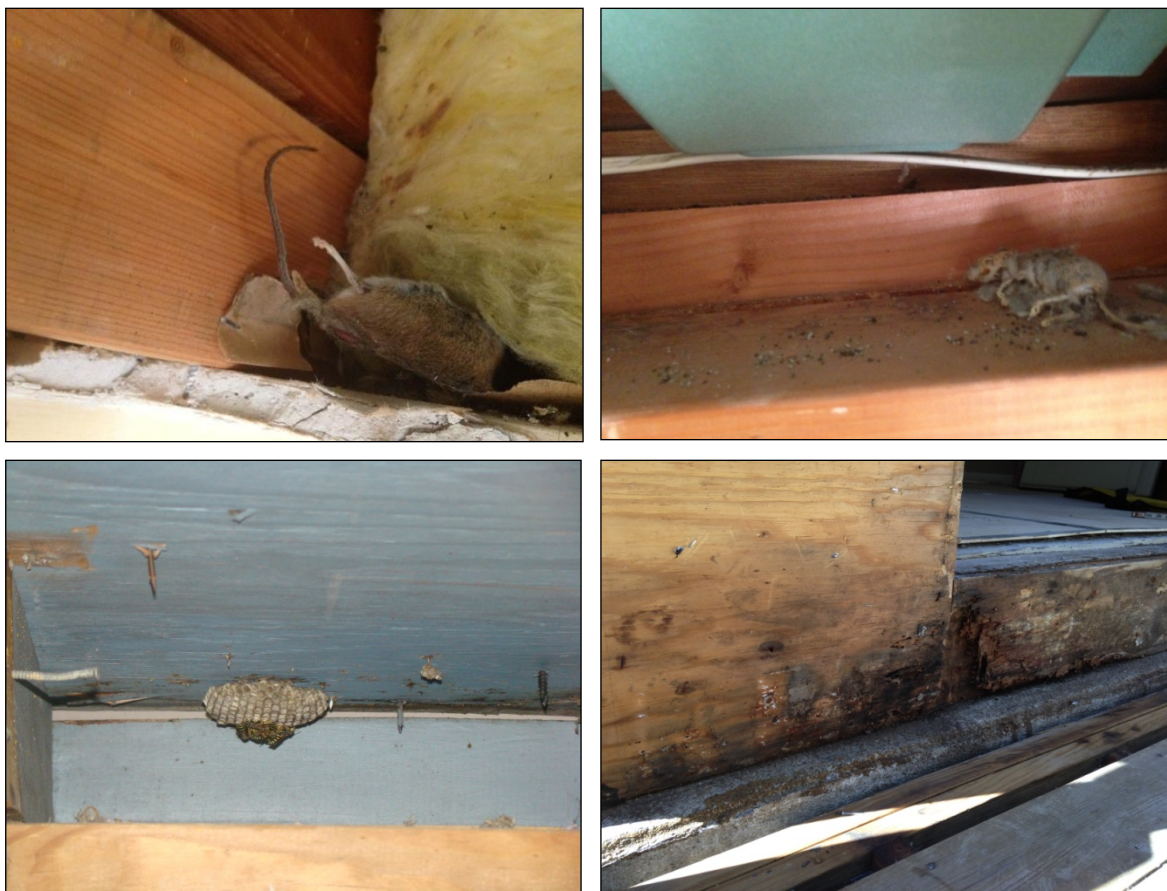
Mice droppings and dead mice (more than two dozen) were removed from the insulated attic and vaulted ceilings. Several active wasp nests were found in the soffit eaves of the family room. Pathways in the building enclosure also allowed wasps inside the house (an interior nest was being formed in the skylight shaft). The French doors leading from the family room to the backyard were water damaged. Further investigation revealed that termites had started to infest the backer board behind the siding and sheathing. Fortunately this was the only evidence of termites and was eliminated quickly.

**Figure 5. Pest hazards: dead mice were found in the vented attic space over the bedrooms and in the vaulted ceilings (upper right and left); active wasp nests were found throughout the soffit eaves and in several cases had a pathway into the home (lower left); termites had started to infest the exterior wood components under the rear French doors (lower right).**

During the process of air sealing, identifying entry pathways for these and other pests (spiders, ants, etc.) was essential to prevent further intrusion. Solid blocking was used to seal entry pathways before air sealing. All accessible ceiling joist bays were vacuumed to remove the fecal droppings. The homeowner indicated that there hasn't been any evidence of pests within the home since the retrofit was completed.

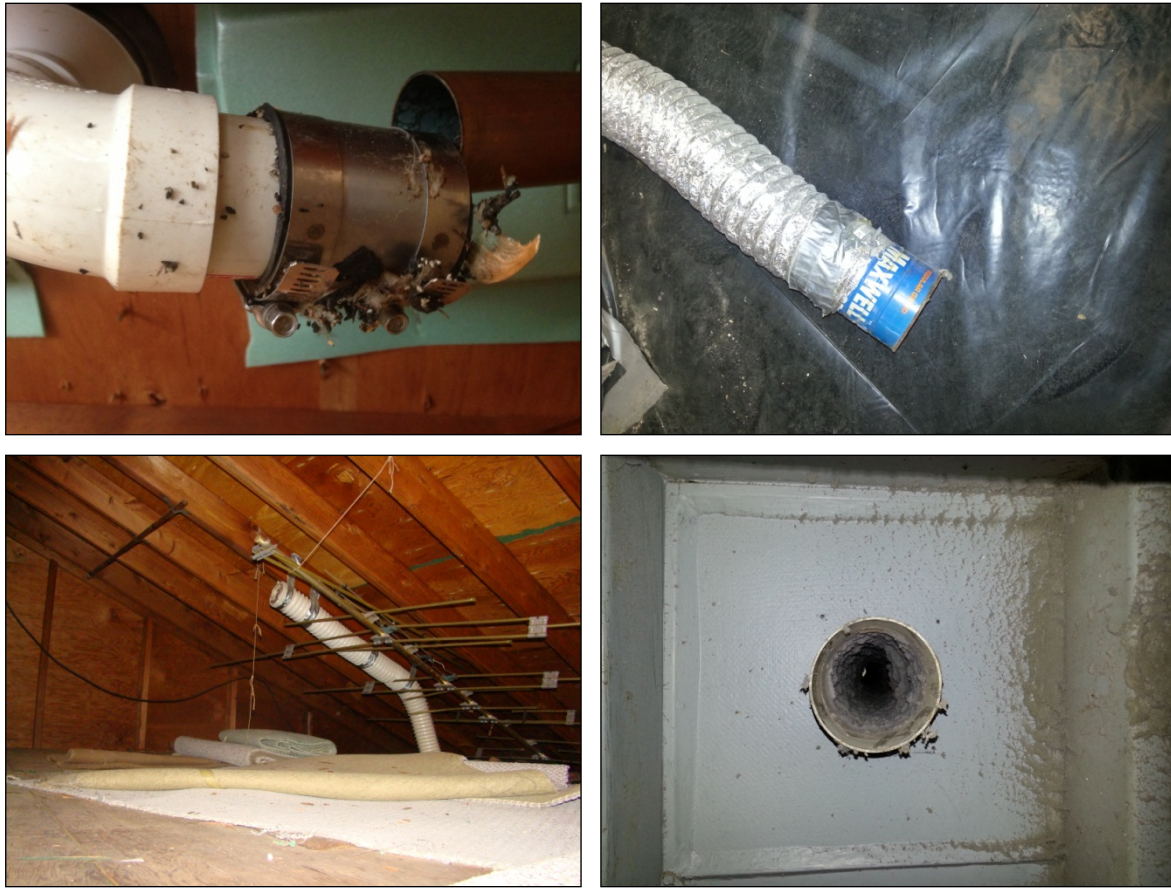
In any retrofit, the more you look, the more you are likely to find. This project was no different. When the vaulted ceiling in the kitchen was opened to insulate and air seal, the plumbing vent pipe in the ceiling was found to be disconnected. Figure 6 (upper left photo) shows mice droppings even on this plumbing concealed in the vaulted ceiling, so this was likely one entry point. In fixing this pipe, it was also discovered that an active wasp nest was in the part of pipe that extended through the roof and may have been the pathway that allowed wasps to enter the skylight shaft.

The laundry room, located in the basement, vented to the outside roughly 20 ft away (the vent ran under the unvented crawlspace of the family room). No evidence of a problem was observed except that a coffee can was used to connect the flex duct to the clothes dryer. When the coffee can connection was removed, the vent pipe was found to have roughly an inch of lint built up along the entire pipe length to outside.

**Figure 6. Piping/duct hazards: disconnected plumbing vent pipe (upper left); coffee can used as clothes dryer vent splice (upper right); clothes dryer exhaust duct was lined with a significant amount of lint (lower right); the second-floor bathroom exhaust terminates in the unvented attic (lower left).**

The last two items to be addressed were the clothes dryer vent and the fireplace. For the clothes dryer vent, the ductwork under the crawlspace was cleaned of lint. The connection of that part of duct to the clothes dryer was re-ducted using round sheet metal ducts and a secondary lint trap was installed. This provides an additional clean out to prevent the ductwork from being lined with lint.

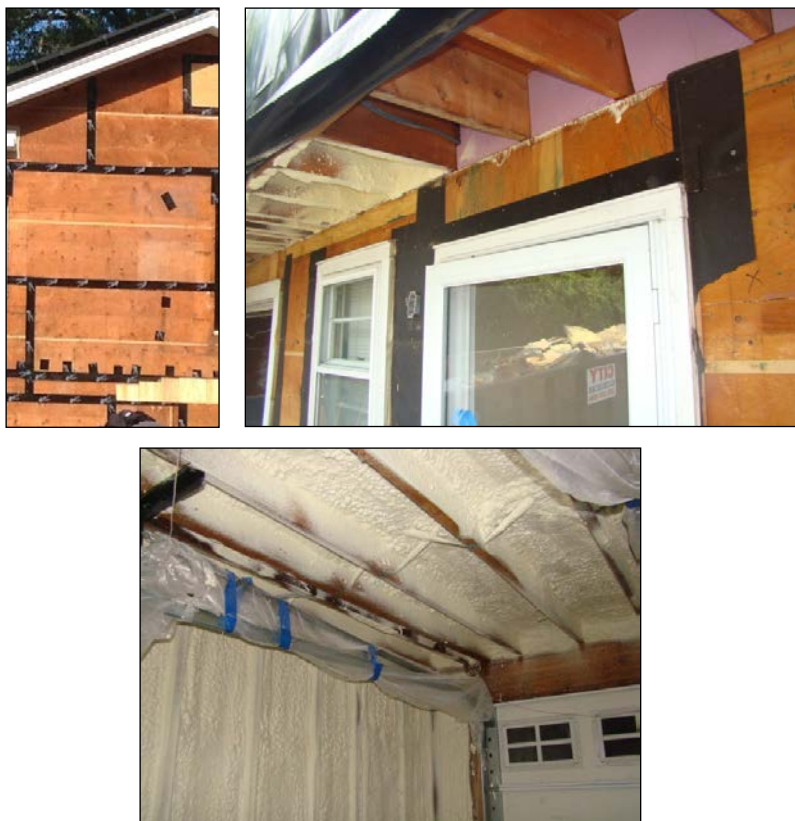
**Figure 8. Air-sealing details: all seams and penetrations in exterior sheathing were taped (upper left); blocking was installed to eliminate cold air from the overhang from entering the floor system (upper right); the attached garage was isolated from the living space with ccSPF (lower center).**

The greatest air exfiltration is typically through the ceiling/roof plane. Therefore, the entire roof structure was air sealed using ccSPF. On the opposite end of the spectrum, the greatest air infiltration is at the lower levels of the home, so in addition to the air sealing of above-grade walls, ccSPF was applied at the rim/band joist connection to the concrete foundation.

The last component of air sealing was isolating the tuck-under garage from the conditioned spaces of the home. Isolating attached garages from the living space is critical for preventing the potential infiltration of carbon monoxide and other contaminants into the dwelling. Open joist bays above the garage that extend into living spaces are unwanted air pathways. Air can also flow through cracks between and around the boards of the rim joist, the top plate, and the sill

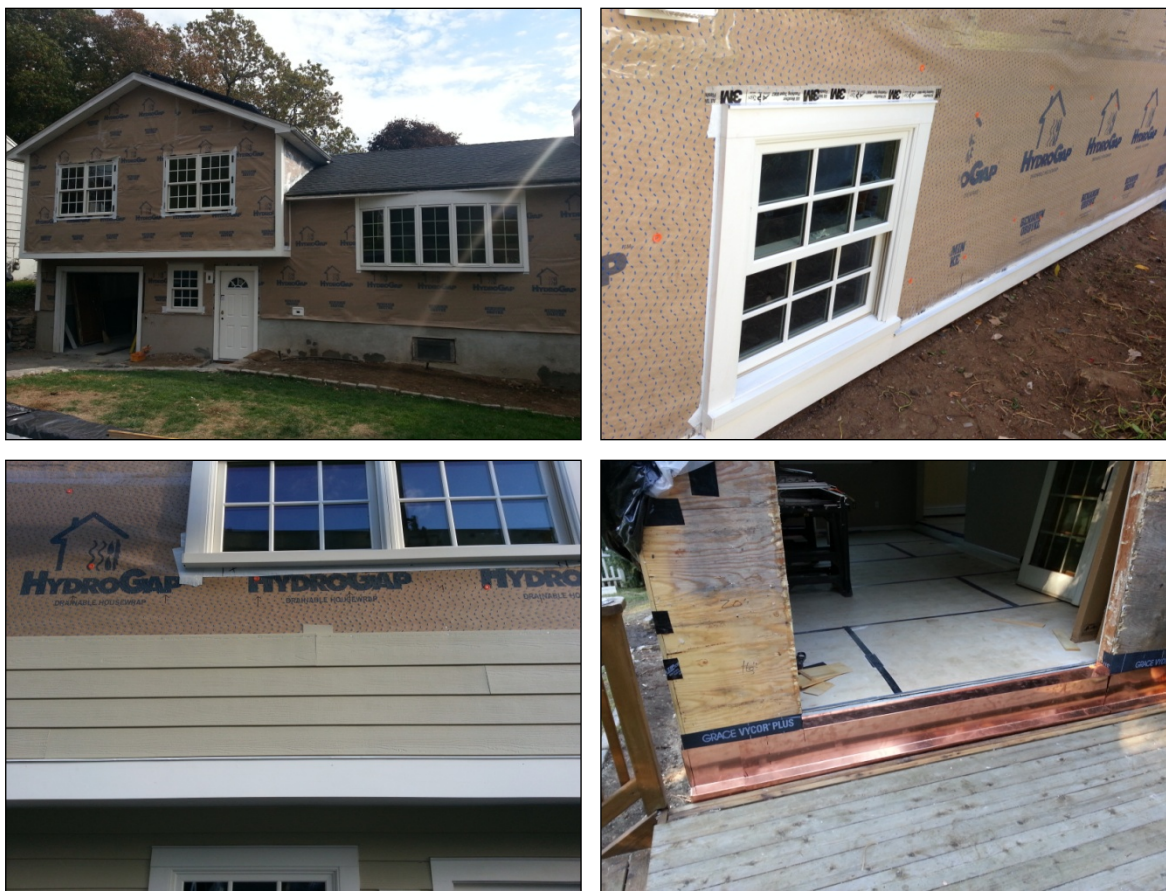
**Figure 9. Continuity of the drainage plane: a dimpled WRB was applied over the sheathing (upper left); windows were properly flashed and drip edges were installed over all windows, doors, and trim board (upper right); a door pan and flashing were used to prevent further water damage at the rear sliding door (lower right); fiber-cement siding was installed over the WRB (lower left).**

A dimpled house wrap was used to provide a drainable WRB over the plywood. All the windows were properly flashed to the WRB and a metal drip edge was installed over the top edge of windows, doors, and water table trim boards. The rear French doors were replaced by a sliding glass door after the termite damage was fixed, so a metal pan was used in combination with a peel-and-stick membrane to ensure proper drainage and to protect against termites. A final layer to provide the continuous drainage plane occurred during the installation of the fiber-cement siding. At the butt joint of any two pieces of siding, a piece of metal flashing (the same color as the siding) was installed behind the siding to maintain the drainage plane even when the siding pieces slightly shrink during winter conditions.

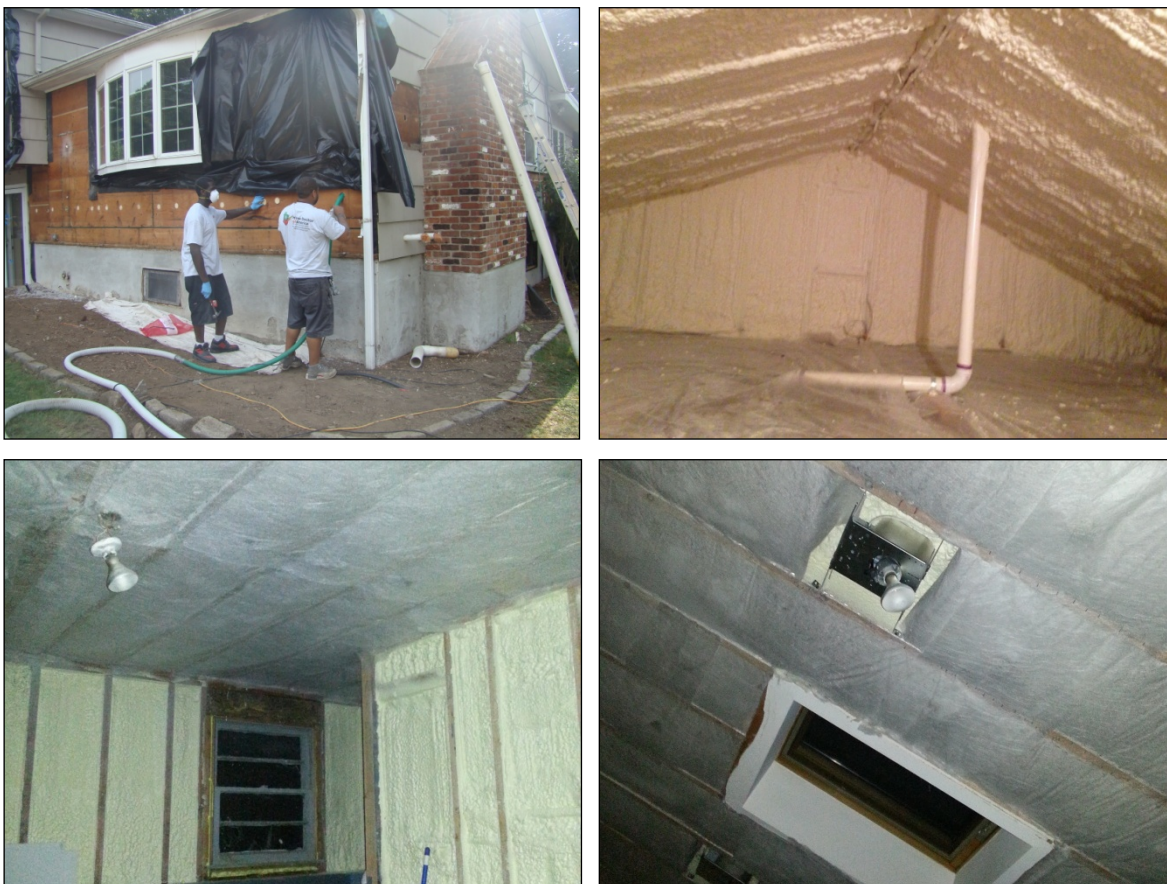
**Figure 10. Continuity of the thermal barrier: dense-packed cellulose blown into the walls from the exterior (upper left); the vented attic over the bedrooms was being used as cold storage, so this space was converted to warm storage by applying ccSPF to the roof deck to make an unvented attic (upper right); the vaulted ceiling drywall was removed to allow for 3 in. of ccSPF to be applied to the roof deck before dense packing the remainder of the roof rafters with cellulose (lower right); drywall from the garage was removed to allow the bedroom floors to be properly insulated and to isolate the garage contaminants from the living space (lower left).**

Most of the bedrooms are over the tuck-under garage, so the homeowners wanted to insulate this space and to isolate any potential contaminants in the garage from entering the living space. Therefore, the drywall in the garage was removed to provide access to the living space from the exterior. The shared walls with the living space were insulated with 3 in. of ccSPF. The underside of the subfloor to the bedrooms above was insulated with 3 in. of ccSPF before the remainder of the floor joists were filled with dense-packed cellulose.

The basement was not insulated because it was a finished space, but the rim/band joist area was air sealed with 2 in. of ccSPF to address the common leakage pathway. The basement had a drop acoustic ceiling, so access to the rim/band joist was easy and nondestructive to interior finishes.

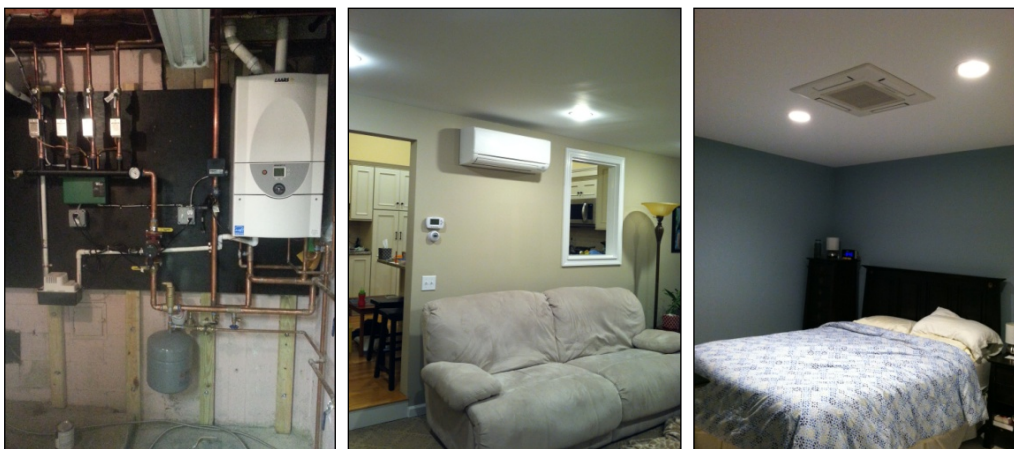
The home had an atmospheric oil boiler that fed a four-zone hydronic baseboard heating system. An immersion coil in the boiler provided DHW. This system would have had a maximum efficiency of 78 annual fuel utilization efficiency, but it was poorly maintained and already at the end of its serviceable life. Initial inquiries with the local gas company indicated that no natural gas was available for the site. Because air conditioning was also desired, CARB focused on how best to incorporate a multiport air-source heat pump (the split-level configuration and vaulted ceilings did not allow space for central ductwork). Though, upon further investigation, a gas line

**Figure 11. Mechanical equipment updates: new natural gas combi-boiler provides heat to the hydronic baseboards and for DHW (left); wall-mounted indoor unit for the multiport heat pump provides air conditioning for family room (center); ceiling cassette indoor unit provides air conditioning and auxiliary heating for bedroom (right).**

The homeowners wanted to eliminate the through-wall air conditioner in the kitchen and the window air-conditioning units in the bedrooms. A central system was not a viable option given the layout of the home, so CARB recommended a multiport air-source heat pump. This selection was primarily predicated on the desires of the homeowner and not on energy cost-effectiveness. The multiport heat pump allows up to eight indoor units to be connected to a single outdoor unit. CARB worked on a system layout that would be least intrusive to run refrigerant and condensate lines to seven zones to allow for the level of individualized control desired by the homeowner. In vaulted spaces, the typical wall-mounted indoor unit was specified. In the bedrooms and living room, ceiling cassettes were installed. In addition to providing air conditioning, this system acts as auxiliary space heating in the guest bedrooms. In case the system was used for heating, to ensure that the unit could continue to operate uninhibited even when there were large accumulations of snow, the outdoor unit was installed on wall brackets 3 ft above grade.

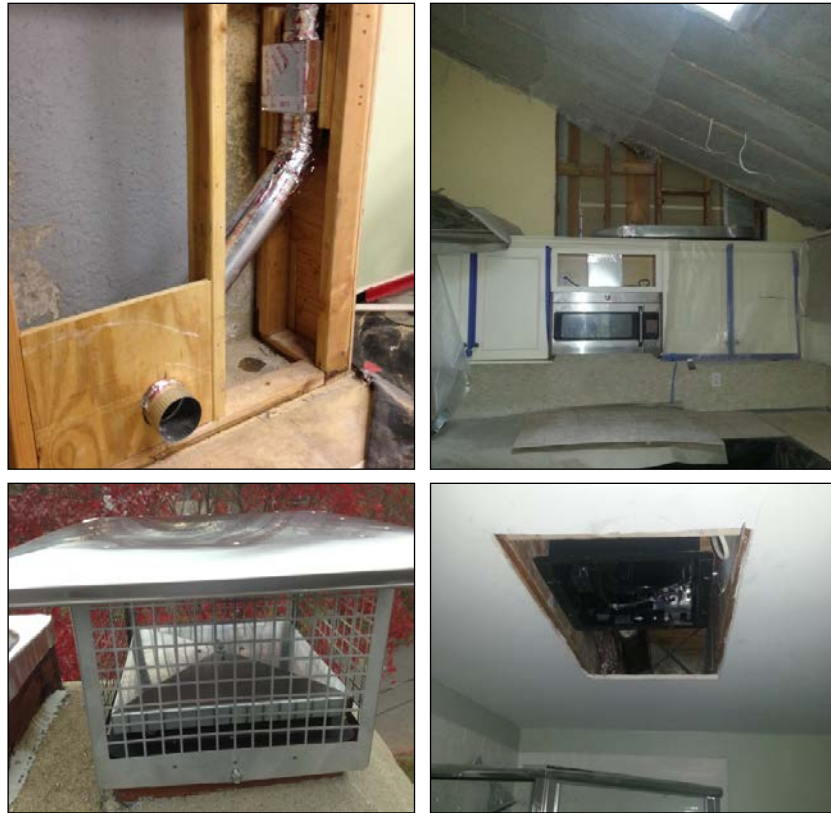
The homeowners knew that the kitchen exhaust hood was a recirculation microwave hood when they purchased the home. With a propane gas range (converted to natural gas during the retrofit), this was not an appropriate system for indoor air quality. Also, the second-floor bathroom exhaust terminated in the unvented attic and the first-floor bathroom had no ventilation or exterior window. Exhaust ducts should always terminate outdoors (refer to applicable codes for vent termination clearance requirements). Running exhaust ductwork up to a vented attic or just in front of an attic vent (gable, ridge, or soffit) is not sufficient. This can result in deterioration of the roof structure over time as condensation is likely to form on the roof framing members in the winter.

**Figure 12. Additional improvements: a secondary lint trap was installed on the clothes dryer (upper left); the microwave over the kitchen range was exhausted to outdoors (upper right); an exhaust fan was added to the first-floor bathroom that had no fan or window previously (lower right); a lock-top chimney damper was installed on the wood-burning fireplace (lower left).**

The homeowners did not anticipate using the wood-burning fireplace much, if at all. With the house being so airtight now, it is not clear how well the fireplace would work if used. The CARB team recommended that the homeowner not use the fireplace, but there was no budget to remove it. Therefore, a lock-top chimney damper was installed to minimize heat loss up the chimney. Heat is still lost through the uninsulated brick of the chimney, but the draft up the chimney was significantly reduced.
