Retrofitting Vegas: Implementing Energy Efficiency in Two Las Vegas Test Homes

Consortium for Advanced Residential Buildings

April 2013

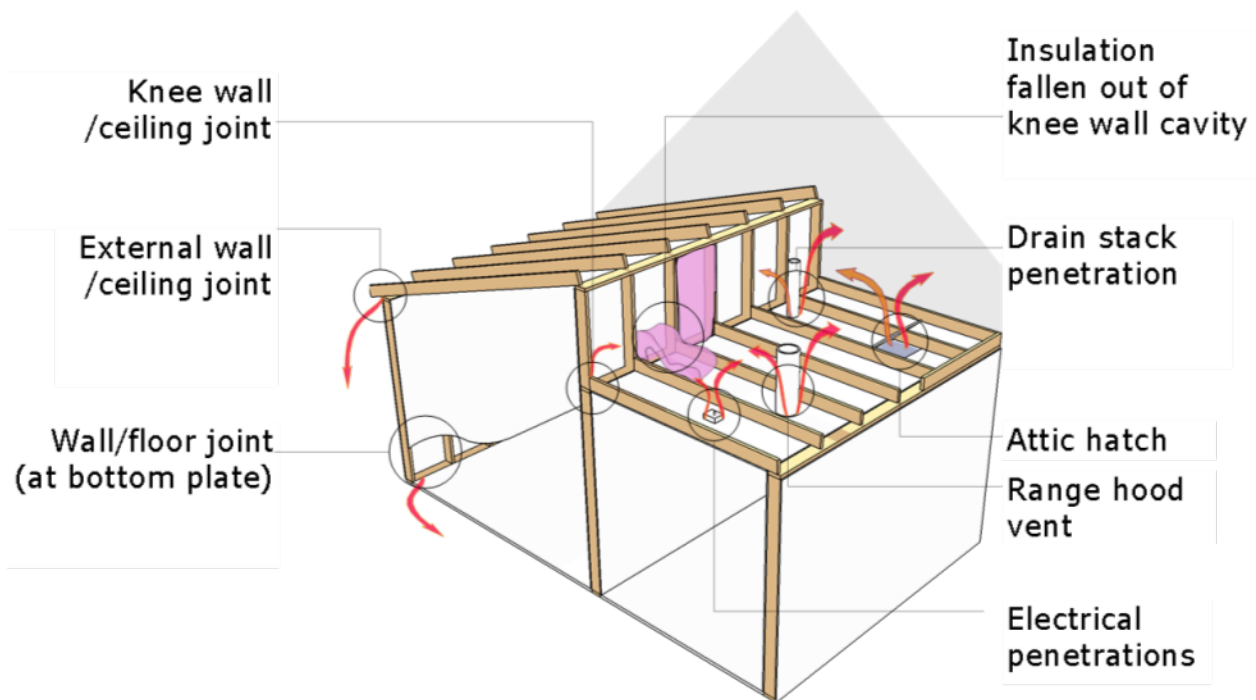
Figure 3. Ceiling leakage points at the Carmen home

IR thermal imaging revealed that many of the interior uninsulated partition walls were communicating with the attic. Penetrations in the top plates to accommodate electrical wiring were the most common culprit for this leakage pathway. Figure 4 shows two instances in which electrical wiring resulted in interior wall cavities that directly communicated with the attic air. These sections were not air sealed, and often did not have ceiling insulation, because it had been pulled or cut back.

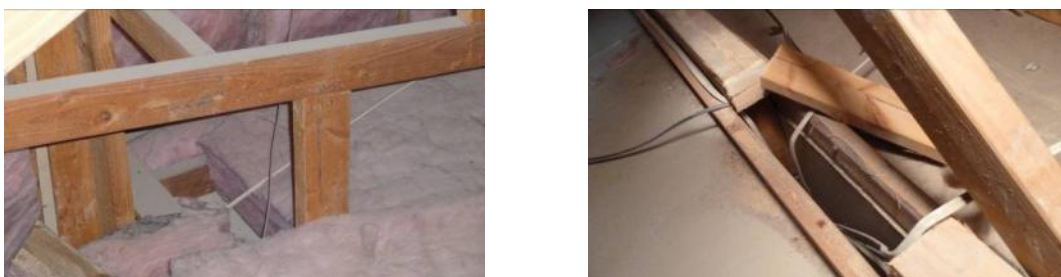
Figure 4. Top plate of interior walls cut out for electrical runs into partition walls

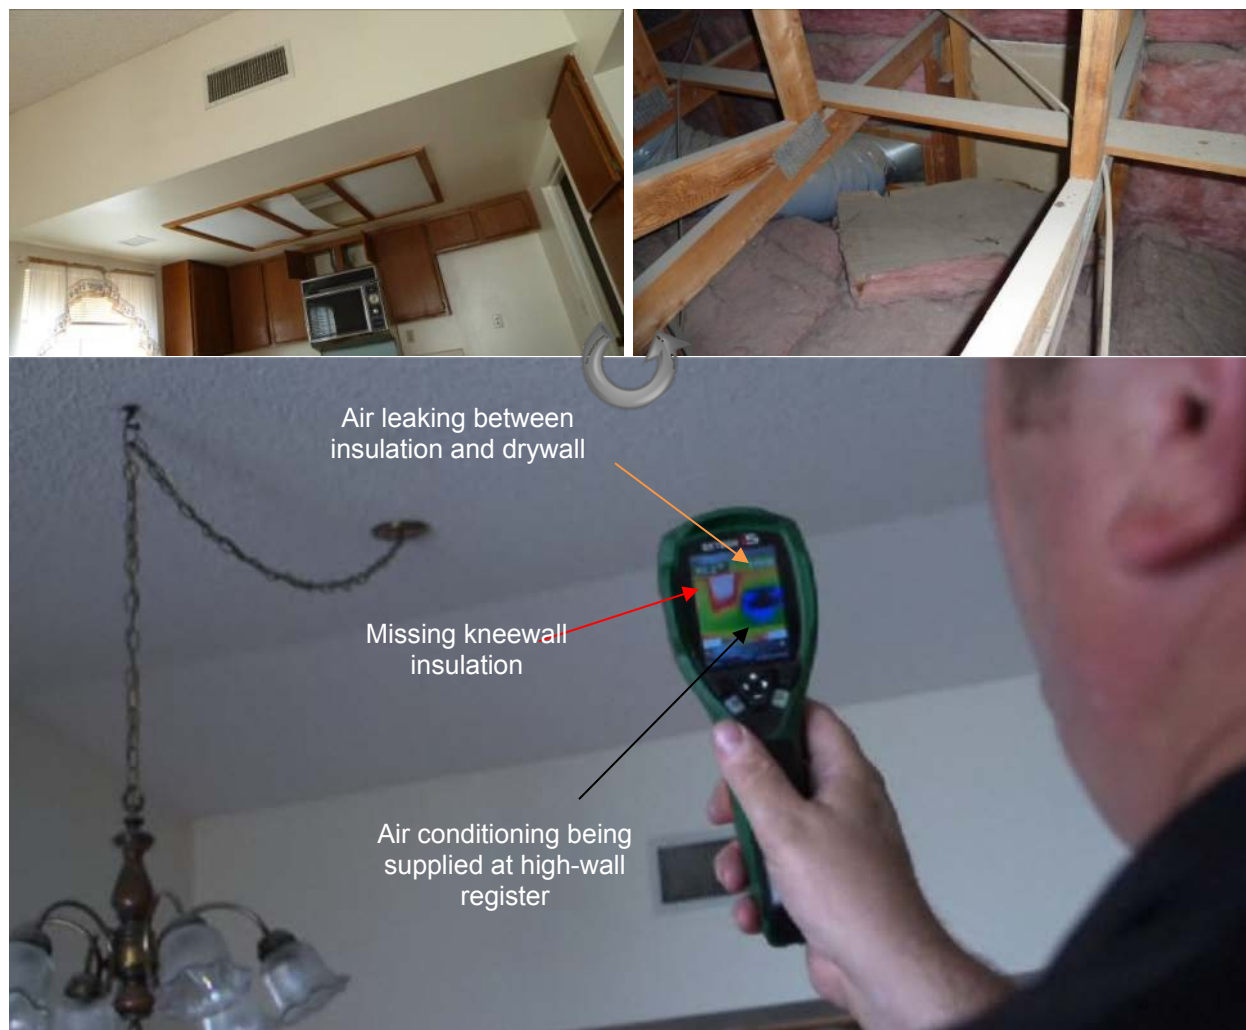
In general, kneewalls were performing poorly, mostly because unsupported batts had been dislodged, leaving uninsulated vertical bays. Figure 5 shows the kneewall at the transition from the kitchen to dining room. The IR camera showed that the bay to the left of the supply register had surface temperatures close to the attic temperature. Further investigation in the attic revealed that this section of the kneewall was not insulated because the fiberglass batt had fallen down. The whole top portion of this kneewall is hot, because all the batts are poorly installed and attic air is leaking between the batt and drywall, significantly reducing the insulation's performance.

Figure 5. Discovery of poor insulation in the kitchen kneewall

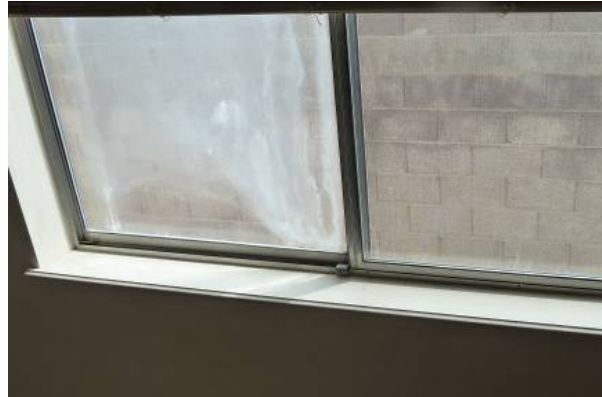
The window in the front corner bedroom was broken and temporarily boarded up. Further inspection revealed that the hermetic seal of several dual-pane windows had been compromised. This broken seal creates a pathway for moist air to enter this dead air space. When the window

surface temperature is lower than the dew point of the air, condensation forms. Over time, mineral deposits and a permanent white silica haze are visible (see Figure 6).

Figure 6. Haze between the window panes is evidence of a broken hermetic seal

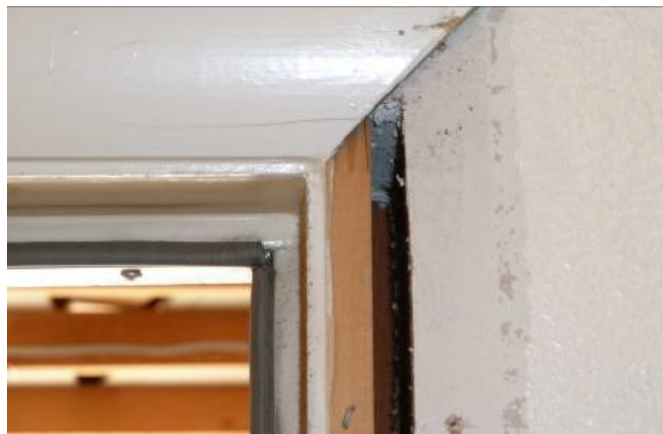
When door trim was removed, there was no evidence of prior air sealing between the exterior door jamb and the rough opening (Figure 7). This is a common source of air infiltration. In some instances, fiberglass batts are stuffed into this opening. This adds some slight insulation value, but is still not an air barrier.

Figure 7. Lack of air sealing around exterior doors

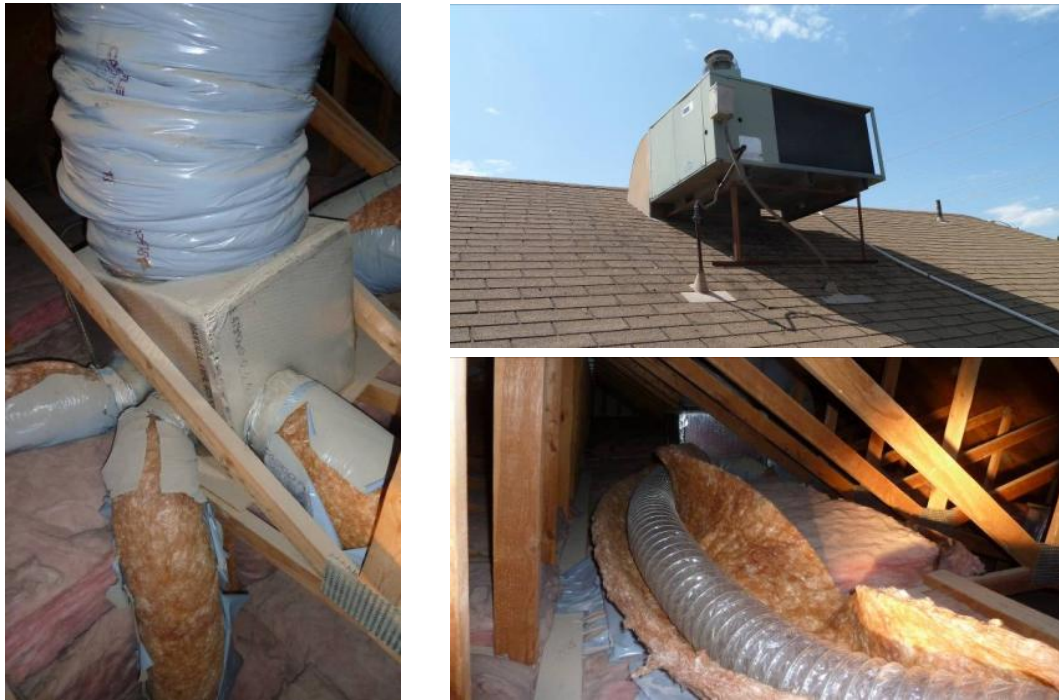
The original HVAC system in the Carmen home was a packaged furnace/air conditioner (AC) located on the rear roof. It was more than 28 years old; its effective life expectancy is anticipated to be 15–18 years, so it was well past due for a replacement.

This furnace unit had a heating capacity of 60 kBtu/h with a seasonal gas heating efficiency of 76% AFUE. On the cooling side, this 3.5-ton AC had a seasonal energy efficiency ratio (SEER)

rating of 8.5 but was poorly installed and maintained, so the actual delivered efficiency was likely closer to an equivalent SEER 5 equipment rating. Ductwork was run from this exterior unit through the roof deck and was distributed throughout the home through ceiling registers located in the vented attic. The flexible ductwork was in very poor condition with significant deterioration of the exterior vapor barrier and in some instances, the insulation had unwrapped from the inner duct liner. Images of this HVAC system are shown in Figure 8.

Figure 8. From left clockwise: supply plenum located in the vented attic, roof-mounted packaged furnace/AC, and insulation unwrapping from flex duct because the exterior vapor barrier had deteriorated

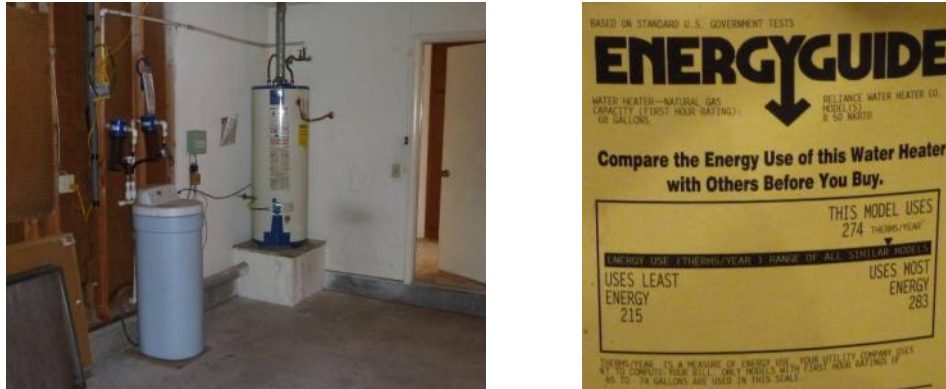
The domestic hot water system is a 50-gal atmospheric, natural gas water heater located in the attached garage. The rated EF for this unit is 0.55. Based on its serial number, it was likely replaced in 1997. Though not original to the home, this unit is past its effective life expectancy of 11–13 years.

Figure 9. Atmospheric gas water heater located in the attached garage

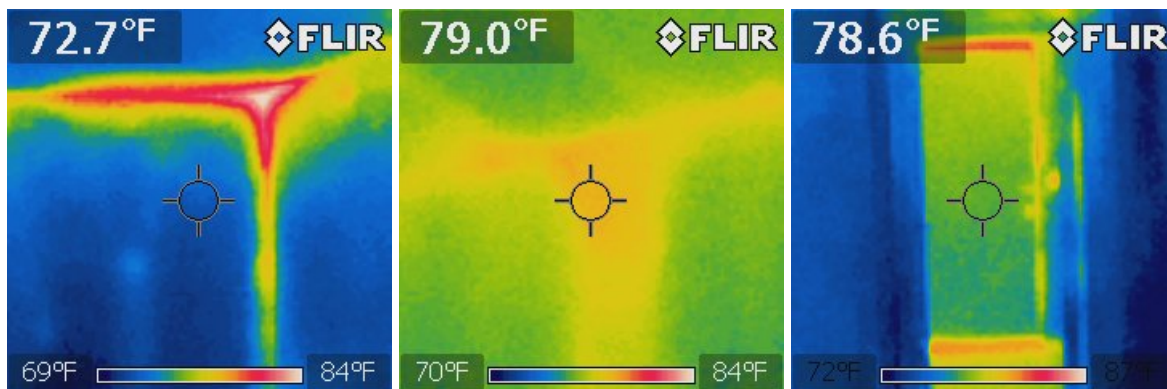
This home uses 2 × 4 wood framing at 16 in. on center with R-11 fiberglass batt cavity insulation and 1 in. of EPS on the exterior. This was not a gut rehab, so the wall insulation was evaluated using IR thermal imaging. There were the air bypasses typically found in existing homes at the top and bottom plates, around windows and doors, and at penetrations of lights, smoke alarms, registers, and attic hatches in the ceiling plane. The IR images in Figure 11 and Figure 12 show that the surface temperature variation across the drywall was approaching 15°F.

Figure 11. (Left) Top plate corner leakage; (center) kitchen exhaust ducting through interior wall without backdraft damper; (right) leakage around garage door from lack of weather stripping

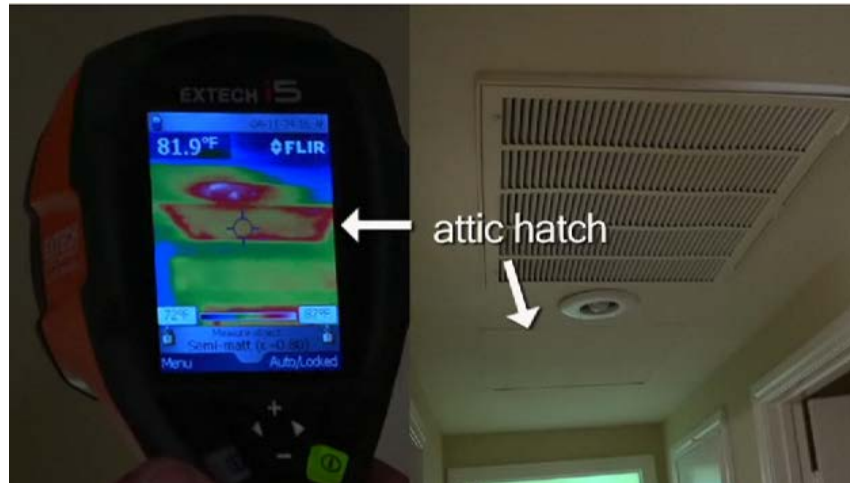
Figure 12. Leakage in ceiling plane
(Image courtesy of Building Media, Inc.)

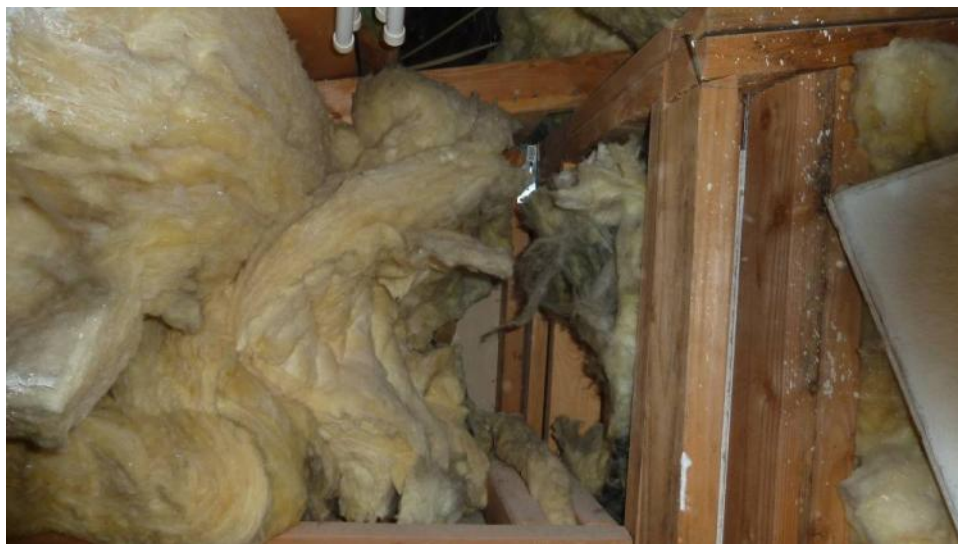
Even though the kneewalls in this home were better than the Carmen home, there still were some issues (see Figure 13). Whenever there is complicated framing, batt insulation is difficult to install effectively. In addition, to achieve the rated performance of the batt insulation, an attic side air barrier should be included to minimize air movement through or around the insulation. Once again, the framing evidenced in Figure 13 would make establishing a continuous attic side air barrier challenging.

Figure 13. Poor insulating of partially vaulted ceiling kneewalls
(Image courtesy of Building Media, Inc.)

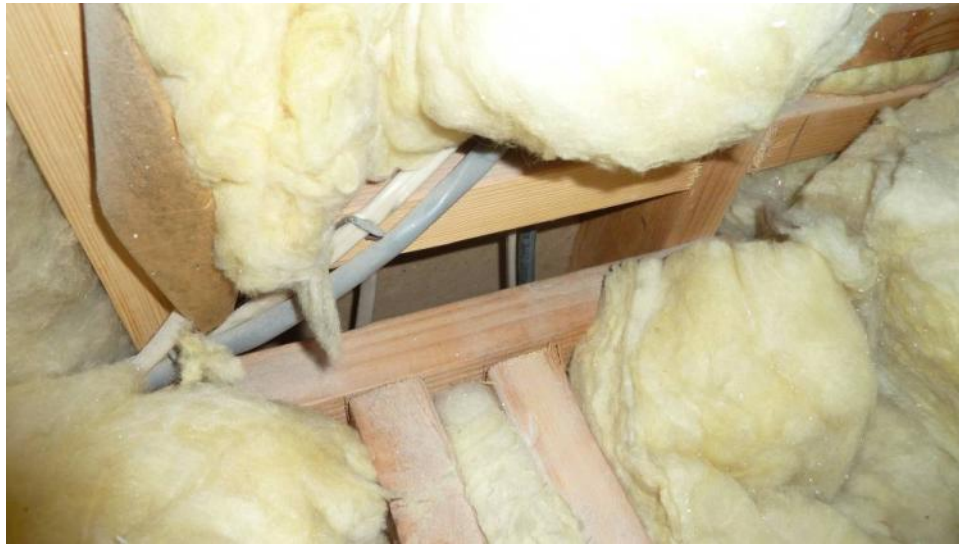
Compared to the Carmen home, the Sierra Hills home has more variation in the ceiling plane with a mix of flat and semi-vaulted ceilings throughout the home. This has led to several interior wall cavities directly communicating with the attic air (Figure 14).

Figure 14. Interior wall cavities that are directly communicating with the attic

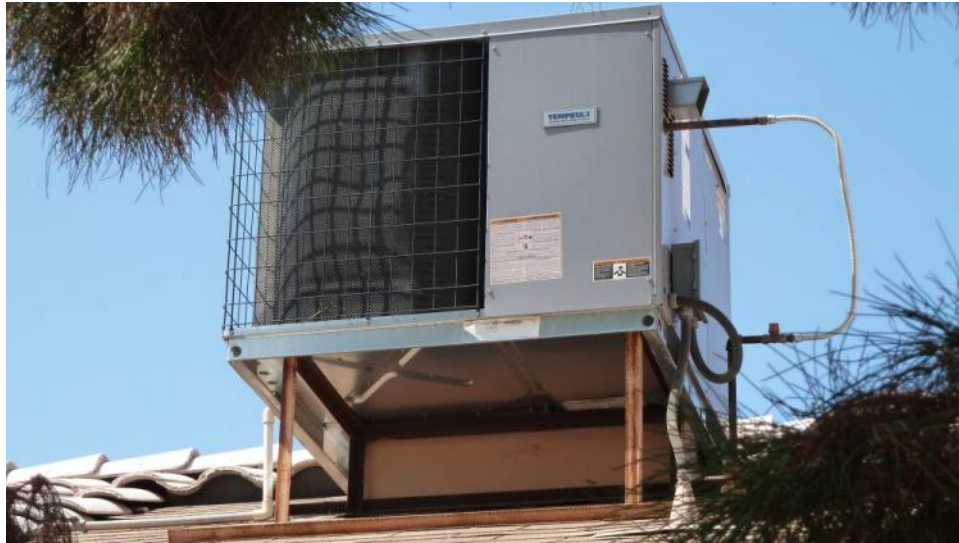
The HVAC system for the Sierra Hills home was a packaged furnace/AC located on the rear roof. It was anticipated that the HVAC equipment would be comparable to the Carmen house system, but the packaged HVAC system was likely replaced in late 2007 or early 2008 (verified with the serial number on the unit: G071141225). For Tempstar units, the second and third number/letter of the serial number represents the year the unit was manufactured and the next two numbers represent the week of the year. This was an unforeseen challenge, as the efficiency of this unit was not suitable to achieve the energy efficiency goals of this project. Also, more than 10 years of usable lifespan remained, so the cost benefit versus the incremental savings benefit was significantly minimized.

Figure 15. Rooftop packaged furnace/AC located at the Sierra Hills home
(Image courtesy of Building Media, Inc.)

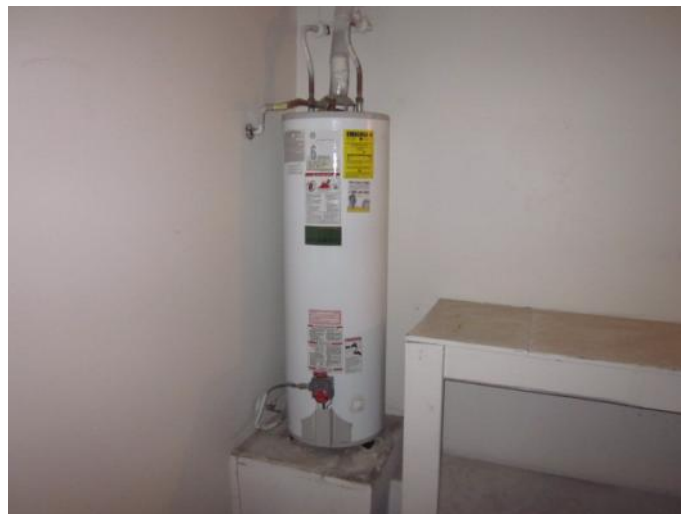
Domestic hot water was provided by an atmospheric 40-gal natural gas water heater. Again, the serial number (GENG 0700123945) of the water heater was used to estimate the install date of this equipment. For General Electric water heaters, the first two numbers refer to the month and the second two numbers refer to the year. So this unit was manufactured in July 2000. It was likely installed shortly after manufacturing, so the water heater was likely replaced in early 2001. Therefore, this unit has basically reached its effective life expectancy of 11–13 years.

Figure 16. Atmospheric water heater located in the garage of the Sierra Hills home
(Image courtesy of Building Media, Inc.)

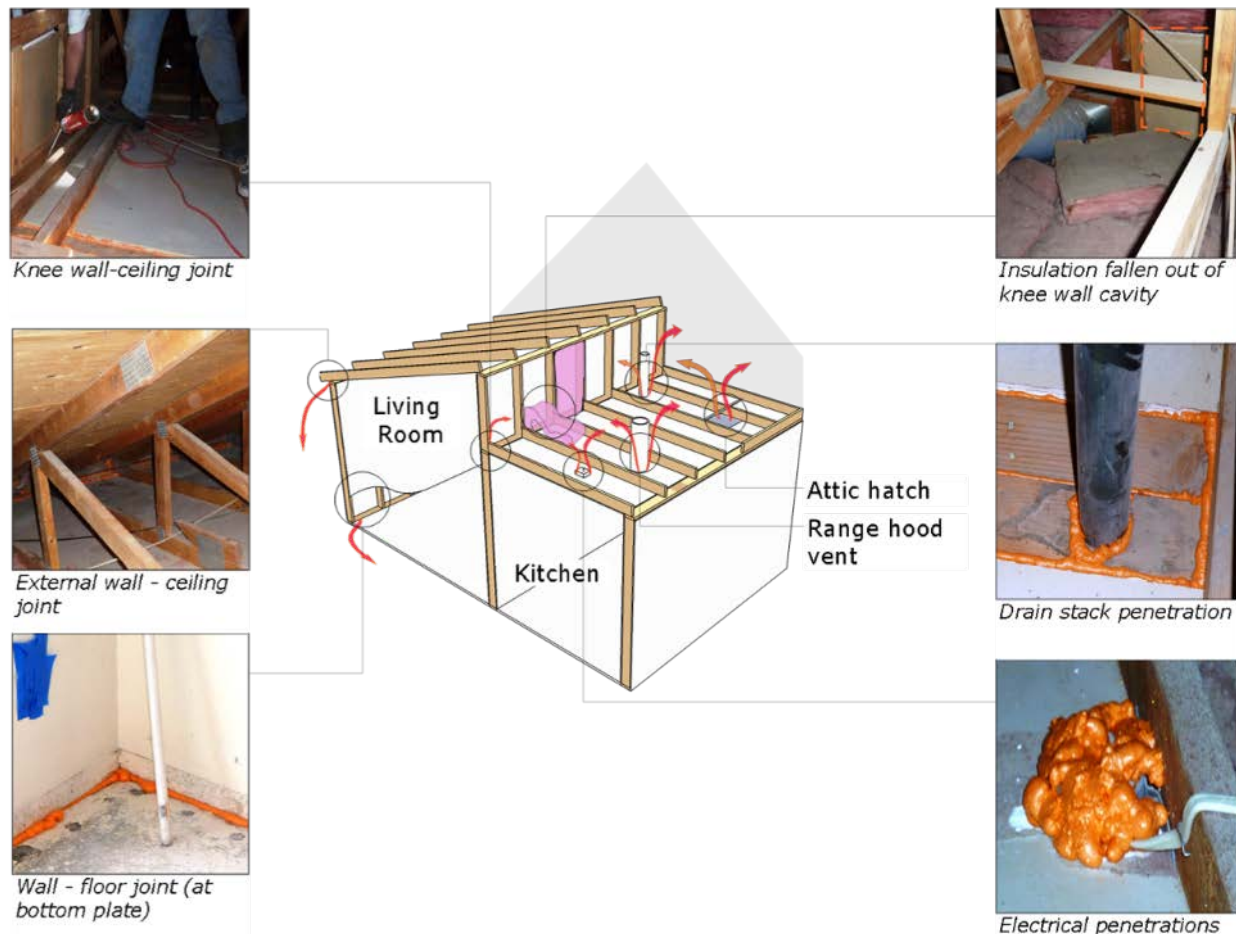
Figure 20. Examples of air sealing at the Carmen home
(Small images courtesy of Building Media, Inc.)

Over the two-day air sealing sessions at each project home, the attendees worked with Mr. Chitwood to air seal all accessible openings, joints, and cracks to maintain a continuous pressure

boundary (see Figure 20). A blower door and an IR camera were used during the session to qualitatively identify air leakage pathways and to quantitatively measure the air sealing efforts.

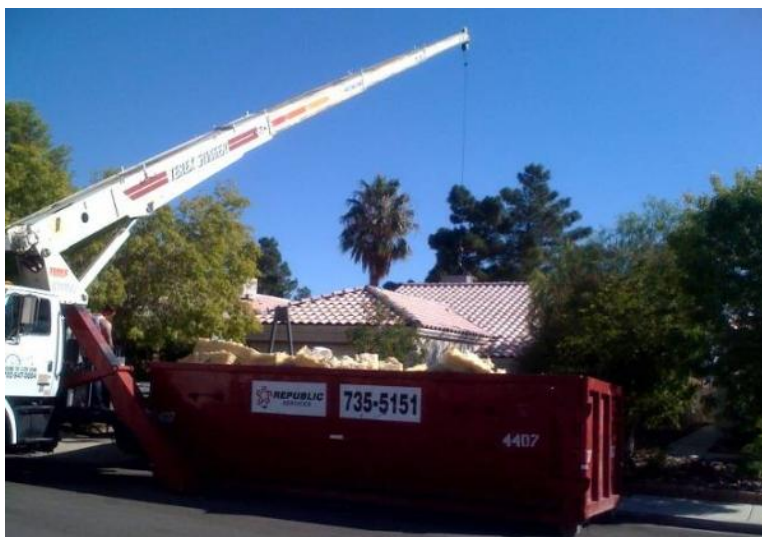
Figure 21. Existing package furnace/AC unit being craned off of the Sierra Hills home
(Image courtesy of Building Media, Inc.)

The existing packaged furnace/AC units were located on the roofs. In the case of the Carmen home, this unit was removed with a crane, the roof was patched, and the new outdoor heat pump unit was located in the backyard. For the Sierra Hills home, the project team decided to maintain the location of the outdoor unit, by placing the new outdoor heat pump on the roof (see Figure 22). This resulted in added cost for a crane (see Figure 21), but simplified running the refrigerant line sets to the indoor air handler unit.

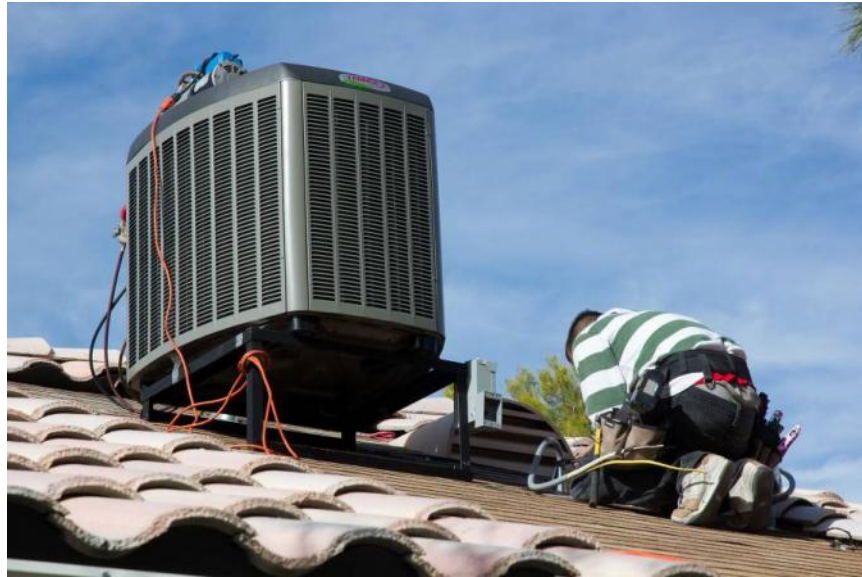
Figure 22. New outdoor heat pump unit being installed at the Sierra Hills home

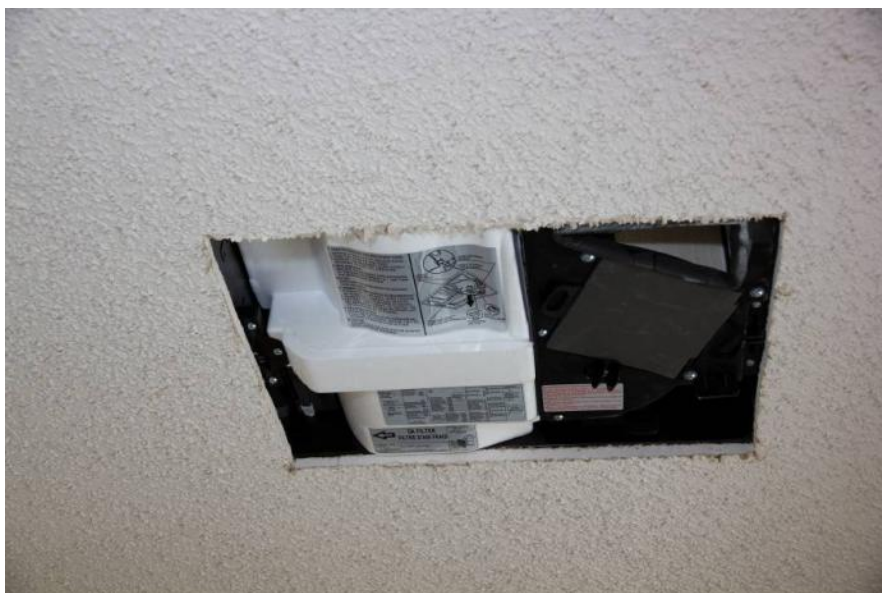
Figure 23. Spot ERVs installed in both homes to provide balanced whole-house ventilation

For ventilation, both homes had Panasonic 80 cfm WhisperGreen exhaust fans located in the bathrooms for local spot ventilation to remove excess moisture from showers. The kitchen ranges also had exhaust hoods that were ducted to outside to remove cooking contaminants from the home. These homes were extensively air sealed, so additional whole-house ventilation was provided in the form of a Panasonic 40-cfm WhisperComfort ERV (see Figure 23). CARB has researched this point source (Arena 2011) to verify that the units do not short-circuit (supply air is directly exhausted before being distributed throughout the home because the supply air and return air are close together).

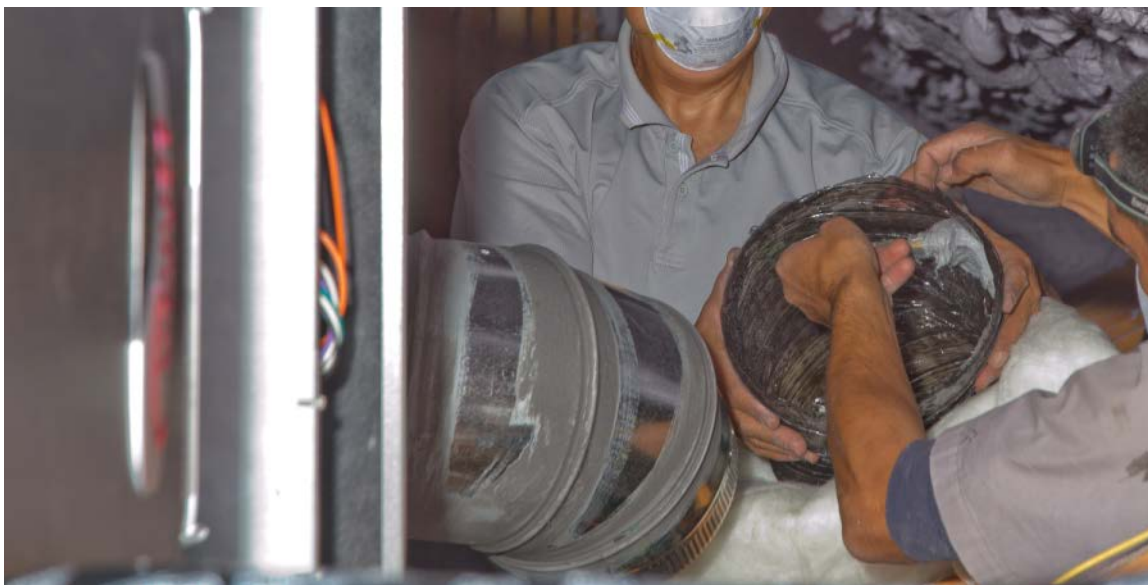
Figure 26. Mastic being applied to inside of flexduct jacket before being slipped over and secured to a branch takeoff elbow with compression bands

CARB calculated the cooling and heating loads during the design process to be 19,411 Btu/h and 19,163 Btu/h, respectively. A 2-ton two-stage ASHP was specified to meet these loads. But as the retrofit was being undertaken, air sealing and building specification goals were exceeded, so the actual building loads were lower than predicted. Therefore, the two-stage ASHP was locked on first stage unless the house was 8°F from the set point, so it operates as an approximately 1.5 ton unit. The class recalculated the duct design based on the final system controls configuration (full-stage lock out) and the in-field revisions to the duct layout (elimination of the dedicated kitchen/laundry supply). Once the target airflows were determined, the attendees worked on best practice installation methods for the various HVAC components (see Figure 26).

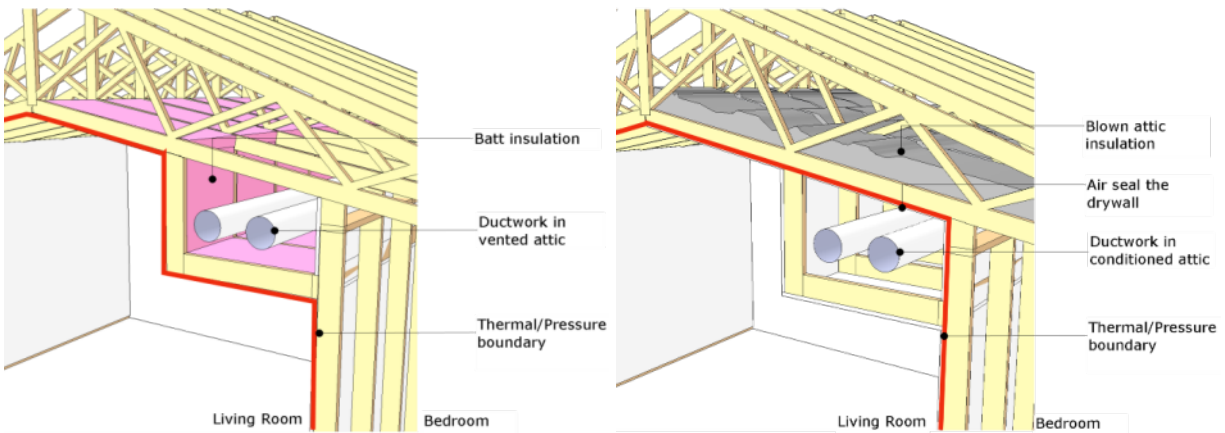
Figure 28. Relocating pressure boundary to bring ductwork into conditioned space. On the left is the existing configuration; the right image shows the new configuration.

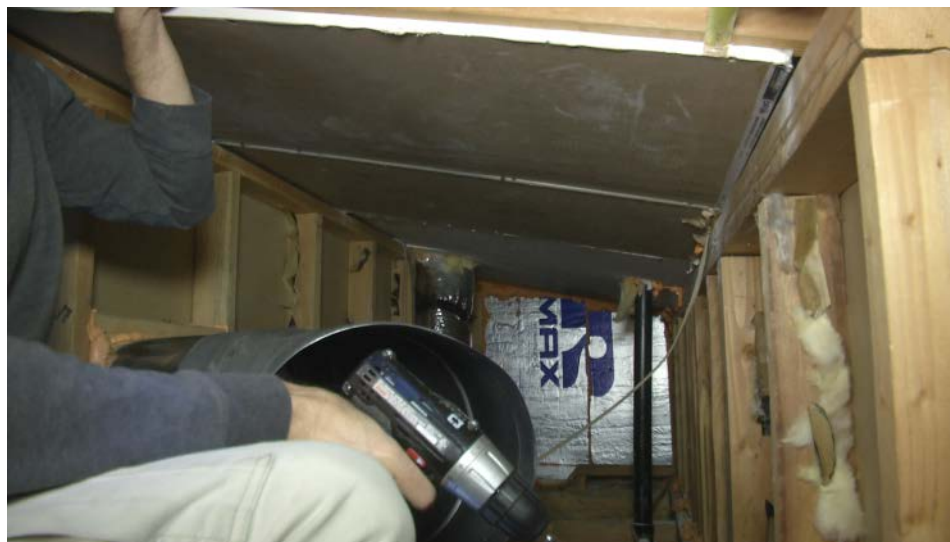
Figure 29. Pressure boundary being moved up to the bottom of the scissor trusses to allow ducts to remain within the building envelope
