# **Performance Evaluation and Opportunity Assessment for St. Bernard Project**

**Bruce Dickson** IBACOS. Inc.

June 2011

# Technical Report: Performance Evaluation and Opportunity Assessment for St. Bernard Project

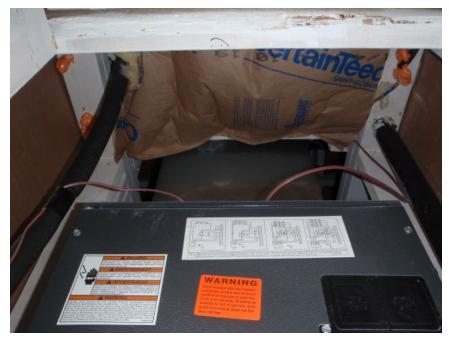
Figure 10. Photo of Open Mechanical Chase Lid

Not sealing the lid at the top of duct or other mechanical chases may lead to 1) increased utility bills for the homeowners due to decreased thermal performance, 2) comfort issues due to the unwanted exchange of air from unconditioned to conditioned spaces.

The best method to seal duct chase lids is to install a panel product over the top of the chase and then cut the duct penetration through. This enables the installer to create a better fit through the lid and makes it much easier to seal. Fiberglass chinking is minimally effective in preventing the passage of air and so should not be used for air sealing. Expanding foam is the most effective sealant to use at this location.

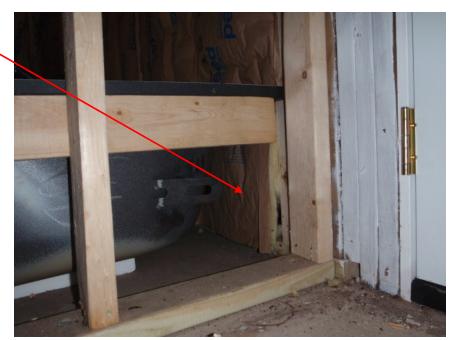
Figure 12. Photo of Missing Draftstopping

Exterior walls behind tub and shower units are insulated but did not have any type of sheathing installed over the insulation to prevent drafts and convective air currents.

This photo shows a cavity sheathed both to encapsulate the insulation so that the proper R-value is achieved and to avoid a convective loop. A convective loop occurs when air rises along a warm surface and falls along a cold surface creating a circular movement of air. Such a loop transfers heat through the building assembly, requiring more energy to replace the lost heat in heating seasons and the lost cool air in cooling seasons.

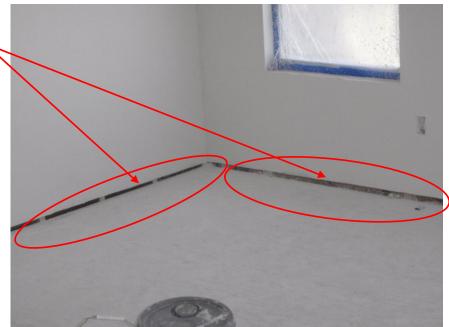
Figure 14. Photo of Drywall Gaps

In homes with ceilings that are taller than the standard 8 feet a large gap was left open at the base of walls. While baseboard will cover this area it will still permit air infiltration or exfiltration if left unsealed.

Gluing the drywall to the perimeter framing will greatly increase the overall effectiveness of the insulation and air barrier.

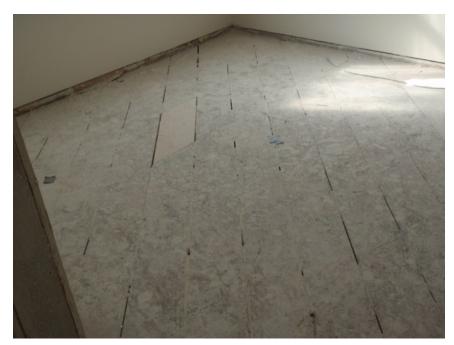
Figure 18. Photo of Open Plan Flooring

Establishing a continuous and thorough air barrier between the thermal shell and outdoors is critical to the overall efficiency and comfort of the indoor environment. This open plank floor should be addressed and sealed with a panel product on the top surface or a continuous spray foam seal from beneath prior to installing the finished flooring.

The most effective insulation and air sealing solution at framed floors on open pier foundations is to use a wash of closed cell foam over the entire underside of the floor system.

As an alternative, sealing the joints in the floor boards with canned spray foam and scraping the excess off once cured is an acceptable approach that requires additional labor and time.

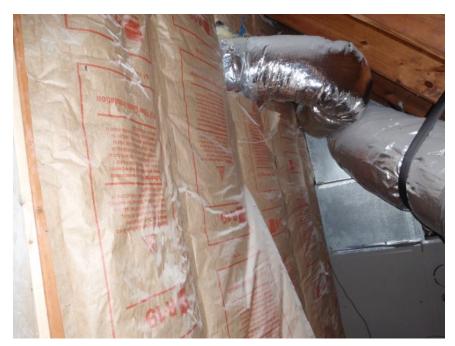
Figure 20. Photo of Unsheathed Attic Knee Walls

At locations where insulated walls are adjacent to unconditioned attic space, the attic side of the wall should be sheathed, both to improve the airtightness of the wall assembly and to fully encapsulate the insulation so that the proper R-value is achieved.

Sheathing the attic side of all kneewalls will ensure the batt insulation within the walls is encapsulated on all six sides. This will also ensure the effectiveness of the thermal envelope by preventing convection loops in the insulation.

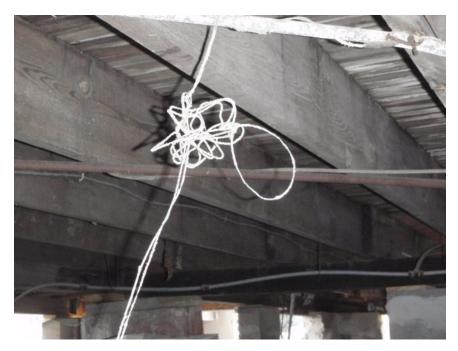
Figure 22. Photo of Uninsulated Raised Floors

A consistent strategy to maintain the thermal boundary at raised floors on open pier foundations needs to be established.

The most effective insulation and air sealing solution at framed floors on open pier foundations is to use a wash of closed cell foam over the entire underside of the floor system. Thickness of closed cell foam will be dependent on desired Rvalue of the floor system.

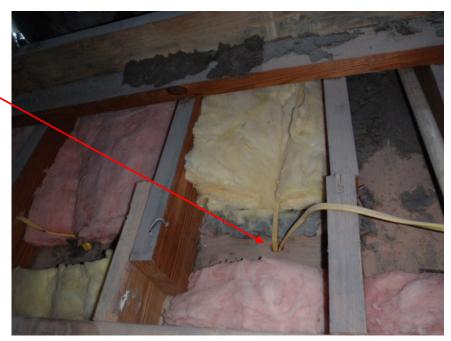
Figure 24. Photo of Missing Attic Insulation at Ceiling

Instances of missing insulation and air sealing at penetrations were observed in most attics.

The best practice at attics is to inspect the attic before insulation to ensure that all penetrations are sealed and then use a loose fill fiberglass blown in insulation (R-30) over the entire attic floor.

Due to the moisture retention capabilities of cellulose insulation, fiberglass fill is recommended for the hot humid New Orleans region.

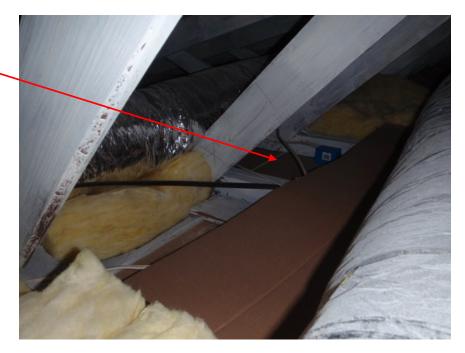
Figure 26. Photo of Missing Attic Insulation

Another instance of missing insulation in the attic.

An alternate method of insulating the attic would be to insulate against the roof deck with closed cell foam. This practice provides a total air seal and thermal boundary that minimizes the extreme temperature effects on the air handling equipment and ductwork.

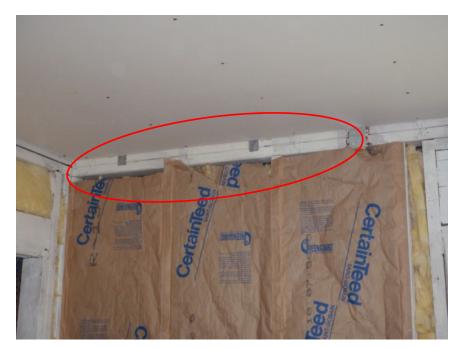
Figure 28. Photo of Short Kraft Faced Fiberglass Batts

The use of Kraft-faced batts is not recommended for hot and humid climate regions. The use of unfaced batts is the better approach that will provide more drying capability to the wall assembly.

Use of fiberglass insulation without any vapor barrier allows the wall assembly to breathe and dry to the inside. Additionally, it is far easier to do a thorough installation with unfaced batts.

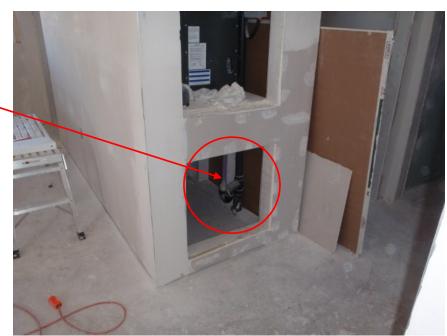
Figure 30. Photo of Panned Return

Panned, or using framing cavities for duct return systems are inherently difficult to seal and tend to draw air from building cavities instead of living spaces which may lead to comfort and efficiency issues.

Building a sealed return plenum box beneath the air handler is the best way to maximize the return air capability of the unit and ensure that the air is coming from the living space instead of framing cavities or the attic.

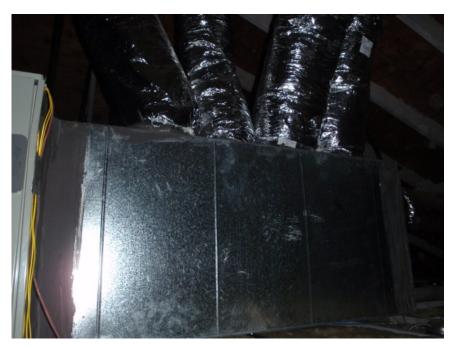
Figure 32. Photo of Identically Sized Ducts

Many of the duct systems that were observed did not seem to have any definitive sizing strategy. Duct systems that use similar size branch ducts may not deliver the necessary air amounts to certain rooms. This practice may result in comfort and efficiency issues that a homeowner will compensate for by adjusting the thermostat.

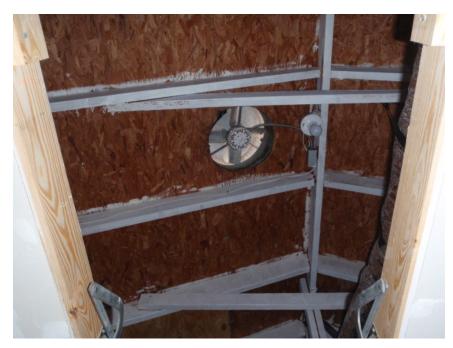
Figure 36. Photo of Attic Exhaust Fan

Concerns regarding attic exhaust fans exist due to the lack of a comprehensive and thorough air sealing between the attic and living space. Without a tight air barrier, the attic fan can pull conditioned air from the living space and induce air intrusion from outdoors.

Installing the appropriate soffit and either ridge or off ridge venting to remove excess heat from the attic is a better practice than the electric exhaust fan due to the impact on the living space that the fan can induce.

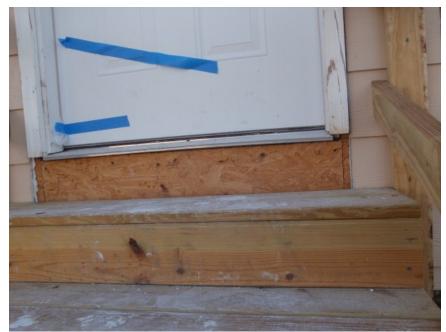
Figure 38. Photo of Missing Door Flashing

No comprehensive flashing strategy was observed at exterior entry doors. Standardizing a complete strategy that includes a pre-formed sill pan beneath the threshold and integrating the sill pan with self-stick flashing at the jambs and head will insure a weather tight assembly.

Example of a pre-formed sill pan beneath an entry door with the front lip extending out and over the drainage plane.

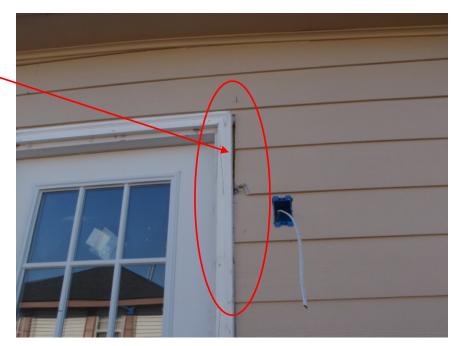
Figure 40. Photo of Missing Door Flashing

No comprehensive flashing strategy was observed at entry doors.

Standardizing a flashing strategy for new door installations that includes a sill pan beneath the threshold and properly applied self-stick flashing and drip edge over the head will minimize any potential for water intrusion at doorways.

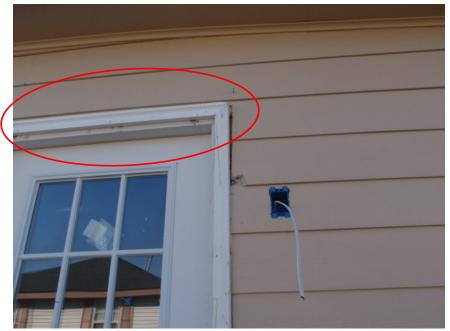
Figure 42. Photo of Missing Drip Cap at Door Head

No "z" flashing or drip edges were installed on the brick mould over the heads of doors.

Extend the drip cap 1" past the jamb on each side.

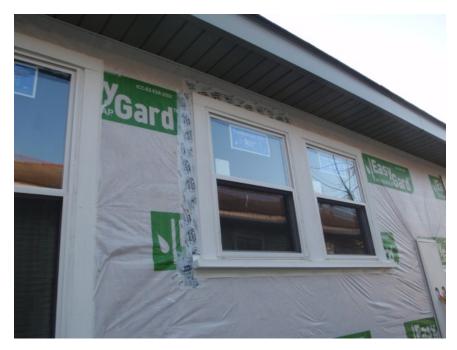
Figure 45. Photo of Mis-lapped Window Flashing

Self-stick window flashing was observed on exposed windows. Often the flashing pieces were mislapped with one another and did not maintain the shingling effect.

Flashing should start at the sill with the side jamb pieces layering over the sill and the head over the jambs. Cutting 2 angle cuts in the house wrap at each corner of the head and creating a flap that can be folded over the flashing and taped is the best strategy at maintaining the shingling effect when flashing windows.

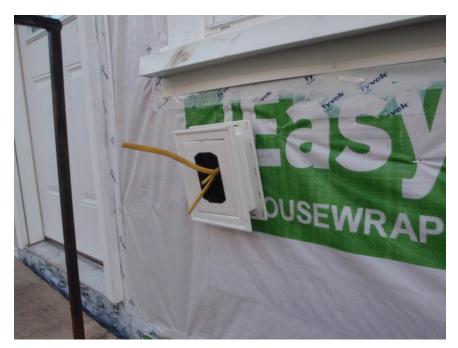
Figure 47. Photo of Unsealed Wall Penetration

Wire penetrations and decorative trim boxes are common leak points if not detailed correctly.

Utilizing self-stick flashing in the proper shingling sequence will minimize any potential for water intrusion at these locations.

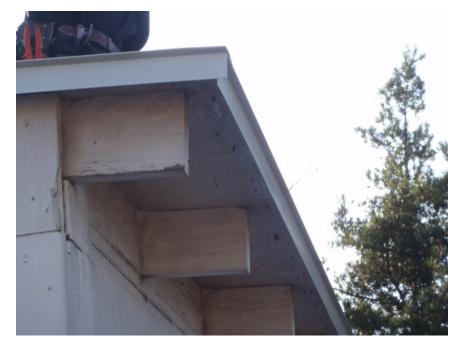
Figure 49. Photo of Improperly Installed Drip Edge

Inconsistent practices were observed at drip edge applications at roof edges. The drip edge should be installed directly against the roof deck at the eave followed by the underlayment paper followed by the drip edges on the rakes. This layering sequence maintains the shingling effect to the gutters.

In this instance, the drip edge was installed correctly with the drip edge installed first at the eave and the underlayment over the edge followed by drip edge at the rakes.

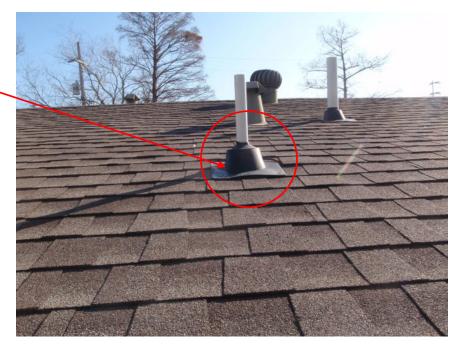
Figure 51. Photo of Improper Roof Boot Installation

Proper roof boot coverage is necessary to promote good drainage. In this instance, there is not adequate shingle coverage at the edges.

Example of a proper installation. The lower part of the flange overlaps the lower shingles and the side and upper shingles overlap the flange.

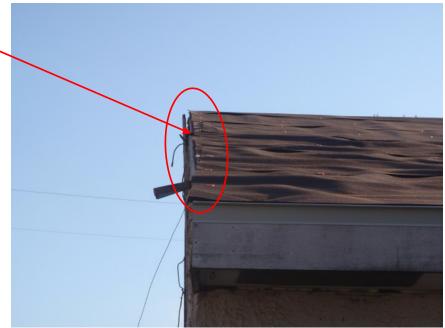
Figure 53. Photo of Insufficient Underlayment at Roof Edge

When roofing practices were observed, the roofing paper underlayment did not completely cover the roof rake edges.

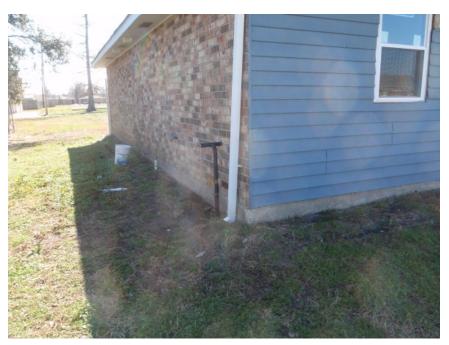
Figure 55. Photo of Downspout Discharge Against Foundation

Rain water and ground water must be properly managed at the foundation and site in order to enhance the long-term durability of a home. If the ground around the house and the foundation system are saturated, then the possibility for water to penetrate the foundation or for moisture to wick through the foundation by capillary action is greatly increased.

In many instances, gutter downspouts deposit bulk water from the roof next to foundations.

The best way to eliminate any potential moisture issues at the foundation is to direct water from downspouts to a yard bubbler or sump pit in the yard.

If that is not feasible, at a minimum, taking the time to properly position splashblocks at downspouts so as to direct bulk water away is recommended.

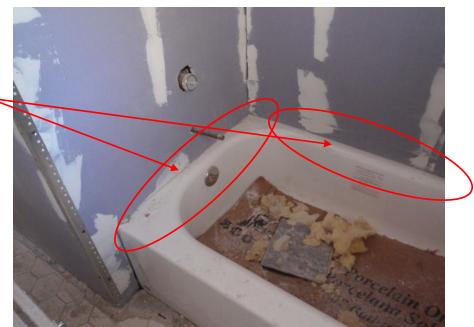
Figure 59. Photo of Insufficient Flashing Surrounding Tub

No comprehensive flashing strategy was observed at the nailing fin of tub and shower units. In most cases the wall board was installed directly upon the unit. This detail will eventually deteriorate due to the wicking ability of the gypsum based backer board.
