Wyandotte Neighborhood Stabilization Program: Retrofit of Two Homes

A. Lukachko, A. Grin, and D. Bergey
Building Science Corporation

April 2013

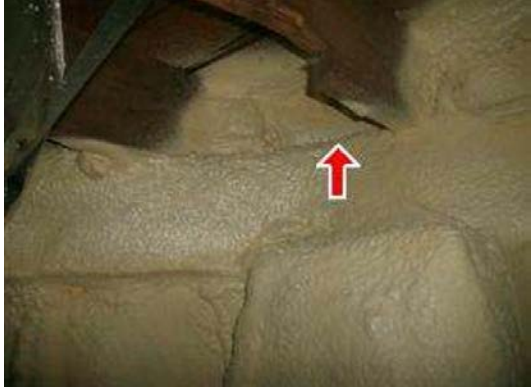
<p>(photo courtesy of Steven Christensen, WARM Training)</p>	<p>#1 – Rim joists. The primary issue with this location is that there may not be enough room for the installer to position the spray foam applicator so that insulation is sprayed on surfaces behind and around all sides of the rim joist. After the foam expands, this area may or may not be adequately air sealed.</p>

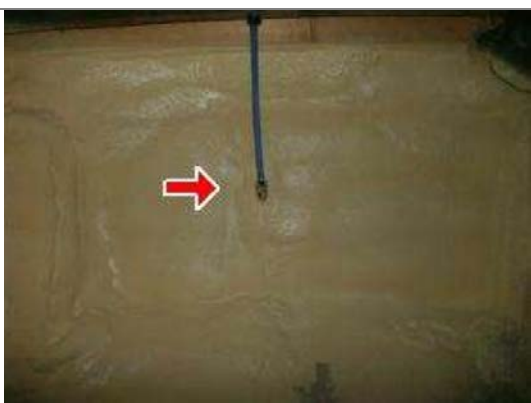
<p>(photo courtesy of Steven Christensen, WARM Training)</p>	<p>#2 – Penetrations. The photograph to the left shows a hose bib that has been installed after the foam has been cut away. This is a common problem where workers do not repair the air seal after the penetration for the SPF installation has been made.</p>

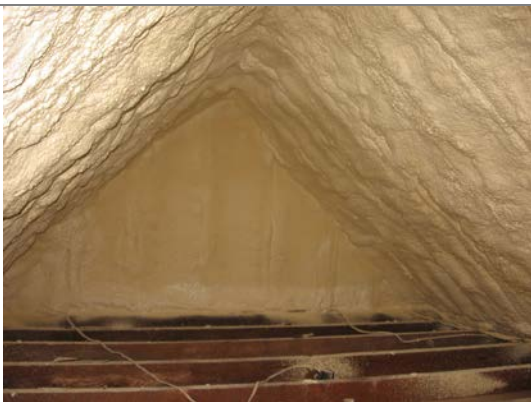
<p>#3 – Attic Rafter to Floor. Although coverage of the underside of the roof with spray foam looks to be complete, it is common for leakage paths to be missed at the intersection of the attic rafters and the attic floor.</p>

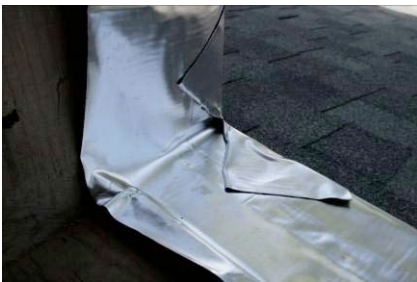
A window on the second floor had not been installed yet allowing a review of the sub-sill flashing. Care must be taken to ensure reversed flashings, gaps, or fish mouths do not occur. Shown in the photo below, a gap has been left in the corner flashing of the sub-sill flashing. This has the potential to direct water on the subsill flashing behind the insulating sheathing which is intended to be the drainage plane. This has the potential to cause moisture related damage to the structural sheathing.

2011-08-28 – Gap in corner flashing
---	-------------------------------------

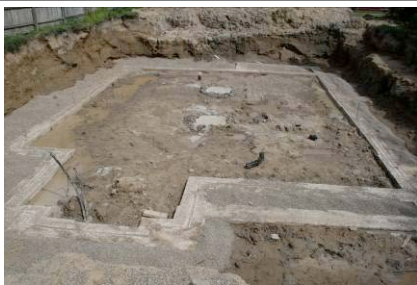
2011-08-22 – Footings complete missing capillary break

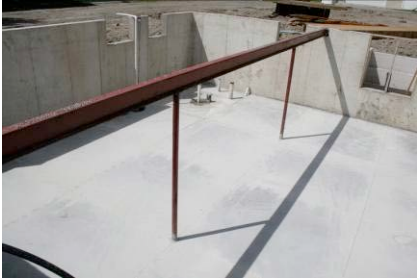
2011-08-22 – Foundation and basement floor complete. The status of the capillary break is unknown

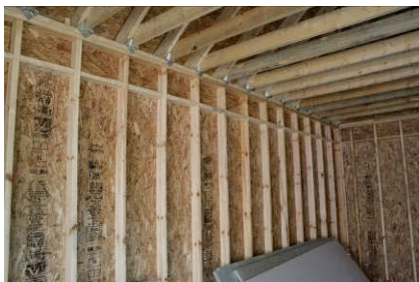
Garage framing at 16" on centre.

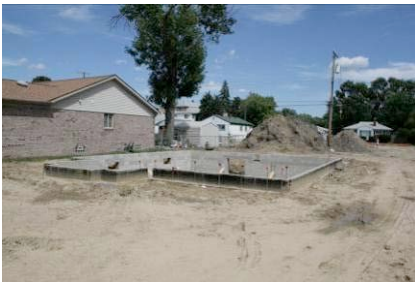
2011-08-22 – Foundation complete, capillary break not apparently present
2011-10-06 – First floor floor framing complete

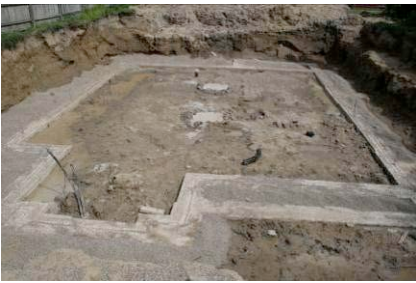
2011-08-22 – Footings complete missing capillary break
2011-10-06 – Foundation complete, nothing else to report

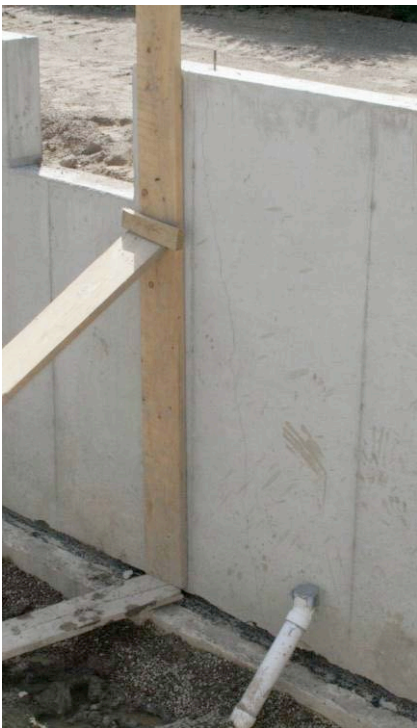
2011-08-22 – Foundation crack
