Impact Resistance of Advanced Framed Wall Systems with Insulating Sheathing as the Primary Sheathing

Research Report - 0603

2006

Joseph Lstiburek and Peter Baker

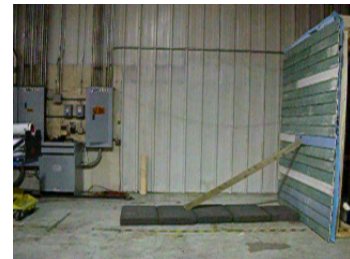
Stud penetrating through Wall 2

Figure 5: Wall 2 (Insulating Sheathing + Housewrap + 2" Closed Cell Spray Foam) fail at 50 fps

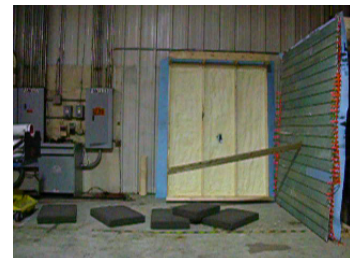
Stud penetrating through Wall 3

Figure 6: Wall 3 (Insulating Sheathing + Snow Fence + Housewrap + 2" Closed Cell Spray Foam) fail at 50 fps

Adding the snow fence material seemed to have little impact in the performance and may be associated with the type of material chosen and placement of the material in the assembly. The material appeared to be more brittle than expected and tore instead of flexing as was hoped.

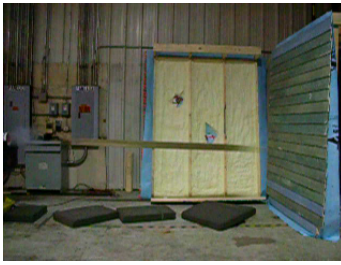
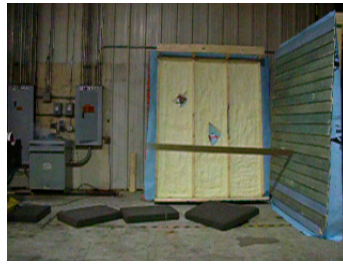
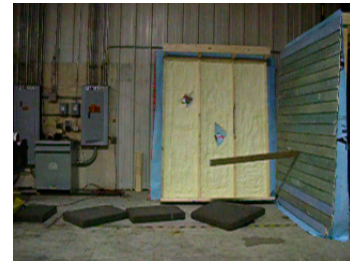
Stud penetrating through Wall 4

Figure 7: Wall 4 (Housewrap + ½ inch OSB Sheathing) fail at 50 fps

The baseline wall provided less resistance to impact than was expected. The failure at 50 fps was dramatic with the 2x4 projectile stud penetrating to half of its length through the assembly.

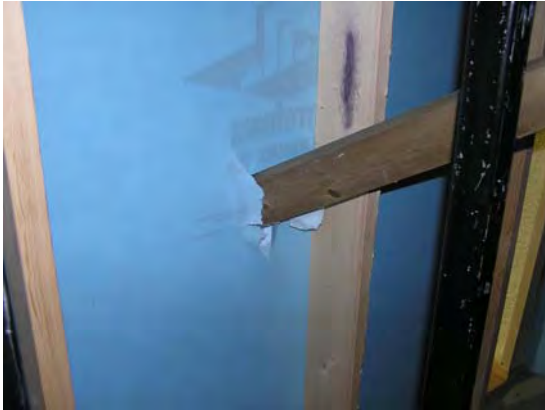
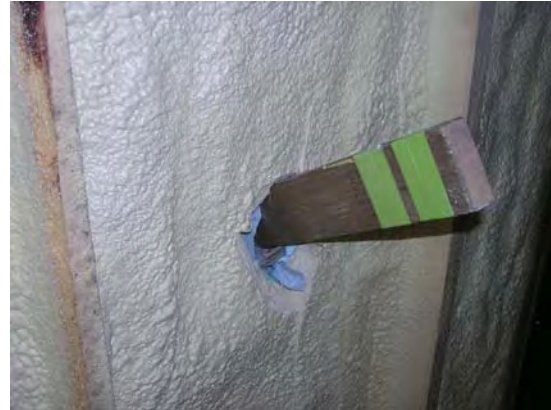
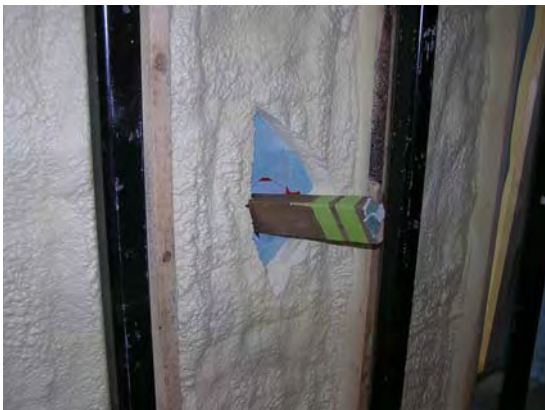
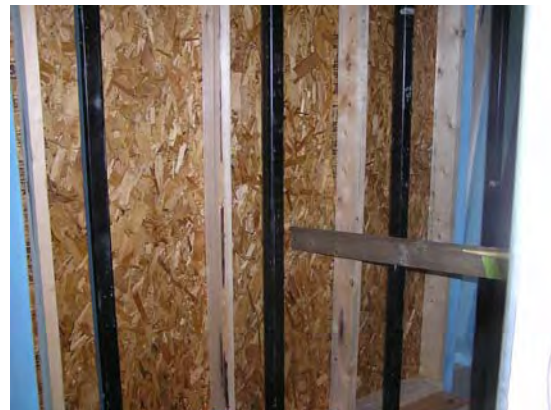
Penetration failures were observed with all of the wall systems (including the OSB sheathed wall) at this stud velocity. These results were surprising as it was expected (based on information from other sources) that the OSB wall would be adequate to resist the impact.

Figure 8: Stud penetration through all wall assemblies at 50 fps

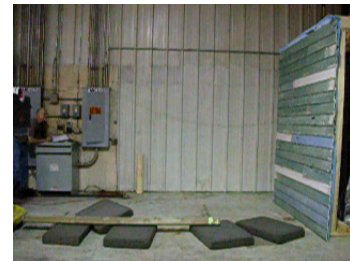
Stud on the ground after rebounding off of Wall 2

Figure 9: Wall 2 (Insulating Sheathing + Housewrap + 2" Closed Cell Spray Foam) pass at 40 fps

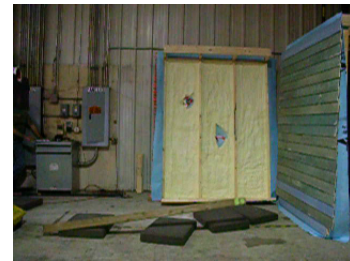
Stud on the ground after rebounding off of Wall 4

Figure 10: Wall 4 (Housewrap + 1/2 inch OSB Sheathing) pass at 40 fps

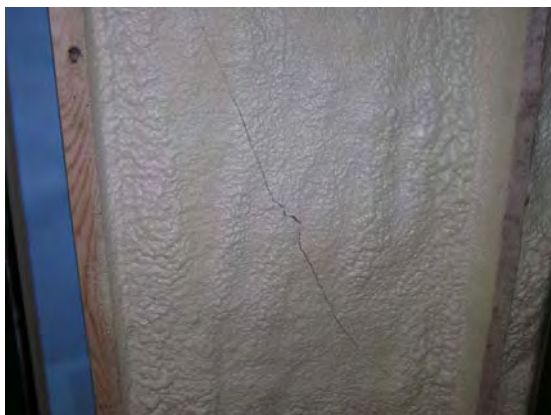
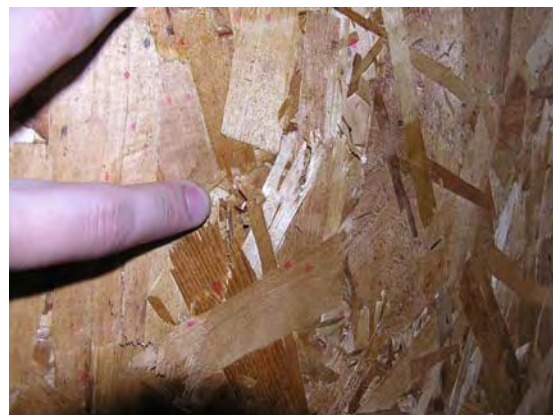
Figure 11: Cracking of both Closed Cell Foam and OSB Sheathing at 40 fps

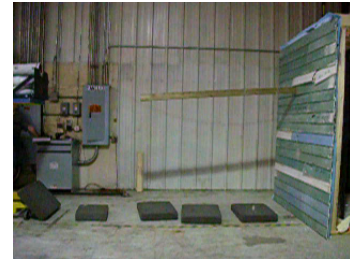
Stud penetrated cladding but not through Wall 2

Figure 12: Wall 2 (Insulating Sheathing + Housewrap + 2" Closed Cell Spray Foam) pass at 43 fps

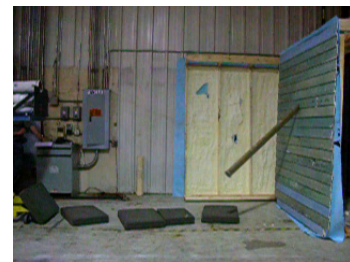
Stud penetrating through Wall 4

Figure 13: Wall 4 (Housewrap + 1/2 inch OSB Sheathing) fail at 43 fps

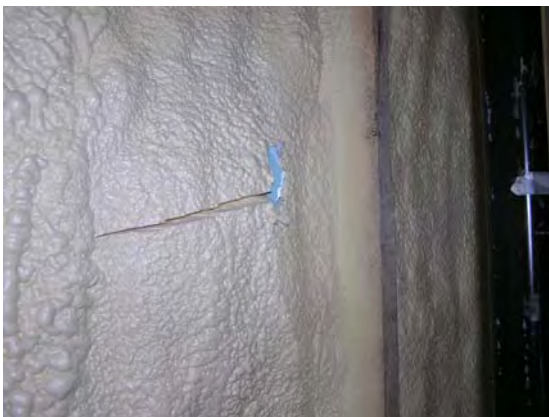
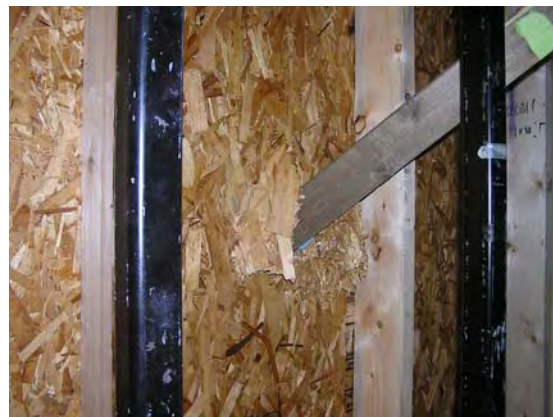
At this velocity, the maximum threshold of Wall 2 was reached with two of the tests resisting the studs from penetrating through the wall assembly and one test allowing the stud to penetrate. At this same velocity, the OSB panel failed on all tests. This indicated that Wall 2 with insulating sheathing and 2 inches of closed cell spray foam was a slightly better performing wall than Wall 4 constructed with ½ inch OSB sheathing.

Figure 14: No penetration of Wall 2 and penetration of Wall 4 at 43 fps

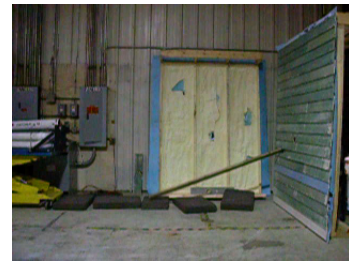
Stud penetrated cladding but not through Wall 1

Figure 15: Wall 1 (Insulating Sheathing + Housewrap) pass at 30 fps

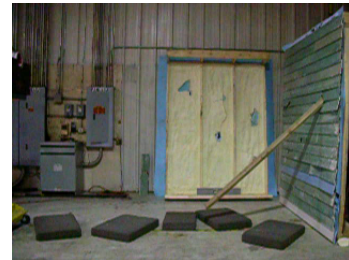
Stud penetrating through Wall 1

Figure 16: Wall 1 (Insulating Sheathing + Housewrap) fail at 30 fps

From these initial test results it was demonstrated that walls design with insulating sheathing only, have little resistance to impact from wind blown debris. The cladding system seemed to play the larger part in the performance of the wall assembly. This could be shown with the variations in pass or fail at the 30fps threshold. There appeared to be a significant chance that if the 2x4 penetrated the cladding system, then it would penetrate the insulating sheathing as well. This result was expected.

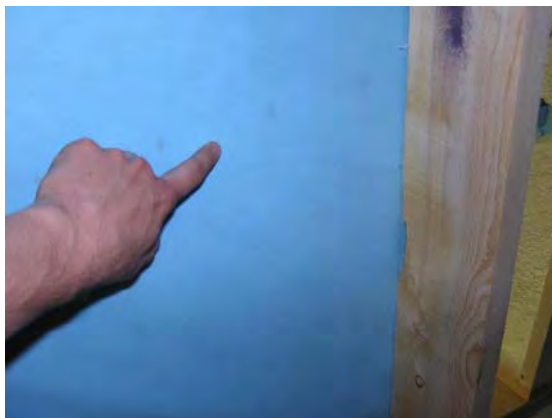
Figure 17: No penetration of Wall 1 at 30 fps

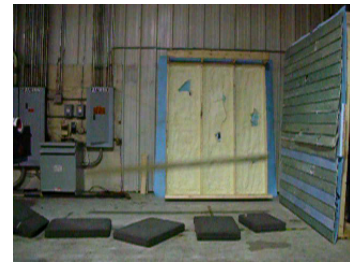
Stud rebounding off of Wall 5 after impact

Figure 18: Wall 5 (Insulating Sheathing + Housewrap + 1/2 " OSB Sheathing + 2" Closed Cell Spray Foam) pass at 50 fps

The site retrofit of a wall panel to create Wall 5 demonstrated how a wall could be constructed to resist puncture at 50 fps test velocity. The performance of this wall seemed to be less affected by the cladding performance than any of the other test walls. The stud penetrated through the fiber cement siding however did not penetrate through the remaining layers and bounced off the wall assembly. Damage to the remaining layers did occur though the stud was not able to penetrate in such a way as to remain lodged in the wall assembly as was seen in other wall panels.

As a final measure, a panel was retrofitted to see what type of wall assembly would be able to meet the 50ft/s original test protocol. The retrofit wall design included a layer of

1/2 OSB sheathing between the foam insulating sheathing and the closed cell spray foam. This design was able to resist the impact force of the 2x4 when tested at 50 ft/s.
