Field Testing Unvented Roofs with Asphalt Shingles in Cold and Hot-Humid Climates

Kohta Ueno and Joseph W. Lstiburek Building Science Corporation

September 2015

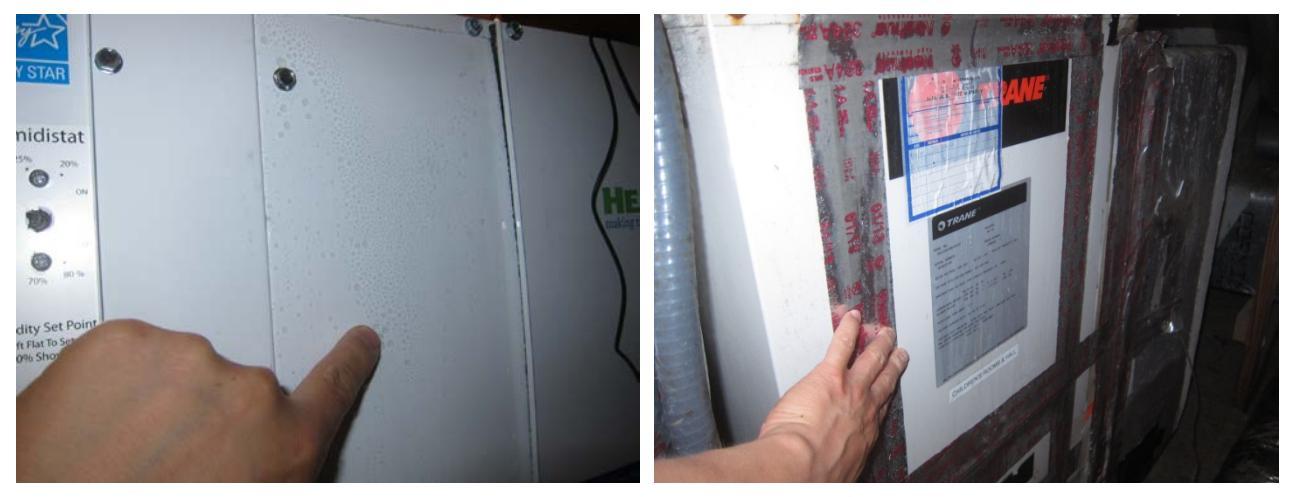
Figure 3. Condensation on HVAC equipment located in vented attic (CZ 2A)

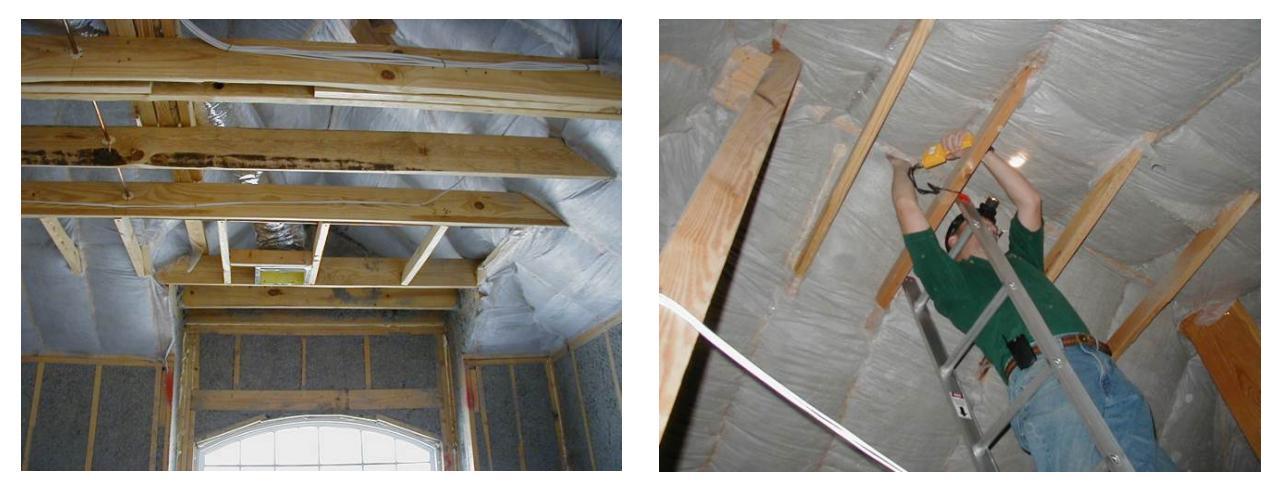
During the first fall of operation, the homeowner reported seeing reflections of moisture condensation and dripping from the ridge of the unvented attic from the interior. Site investigations (Figure 7, right) revealed elevated wood MCs at the ridge and evidence of previous condensation (such as rusted staples).

Figure 7. Netted and blown cellulose roof insulation in Houston (left); MC at the roof ridge (right)

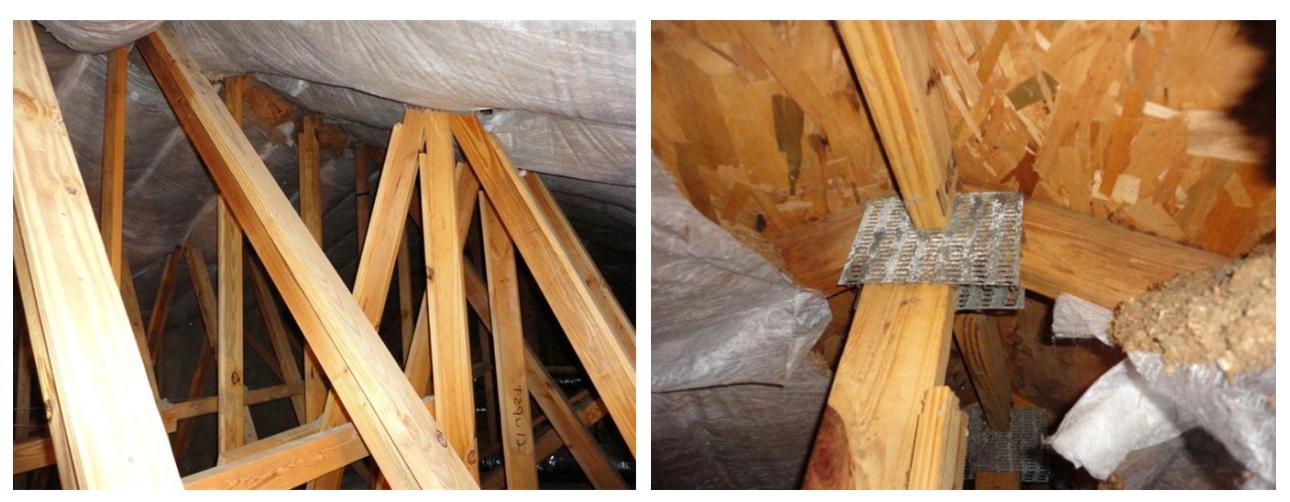
During a site visit, the cellulose and roof sheathing above were wet to the touch, and the steel truss plate was corroded; however, the wood had not decayed. In response, the insulation was removed near the ridge (roughly 2 feet; Figure 8, right) to increase surface temperatures at the condensing roof sheathing surface. This roof has been rechecked over time (circa 2003 and as recently as March 2014); roof sheathing conditions remained dry with this assembly.

Figure 8. Netted and blown cellulose roof insulation in Jacksonville (left); corrosion of ridge truss plate (right)

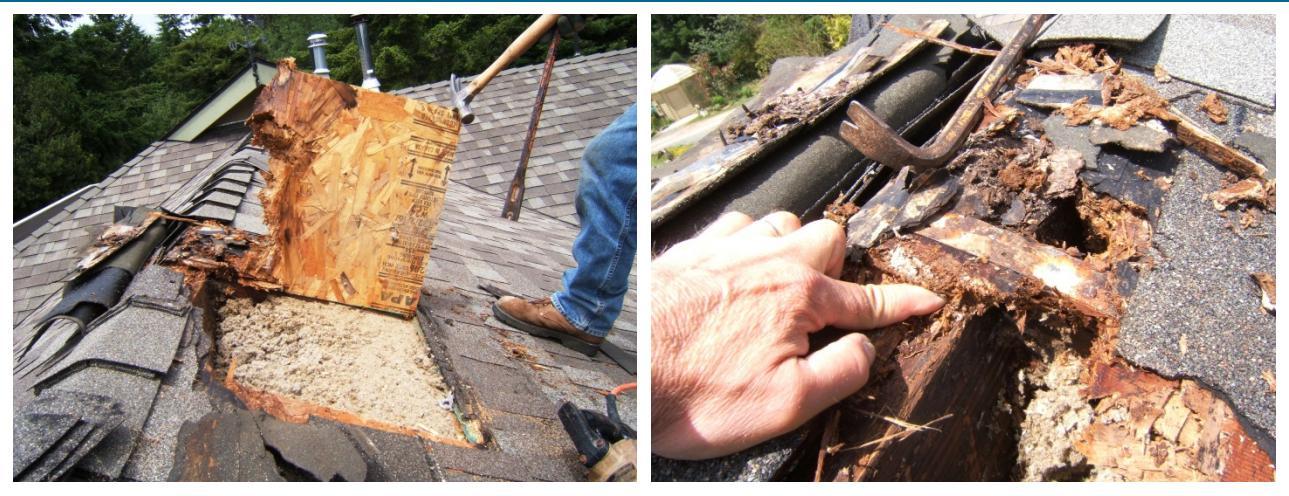
Figure 9. Ridge sheathing degradation with dense-pack cellulose in northern California

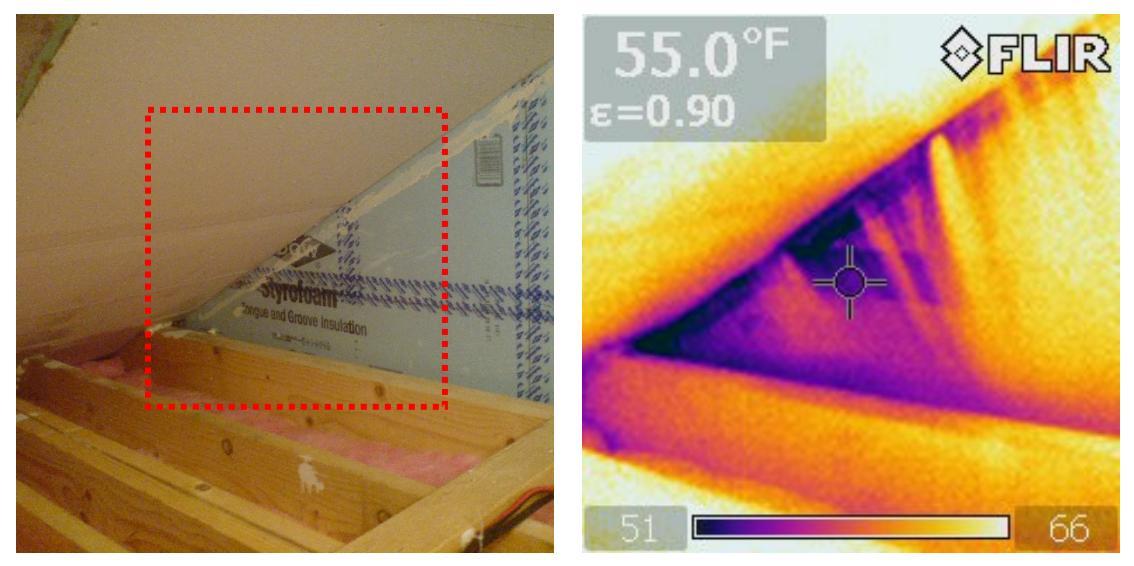
Figure 36. Air leakage at roof connection to main house (XPS sheathed wall)

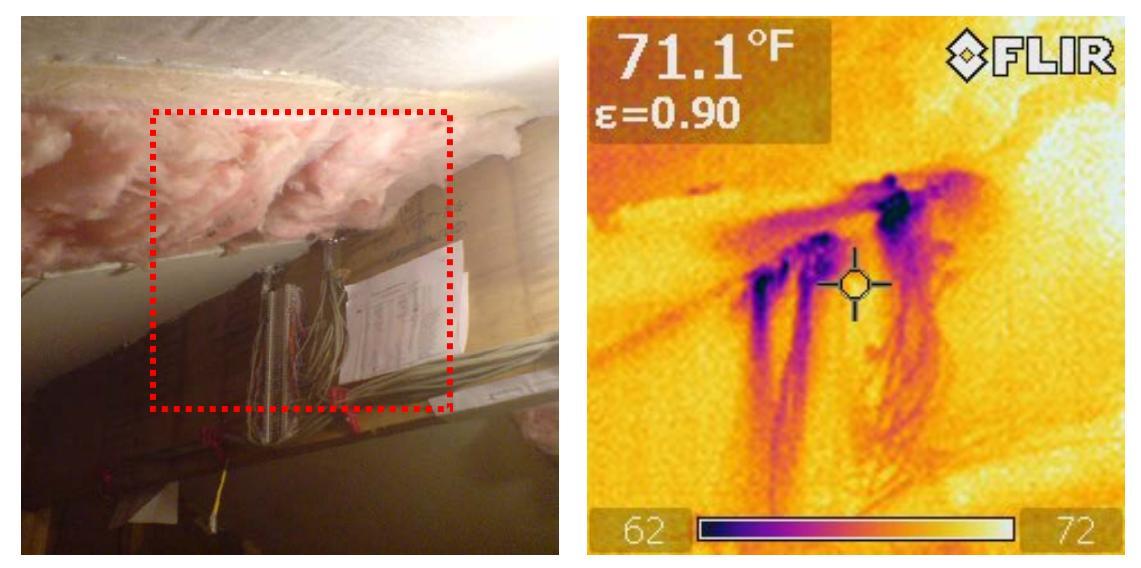
Figure 37. Air leakage at ridge and instrumentation wire penetrations

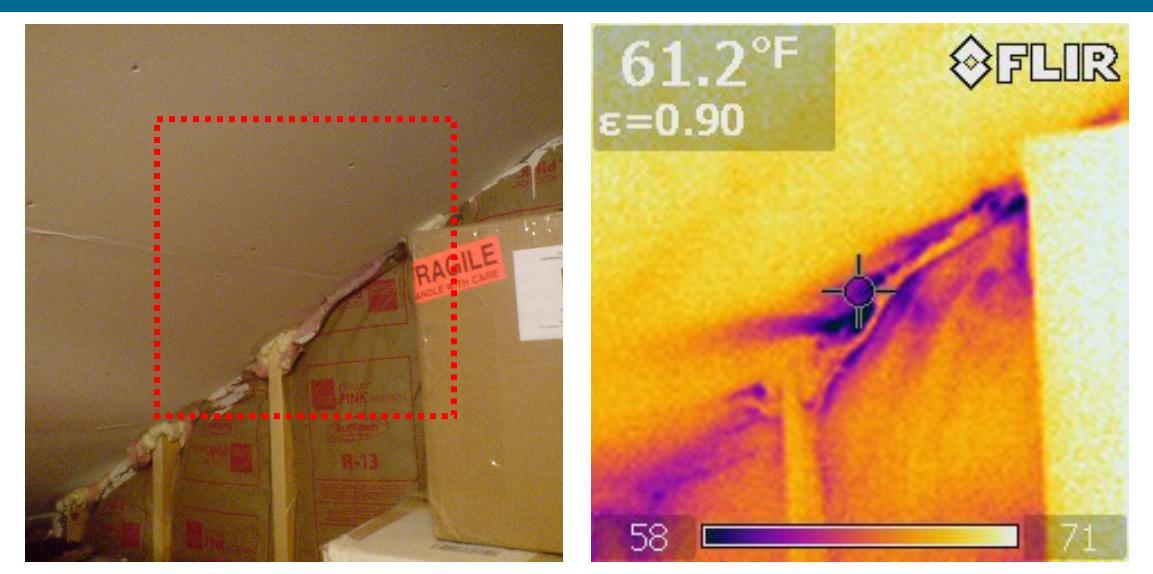
Figure 38. Air leakage at gable end rake wall (connects to unvented cellulose Roof 7)

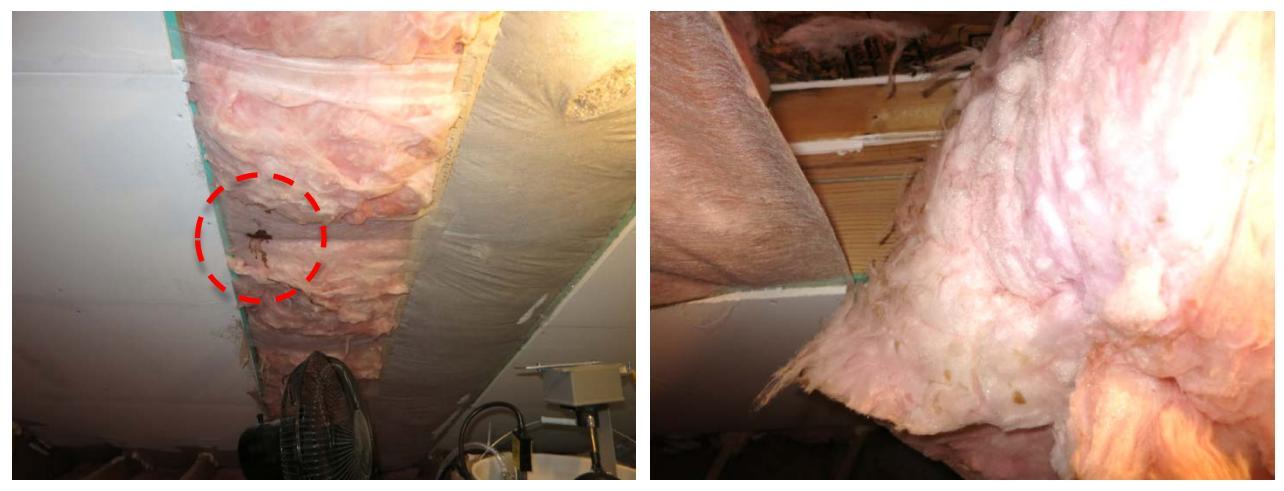
A mid-December site visit enabled researchers to verify that the monitored data reasonably reflected reality. The top vent fiberglass assembly without GWB (Roof 4) was examined from the interior. A brown stain that indicated water leakage was found (Figure 53, left); when the batt was removed, very wet and saturated roof sheathing and fiberglass were observed (Figure 53, right).

Figure 53. Top vent fiberglass, no GWB (4) water leak (left); wet fiberglass batt (right)

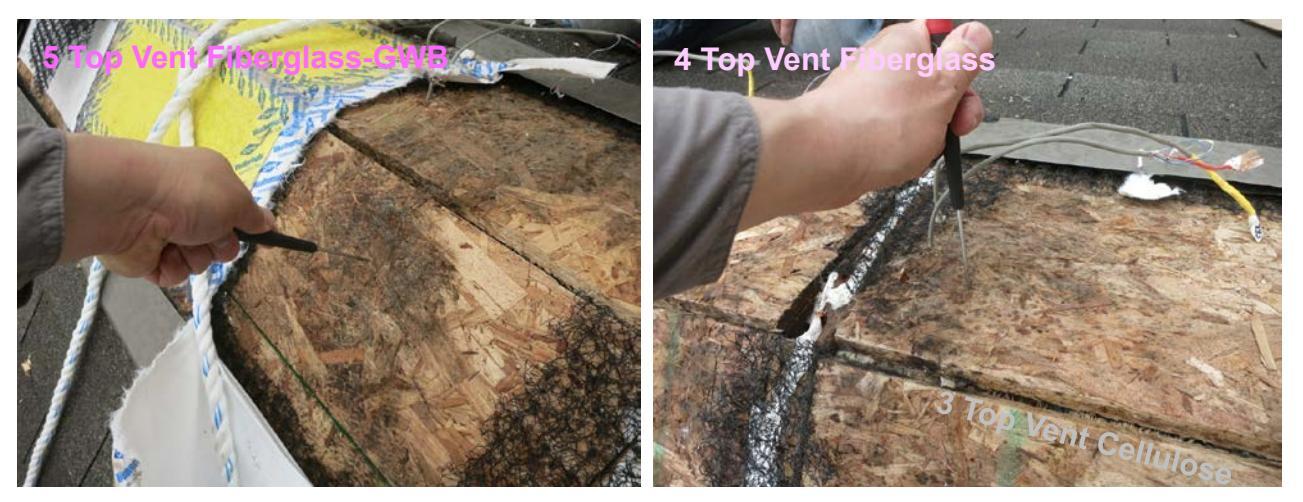
Figure 68. Ridge sheathing conditions (screwdriver test) for Roofs 4 and 5

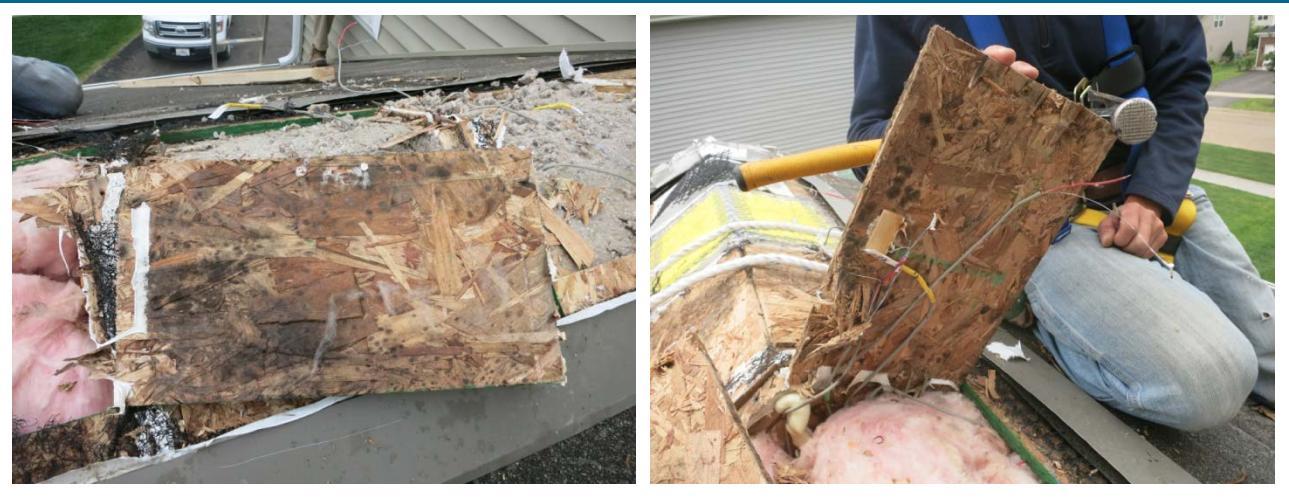
Figure 73. Ridge sheathing bottom conditions, Roof 4

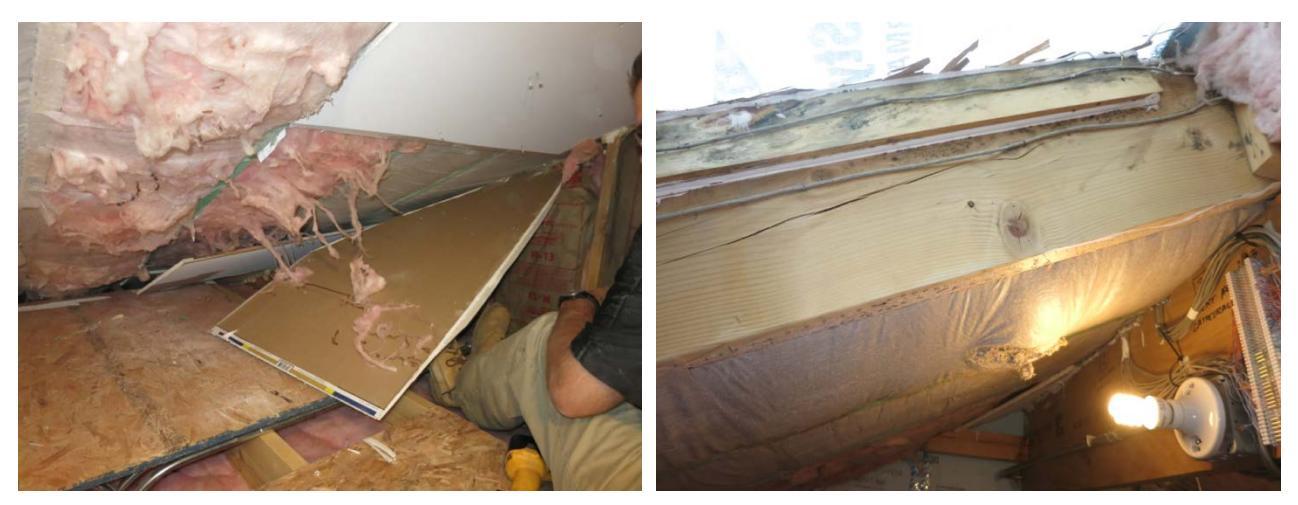
Figure 83. Staining of the ceiling GWB (left); mold on the framing (right), Roof 5

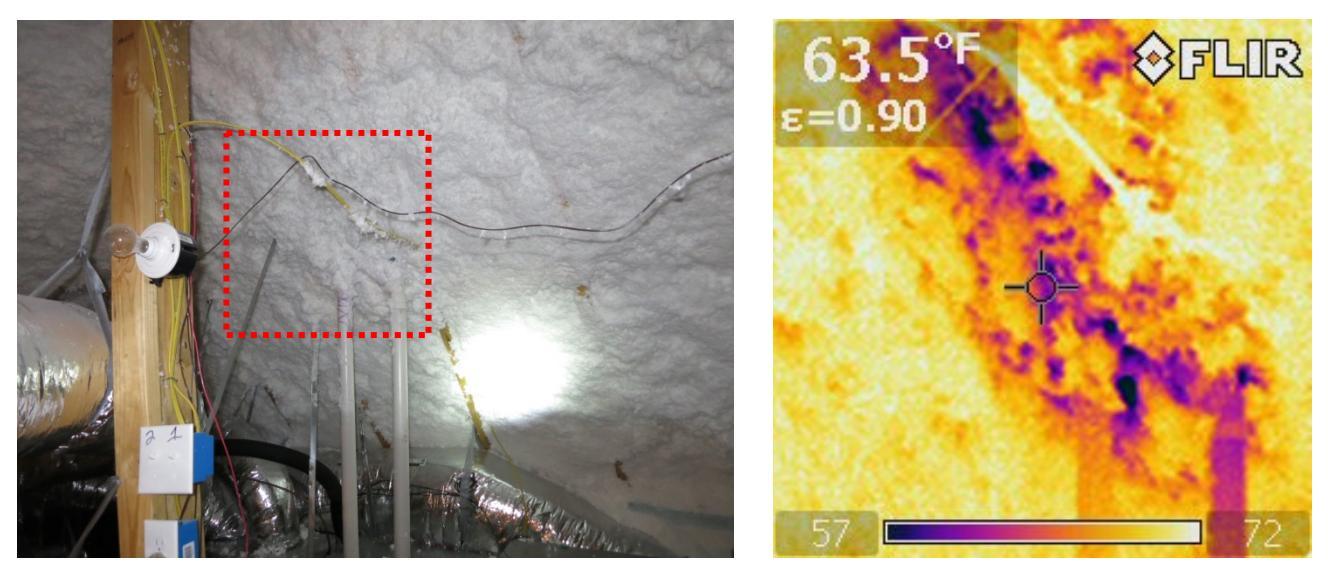
Figure 107. Unsealed gas appliance exhaust and intake with evidence of air leakage

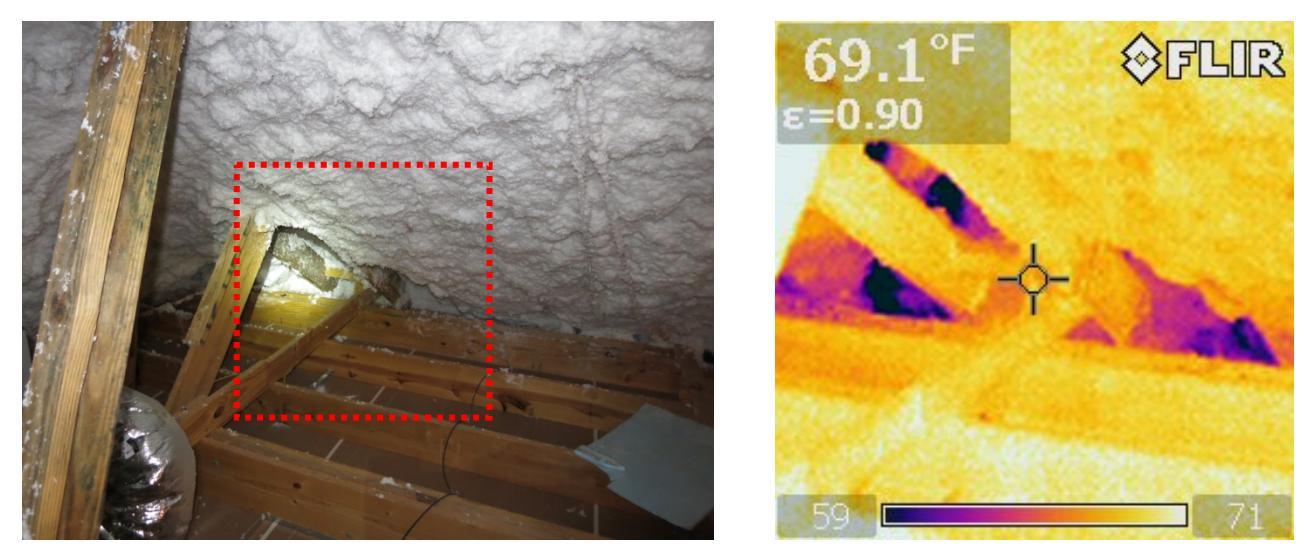
Figure 108. Air leakage at roof-to-wall details at dormer/intersecting roofs (location A)

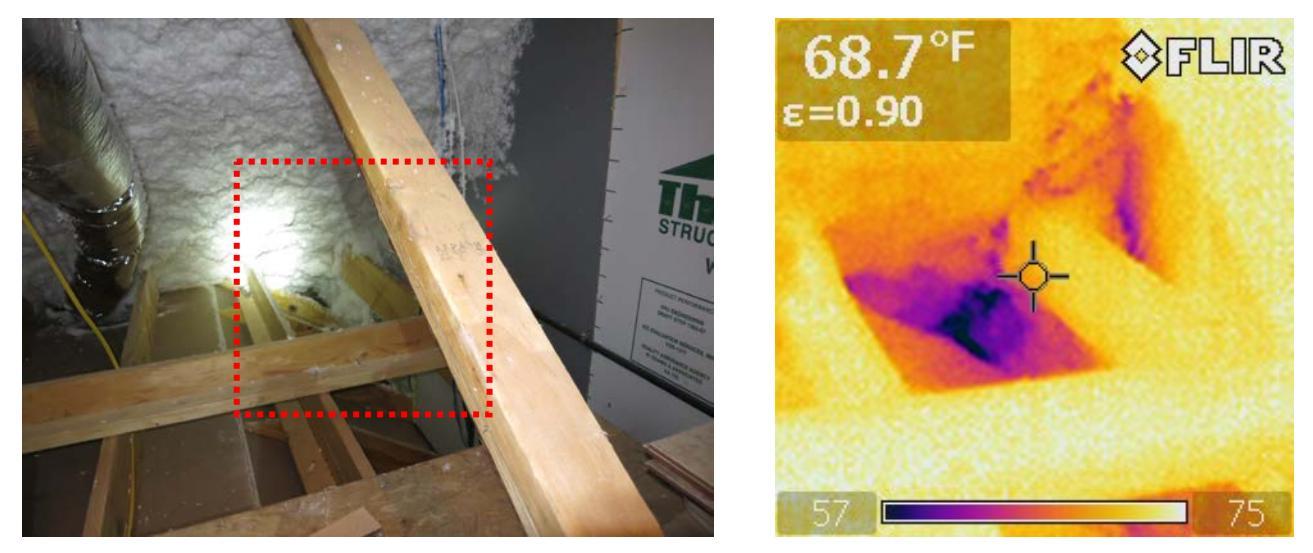
Figure 111. Air leakage at roof-to-wall details at roof-wall intersection (location C)

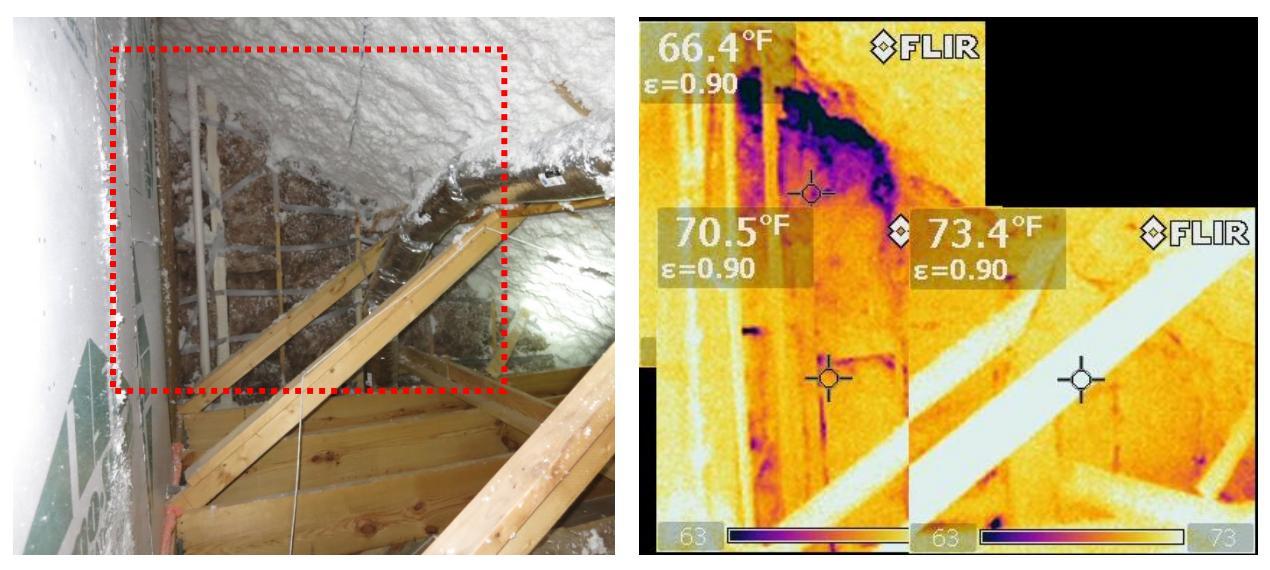
Figure 112. Air leakage at the rear attic over the master bedroom (location D)

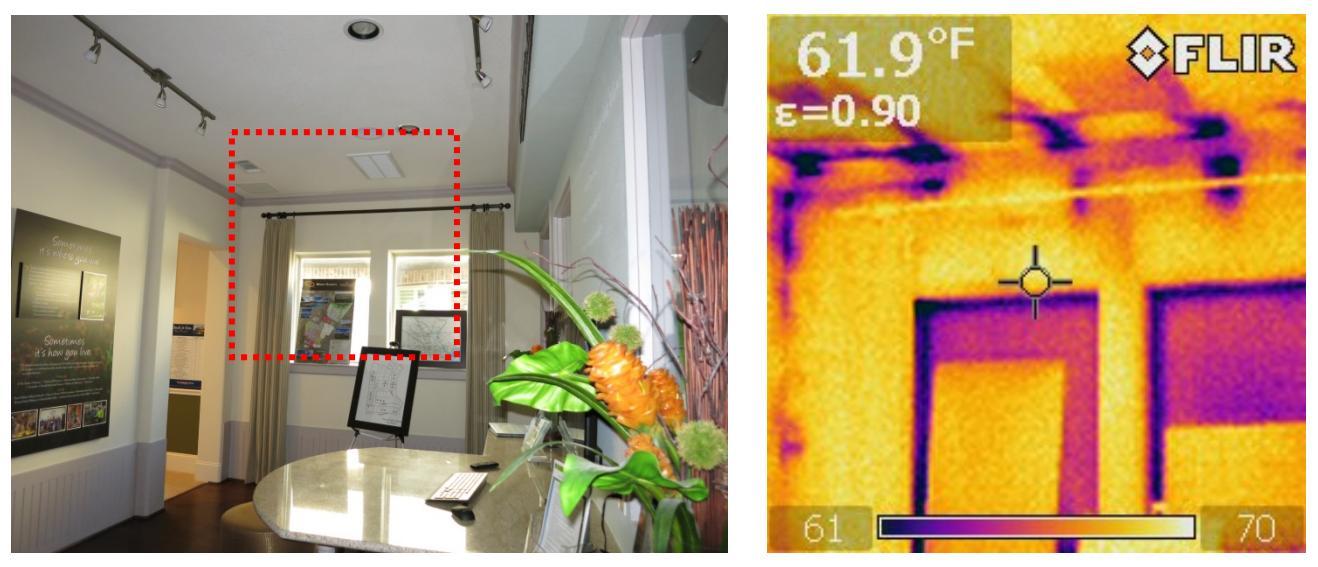
Figure 113. Air leakage at roof-wall connections from the interior space (first floor)

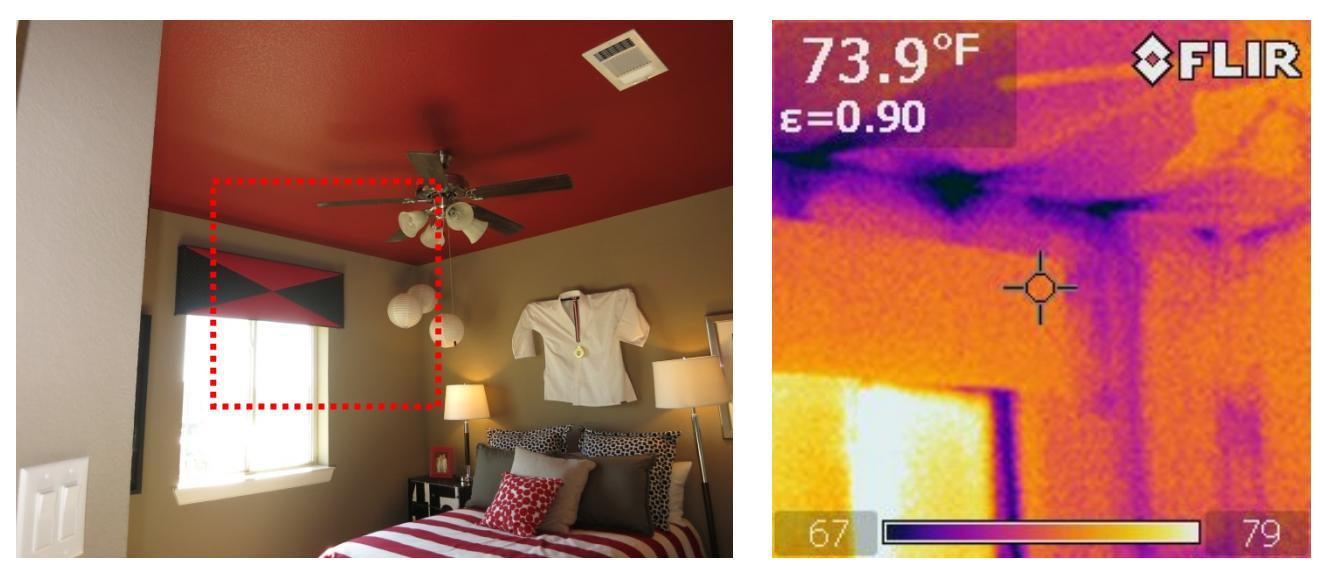
Figure 114. Air leakage at roof-wall connections from the interior space (second floor)
