# Field Performance of Inverter-Driven Heat Pumps in Cold Climates

James Williamson and Robb Aldrich  
*Consortium of Advanced Residential Buildings*

August 2015

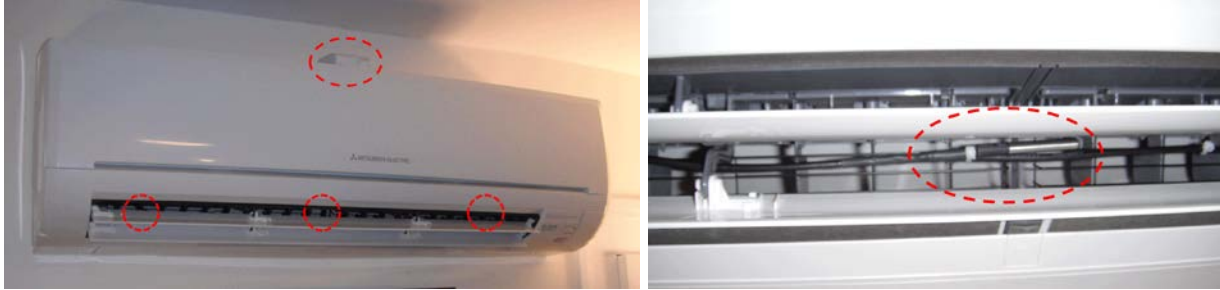
**Figure 1. At left, supply and return temperature sensor locations. The right image shows a close-up of the supply temperature sensor**

Temperature sensors were installed at both the supply and return grilles on the indoor fan coils. Figure 1 shows the location of the installed sensors. Supply sensors were attached behind the supply louvers against the fan guard. In order to correct for varying supply air temperatures, three measurements were taken and averaged across the horizontal length of the supply stream. The return temperature and relative humidity sensor was simply mounted on top of the indoor unit near the center of the return grille. The entering airstream was assumed to be well mixed. A single measurement was used here.

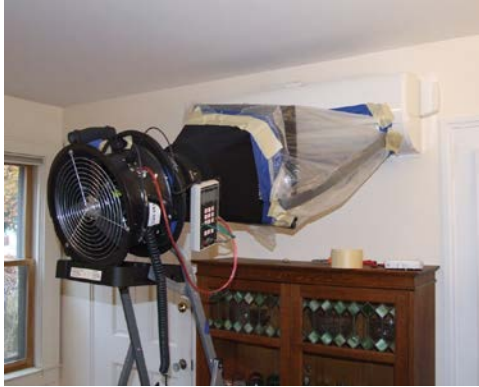
Figure 2. An early “bag” plenum

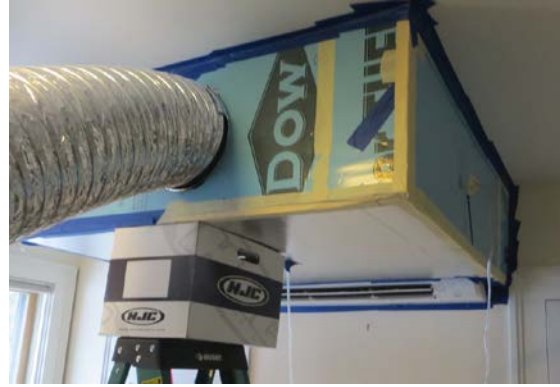
Figure 3. A return plenum

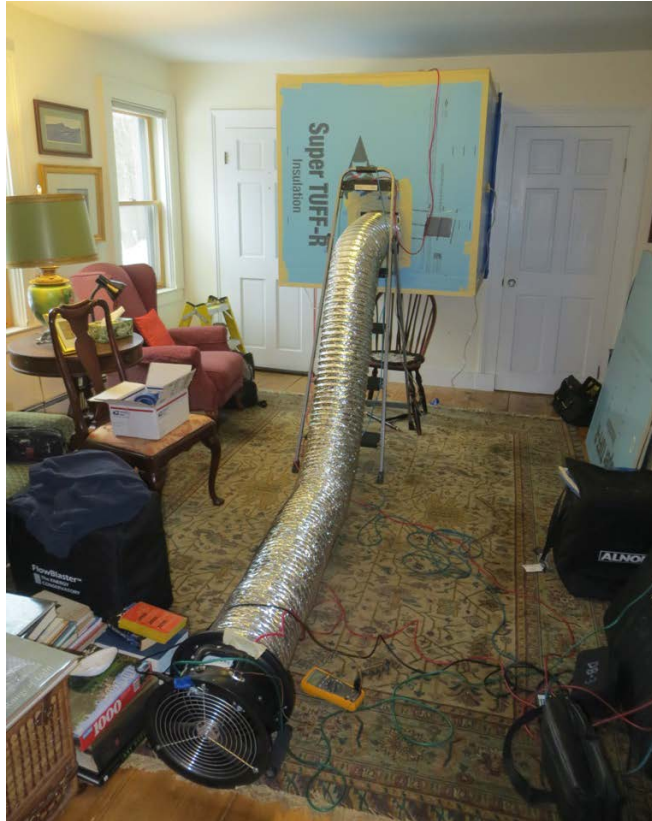
Figure 5. Final flow testing configuration

The final test configuration is shown in Figure 4 and Figure 5. Using air temperature and site elevation, flow rates were converted to standard cubic feet per minute (SCFM) at air density of 0.075 cubic foot ( $\text{lb}_m/\text{ft}^3$ ). Flow rates were then plotted against current at each fan speed as shown in Figure 6.

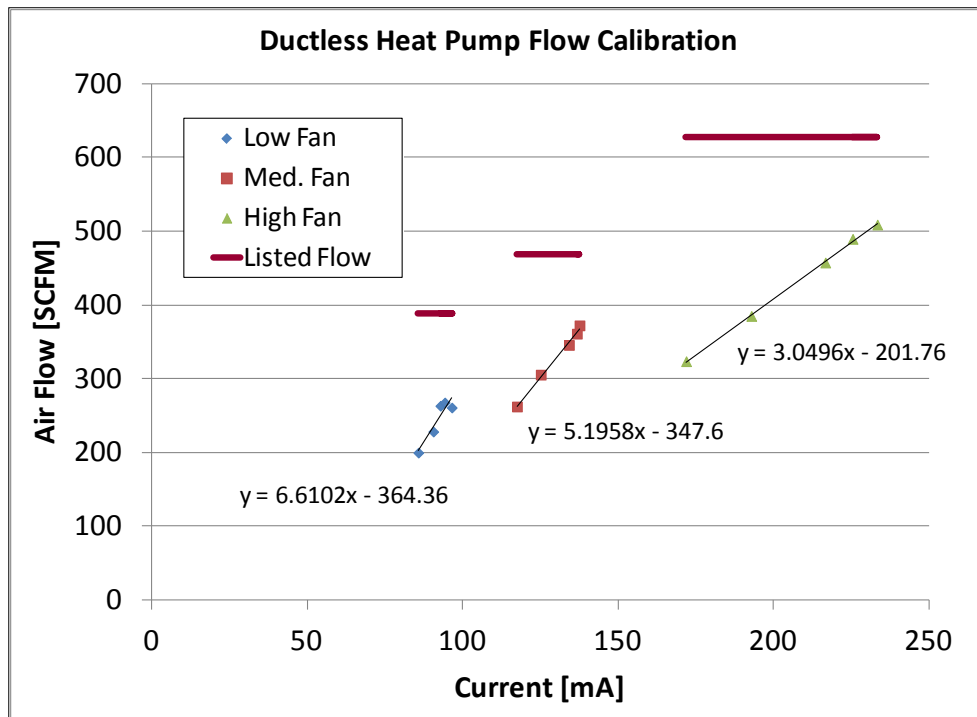
Figure 6. Example of flow calibration results at Site 1.  
The five points at each fan speed represent the five louver positions

Figure 6 shows that various louver positions led to very different flow rates. Also, flow rates were significantly lower than rates published by the manufacturer (approximately 50%–80% of published flow rates). This was concerning, because CARB could find no precedent for similar results in published studies. This discrepancy led to the following tests:

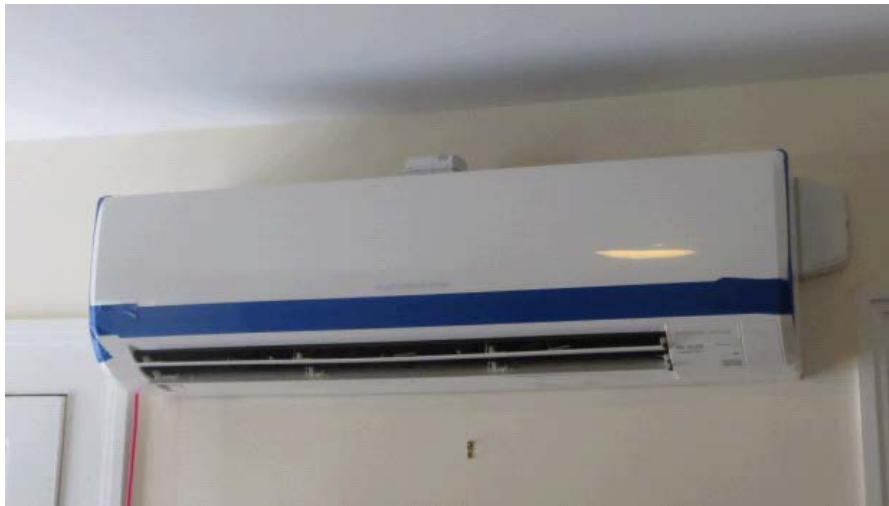
**Figure 7. FE18 with return leakage pathway taped**

The most prevalent heat pump model in the study was the Mitsubishi FE18. Initially, CARB tested each unit with the rigid plenum supply method. Flow rates measured were consistent with each other but well below the published values. In an effort to understand this discrepancy, CARB discussed this with other researchers, equipment manufacturers, and Mitsubishi engineers. As part of the troubleshooting effort, CARB repeated the flow measurement test with help from a Mitsubishi engineer at Site 1. During this test, a return leakage pathway was discovered through the filter cover. When the plenum was installed, it was possible for air inside the plenum to be drawn into the seam of the filter flap. By repeating the flow test with this pathway taped off (Figure 7), measured flow rates increased slightly.

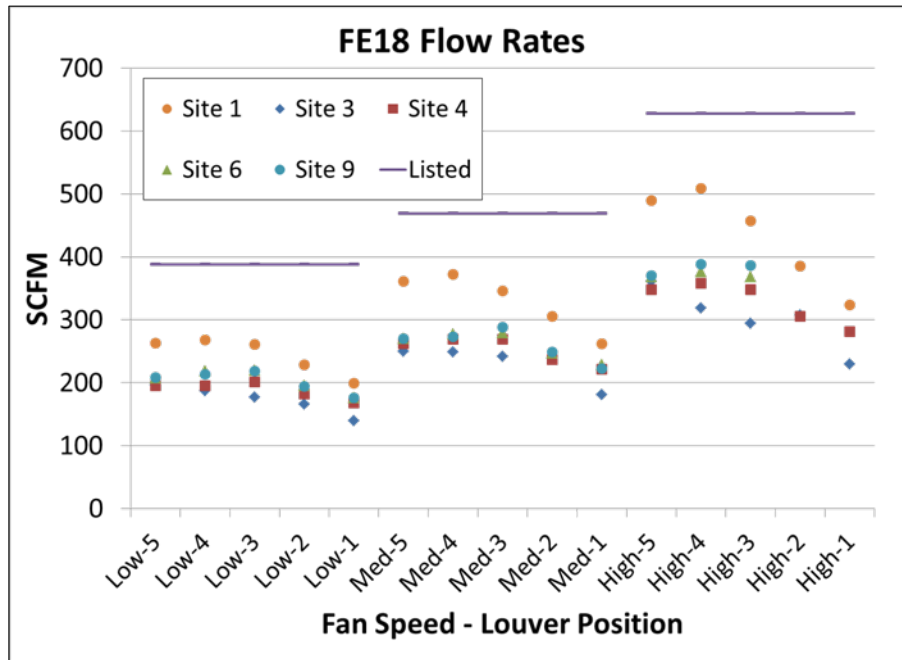
Figure 8. FE18 airflow rates: 5 is the highest louver position; 1 is the lowest

Flow results from the Mitsubishi FE18s at various fan speeds and louver positions are shown in Figure 8. At Site 1 (where the return leakage pathway was taped during testing) flow rates are slightly higher than at other sites. CARB does not believe that taping this leakage pathway affected “normal” airflow rates through the fan coil for two reasons:

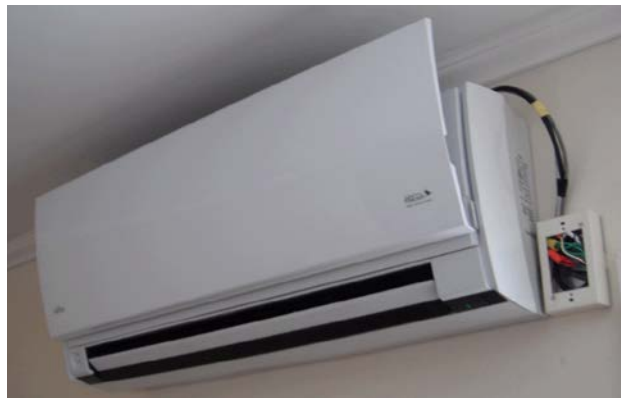
Figure 10. Fujitsu 15RLS2 indoor unit

One heat pump tested was a Fujitsu 15RLS2. An image of the unit while operating is shown in Figure 10; note the front face is elevated during operation. The flow measurement process differed slightly from the process for Mitsubishi units. The mechanics and geometry of this unit complicated mounting of the supply plenum. CARB could not attach the plenum until the fan coil was operating (and therefore open). All visible leakage points were taped; however, the complex geometry made leaks and/or bypasses more difficult to identify.

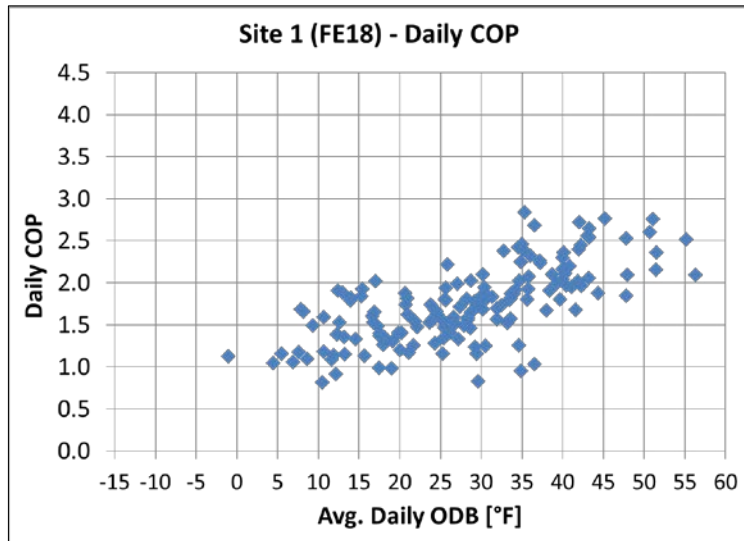
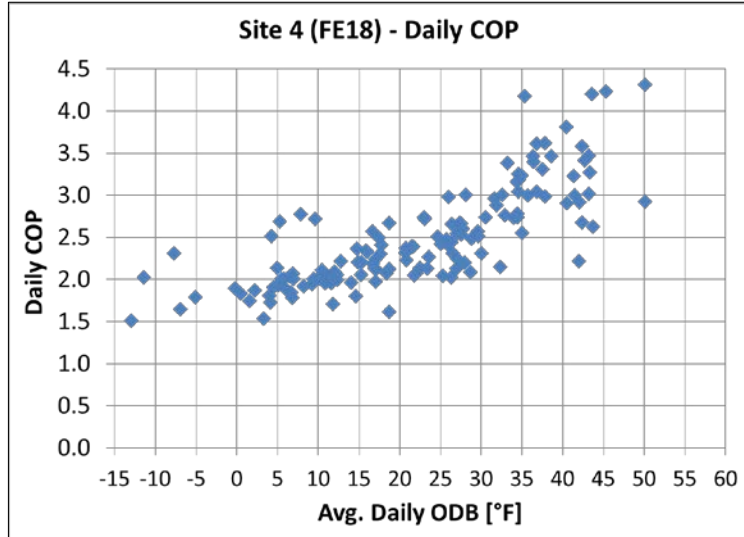
Figure 12 through Figure 18 illustrate daily COPs versus outdoor dry bulb (ODB) temperatures for each site. Ideally, outdoor wet bulb temperature would have been used for this comparison to account for effects that humidity has on the outdoor coils' performance. Unfortunately, the monitoring package did not provide relative humidity from the local weather station. As temperature is the primary influence of performance, the general trend can still be observed.

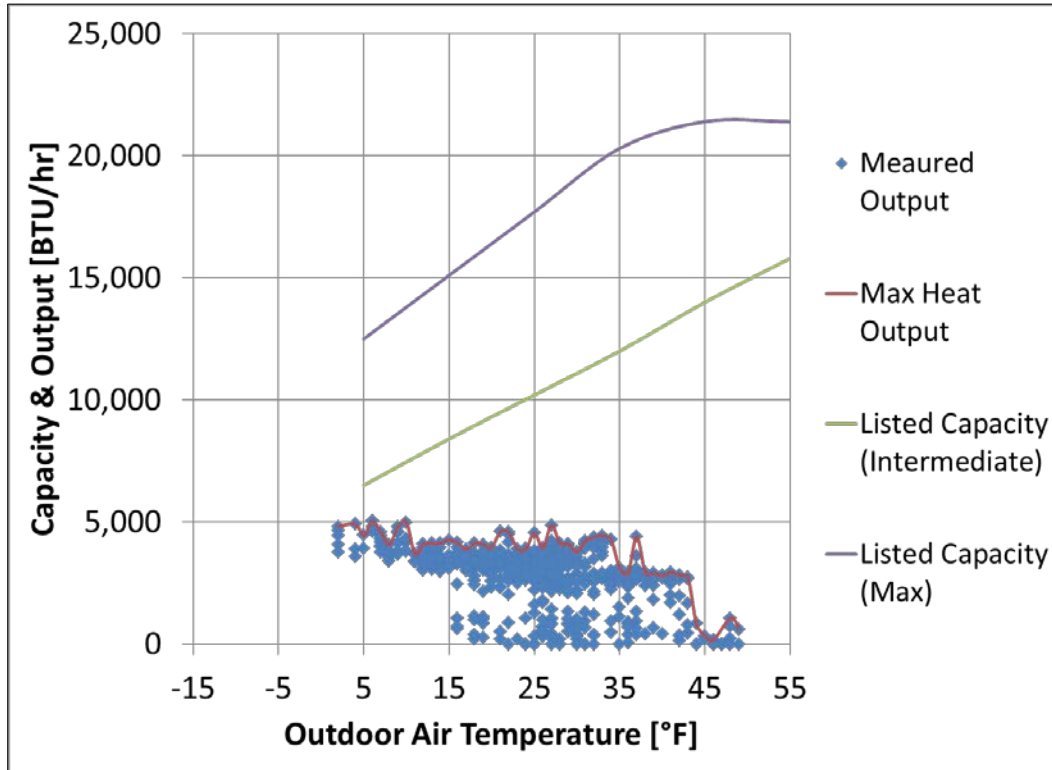
**Figure 21. Hourly heat delivered versus outdoor air temperature at Site 2 during February**

Figure 21 displays heat output seen during the month of February at Site 2 (FE12). At first glance, it may appear that this heat pump is underperforming, but this home was built to Passive House standards and used the heat pump as the only heat source. The home’s design heating load was calculated at approximately 6,000 Btu/h, and comfortable indoor conditions were

maintained all winter. The low output, therefore, seems to be a result of very low loads rather than of the heat pump not meeting listed capacities.

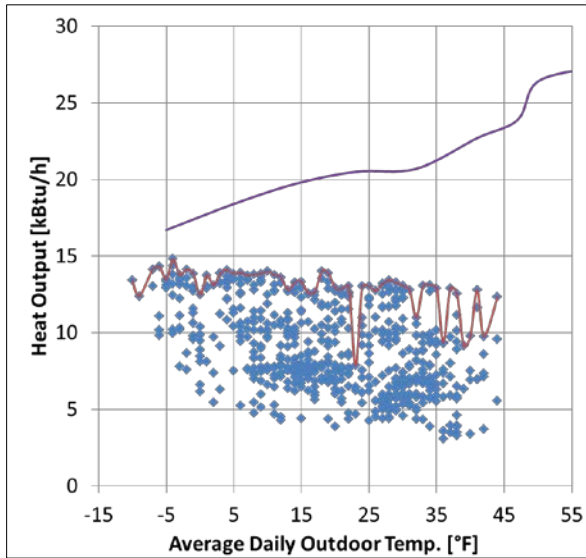
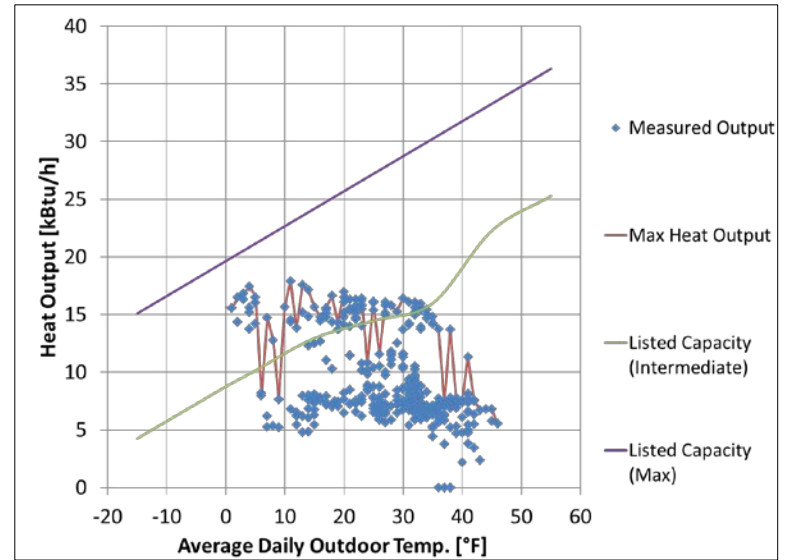
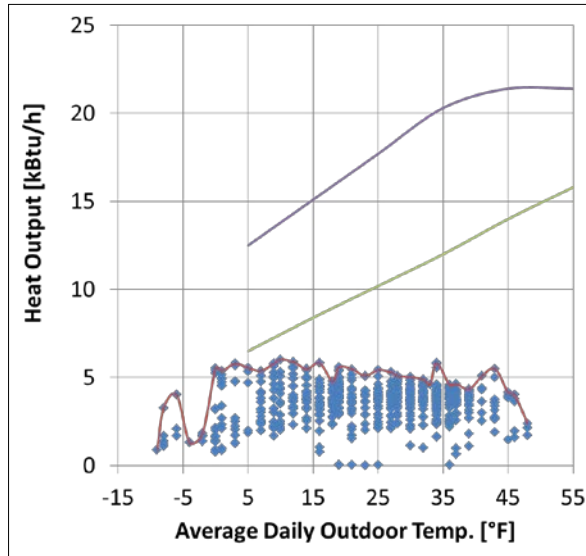
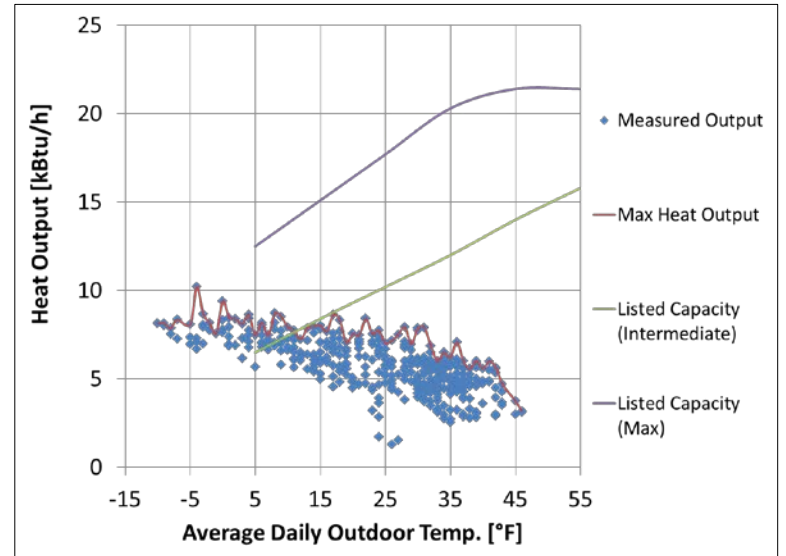
The heat outputs for the other sites are shown in Figure 22 through Figure 25. Site 9 used a Mitsubishi FE12 for supplemental heating. It had the lowest overall COP of all sites monitored. As with Site 1, the homeowner only ran the unit in “low” fan speed. During March, outdoor temperatures still dipped down to  $-10^{\circ}\text{F}$ ; however, heat output of the system does not exceed 6 kBtu/h. CARB believes that part of the low capacity and poor performance is attributed to restrictions imposed by the “low” fan speed setting.

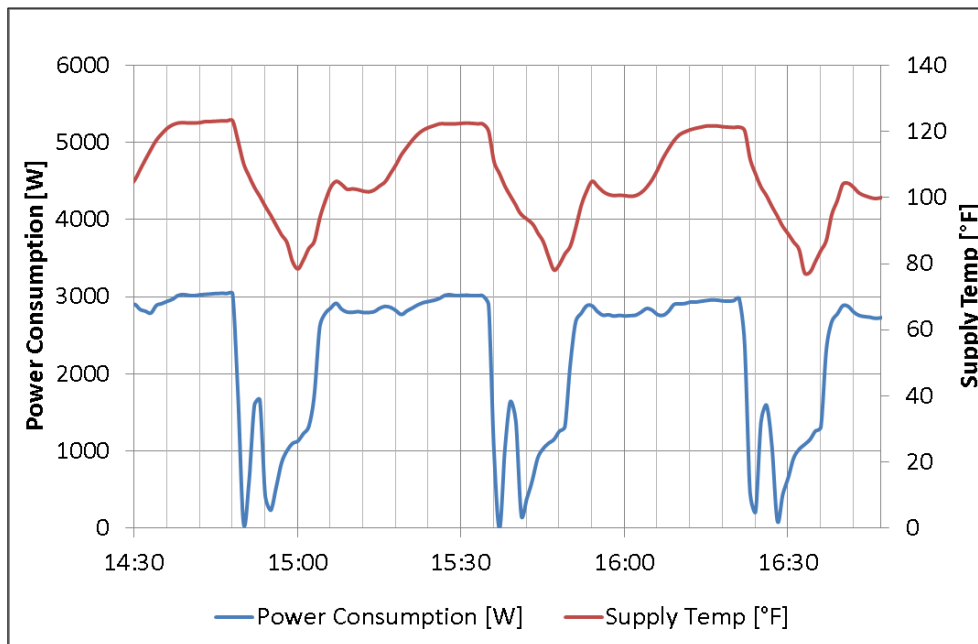
**Figure 26. Examples of defrost cycles at Site 4**

A time period at Site 4 with an average outdoor temperature of  $-9^{\circ}\text{F}$  is shown in Figure 26. During this 2.5-hour period, the unit enters defrost on three occasions. Supply temperatures dip down to about  $80^{\circ}\text{F}$  at the end of the defrost cycle. Figure 27 through Figure 33 show minutes in defrost (for each day) as a function of average outdoor temperature for each site.

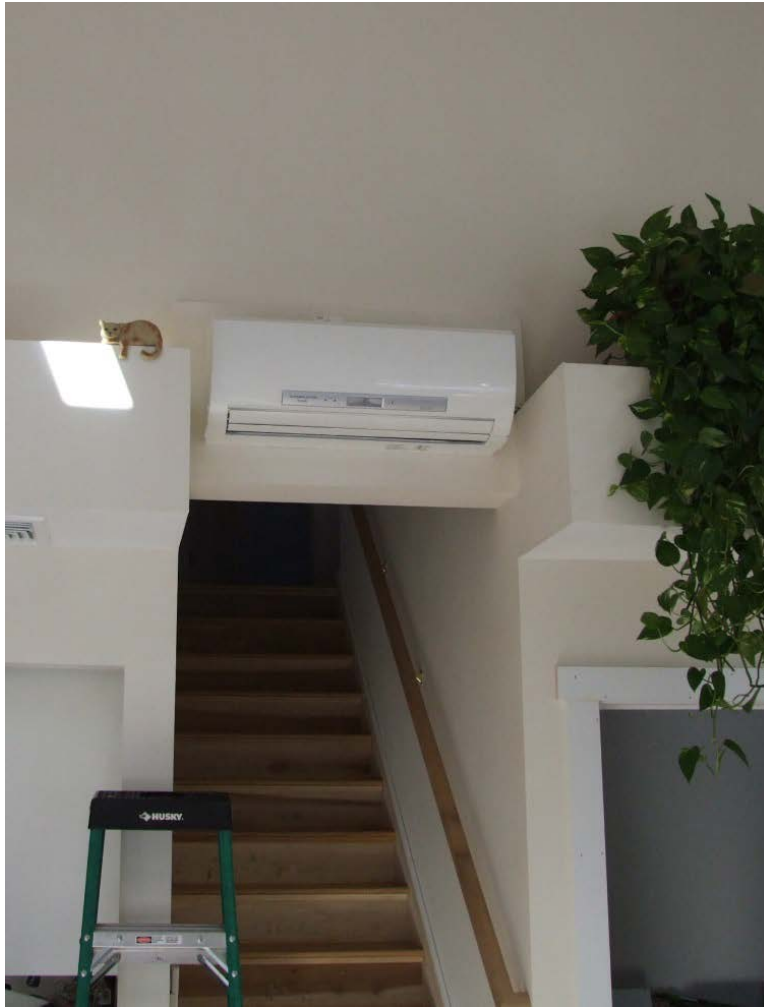
**Figure 36. The heat pump at Site 2 was located above a stairway in an area with a vaulted ceiling. This location may have led to relatively high return air temperatures**

Most of the heat pumps were mounted high up on walls (see Site 2 fan coil in Figure 36). Air temperatures near the ceiling will certainly be warmer than at other heights. To examine the potential of hot supply air short circuiting back to the return, CARB performed some simple tests with an infrared camera at two sites. Figure 37 shows that while direct short-circuiting does not appear to be occurring, there is potential for return temperatures to be higher when the heat pump is operating. While air temperatures elsewhere in the homes were not monitored, the room air temperatures during testing were in the 68°–70°F range—significantly lower than the typical return air temperatures measured.

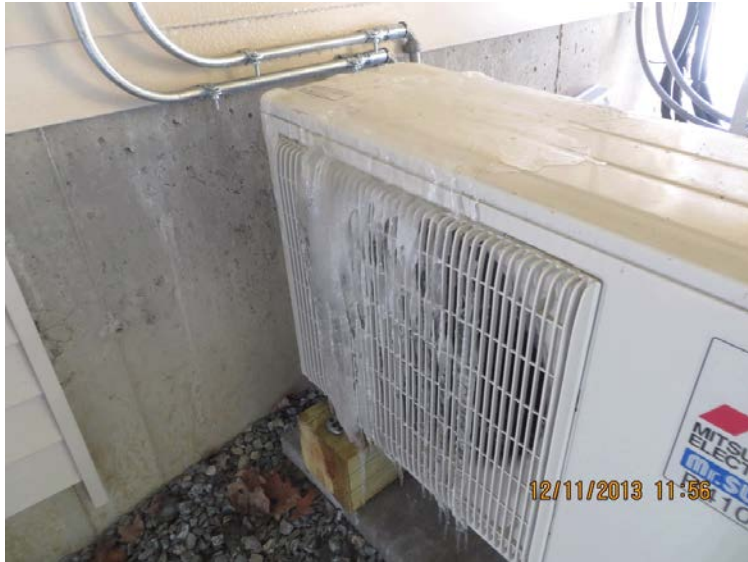
**Figure 38. Snow melting from deck above causes icing and excessive defrost on this heat pump (not one of the units monitored for this study)**

The location of the outdoor unit can also have some effect on defrost frequency. If a unit is installed where water or melting snow or ice can drip onto it, ice is very likely to form on the evaporator coil. The heat pump in Figure 38 was installed beneath a deck. Although out of direct weather, as snow and ice melted on the deck, water would drip down onto the heat pump and refreeze. CARB observed other instances where two (or more) heat pumps that were installed vertically had defrost problems. For example, when the upper heat pump in Figure 39 defrosted, water would drip onto the lower heat pump. When testing performance of the lower unit, CARB found the system entered defrost mode every 10 minutes.

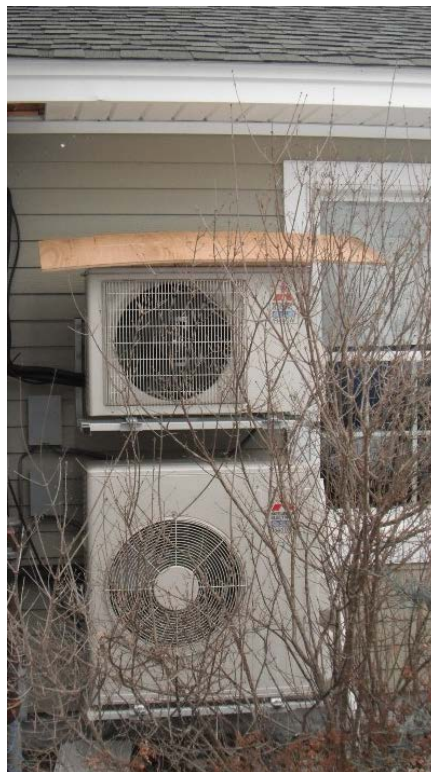
**Figure 39. Heat pumps at Site 8. During short-term testing, the lower unit entered defrost mode every 10 minutes; CARB suspects this was largely a result of defrost water from the upper unit refreezing on the lower unit**

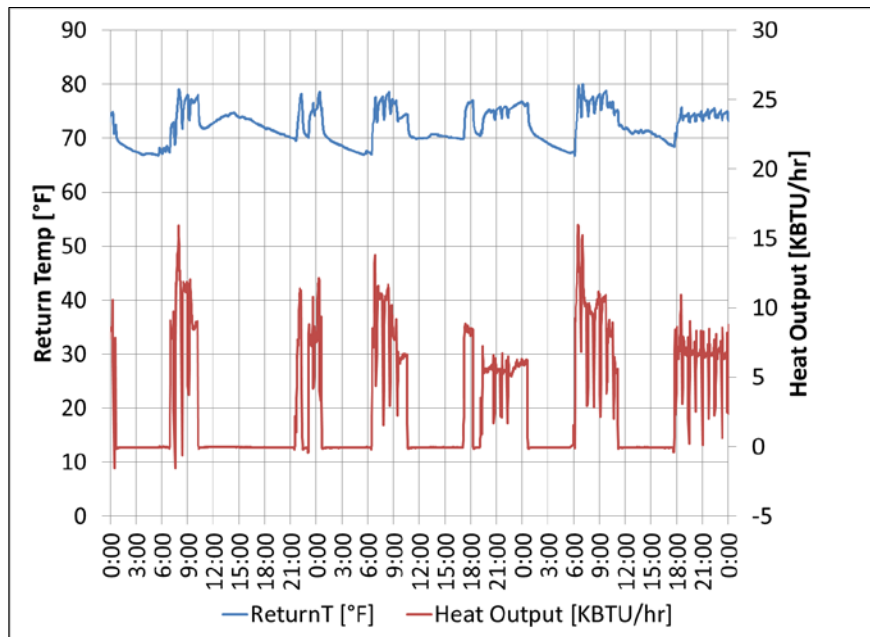
**Figure 40. Setback strategy over 3 days in February 2014 at Site 1**

In this study CARB did not assess setback strategies in detail, but several sites did use programmable thermostats to lower set points over the course of the day. Site 1 employed a setback strategy where set point was reduced from midnight to 6 a.m. and from 10:30 a.m. to 5 p.m. An example of data from this site is shown in Figure 40. When the unit turned back on following a setback period, the compressor often operated at high speed to recover. While having the heat pump off during setback periods will certainly save energy, the unit operates with lower efficiency during recovery.
