Advanced Materials For the Pulp and Paper Industry

Industrial Technologies Program

Innovative Materials and Operating Practices Save Energy in Recovery Boilers

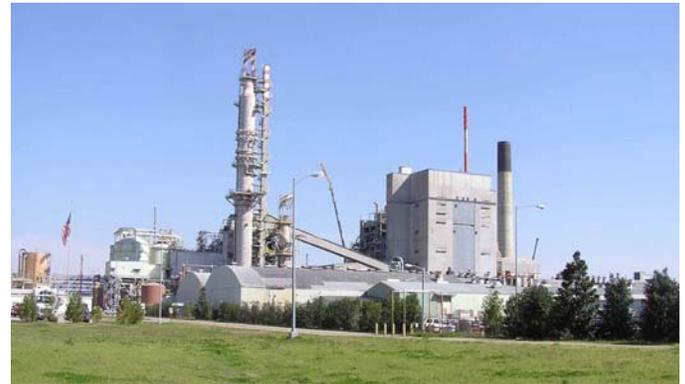
Figure 1: Recovery Boilers are the heart of the pulp and paper making process, and the largest single structure at a mill

The recovery boiler is the heart of the pulp and paper mill. It makes the entire process economically practical through the generation of nearly all of the mill's steam power, 60 to 80% of the mill's electricity and the recovery of the valuable pulping chemicals. It is also the most capital-intensive (typically over \$100 million) operation in the mill.

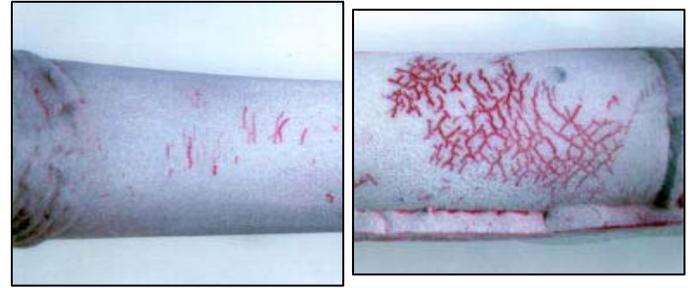
Figure 4: Dye-marked circumferential and crazed tube cracking

and that these cracks were independent of the boiler floor design. These surface cracks were frequently visible using dye penetrants (Figure 4).

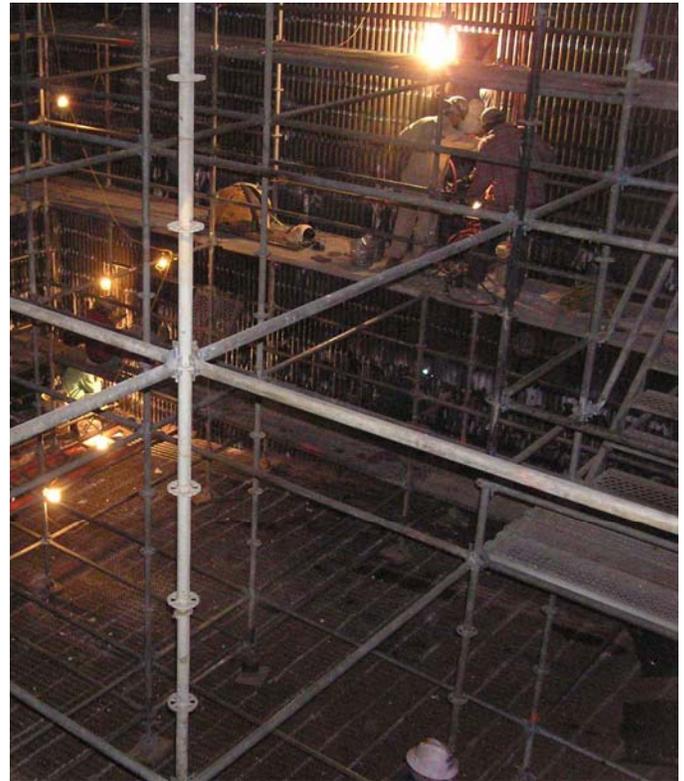
Figure 6: Interior view of recovery boiler during tube maintenance and replacement
