Advanced Materials For the Pulp and Paper Industry

Industrial Technologies Program

Innovative Materials and Operating Practices Save Energy in Recovery Boilers

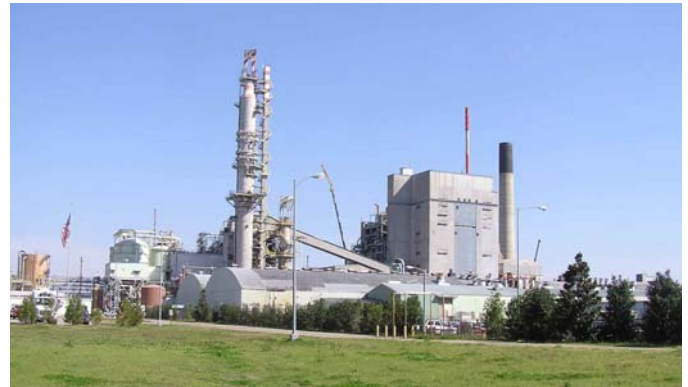
Figure 1: Recovery Boilers are the heart of the pulp and paper making process, and the largest single structure at a mill

The recovery boiler is the heart of the pulp and paper mill. It makes the entire process economically practical through the generation of nearly all of the mill's steam power and 60 to 80% of the mill's electricity, and the recovery of valuable pulping chemicals. It is also the most capital-intensive (typically over \$100 million) operation in the mill.

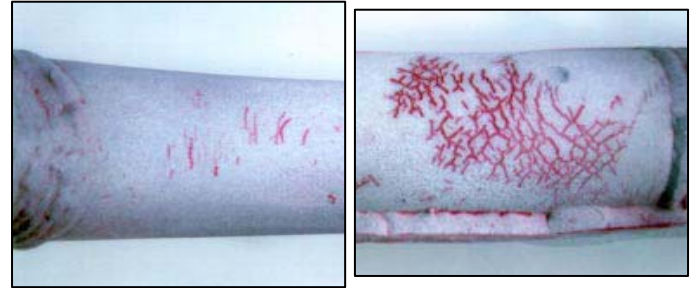
Figure 4: Dye-marked circumferential and crazed tube cracking

The project team determined that co-extruded floor tubes cracked in as little as six months of operation and that these cracks were independent of the boiler floor design. These surface cracks were frequently visible using dye penetrants (Figure 4).

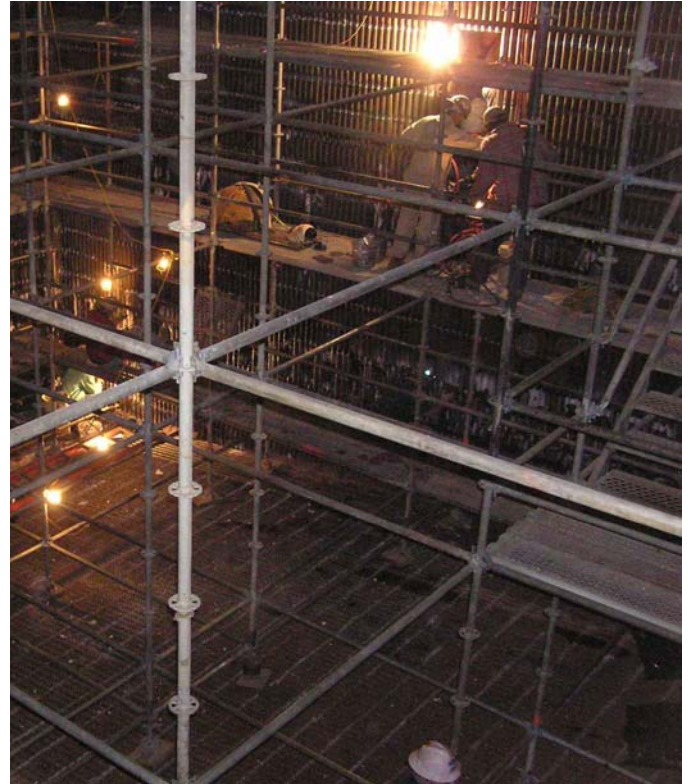
Figure 6: Interior view of recovery boiler during tube maintenance and replacement
