Development of a High Reliability Inverter

Ray Hudson - Xantrex Technology Inc.

Oct 13/2004

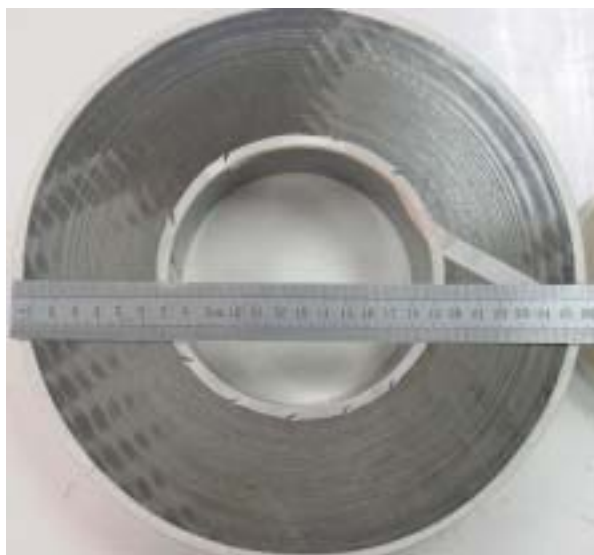
- Single stage
 - Very high efficiency toroidal transformer
 - High surge capability
 - Simple tap changes for output Voltage configuration
 - Low magnetizing current for reduced tare loss

< 10.8W Core loss

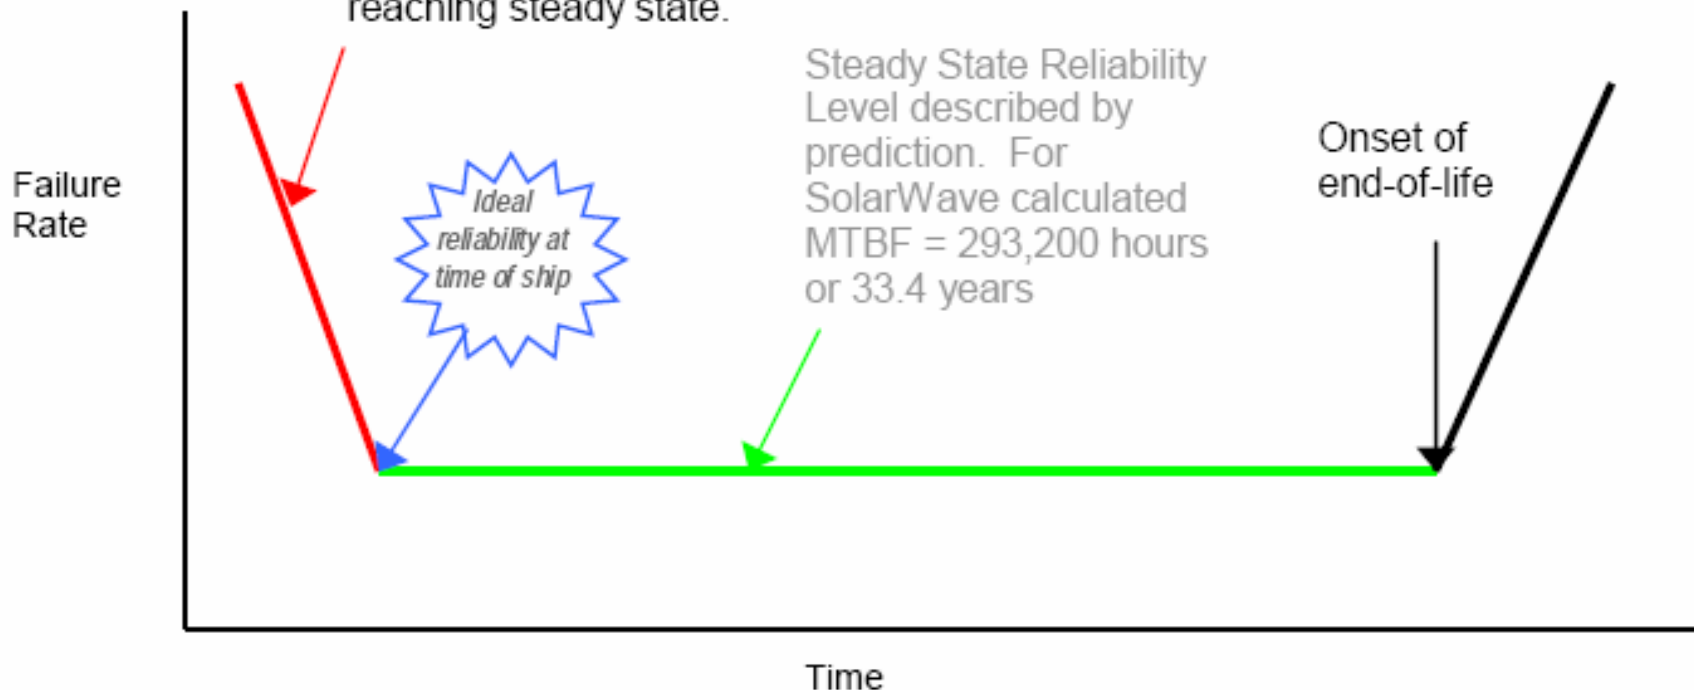
Infant Mortality level driven by amount of screening in mfg./characterized using a special factor in prediction. The estimate for this factor is 3.8, indicating that reliability in 1st year will be 3.8x lower than after reaching steady state.

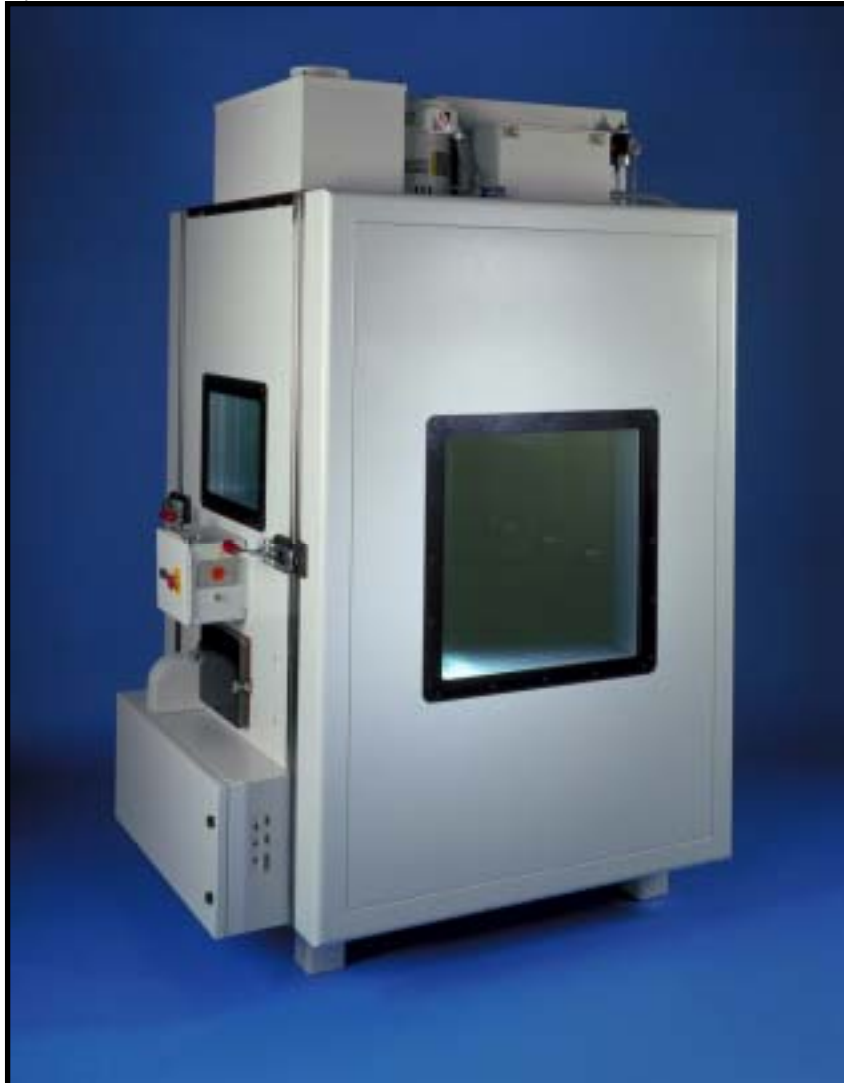
Equipment Used in HALT and HASS

- Liquid nitrogen cooled
 - Rapid thermal transitions
 - -100°C to $+200^{\circ}\text{C}$ range
- Repetitive shock/vibration
 - 6 degrees of freedom
 - 3 axis & 3 rotations simultaneously
 - Broad frequency band (2-10,000Hz)

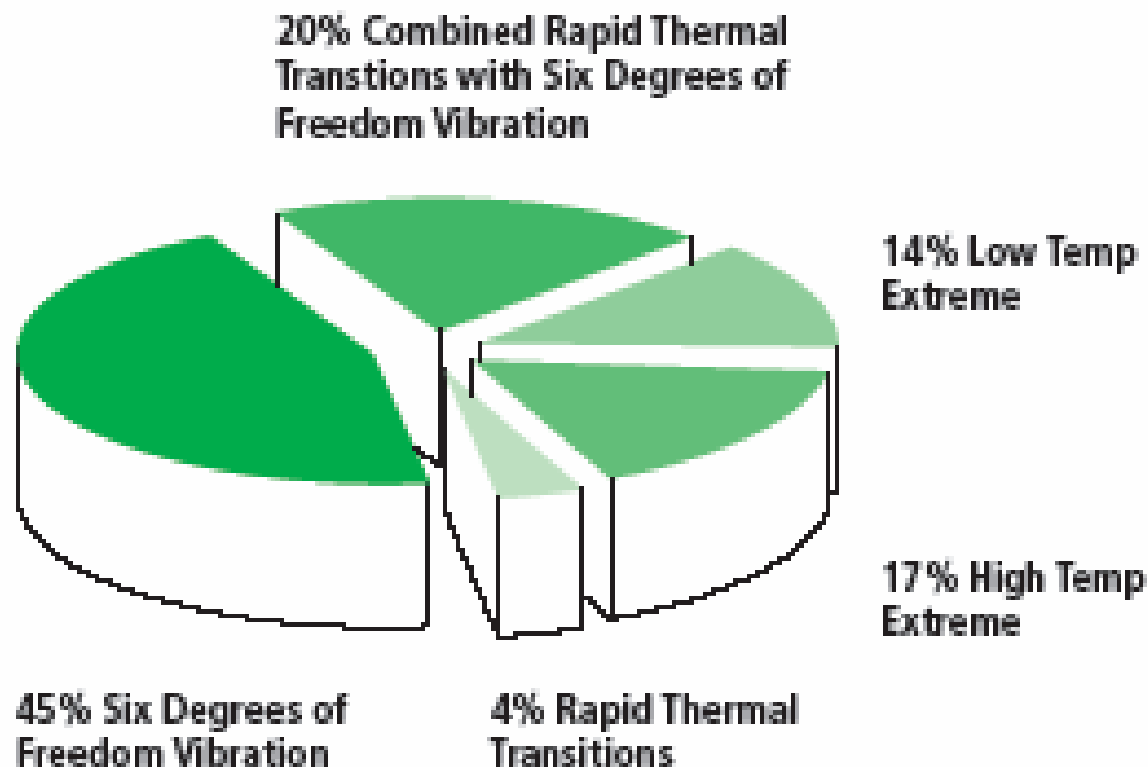
HALT Failures Induced by Stress Environment - typical

- Finds design weaknesses as early in the design cycle as possible

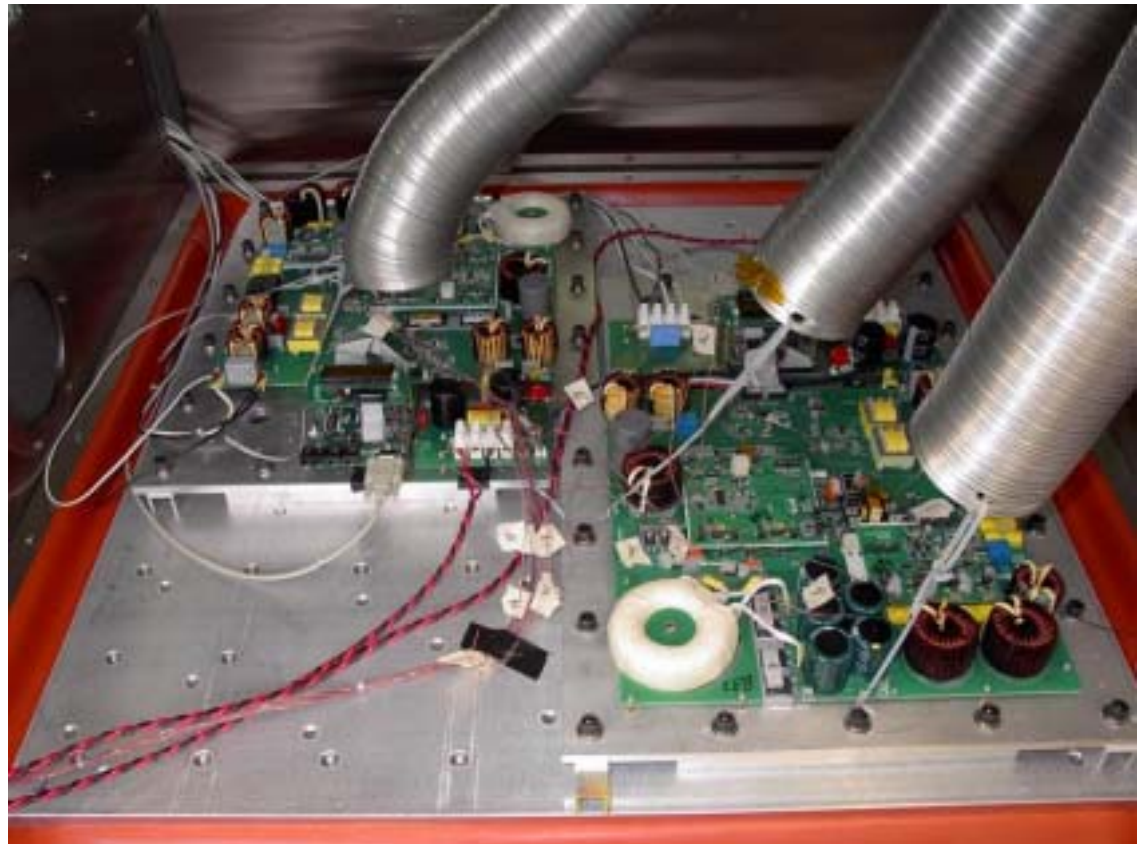
HALT Setup, operational sub-assemblies

- Boards set up without heatsinks and enclosures
- Fully operating
- High volume air flow keeps near constant temperature gradient

- HALT performed on inverter circuit board sub-assemblies
 - Thermal: -70°C to 100°C with 60°C/minute ramp
 - Vibration: up to 32Grms
- At -50°C: Unit would not enter Inverter Mode
Increased temperature to -45°C and the unit would cycle through the boot sequence every 8s
 - Changed 47uF electrolytic to tantalum cap, stopped regulator from oscillating due to ESR change

- At +80°C: Unit would fault under load
 - Terminator was not making good connection on interface board
- At -60°C and 28Grms: Over voltage shutdown tripped
 - Software bug
- Several components found susceptible to vibration damage at 30Grms
 - Simple fixes with layout changes or adding RTV
