# OUTDOOR HIGH-VOLTAGE BIAS TESTING OF PV MODULES

Neelkanth G. Dhere, Ashwani Kaul

Florida Solar Energy Center, 1679 Clearlake Road, Cocoa, FL 32922-5703 USA

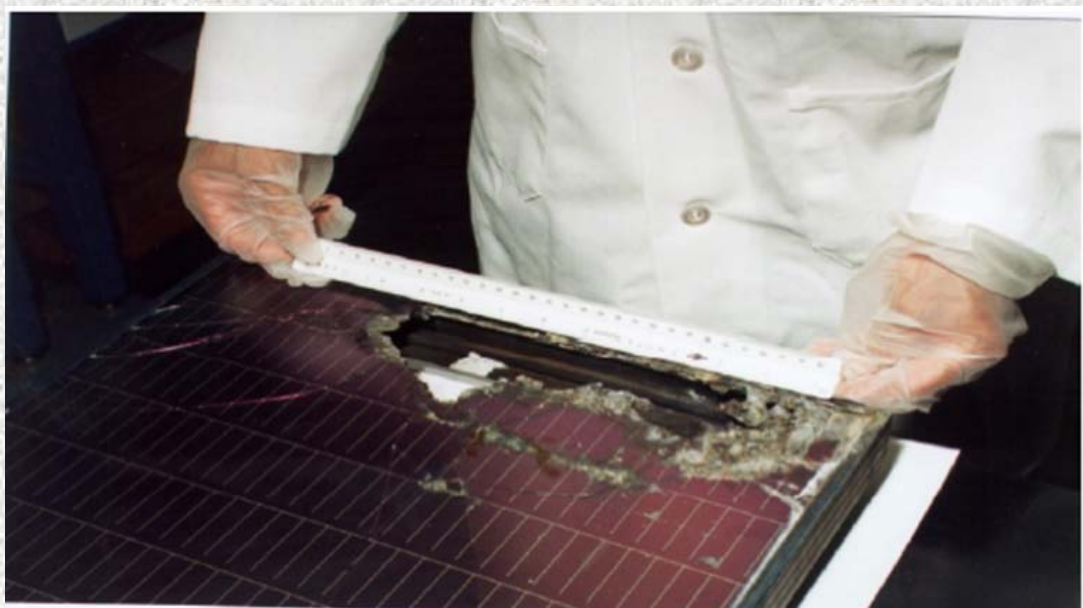
FIGURE 1

- In late 80's and early 90's, array of 640 first-generation, framed, a-Si:H PV Modules were installed with a tilt of  $\sim 25^\circ$  towards the south by the Florida Power Corp at Orlando, FL in collaboration with researchers of the Florida Solar Energy Center. The array operational voltage was 300 V DC.
- a-Si:H thin-film PV modules were fabricated with  $\text{SnO}_2\text{:F}$  TCO layers on superstrate glass. Ground fault was created within the PV circuit of the module. Considerable degradation was observed in negatively-biased, modules (Fig. 1 showing arcing and molten glass as a result of corrosion reaching the junction box that created  $\sim 7$ " long gaping hole.
- Cause of degradation was thin-film circuit reaching all the way to the edge of the frame

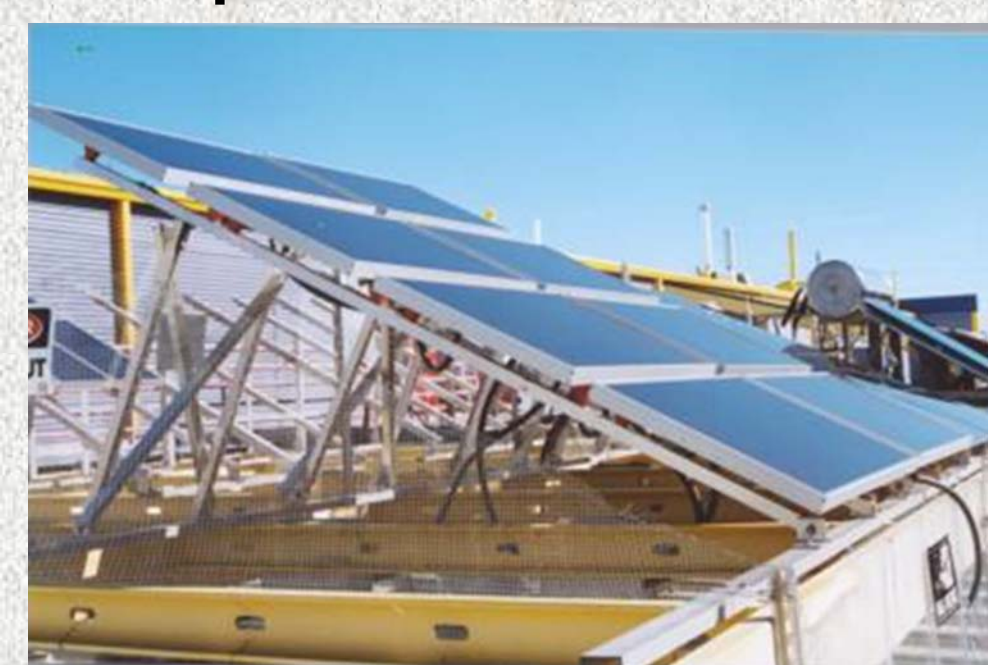
FIGURE 4

- Study of BP Solar a-Si:H (Fig. 4) PV module installed at latitude tilt at various bias voltages during 2001-2004.
- Corrosion initiated near the southern edges of individual cell strips and moved inwards (Fig. 5).

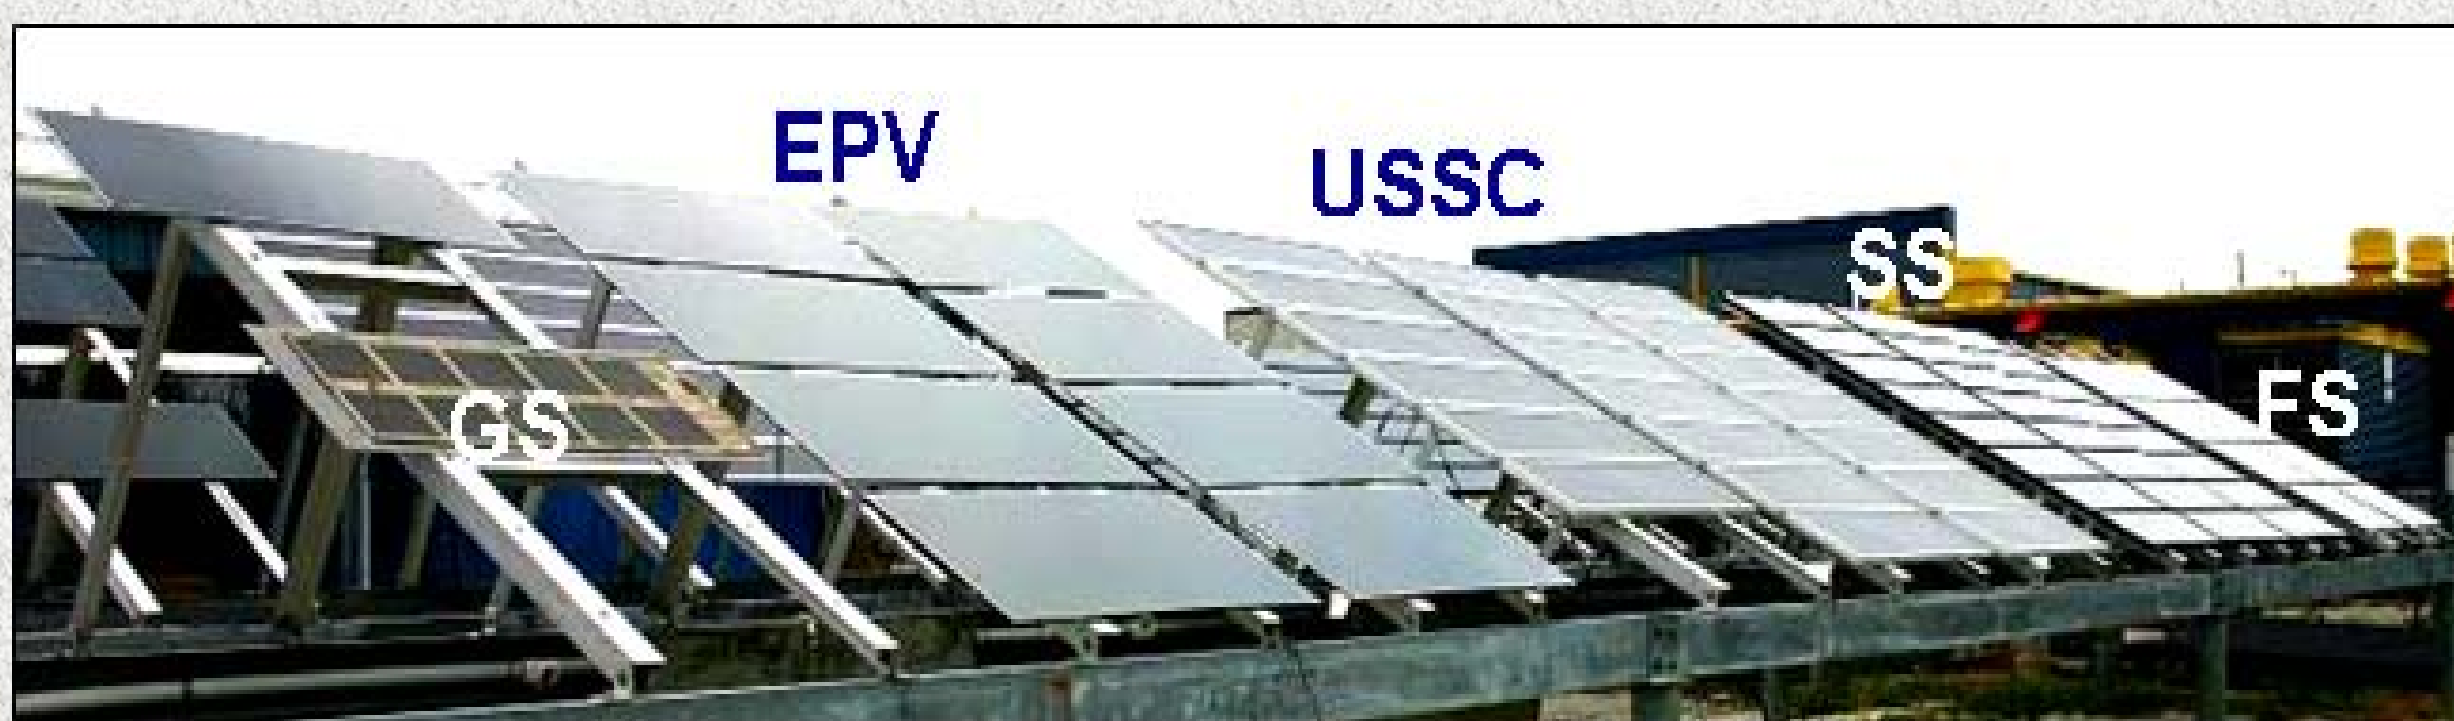
FIGURE 7

- Side by side testing of thin-film PV modules with maximum system voltage of  $\pm 600$  V from all US manufacturers was carried out with a project from NREL (Fig. 7).

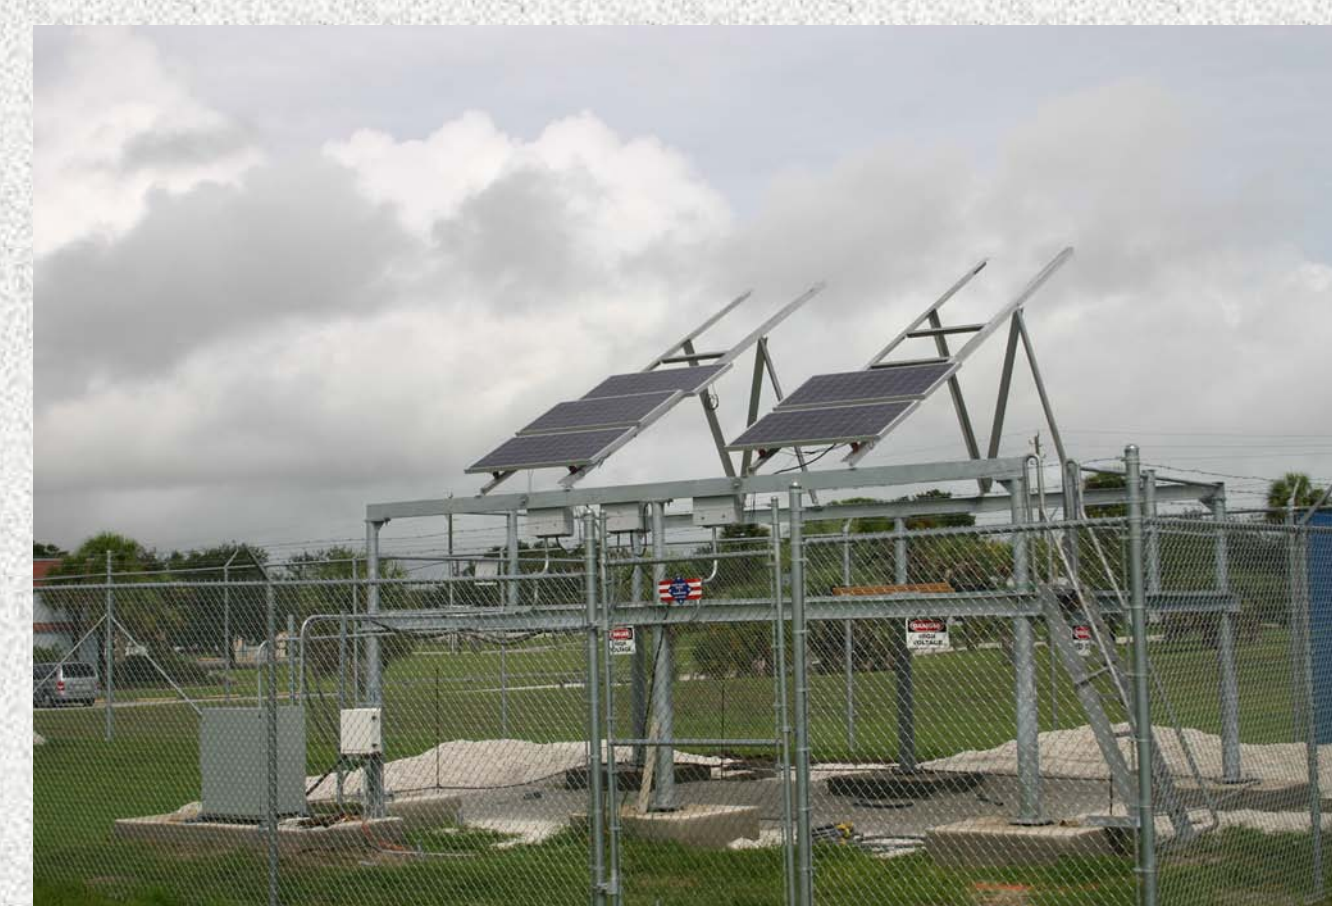
FIGURE 11

- High-voltage bias testing ( $\pm 1500$  V) of c-Si PV modules, specially designed for HV applications was carried out (Fig. 11).
- Negatively biased modules showed degradation within an year.

- Very high-voltage test bed was designed with the participation of graduate students. Design was approved by structural engineering firm and the entire arrangement complies with the electrical (NEC) and safety codes (OSHA).
