# Analysis of Hot Spots in Crystalline Silicon Modules and their Impact on Roof Structures

Daniel W. Cunningham, BP Solar  
February 17<sup>th</sup> 2011

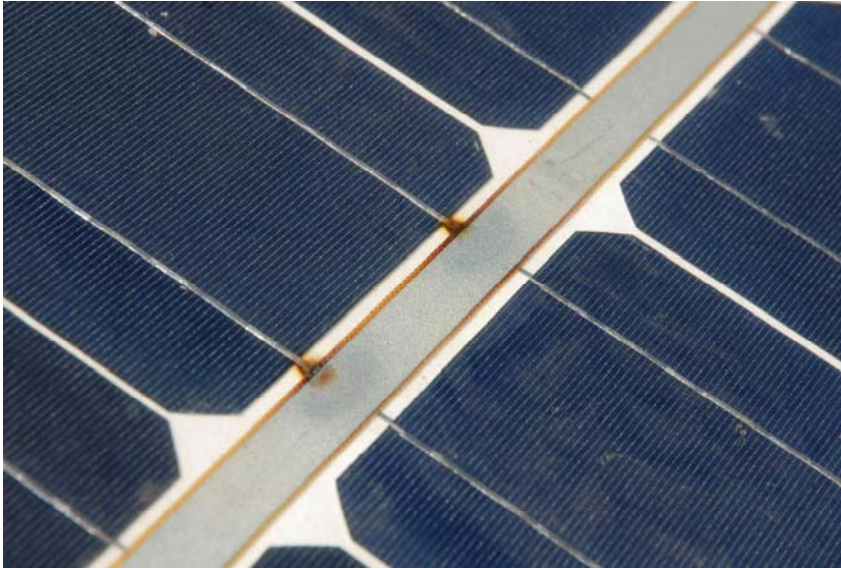
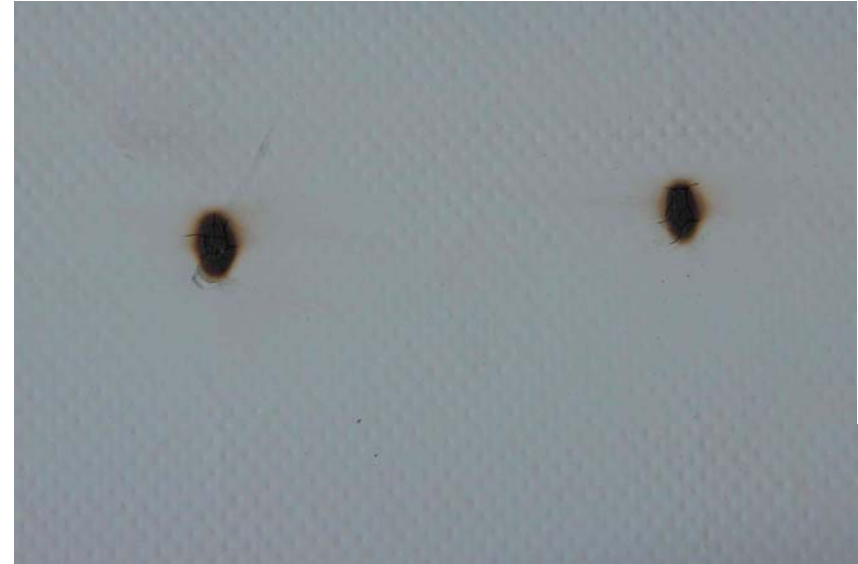
# Example: Non cell hot spots

- Resistive heating is not associated with reverse bias conditions
- The heating is localized at the defect and can discolor the encapsulant and back sheet
- Poor workmanship can lead to soldering defects. These are not seen at the solar simulator
- The hot spot can be stable, does not increase in temperature
- In some cases, the contact will open

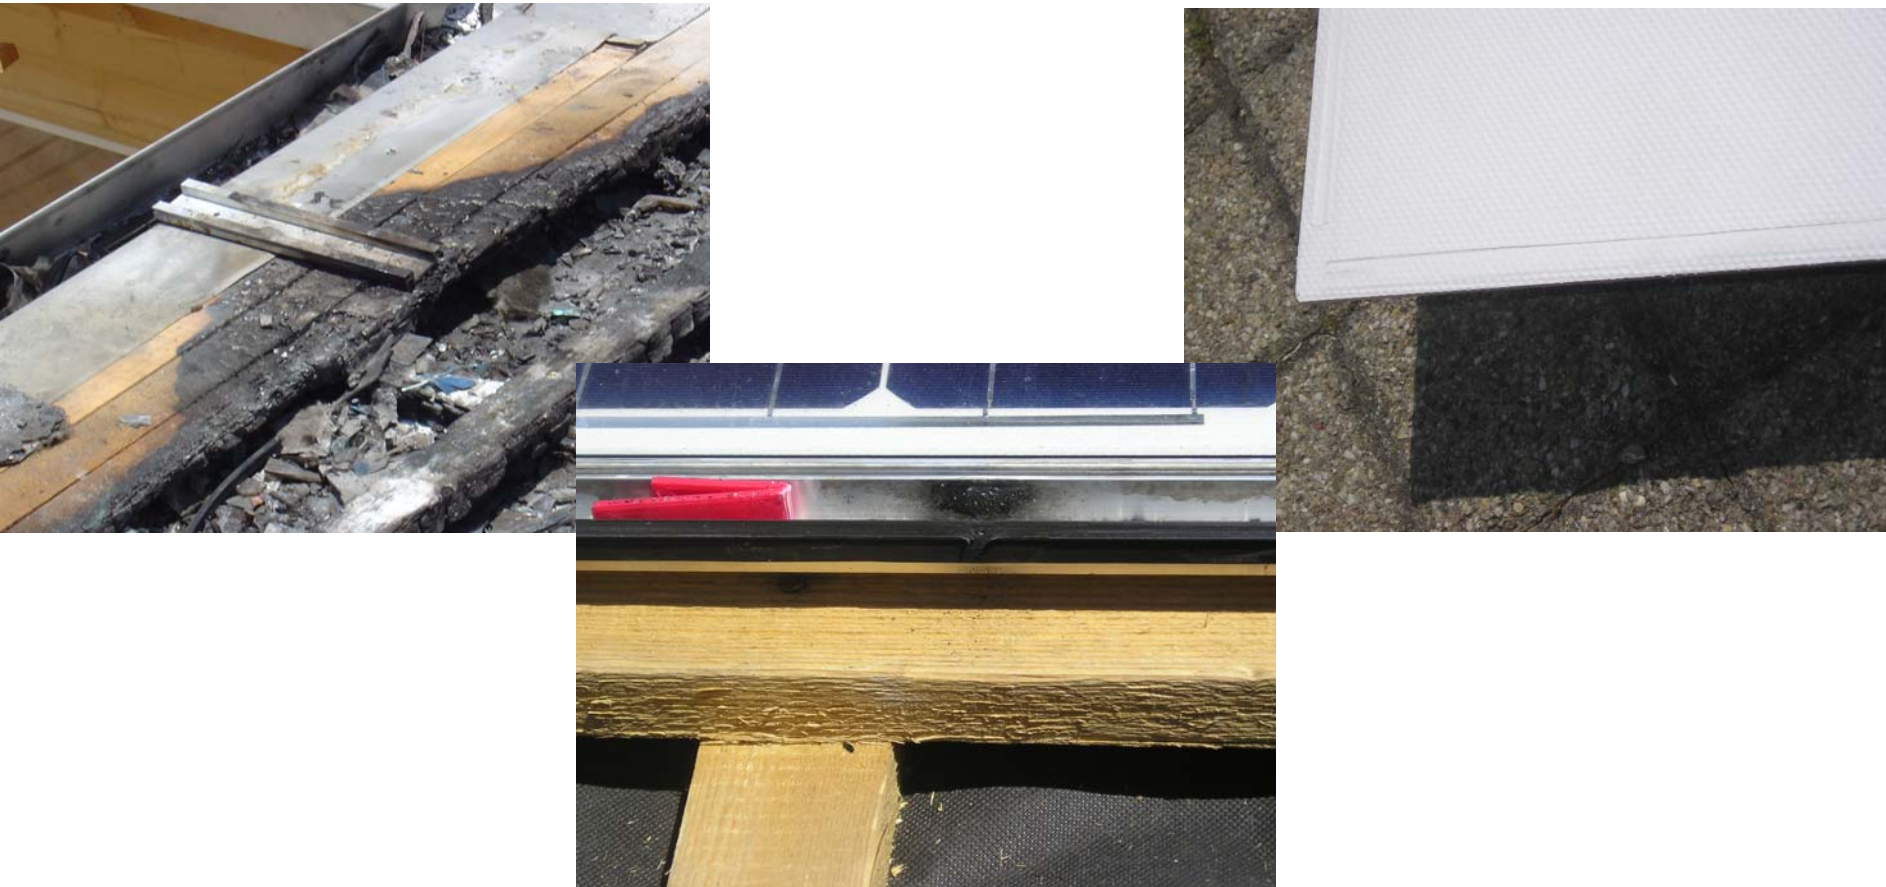
# Example: Structural interference

- Root cause is DC arc generation due to back sheet damage
- US systems: Negative ground needs single short
- EU systems: Typically need 2 shorts due to double isolation approach

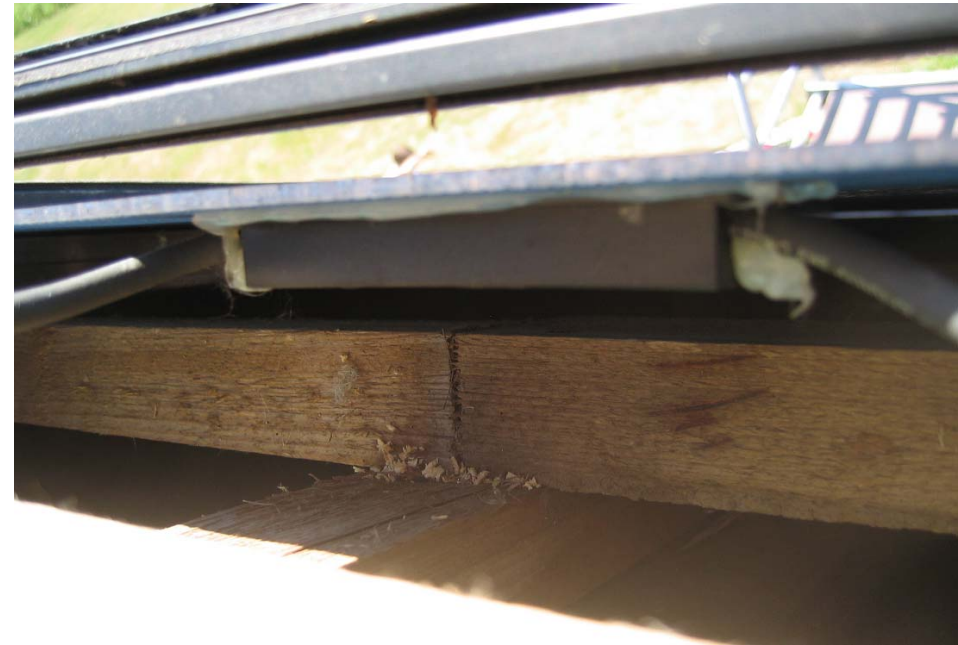
# Impact of roof structure proximity

- BIPV designs often require close proximity of the module to the roof structure
- The study performed between BP Solar and the Fraunhofer Institute was initiated to better understand and quantify the risks and behavior

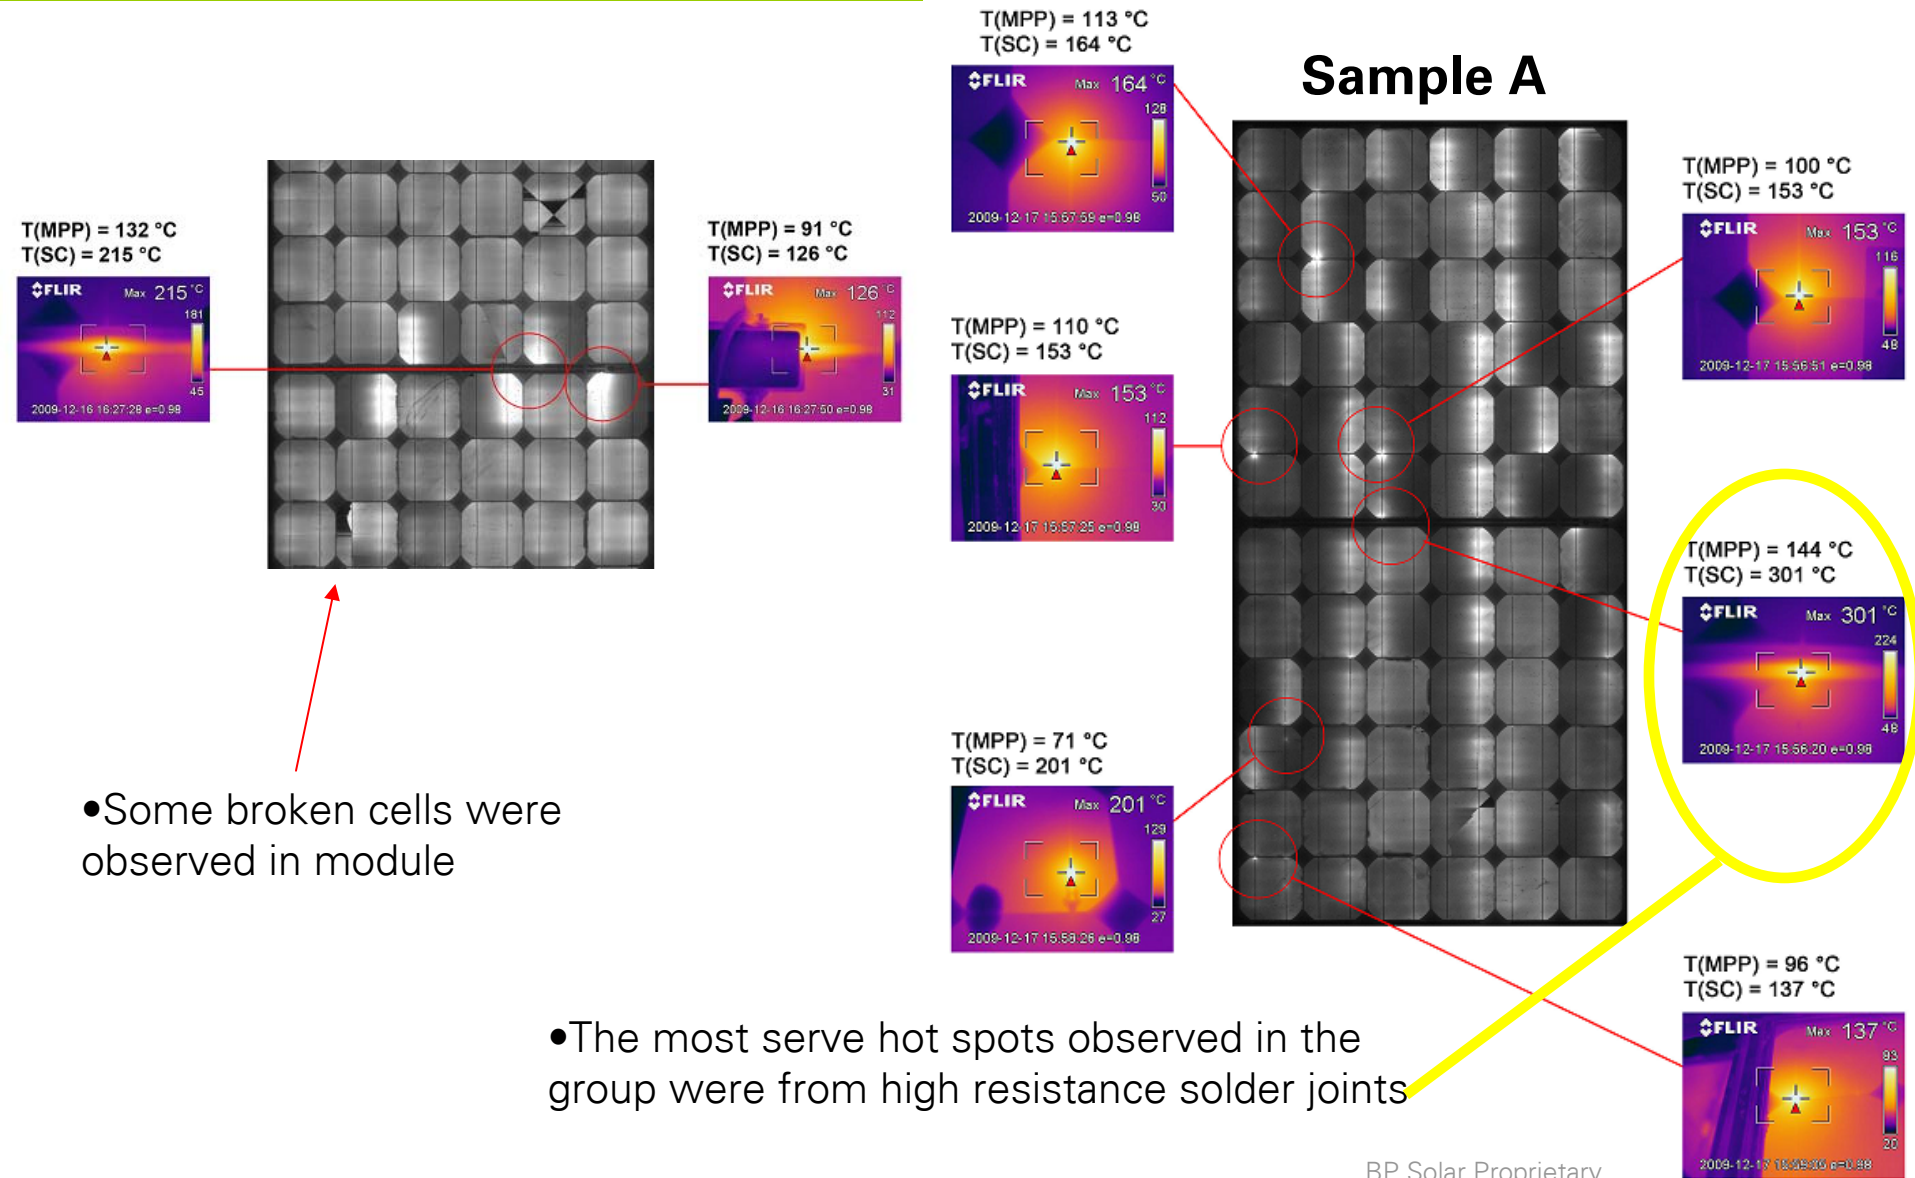
# EL and IR images

- Full visual inspection, EL, & IR images was made on all modules
- Hot spot temperatures were measured under illumination (Class B-B-A solar simulator at  $1000\text{W/m}^2$ ).
- Both  $I_{sc}$  and  $I_{mp}$  current condition were investigated
- Initial condition: Ambient temperature was  $20^\circ\text{C}$  and ventilation was not limited
- Table below shows the 5 highest hot spot temperatures found in the study

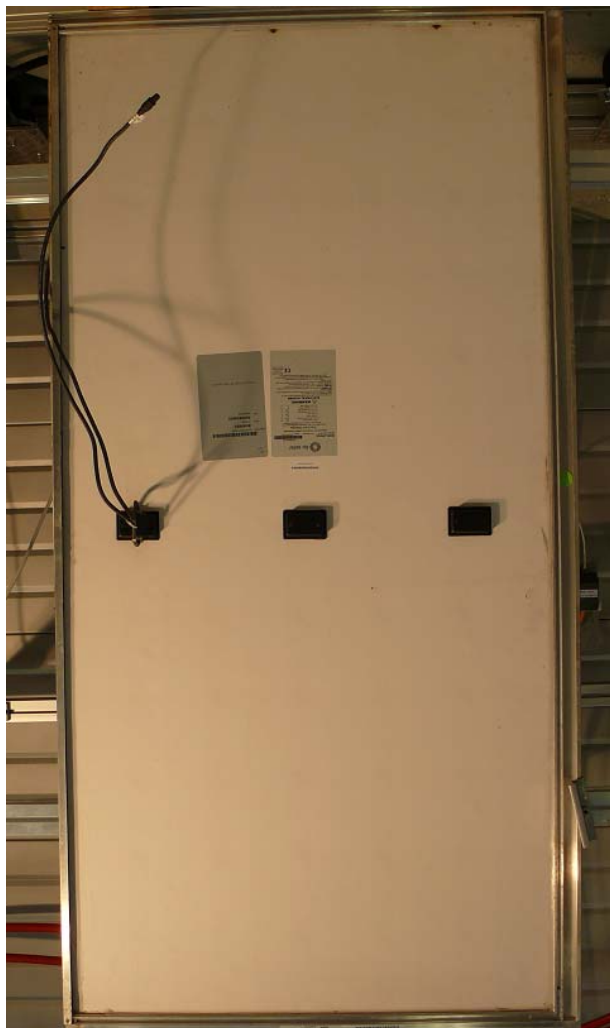
# EL and IR images continued

$T(\text{MPP}) = 190\text{ }^{\circ}\text{C}$   
 $T(\text{SC}) = 285\text{ }^{\circ}\text{C}$

**Sample B**

$T(\text{MPP}) = 267\text{ }^{\circ}\text{C}$   
 $T(\text{SC}) = 312\text{ }^{\circ}\text{C}$

$T(\text{MPP}) = 69\text{ }^{\circ}\text{C}$   
 $T(\text{SC}) = 76\text{ }^{\circ}\text{C}$

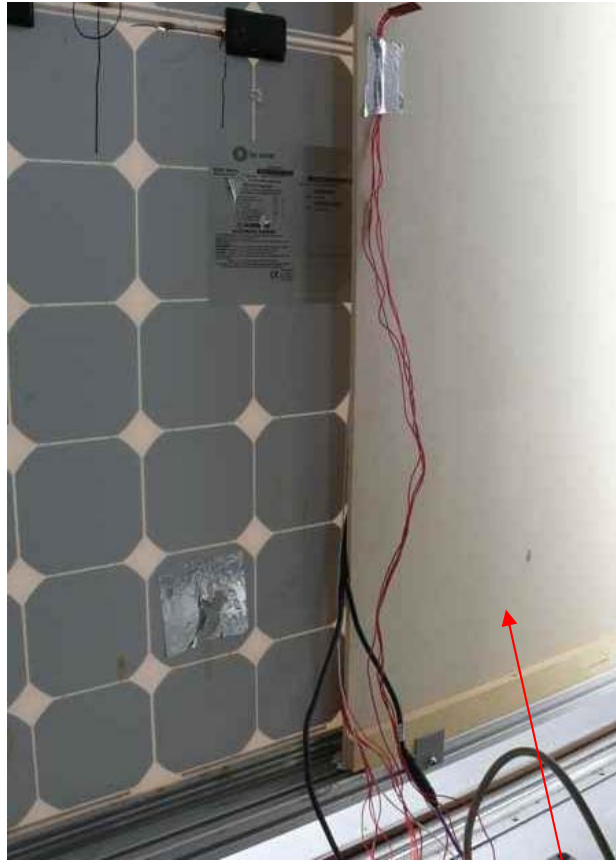
## Hot spot behavior in 10mm enclosure

Back of module (**Sample B**)  
**completely enclosed** before start of  
test

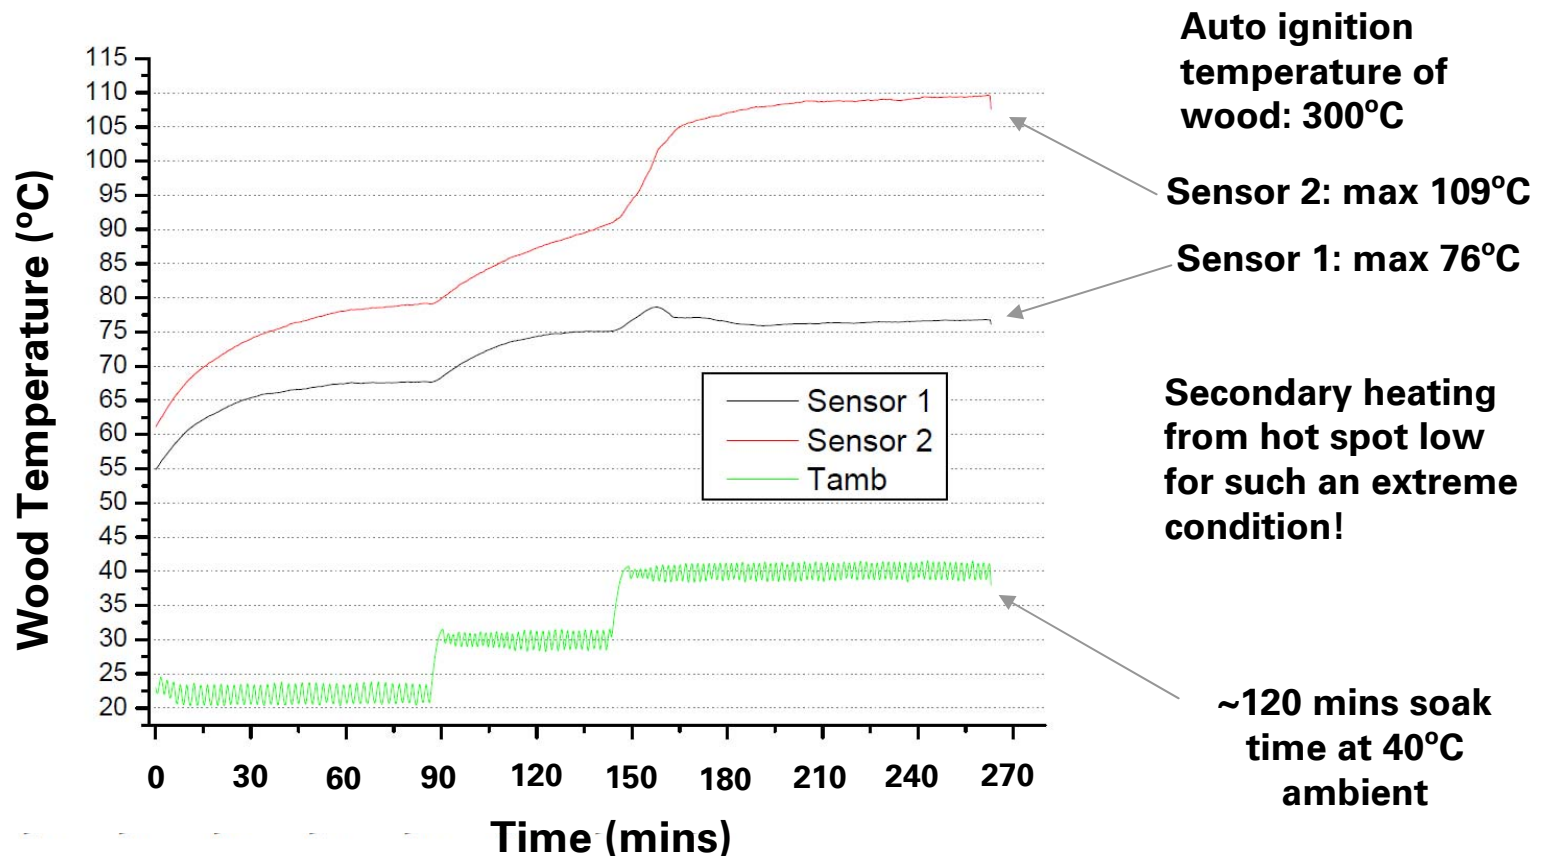
# Max temp at 10mm from structure

- Ambient temp stepped from 25°C to 40°C while module illuminated to produce Isc current
- Maximum temperature range at wood surface by end of test: 76°C to 109°C
- **While absolute temperature of hot spot is high, the dissipated energy from it is very small**
- This accounts for the relatively low temperatures of adjacent surfaces

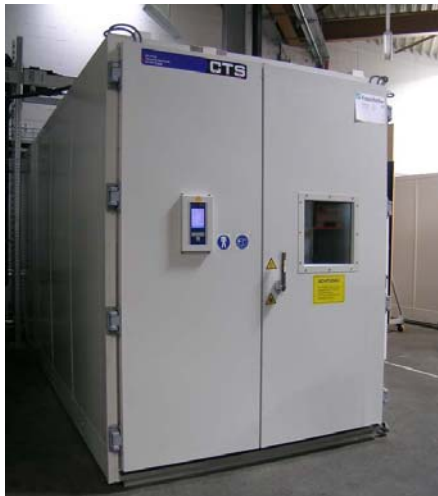
1) Thermal cycling

- As part of the study, the effect of thermal and mechanical cycling of hot spot propagation was investigated
- IEC 61215ed2, 10.11 and 10.6 (thermal & mechanical cycling respectively) procedures were followed
- Thermal cycling:  $-40^{\circ}\text{C}$  to  $+85^{\circ}\text{C}$ , 200 cycles
- Mechanical cycling: 2400Pa and 1500Pa, cycling front & rear, 1 hour period

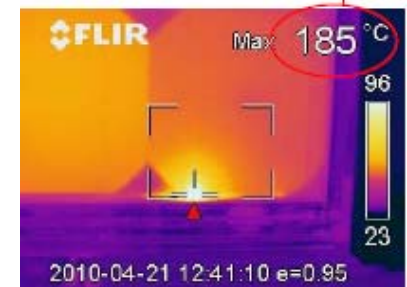
**Sample 2: Thermal cycling**

**Initial**

**Post TC200**

- For the examples used in the study, there was not a strong influence of thermal cycling on the propagation hot spots
- In the case above, the hot spots were located at interconnect to bus bar interface

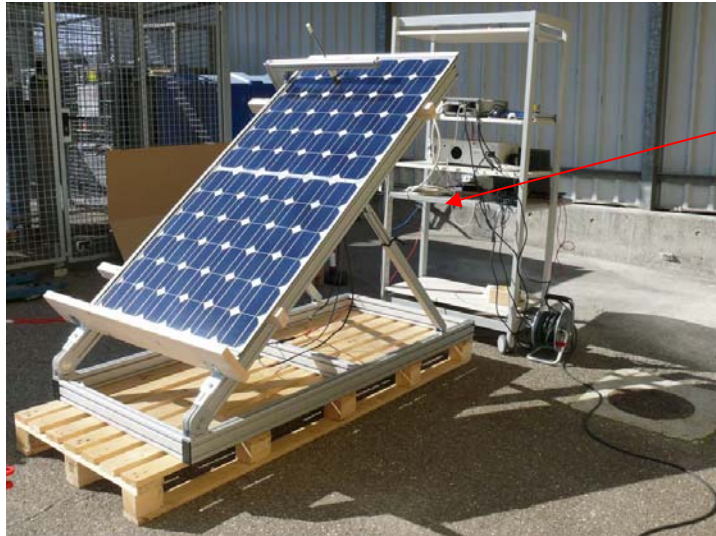
**Isolated structure with  
metal probe at -1000V**  
**+ve to output cables**  
**Current limit: 1A**

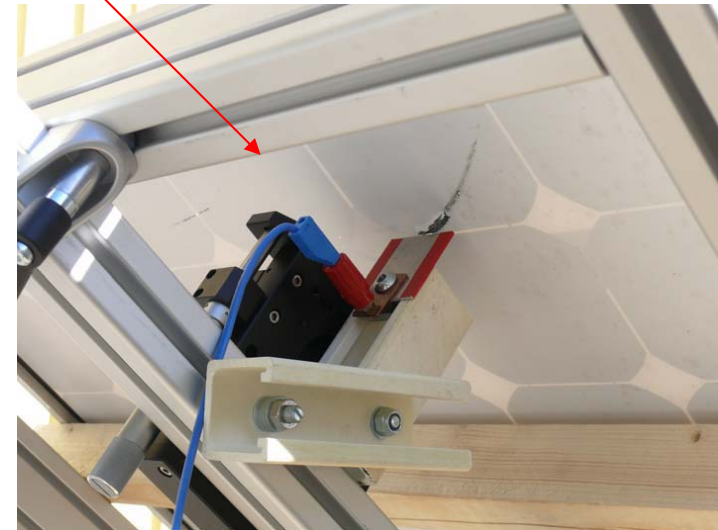
**Pressure applied to  
front of glass to  
generate deflection**

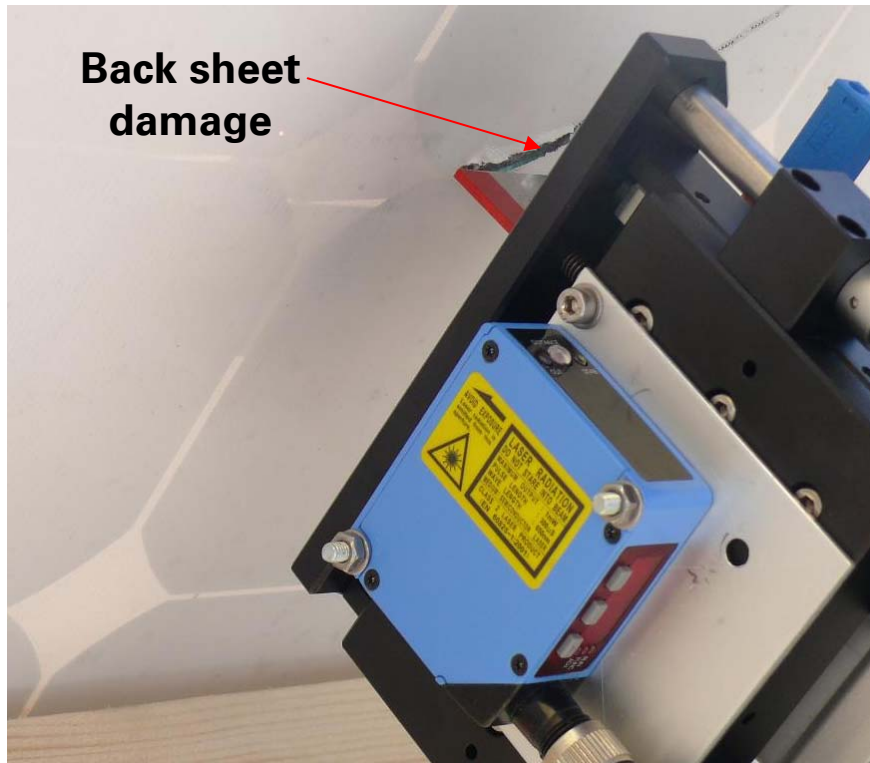
## Arc initiation

- Flash over occurred when the probe was in close proximity ( $<2\text{mm}$ ) or direct contact
- Flash over occurred in dry environments but the presence of water greatly increased the chance for occurrence
- For these conditions, flash over was detected at voltages of 300V or higher
- Undamaged back sheets did not lead to leakage current or arc initiation

- Many different failure modes can create a hot spots not just p-n junction effects from shading
- A study between BP Solar, Fraunhofer Institute, and VDE examined 28 modules with examples of hot spots
- Broken cells were present but the most common root cause was resistive heating due to defective solder joints
- Maximum temperature measured was 343°C, however the heating effect on the adjacent wooden structure was low
- This is due to the small physical size of the hot spot and low energy dissipation
- Stress testing showed a greater effect from mechanical cycling compared to thermal cycling
- However, this did not significantly increase the hot spot temperature
- By far the biggest risk for secondary damage from hot spots is if their source is a DC arc
- This was demonstrated by simulated back sheet damage at high voltage
