## Product Reliability Challenges due to Packaging in A-Si Thin Films Modules

*Deepak Shivaprasad, Novasolar Technologies,  
Hayward Ca, USA*

# Key Reliability Challenges – Edge Deletion Using Sand Blasting

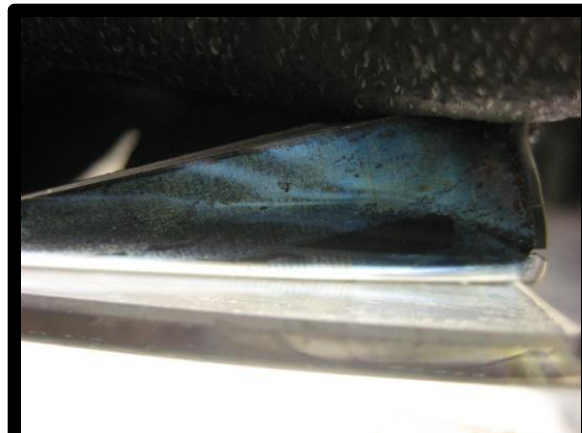
Polymer peel off due to poor adhesion & Contamination Post HF

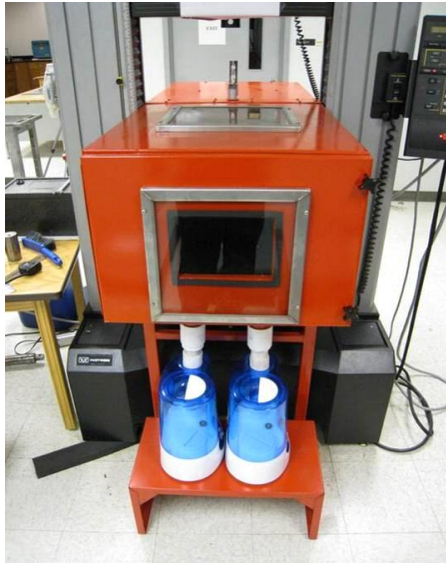
# Mechanical Testing : Rupture Test Results

Glass Micro-cracks due to Sanblast Edge Deletion Causing Poor Adhesion and Lower Module Strengths

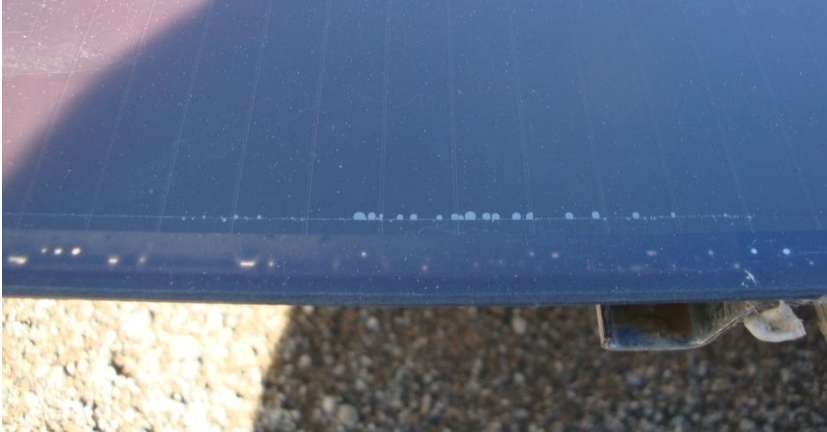
# Arcing Effects Due to Sand Blasting

Arcing effects observed across isolation scribe due to pockets of un-removed TCO in the edge area - Issue found in the field

- Novasolar has found both by accelerated stress tests and field exposure tests that Sand Blasting used for Edge Deletion contributes negatively to the module reliability and long term performance
- Seeing the effects of Sand Blast Technique, Novasolar Technologies switched to Laser Based Techniques on the production lines and saw a significant improvement in the module reliability performance

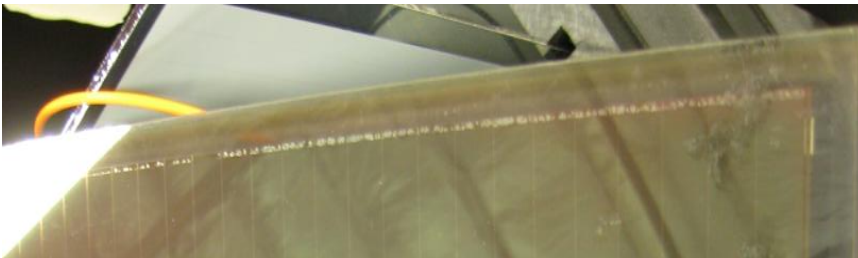
Arcing effects observed across isolation Scribe due to pockets of un-removed TCO in the edge area – Issue Simulated in the Lab during Accelerated Stress Testing
