Stress Testing and Failure Analysis Methods for Determining the Reliability of Metal Buss Tapes

Jason Hevelone*, Michelle Propst and Chris Richardson

Abound Solar

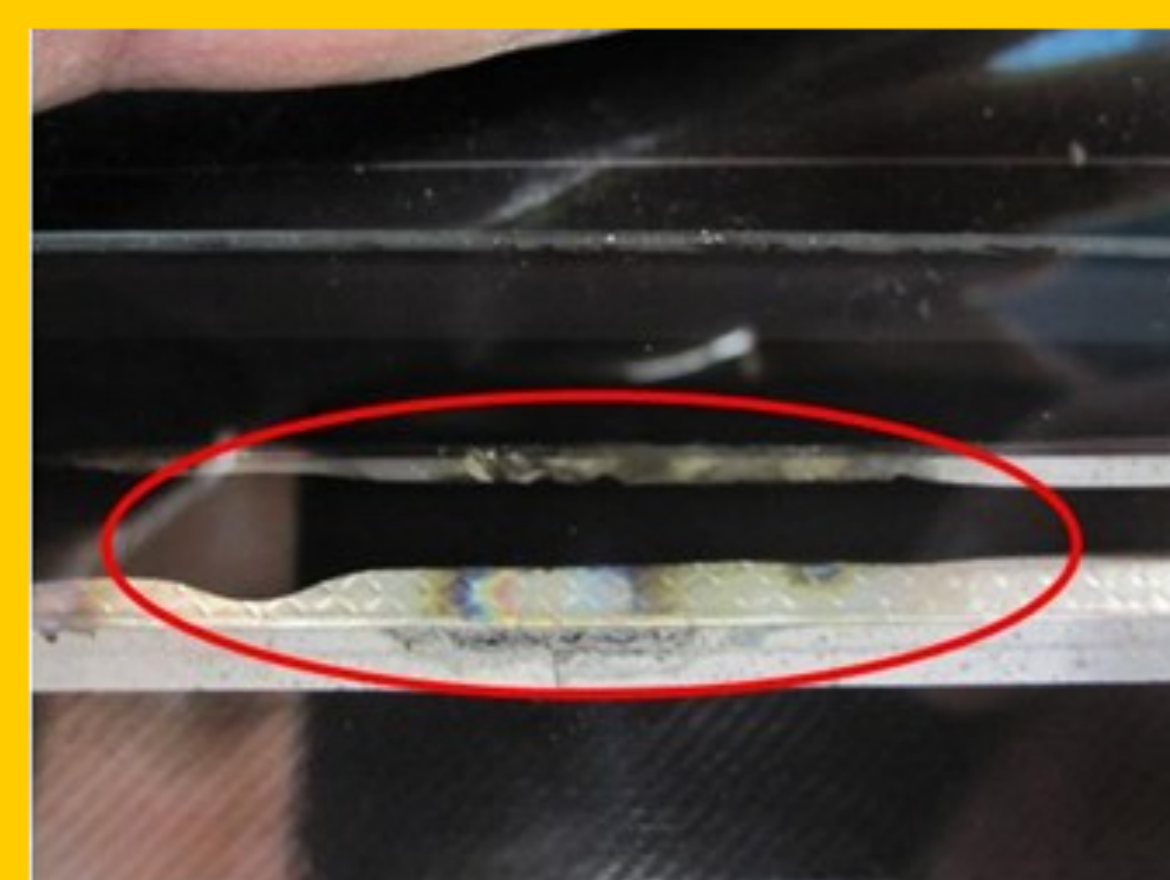
Buss tape failure as seen from the backside of the module

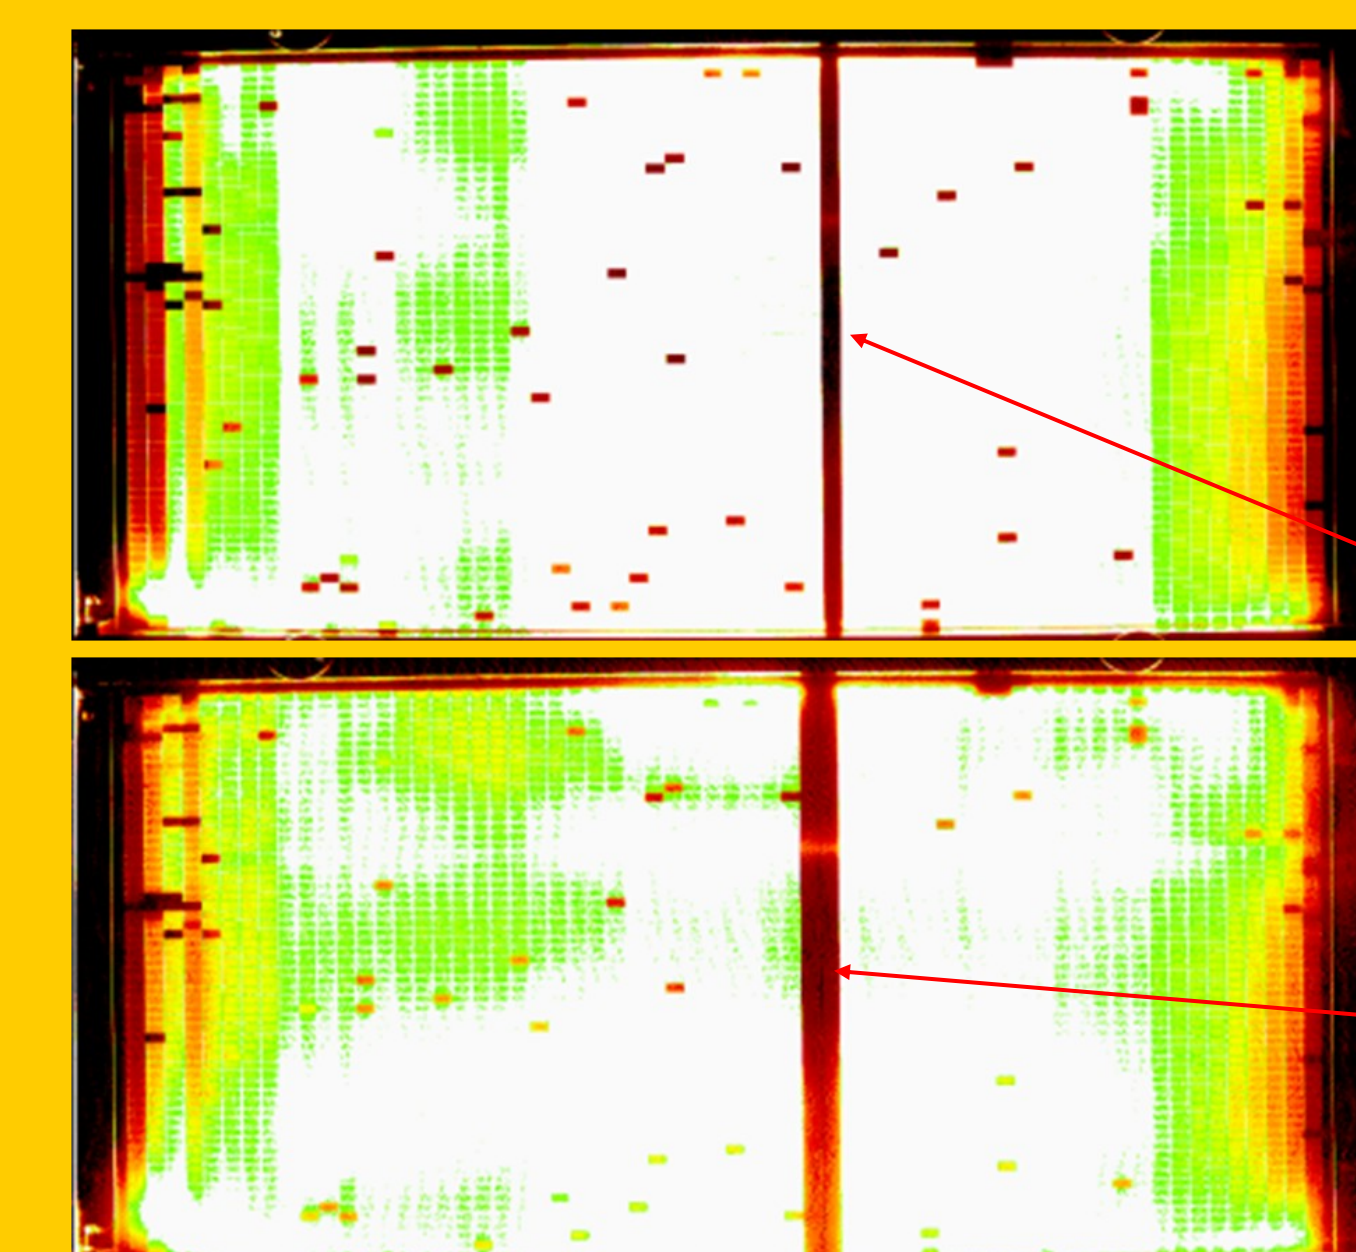
LBIC (Laser Beam Induced Current) image of a perpendicular, isolation laser-scribed module

Dark vertical line shows location where a 2 cm length of the metal buss tape is not making contact with the back metal

After additional stress testing, another 2 cm length of metal buss tape has failed
