# Test-to-Failure for Long-Term Performance Assessment

Peter Hacke

PV Module Reliability Workshop  
February 18–19, 2010

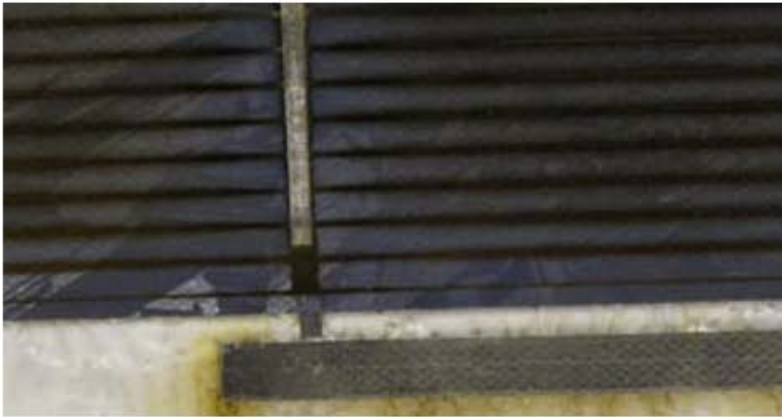
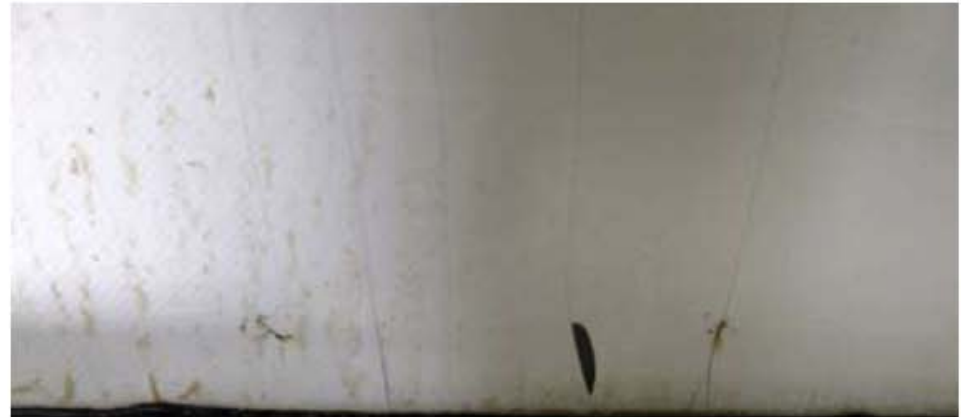
Ag gridline corrosion visible

Series resistance increase according to dark I-V curve fitting
