## 7. MAINTENANCE, REPAIR, RECYCLE

### A. Effects of Highway Ice-Clearing Treatments on Corrosion of Heavy Vehicle Materials and Components

*Principal Investigator: Elizabeth V. Stephens*

*Principal Investigator: Dane F. Wilson*

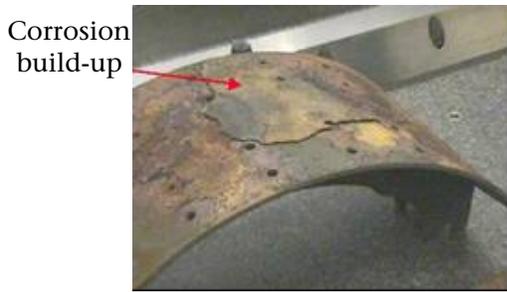
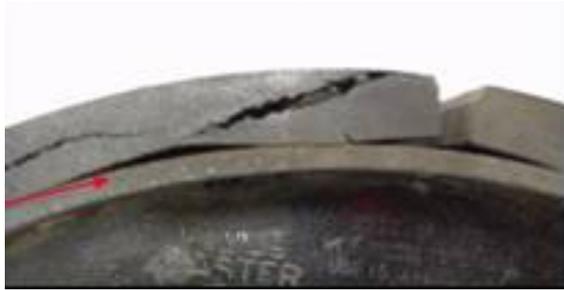
**Figure 1.** An illustration of rust jacking: (a) corrosion product buildup on the brake shoe table displaces the brake lining; (b) shoe table/friction liner interface.

truck brake systems, also known as “rust jacking” (Figure 1).

An initial forensic evaluation of a failed brake system showed that corrosion is nonuniform (as is to be expected for plain carbon steel) in chloride environments.

Banding of the oxide scale was observed. This may reflect the changing corrosion conditions to which the brakes are exposed. Variations in composition and concentration of anti-icing and deicing salts, pH, moisture, temperature, and frequency and pressure of braking could all impact the corrosion rate and resultant products. Salt composition and concentration and pH, which affect the corrosion potential of the plain carbon steel, are the major contributors to the banding. A small change in salt composition and/or concentration, with or without a slight change in pH, can result in shifts between  $Fe_3O_4$  and  $Fe_2O_4$  phase fields.
