# NDE DEVELOPMENT FOR ACERT™ ENGINE COMPONENTS

**J. G. Sun**

**Argonne National Laboratory**

**DOE VT Program Annual Merit Review, May 9-13, 2011**

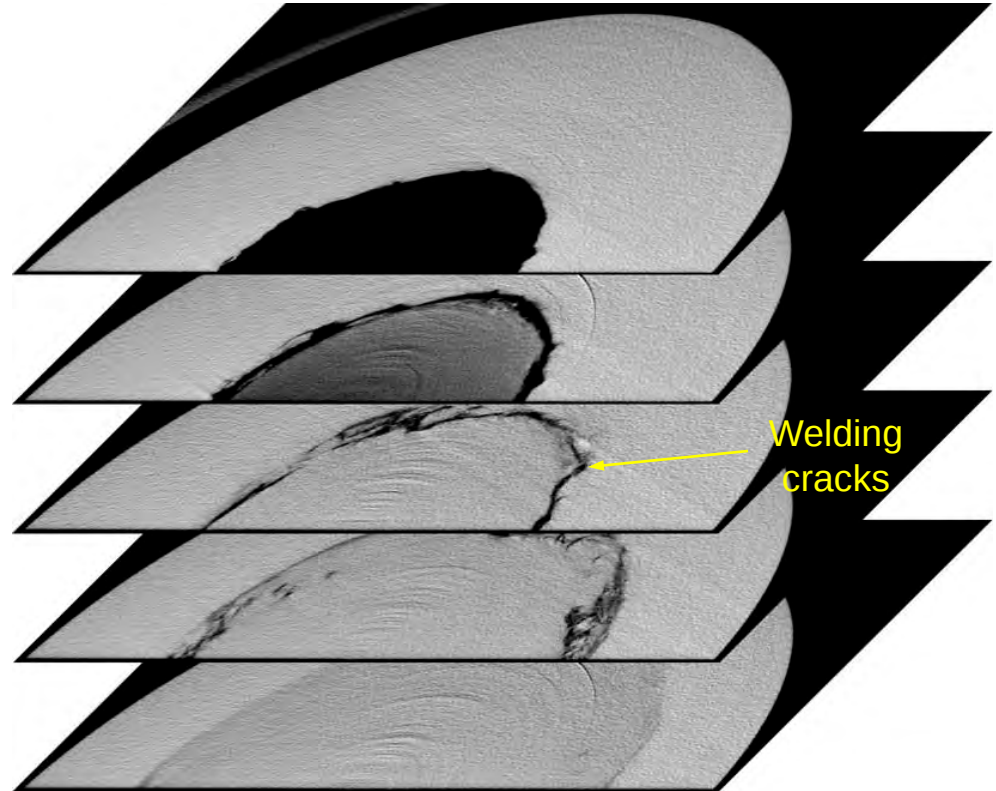
## Typical plane CT slices

- Tests performed at the Advanced Photon Source (APS) at ANL
- Complex 3D cracks and voids are imaged with high resolution ( $\sim 40\mu\text{m}$ )
  - Such data help to understand processing issues
  - Such detailed data cannot be obtained by other NDE methods!

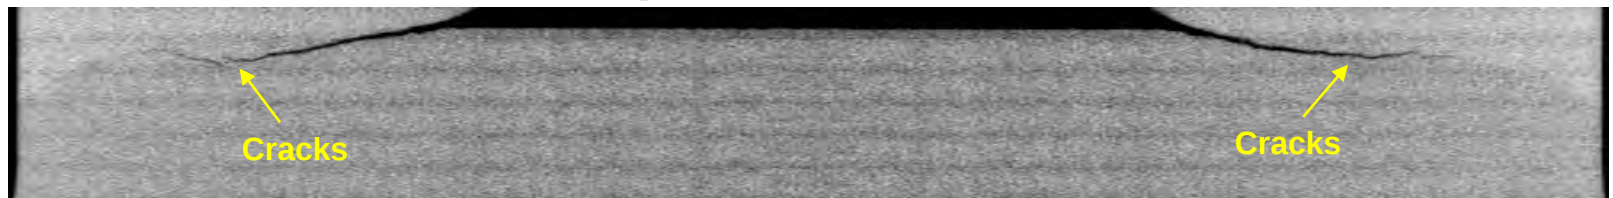
Recomposed Axial CT Slice

- CT data analysis to extract detailed 3D crack information is required
- Detailed characterization of casting cracks requires removal of CT artifacts (ring artifact) – work is on-going

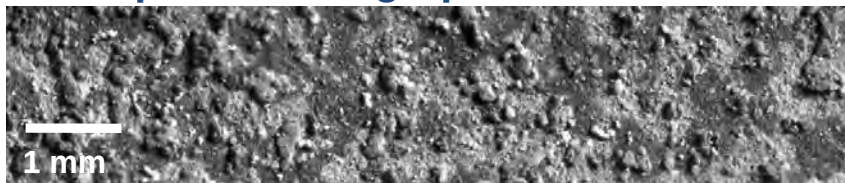
**Optical micrograph of TBC surface**

- Good correlation in NDE data and with visual observation
- Thermal NDE may detect deeper flaws not observed on surface
