Attic Retrofits Using Nail-Base Insulated Panels

March 2018

D. Mallay and V. Kochkin
Home Innovation Research Labs
400 Prince George's Blvd.
Upper Marlboro, MD 20774

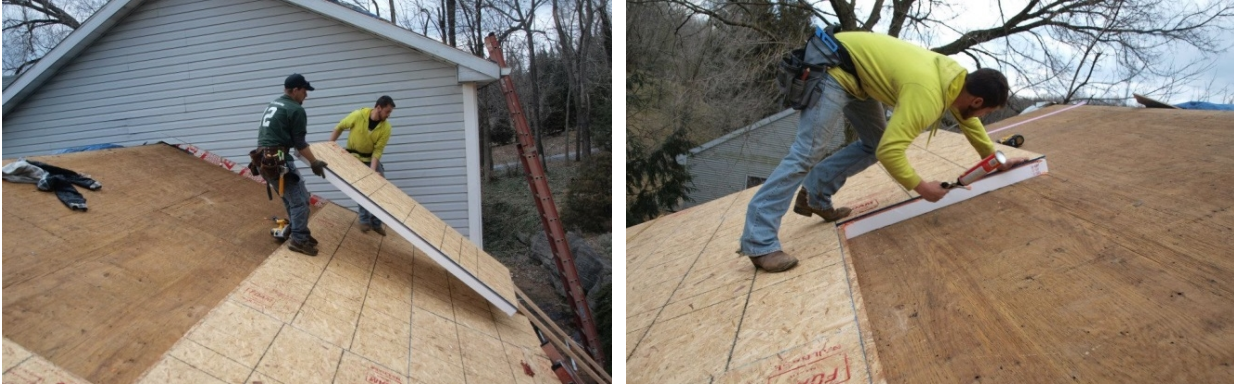
Figure 2. Example installation of retrofit panels during a reroofing effort

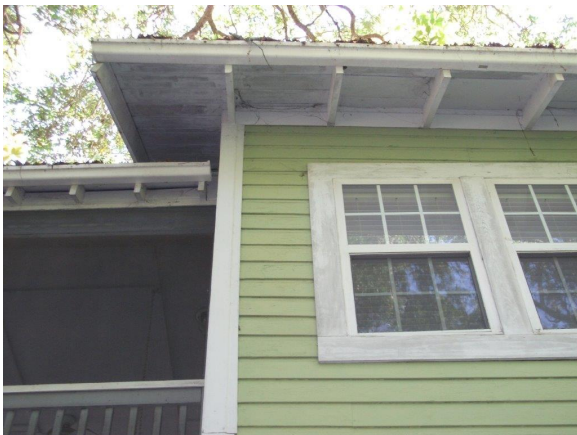
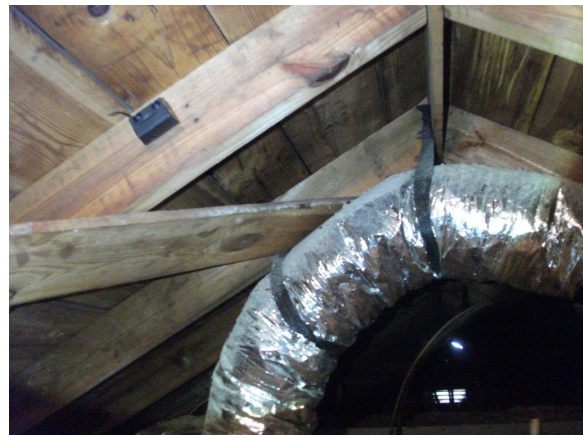
Figure 5. Georgia house eaves and roof framing with rafter sensor

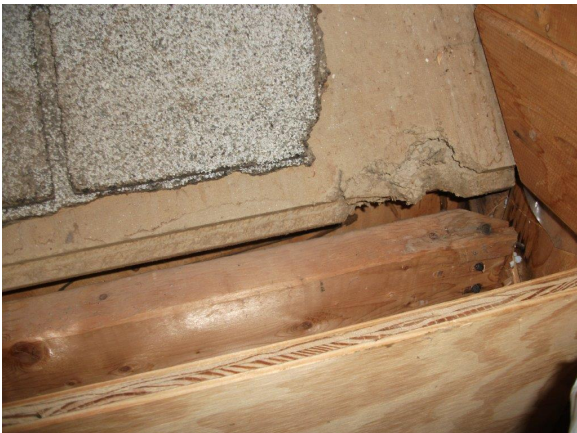
Figure 8. Michigan main house existing fiberboard roof deck/ceiling

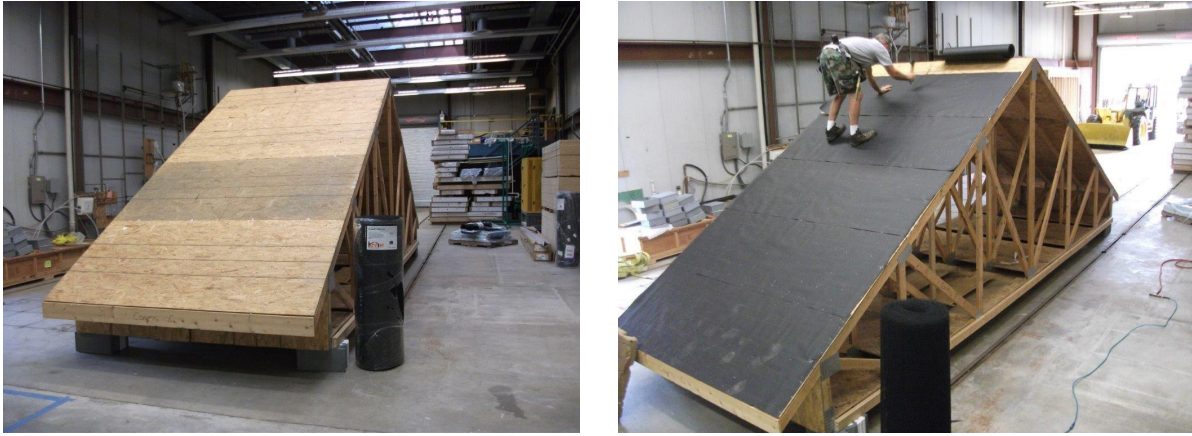
Figure 9. Mock-up roof deck assembly and installation of underlayment

before (underneath) the vent mat on the 3-tab shingle side and after (over) the vent mat on the architectural shingle side to cover the edge of the vent mat. Drip edge at the eave was installed underneath the vent mat on both sides. A rigid-type ridge vent was installed over the vent mat. Some shingles were left off to allow for inspection of the roofing layers. The roofing installation sequence is shown in Figure 9 through Figure 13.

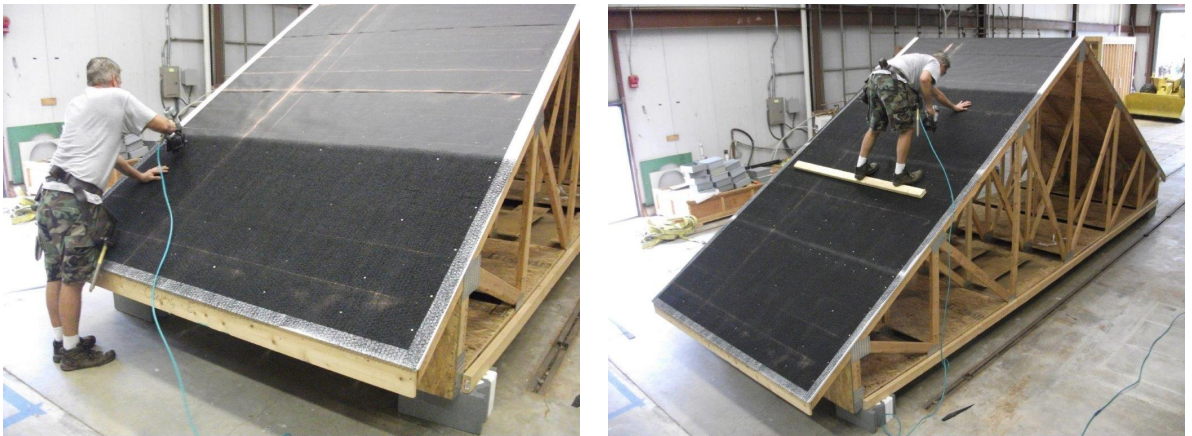
Figure 10. Installation of ventilation mat

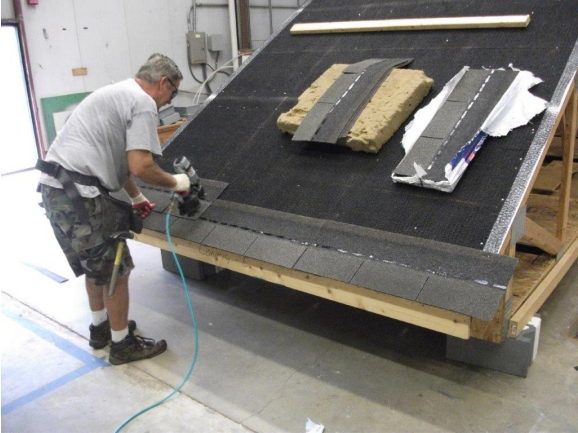
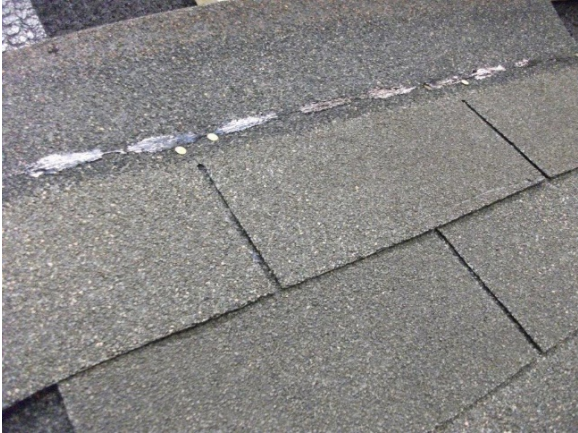
Figure 11. Installation of shingles

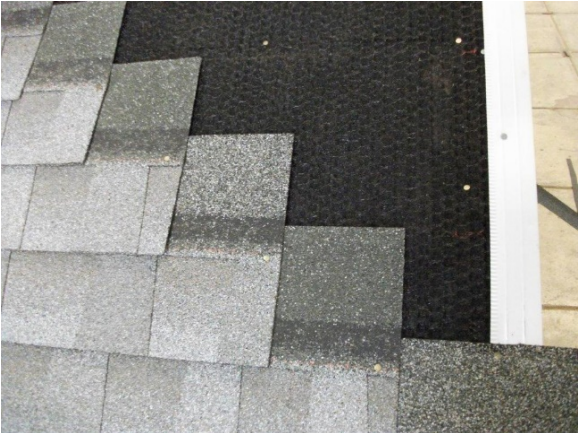
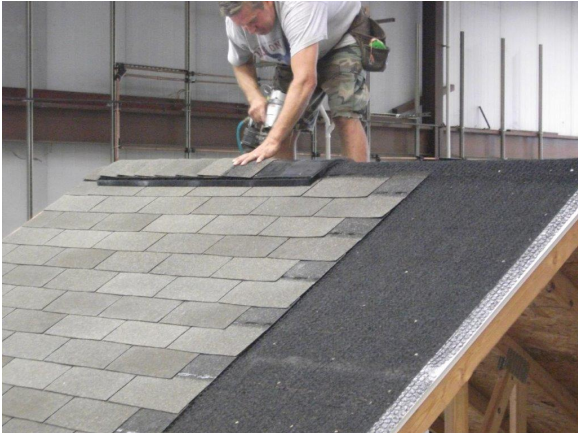
Figure 12. Installation of shingles and ridge vent

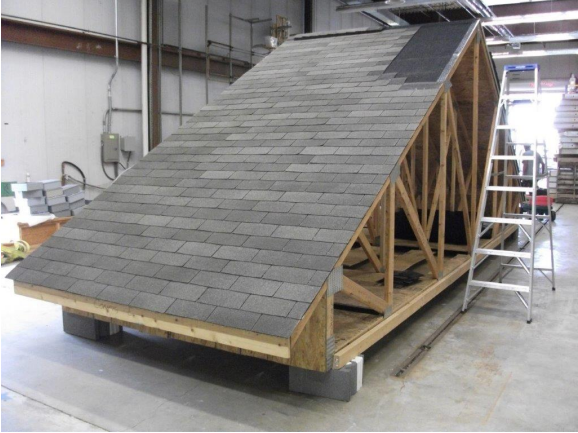
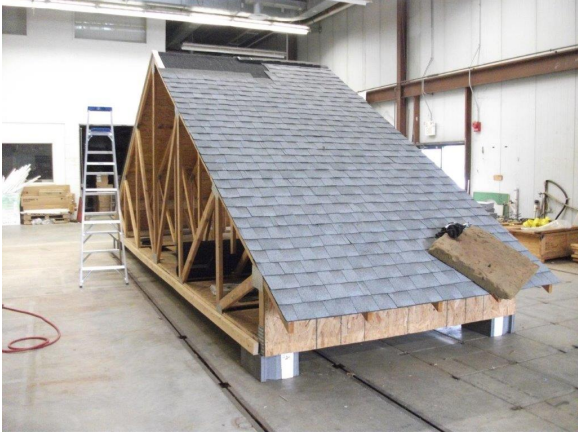
Figure 13. Roofing complete showing standard shingles and architectural shingles

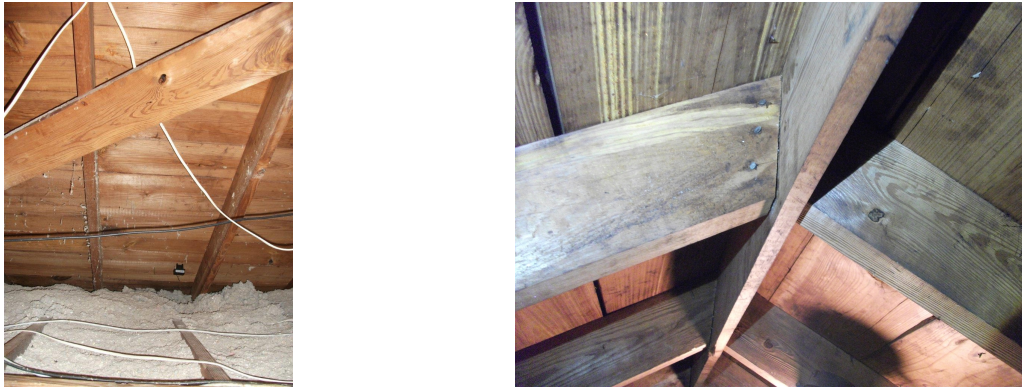
For Georgia, Home Innovation recommended reinforcement of the existing roof framing. The 2x6 roof rafters 24-in. on-center did not consistently align with, and therefore typically were not connected to, the 2x6 ceiling joists. The rafters were connected (toe-nailed) to top plates at eave walls in some places using only one nail. The rafter/ridgeboard connection was a more robust 3–5 nail toe-nail connection (Figure 17). Home Innovation recommended collar ties at every other roof rafter and hurricane clips at the rafter/top plate connections.

Figure 17. Georgia roof framing

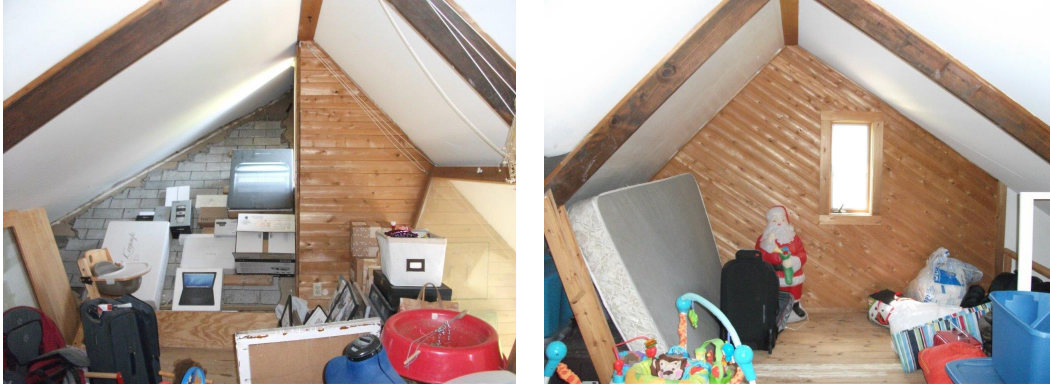
**Figure 19. Michigan addition roof
(Rafters shown are decorative.)**

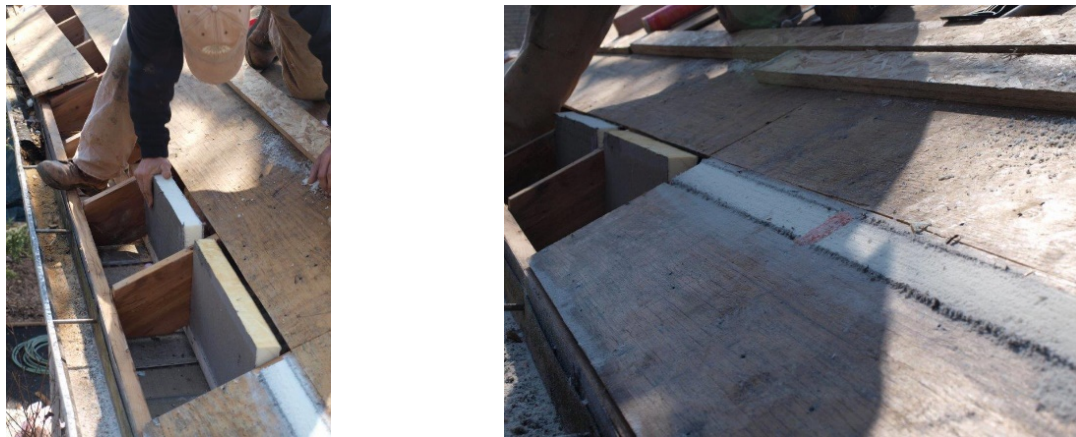
The eave area is a critical area to insulate and air seal but can be difficult to reach during a retrofit. Figure 23 shows an example method to insulate and seal this area to maintain continuity of insulation between the existing wall and the new roof retrofit panel. The sequence: cut and remove the lower portion of the roof deck sheathing for access (retain this section of sheathing—it will be trimmed by the width of the foam board and reinstalled); install foam board vertically between roof rafters, above the eave wall top plates, projecting just above sheathing; seal foam board at rafters and top plates; trim the sheathing that was removed to accommodate the foam and reinstall; trim foam board slightly proud of sheathing; seal top edge of foam board at sheathing; install sealant or gasket above foam board just before installing the retrofit panel.

Figure 23. Example eave insulation method

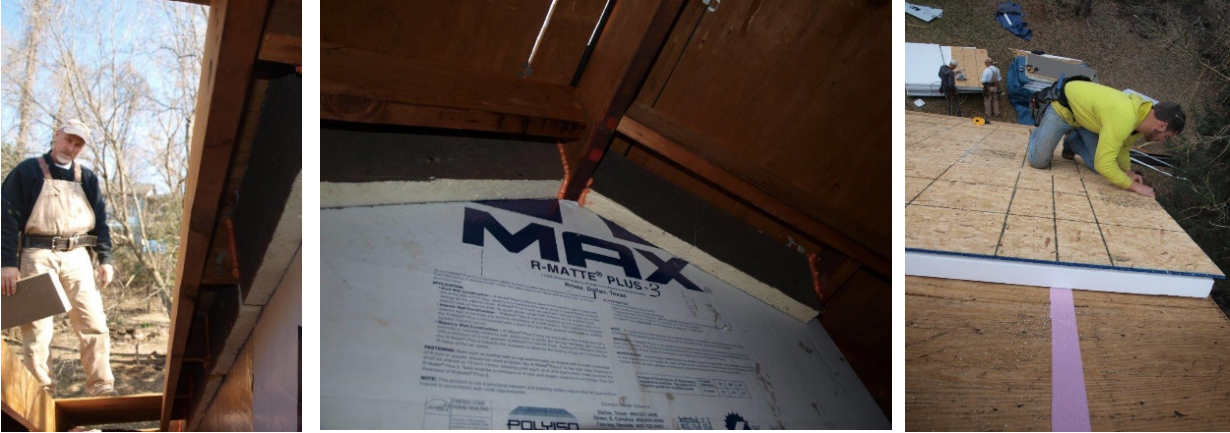
The gable walls of an unvented attic are also important to insulate and seal. Figure 24 shows an example method to insulate and seal this area. The sequence: remove a section of roof deck sheathing for access (easier than crawling through the attic and cleaner than walking materials through the house); seal the rake from inside the attic; install and seal rigid foam insulation at gable walls (same insulation value as panels); from the roof, install gasket or sealant on the roof deck sheathing above the gable wall just before installing retrofit panels.

Figure 24. Example gable wall insulation method

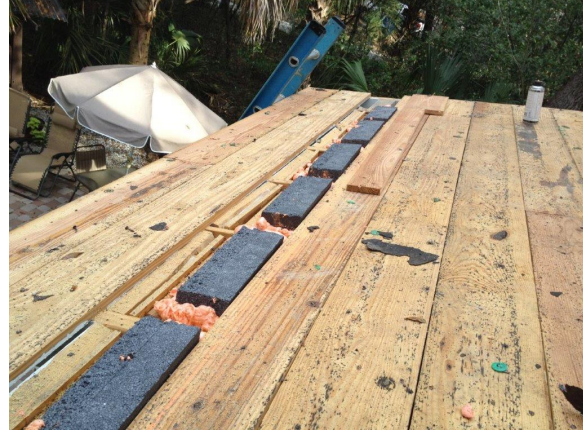
Figure 28. Rigid foam insulation at eaves

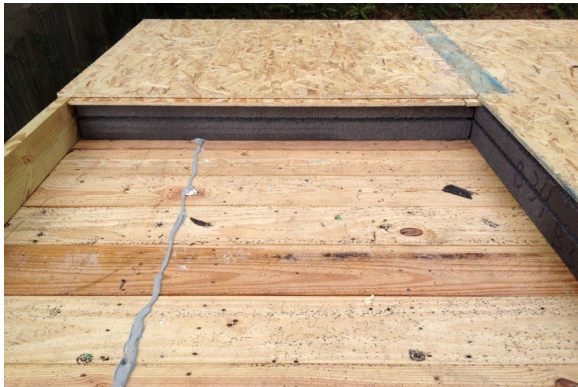
Figure 31. Oriented strand board surface spline and sealant at deck above rake wall

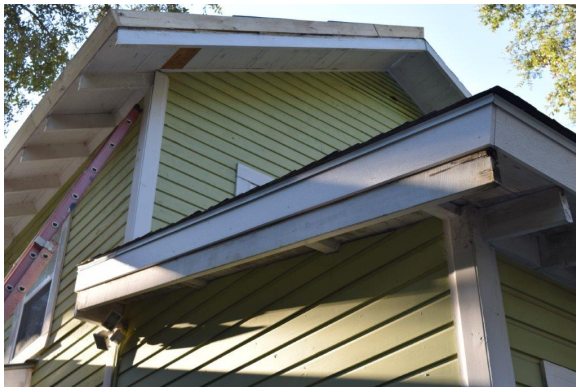
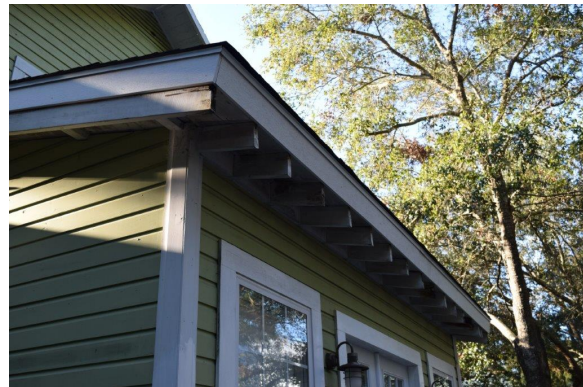
Figure 36. First-story roof complete

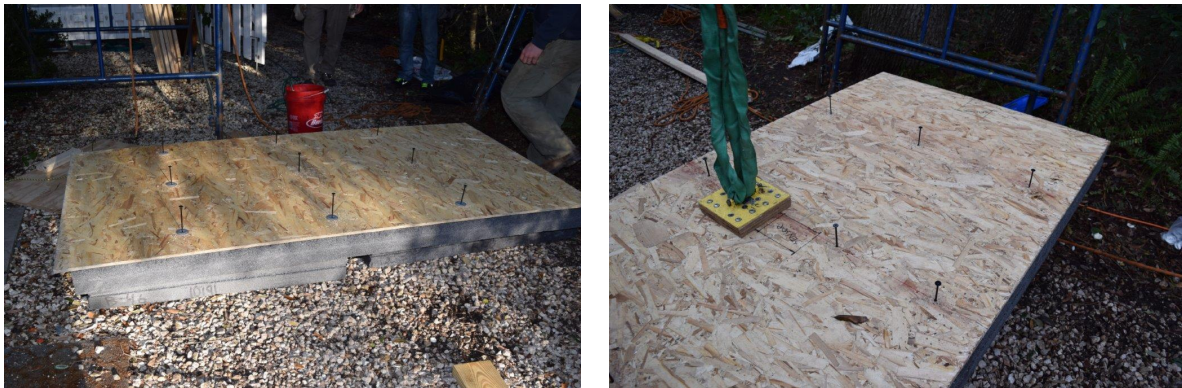
The retrofit panels for the second-story roof were installed in the same way. Most screws were installed while the panels were still on the ground to speed the process along for the workers on the roof (Figure 38). The workers on the roof provided rafter measurements so the workers below could locate the screw accurately. The panels at the top row on each side were cut at an angle so the vertical surfaces met at the ridge; gaps were filled and sealed at the ridge using spray foam. Figure 39 through Figure 43 show the installation for the second-story roof.

Figure 38. Pre-installed screws
(Note the sensor location marked on the OSB next to the cleat.)

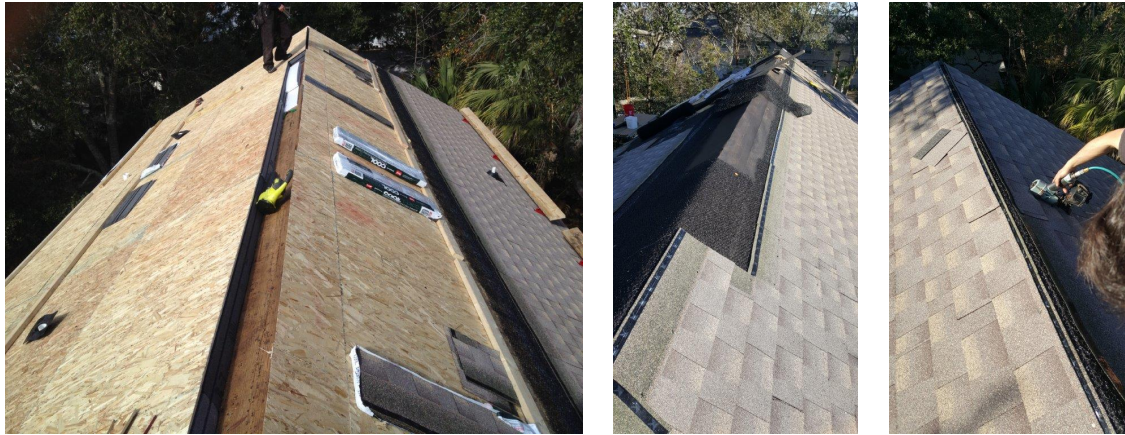
Figure 42. Panel and roofing during installation

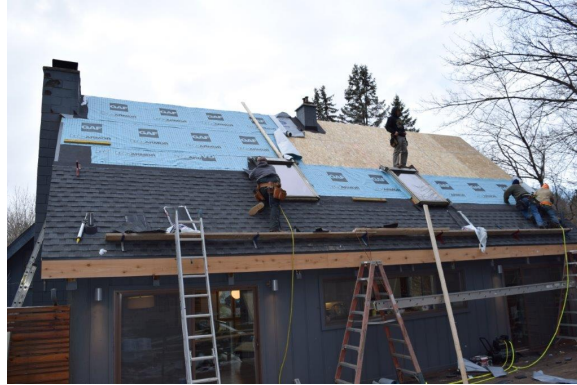
Ice and water shield membrane was installed as required at eaves and valleys, and vapor permeable synthetic underlayment was installed above the retrofit panels (Figure 47).

Figure 47. Roofing the back of the main roof

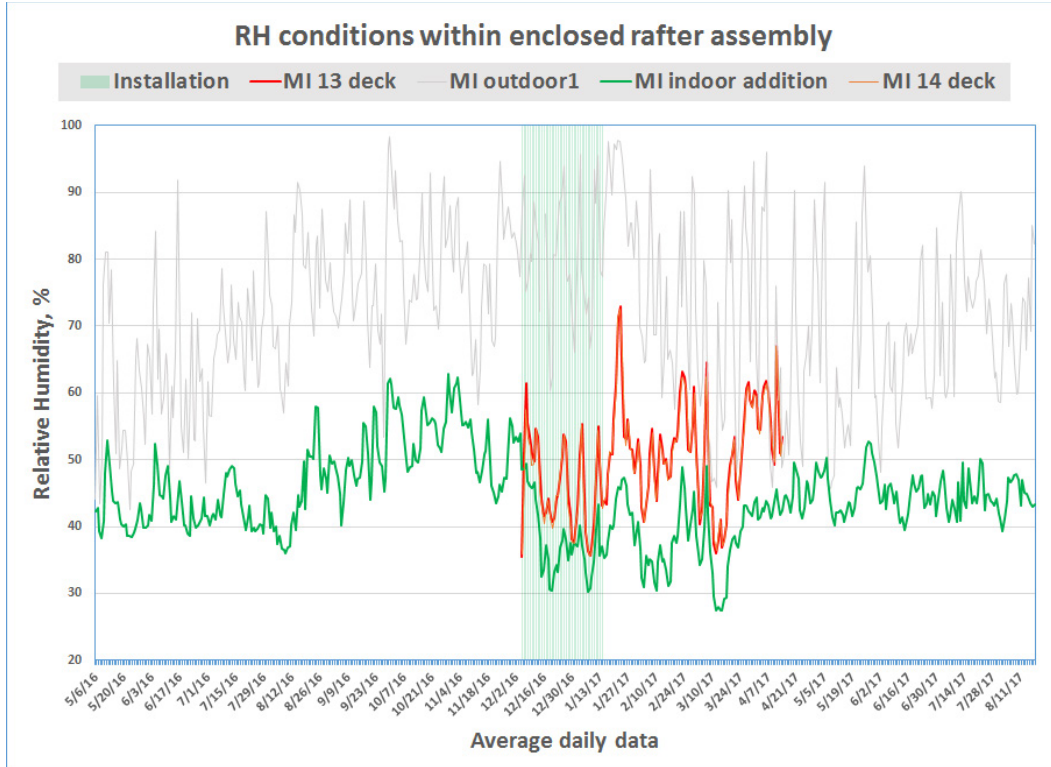
Figure 60. Michigan relative humidity conditions: addition roof assembly

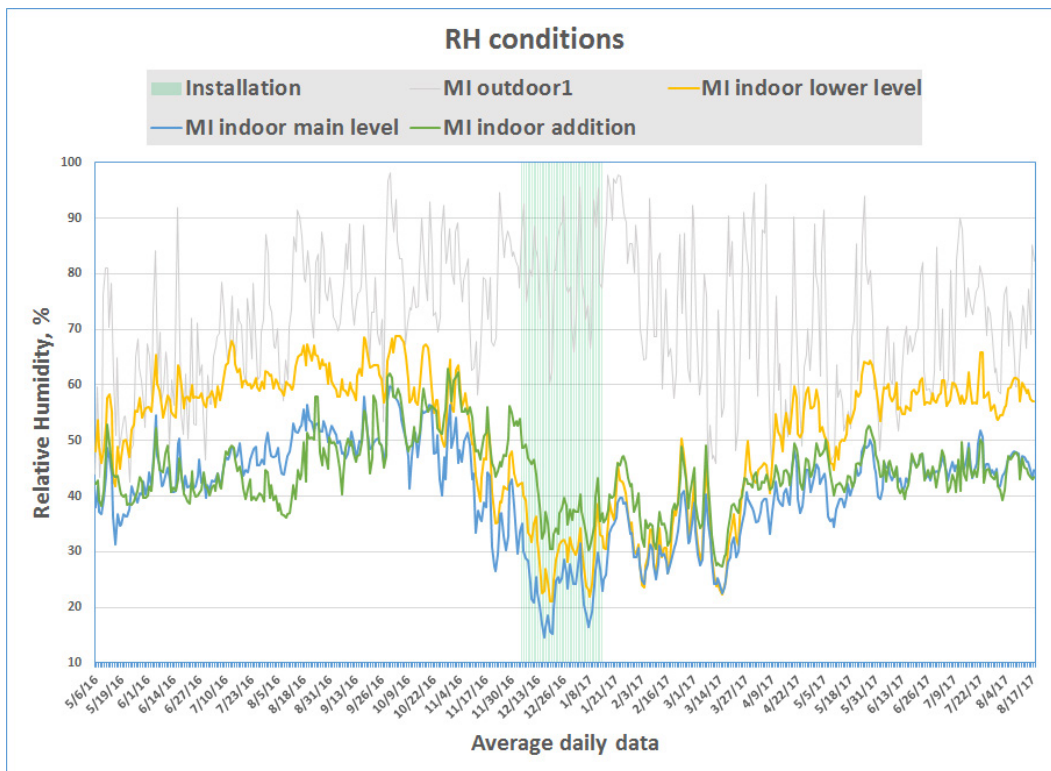
The RH conditions indicate that the house might be somewhat less humid during the summer after the retrofit panel installation (Figure 61), during a period when the temperature conditions appear to be about the same (Figure 62).

Figure 61. Michigan relative humidity conditions
