Extended Plate and Beam Wall System

May 2018

Patti Gunderson
Home Innovation Research Labs
EP&B Wall System Project Team
400 Prince George's Blvd.
Upper Marlboro, MD 20774

This report, "Extended Plate and Beam Wall System," explores the extended plate and beam wall system to determine its structural performance, moisture durability, constructability, and cost-effectiveness for use as a high-R enclosure system for energy code minimum and above-code performance in climate zones 4–8.

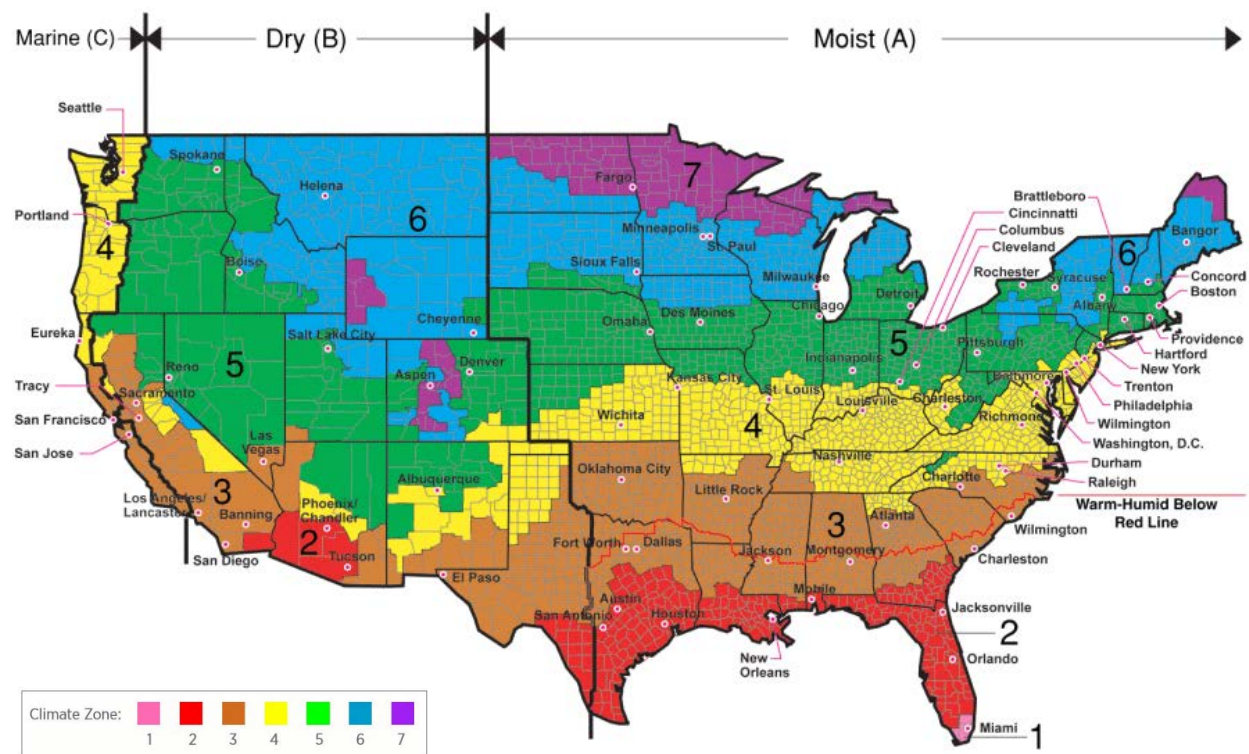
The International Energy Conservation Code (IECC) Table R402.1.1 lists prescriptive thermal performance values for envelope components based on local climate conditions. Figure 1 illustrates the range of each climate zone.

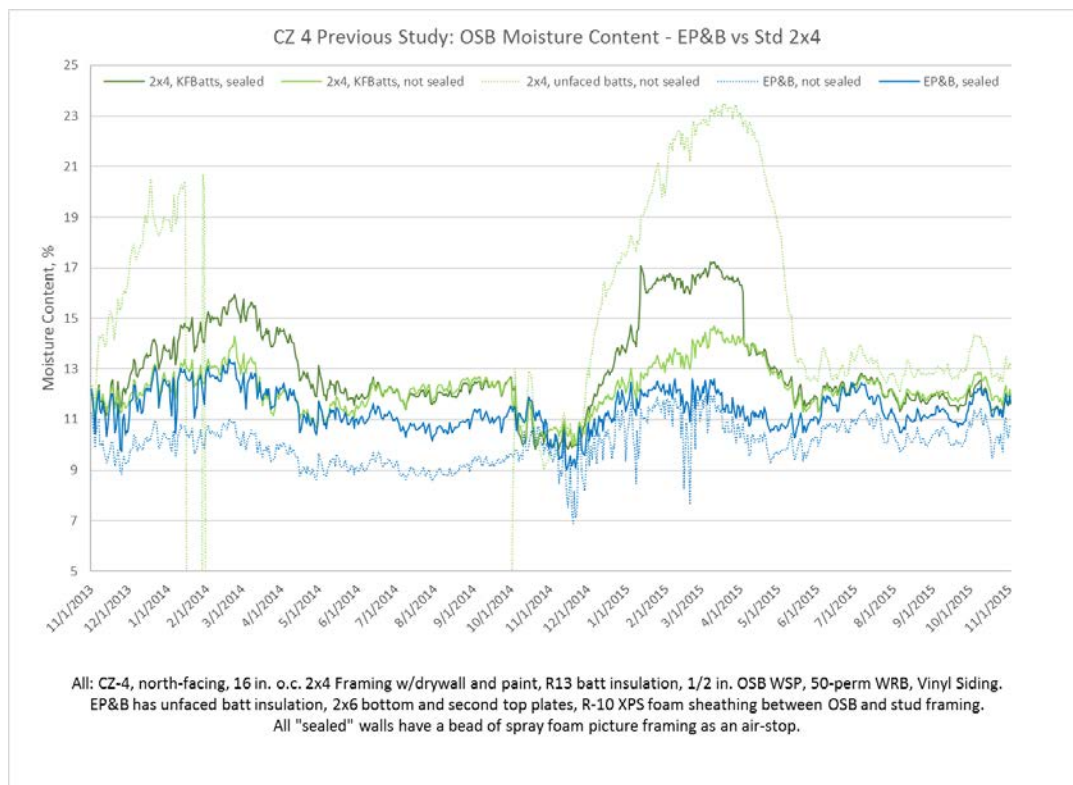
Figure 3. Proof-of-concept EP&B walls in Climate Zone 4 maintained moisture levels below ~13% (blue)

Increased air sealing improves thermal performance but potentially reduces drying capability. The Climate Zone 4 data indicate that the EP&B wall with air sealing in Figure 3 was more resilient to this effect than the Kraft-faced batt wall with air sealing. This is likely due to the location of the rigid foam layer which provides a centrally located vapor plane, allowing the OSB to dry directly to the outside and protecting it from interior vapor drive.

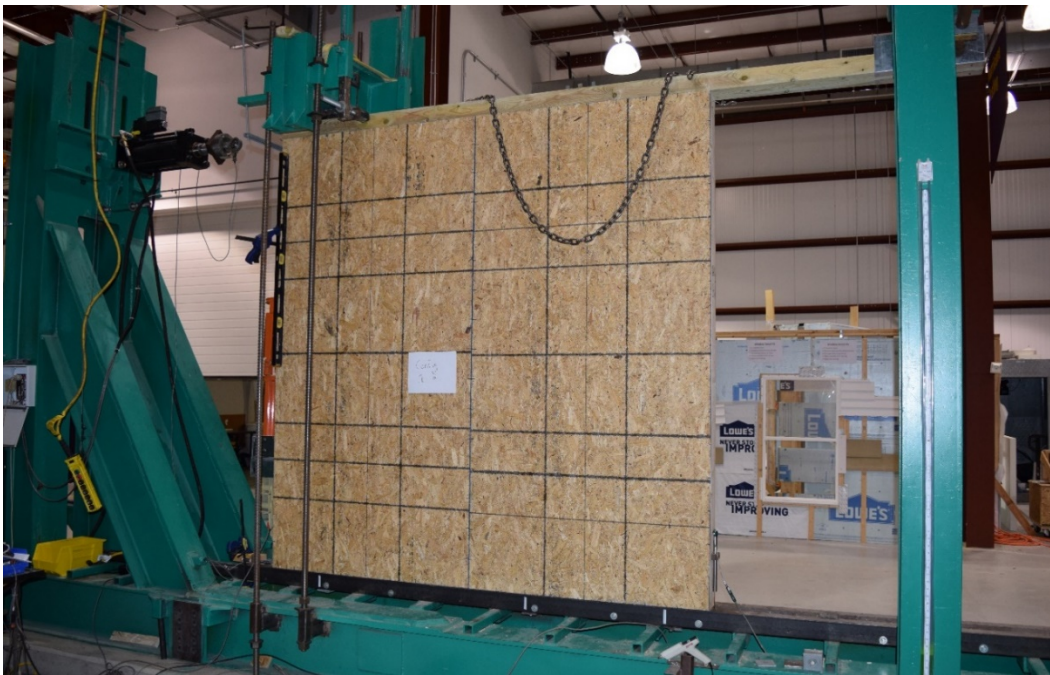
Figure 4. A 2x6 standard reference wall in testing apparatus prepared for an ASTM 72 test

Racking shear performance testing of the EP&B wall system was conducted in two phases. Phase I of the test plan applies American Society for Testing and Materials (ASTM) E72 Section 14 procedures per AC269.1 Section 4.1 to qualify the wall system for intermittent bracing. Phase II of the test plan applies ASTM E564 procedures per AC269.1 Section 4.2 to qualify the wall system for continuous bracing. See Figure 4 for an example of a wall specimen installed in the testing apparatus.

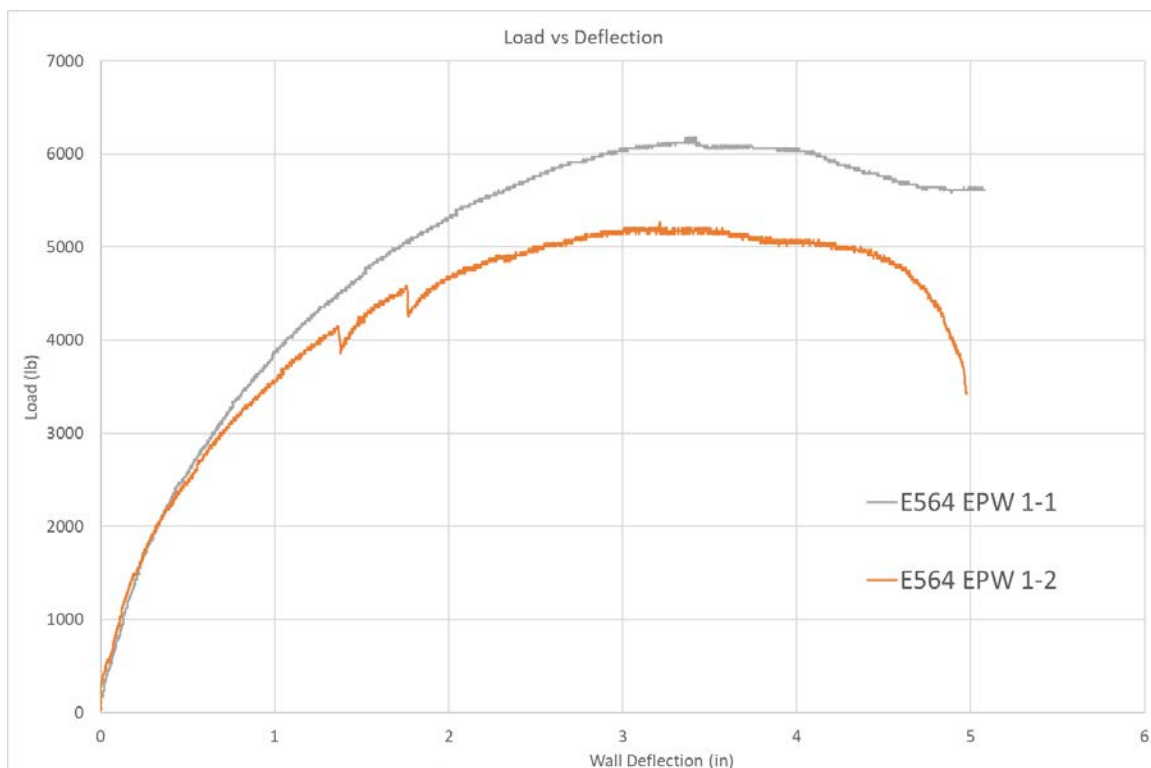
Figure 6. Shear load deflection curves: E564 test—baseline EP&B walls (spruce-pine-fir)

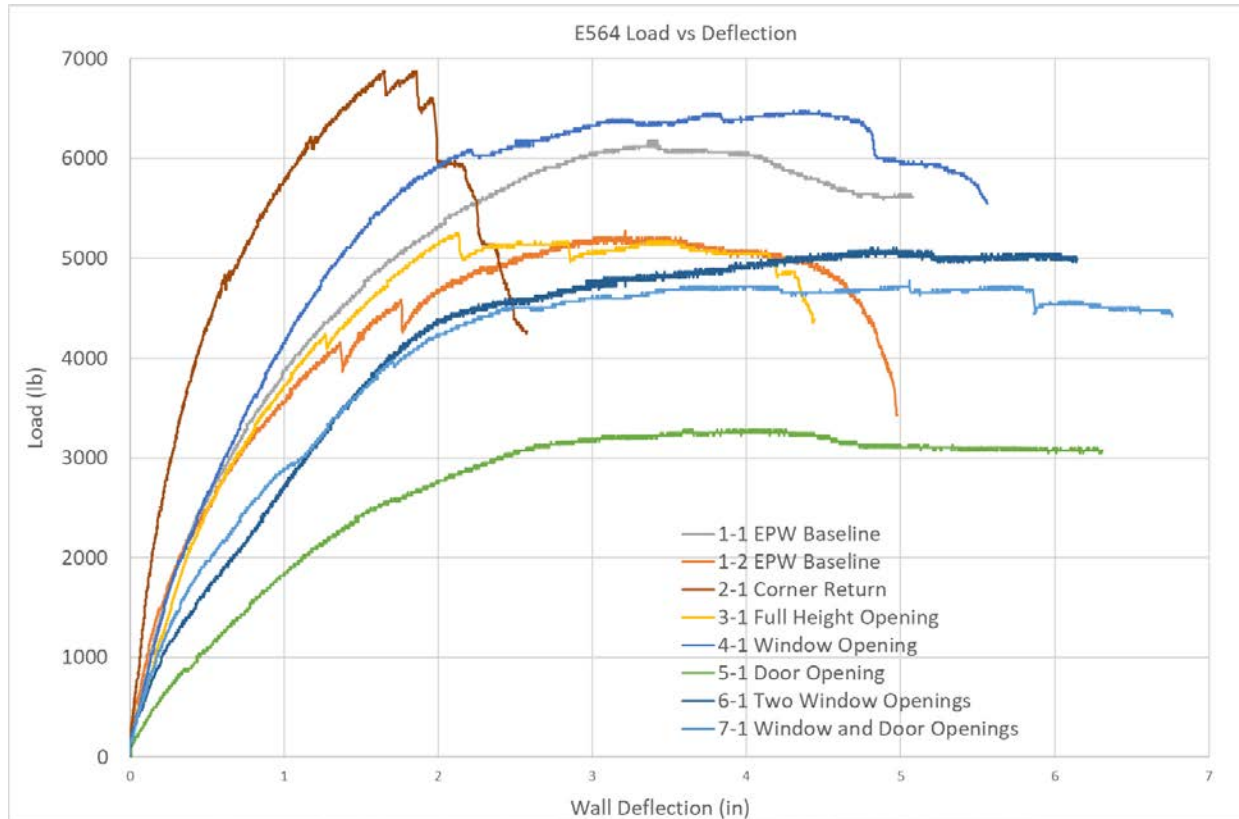
Figure 7. Load deflection curves: E564 test—EP&B walls (spruce-pine-fir)

Figure 7 graphs the load deflection curves for the EP&B wall specimens of the ASTM E564 tests for IRC continuous braced wall equivalency. Tested values for wall types 2–7 meet all target performance values for both strength and stiffness (drift at reference shear load) per AC269.1. See Table 8.

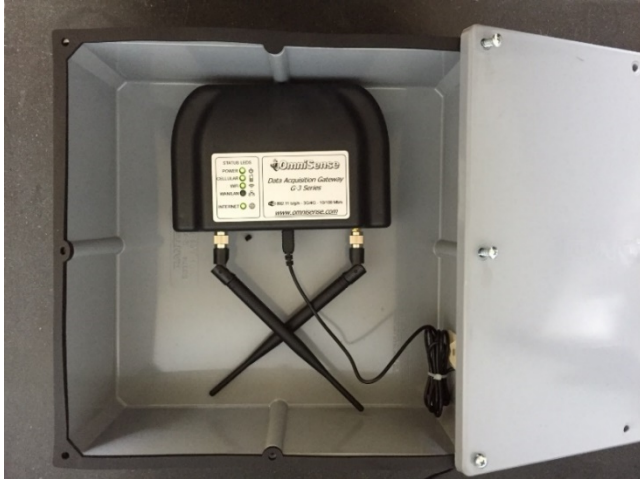
Figure 10. Omnisense Gateway data acquisition unit

Figure 10 and Figure 11 itemize the equipment used in both Grand Rapids demonstration house to monitor wood moisture, temperature, and RH.

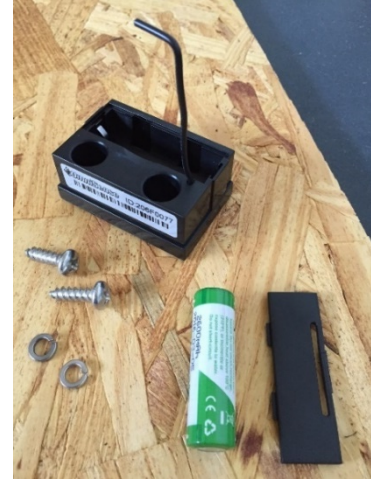
Figure 11. Omnisense T/RH%/MC% sensor

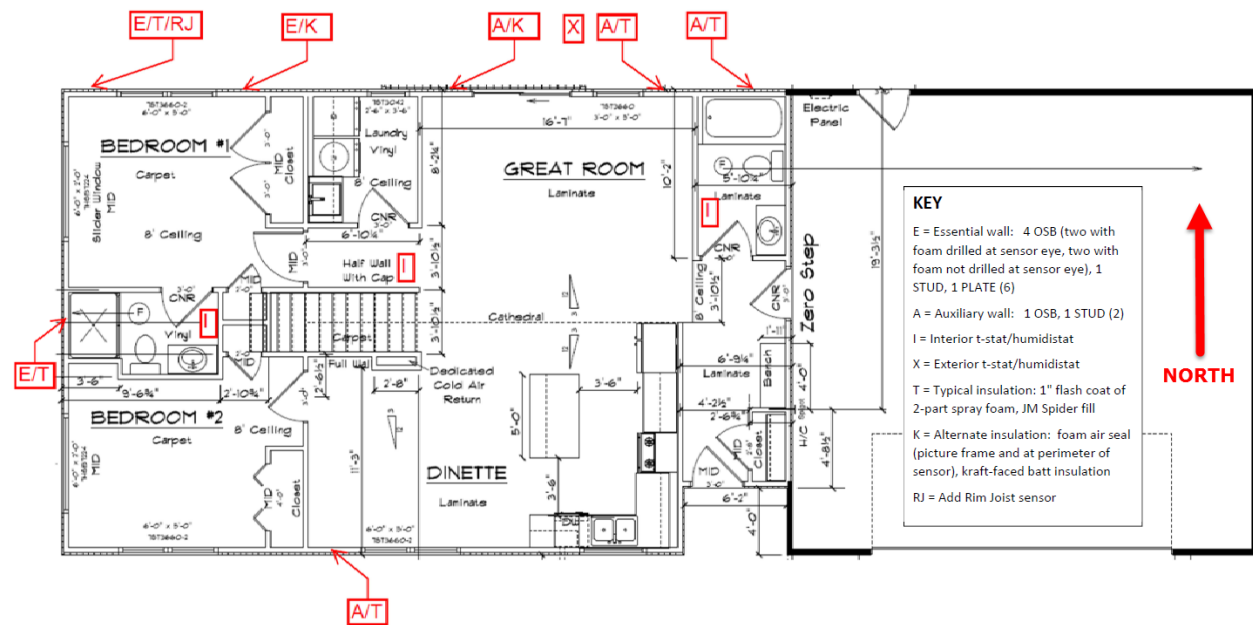
Figure 12. Sensor layout, House 1

House 1 had 36 total sensors, and House 2 had 33. See Figure 12 and Figure 13 for the sensor layouts of the two houses. See Table 19 and Table 20 in Appendix D for a summary of the purpose and coverage of each sensor.

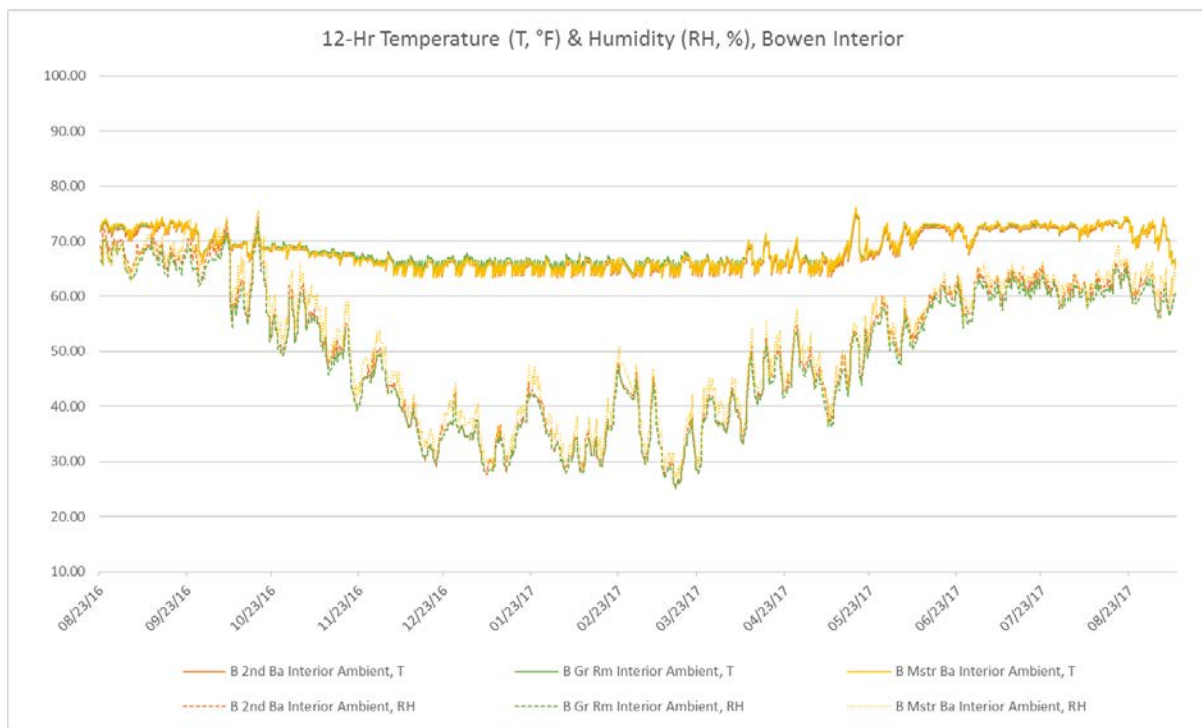
Figure 14. Interior ambient temperature and RH, House 1

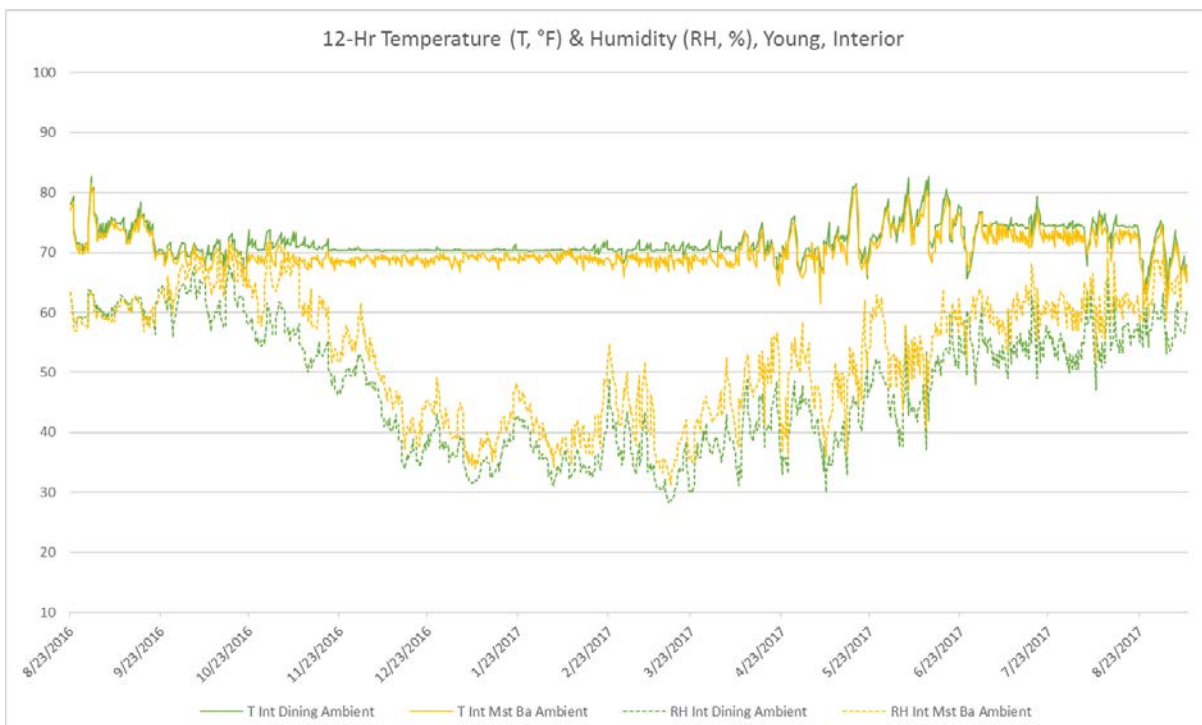
Figure 15. Interior ambient temperature and RH, House 2

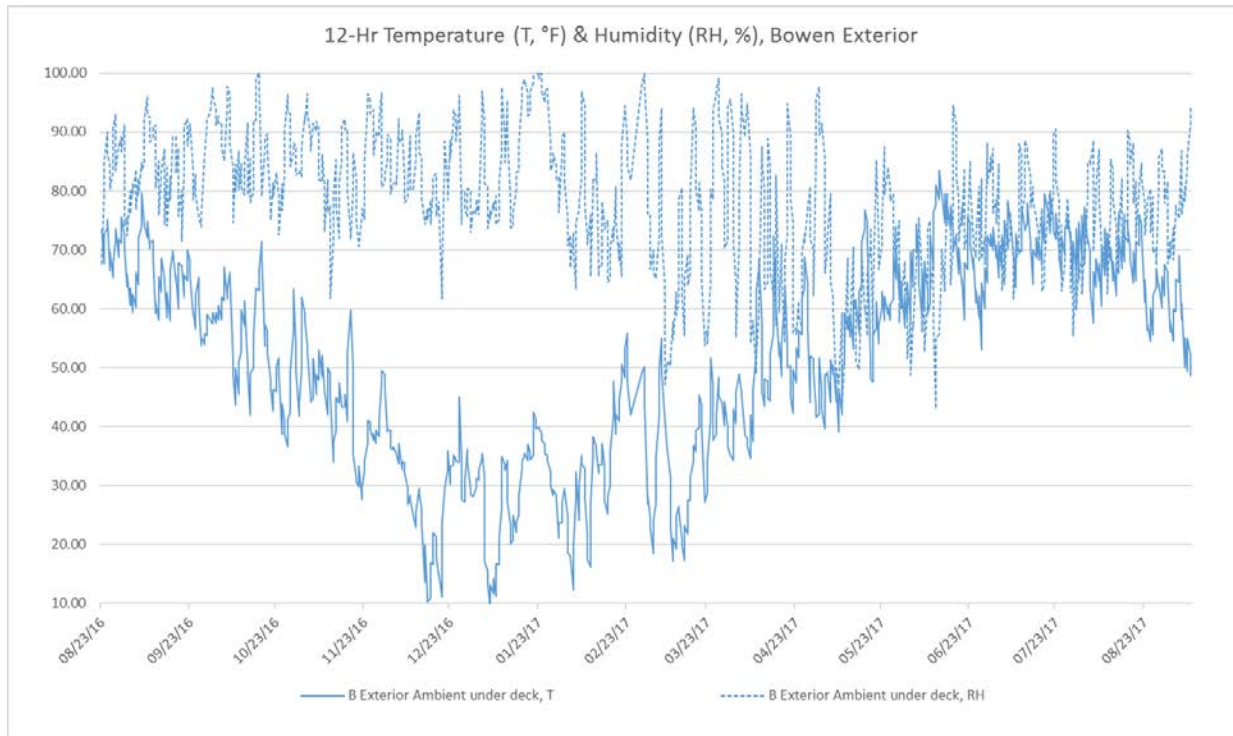
Figure 16. Exterior ambient temperatures, House 1

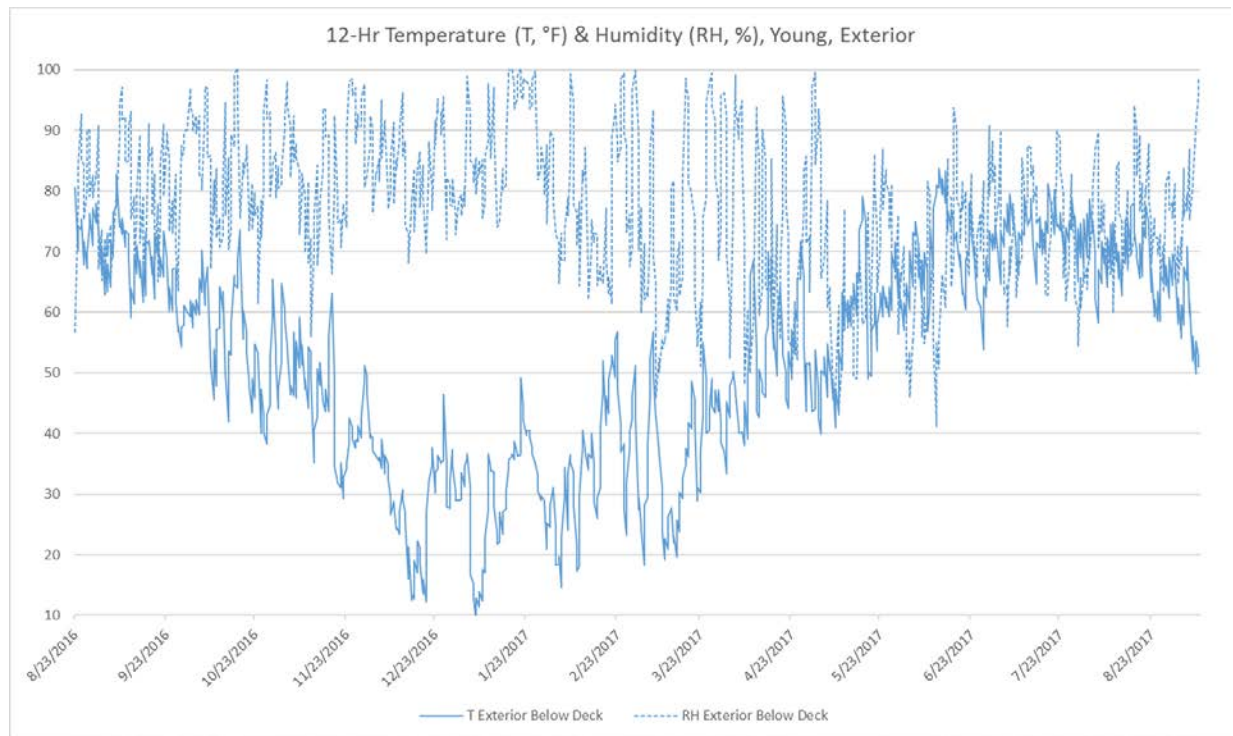
Figure 17. Exterior ambient temperatures, House 2

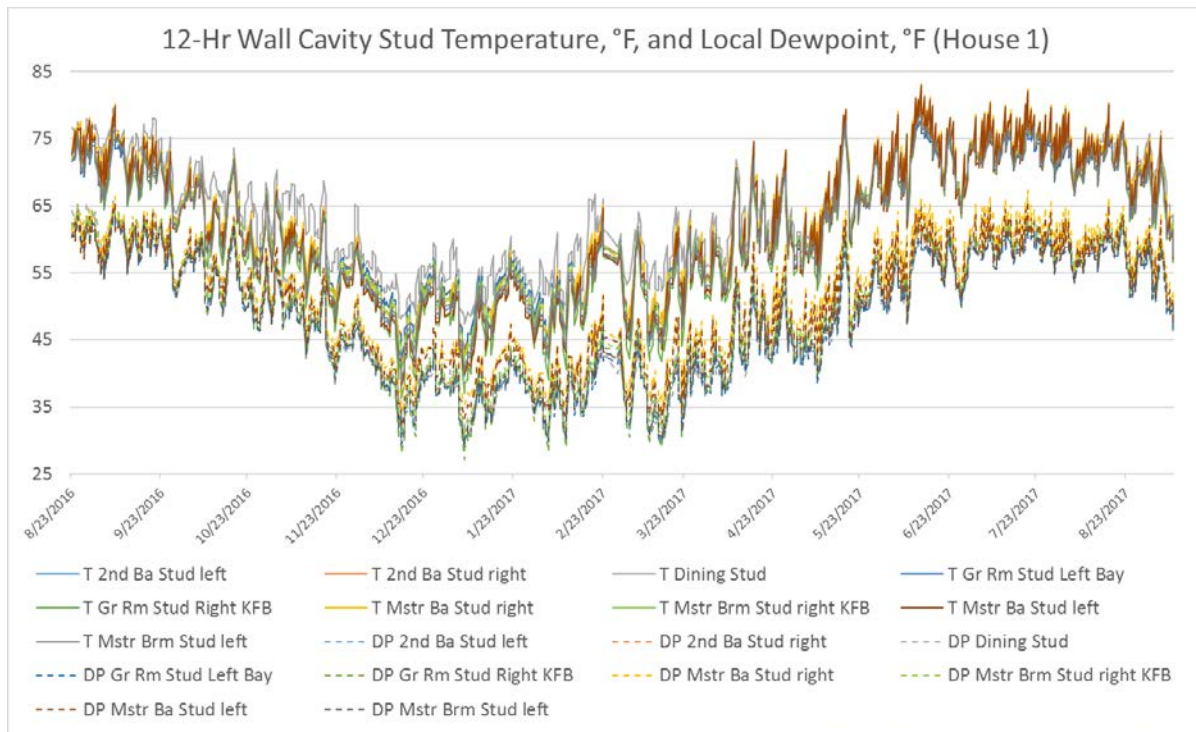
Figure 18. Wall cavity temperatures and dew points, House 1

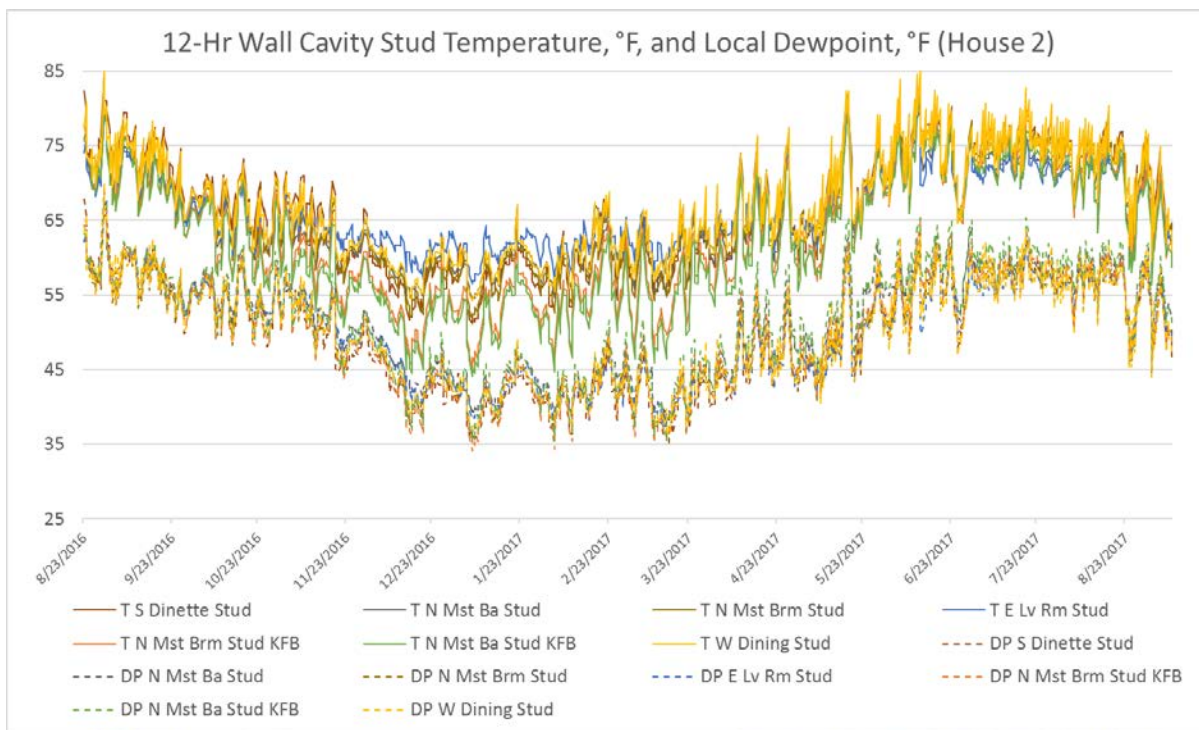
Figure 19. Wall cavity temperatures and dew points, House 2

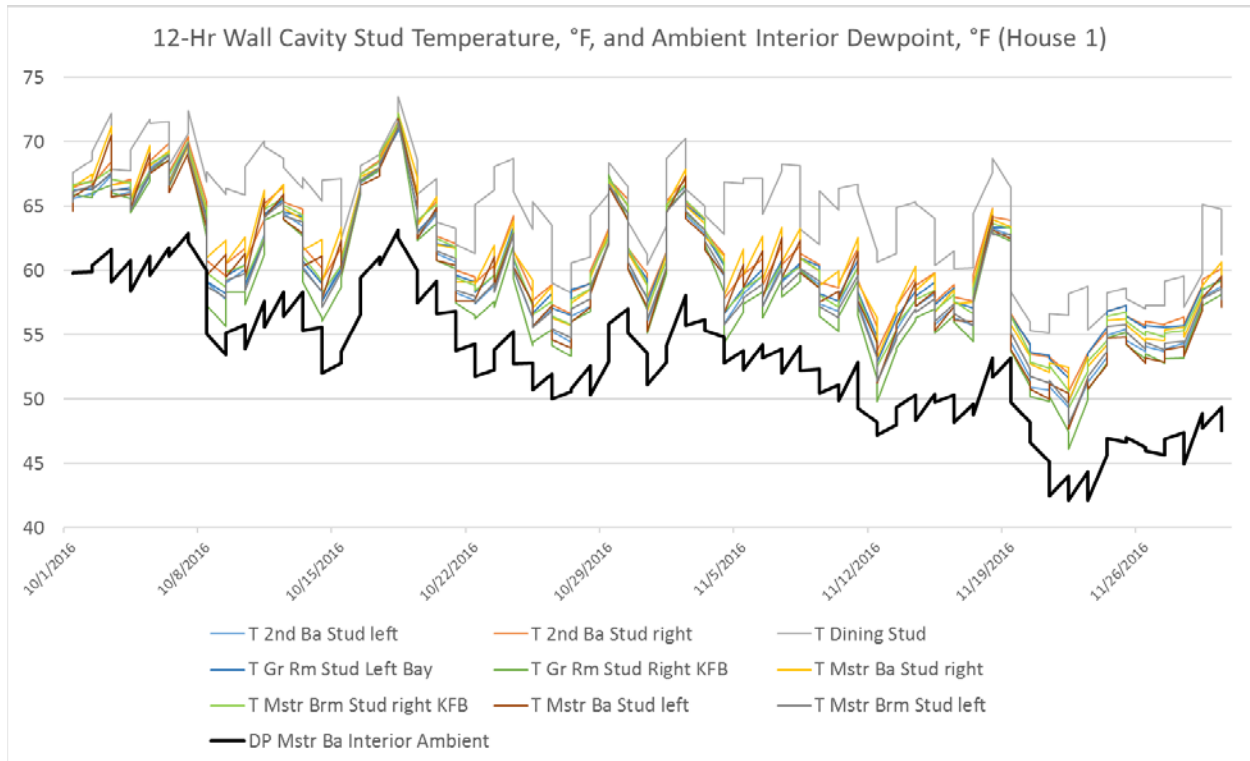
Figure 20. Wall cavity temperatures and house interior ambient dew point, House 1

Theoretically, if the interior vapor retarder were to be breached, moisture-laden air from the interior might enter the wall cavity. The following pair of graphs (Figure 20 and Figure 21) shows that even intrusion by the worst-case interior air (bathroom areas—solid black line) is not likely to produce condensation. Again, except for very brief periods, the local temperature for all wall cavities in both houses remained safely above the coincident interior ambient dew point of air from within the house, indicating that the EP&B provides good moisture protection. The solid lines in Figure 20 and Figure 21 show the wall cavity dry bulb temperatures for each house; the solid black line shows the dew point temperature of the air inside the building for the two most challenging months: October and November.

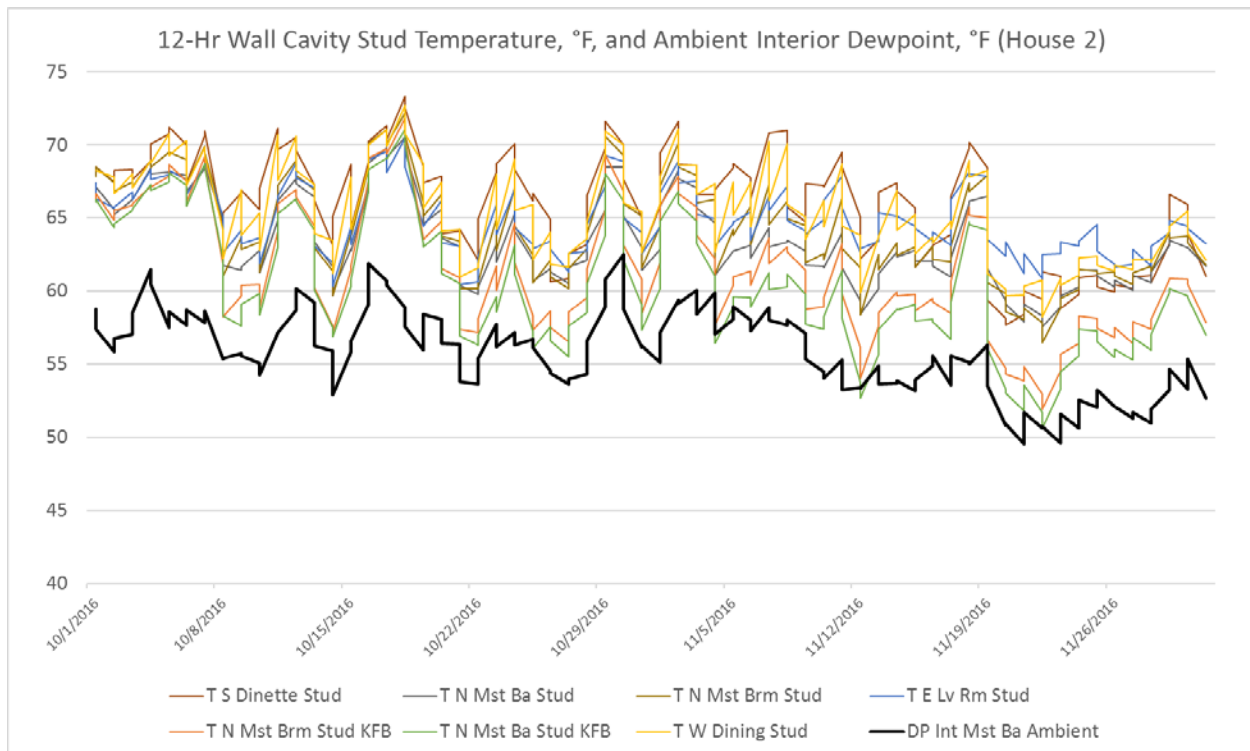
Figure 21. Wall cavity temperatures and house interior ambient dew point, House 2

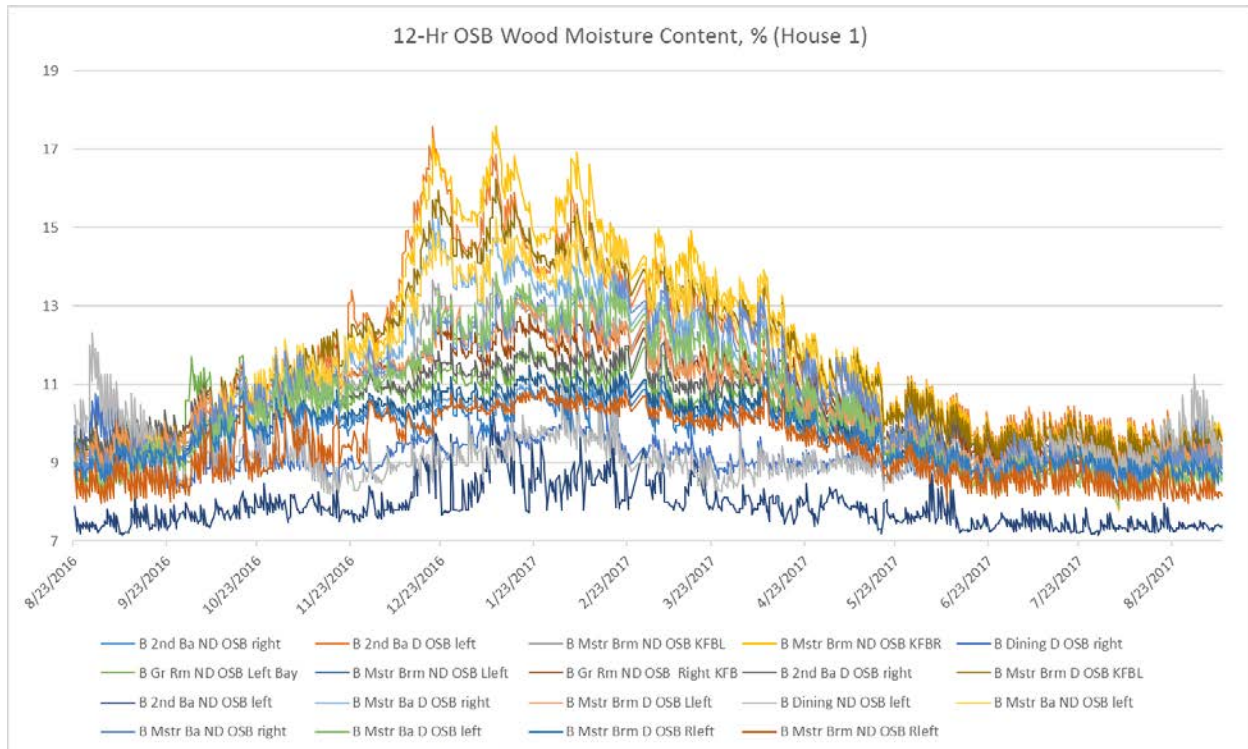
Figure 22. Moisture content for OSB in all EP&B walls, House 1

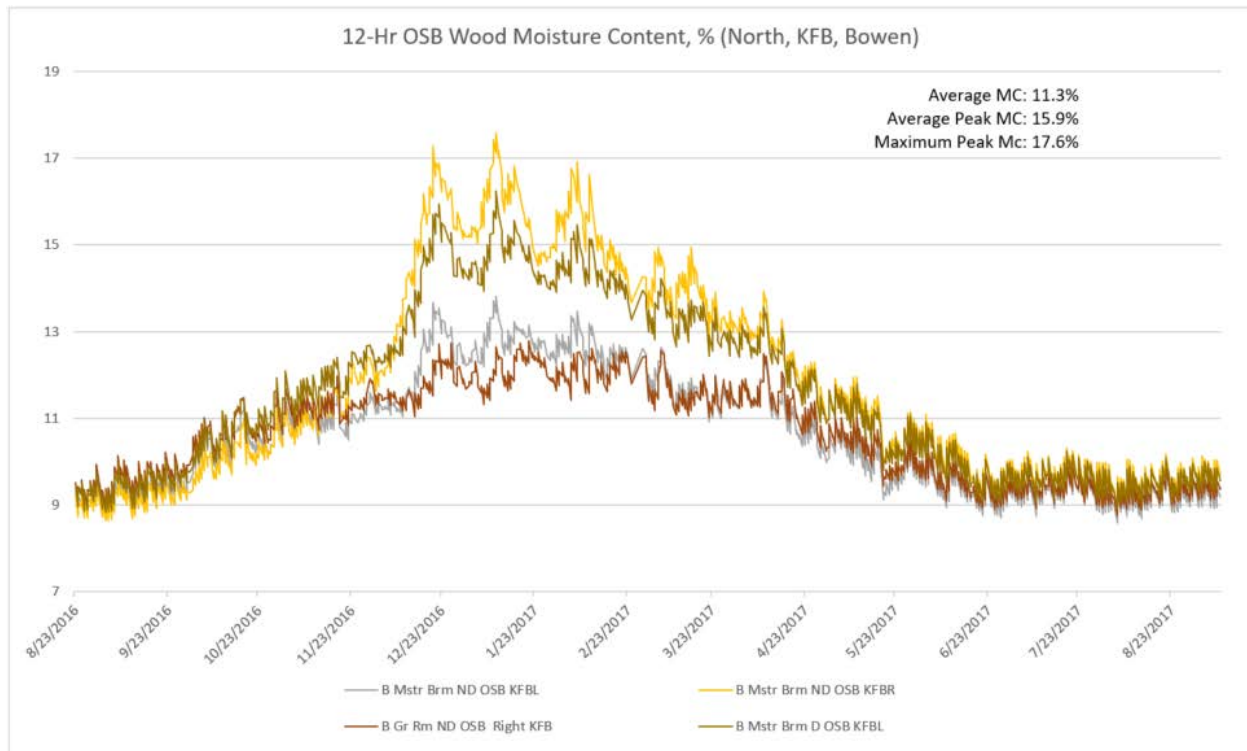
Figure 23. Moisture content for OSB in EP&B walls with acrylic caulk air sealing and Kraft-faced batt insulation, House 1

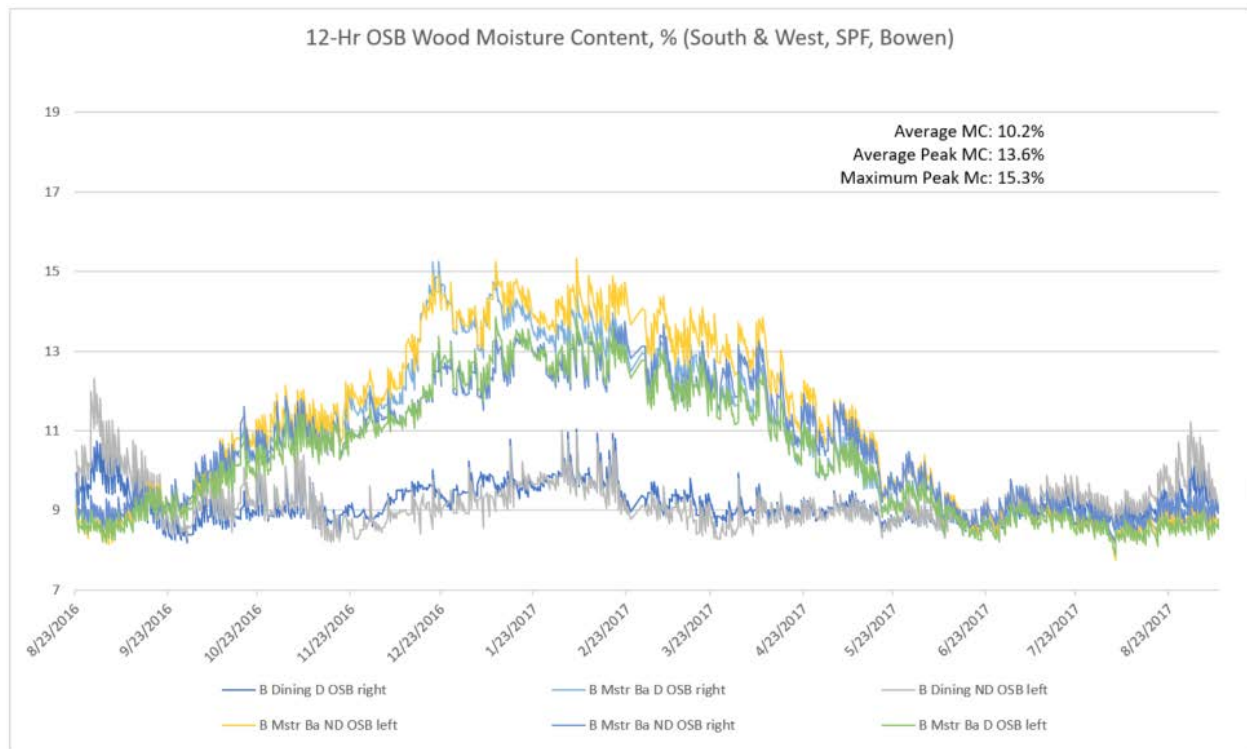
Figure 26. Moisture content for OSB in EP&B walls with ccSPF, non-north orientations, House 1

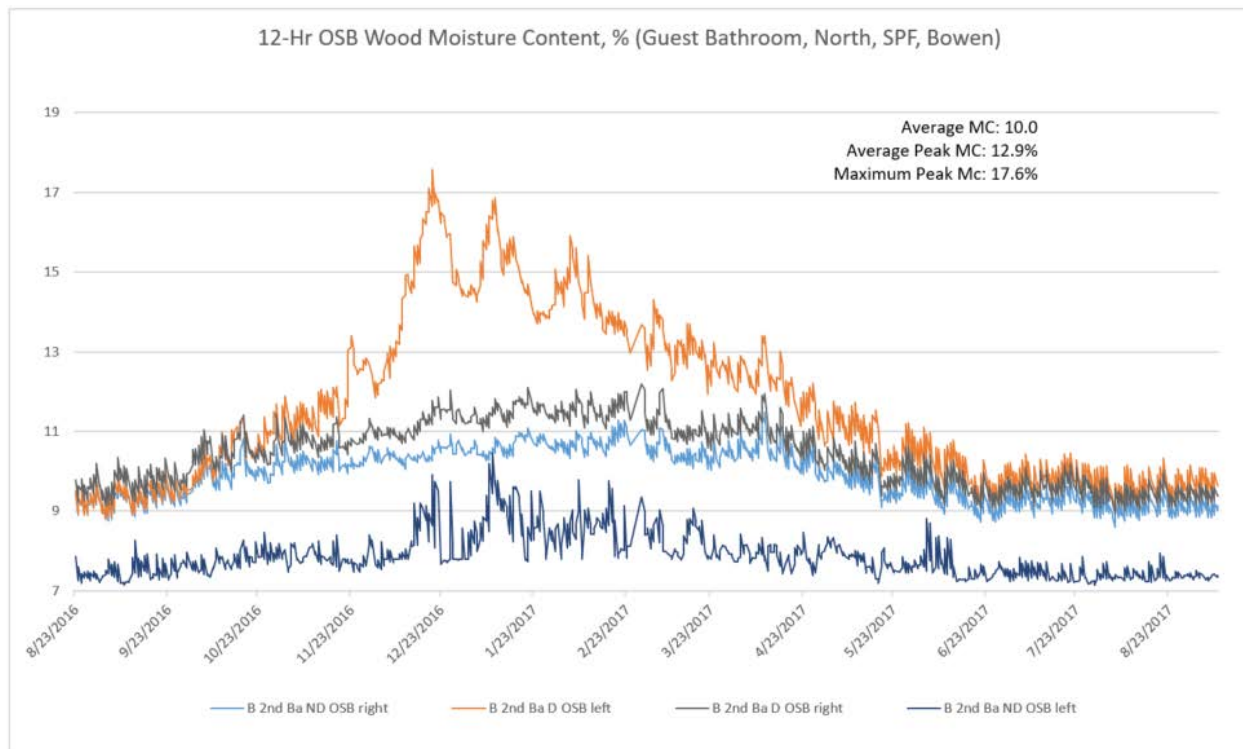
Figure 27. Moisture content for OSB in north-facing guest bathroom, ccSPF, House 1

Figure 27 and Figure 28 Bathroom Wall Moisture Content. House 1 has two bathrooms: a master bath with a west orientation and a guest bath with a north orientation. The owner of House 1 is a single adult male; the guest bathroom is very seldom used for bathing. The moisture performance of the four OSB sensors in the guest bathroom appears to vary gradually with seasonal changes. The master bathroom appears to be more varied and responsive to daily and weekly changes, presumably because of more frequent bathing activities.

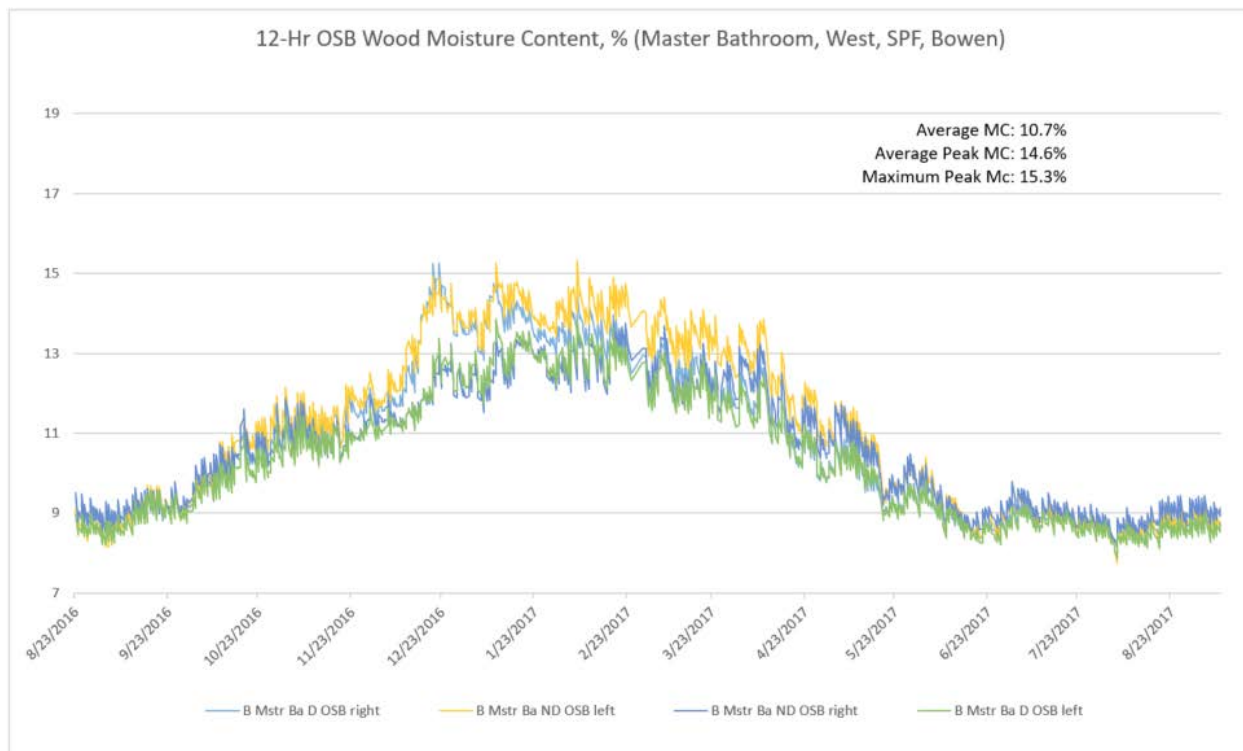
Figure 28. Moisture content for OSB in west-facing master bathroom, ccSPF, House 1

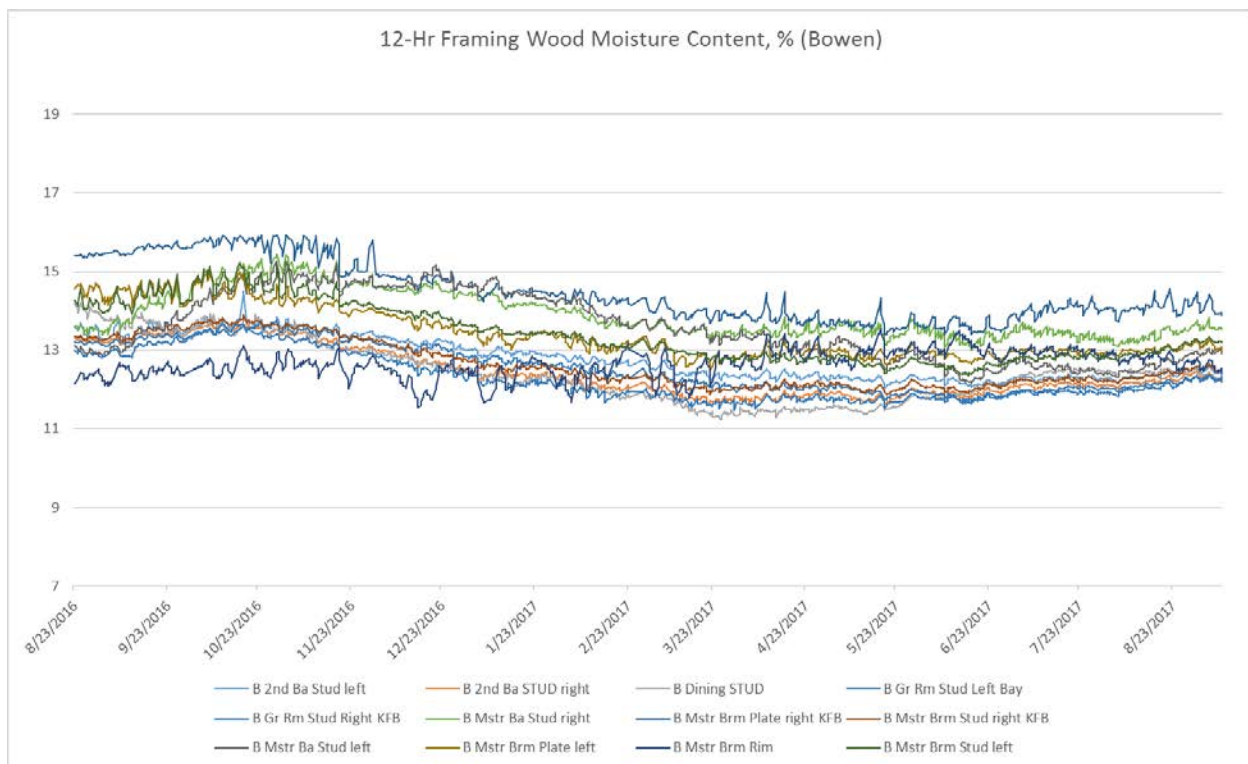
Figure 29. Stable moisture content for framing lumber in all EP&B walls, House 1

All sensors monitoring studs, plates, and rim in House 1 exhibited excellent moisture performance with a maximum of 15.9%, well below the level generally considered to indicate moisture durability risk. Per the instrumentation and methodology discussion, for lumber the fiber saturation point is assumed to be approximately 30%. For the purposes of this study, MC above approximately 20% indicates potential risk for moisture performance problems. All sensors indicate good moisture performance for framing lumber in EP&B walls in House 1, with very little variation because of orientation, air-sealing methods, insulation materials, or seasonal psychrometric variations. See Figure 29.

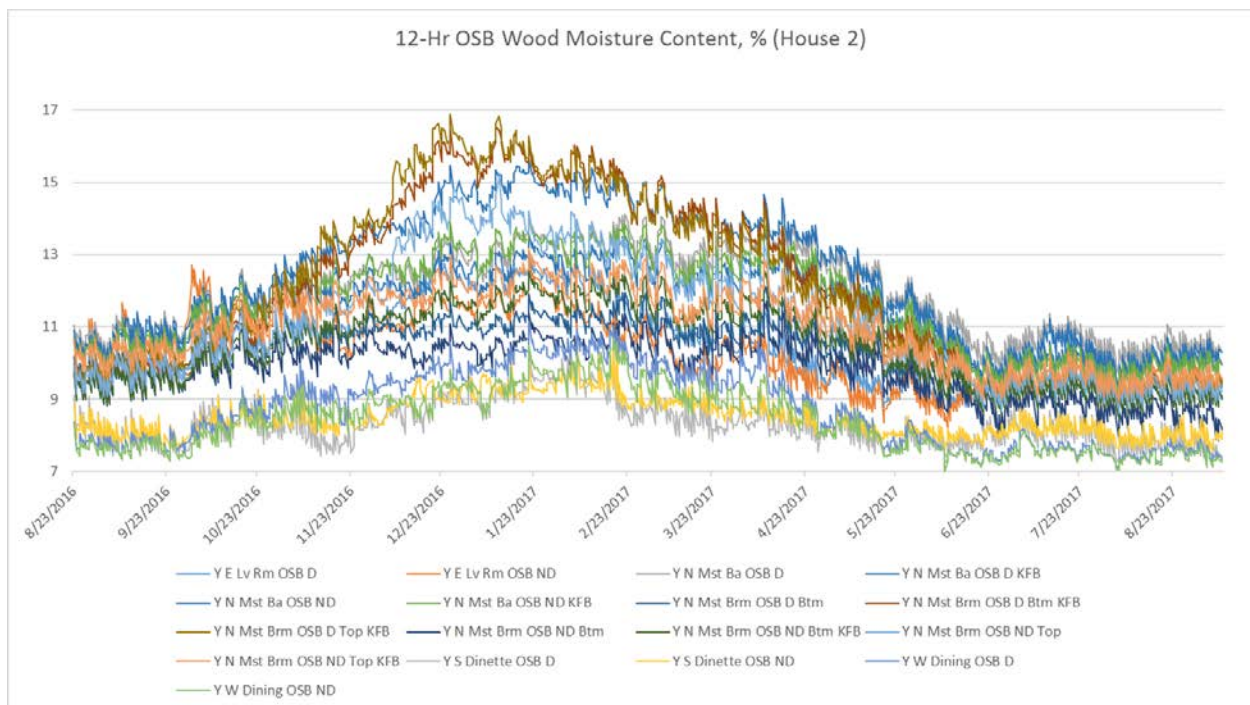
Figure 30. Moisture content for OSB in all EP&B walls, House 2

Figure 30 shows 12-hour averaged MC readings for all sensors (outlier removed) monitoring OSB in House 2 for a 12-month period starting in August, 2016.

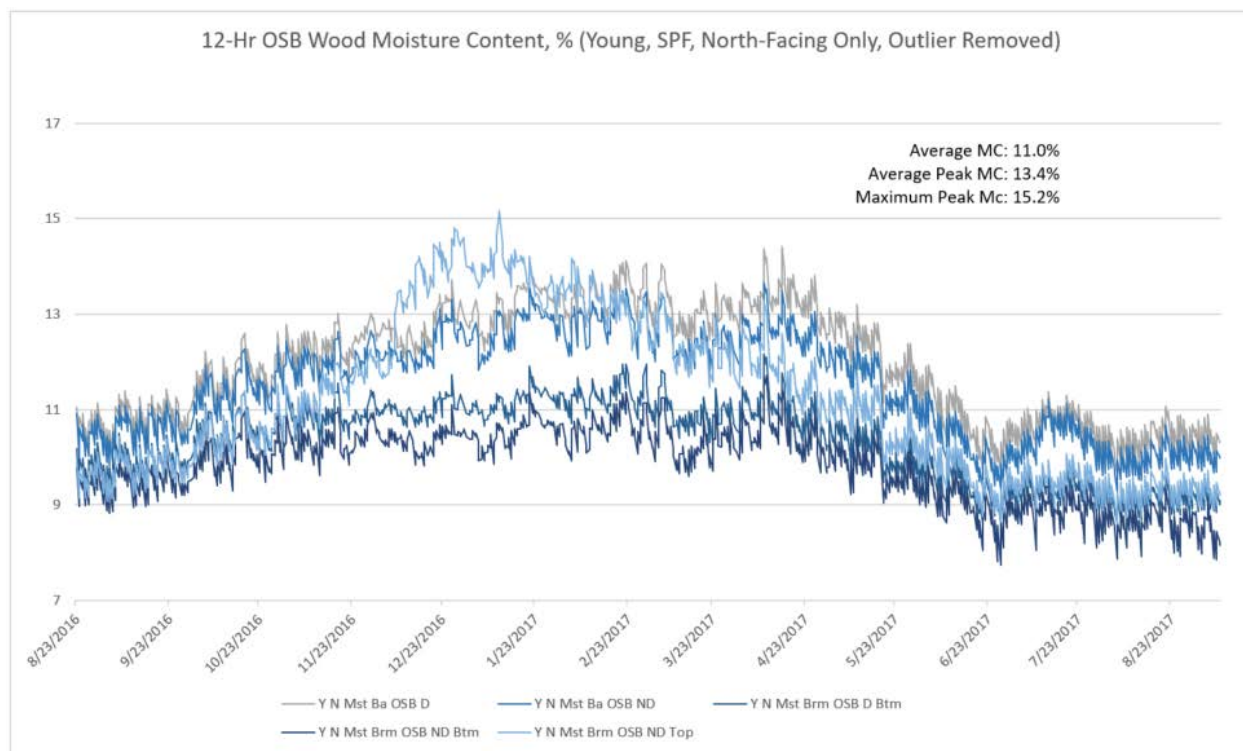
Figure 31. Moisture content for OSB in EP&B walls with ccSPF air sealing and blown-in fiberglass insulation, House 2

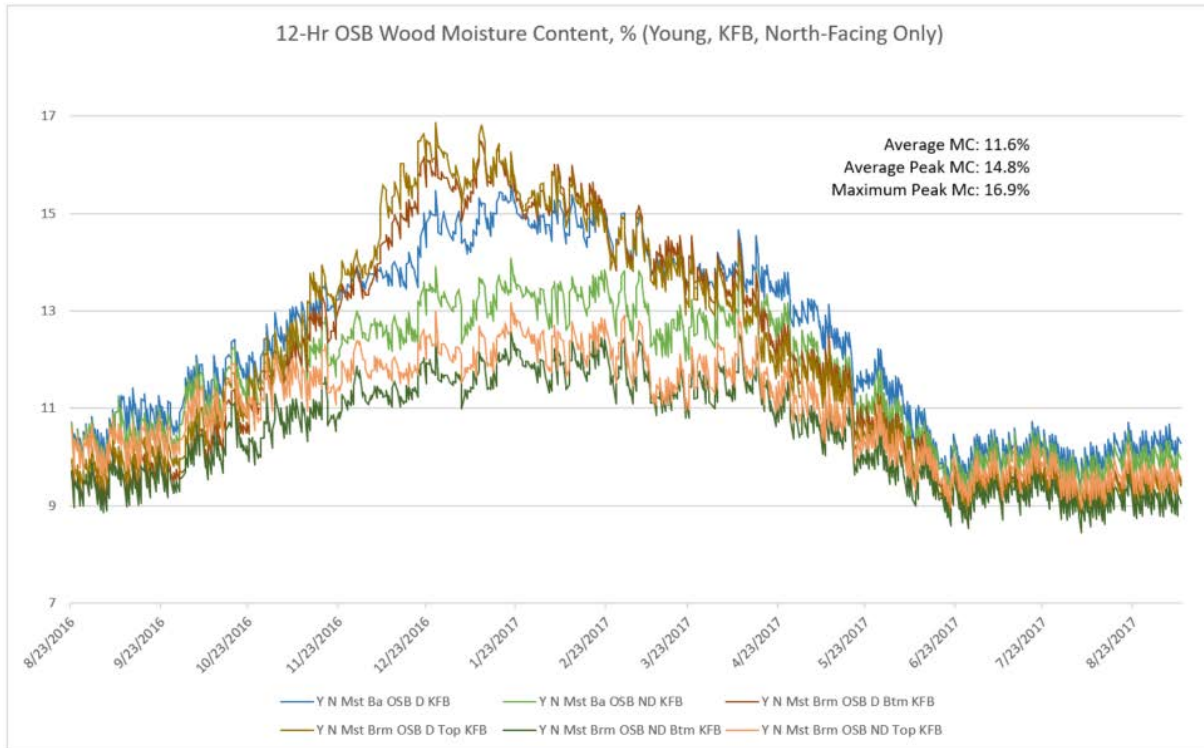
Figure 32. Moisture content for OSB in EP&B walls with acrylic caulk air sealing and Kraft-faced batt insulation, House 2
