Extended Plate and Beam Wall System

May 2018

Patti Gunderson
Home Innovation Research Labs
EP&B Wall System Project Team
400 Prince George's Blvd.
Upper Marlboro, MD 20774

This report, "Extended Plate and Beam Wall System," explores the extended plate and beam wall system to determine its structural performance, moisture durability, constructability, and cost-effectiveness for use as a high-R enclosure system for energy code minimum and above-code performance in climate zones 4–8.

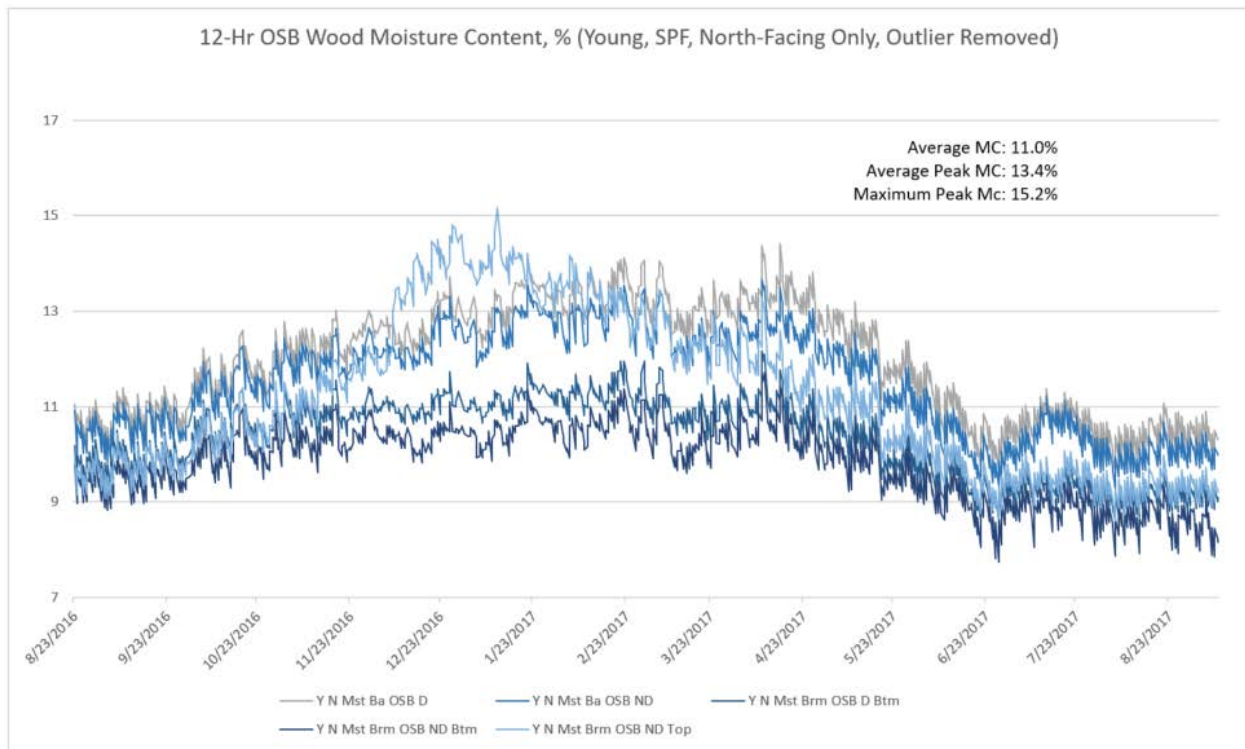
Figure 33. Moisture content for OSB in EP&B walls with ccSPF/blown fiberglass, North only, House 2

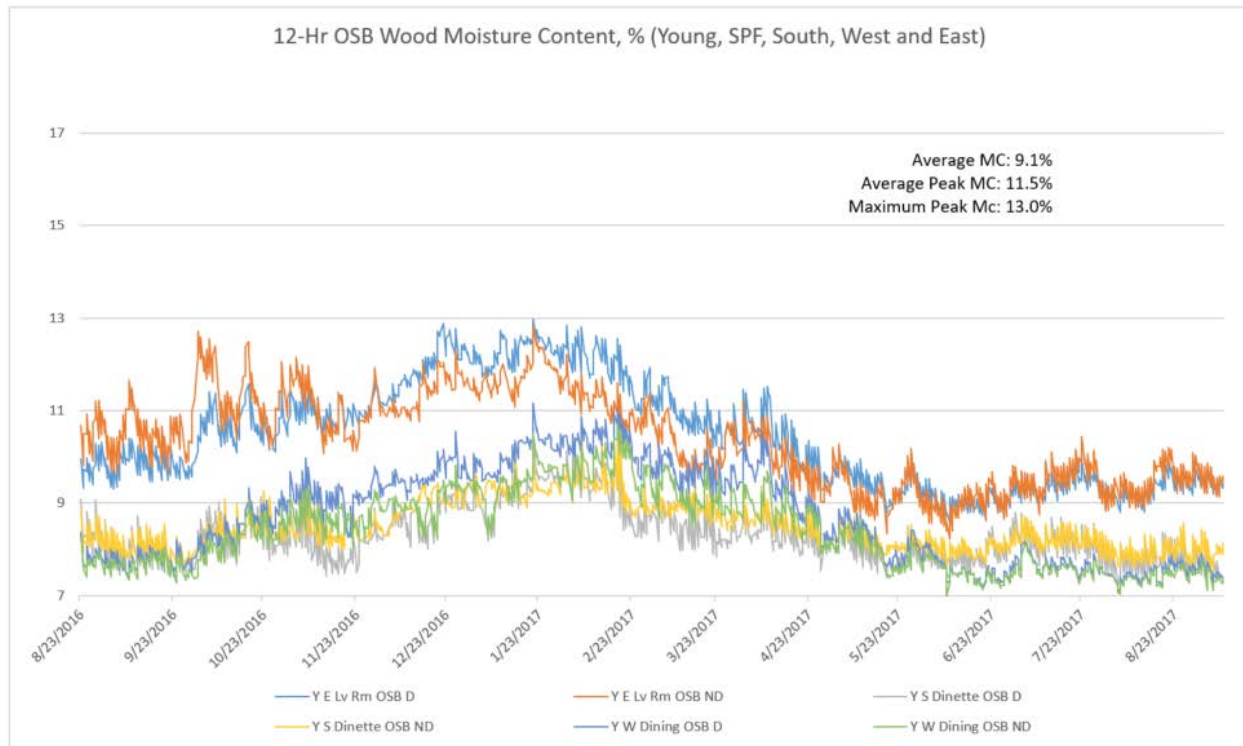
Figure 34. Moisture content for OSB in EP&B walls with ccSPF and blown fiberglass, non-north orientations, House 2

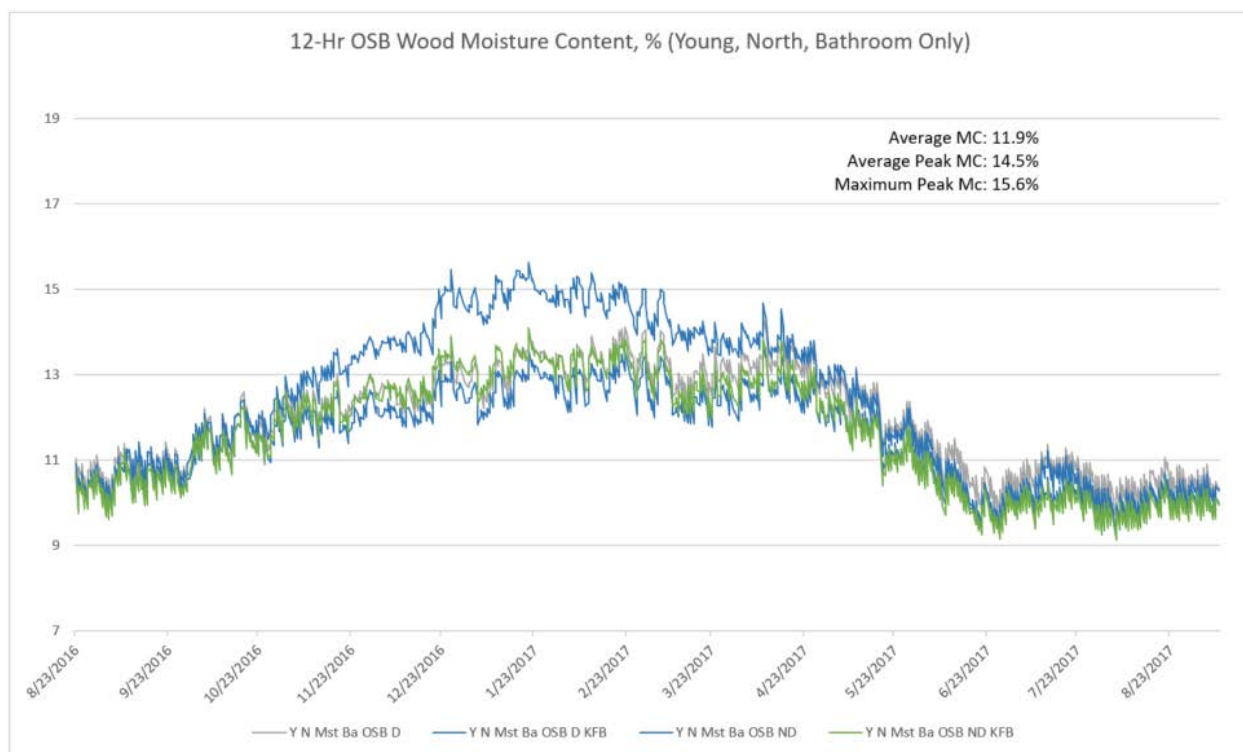
Figure 35. Moisture content for OSB in EP&B bathroom walls, north orientation only, House 2

Figure 35 and Figure 36 Comparing Bathrooms to Bedrooms. When controlled for room type, north-facing EP&B walls in the master bathroom exhibit very similar MC averages to north-facing EP&B walls in the master bedroom. The bathroom OSB exhibits a lower subset maximum peak than the bedroom OSB as well as somewhat more stable behavior over time.

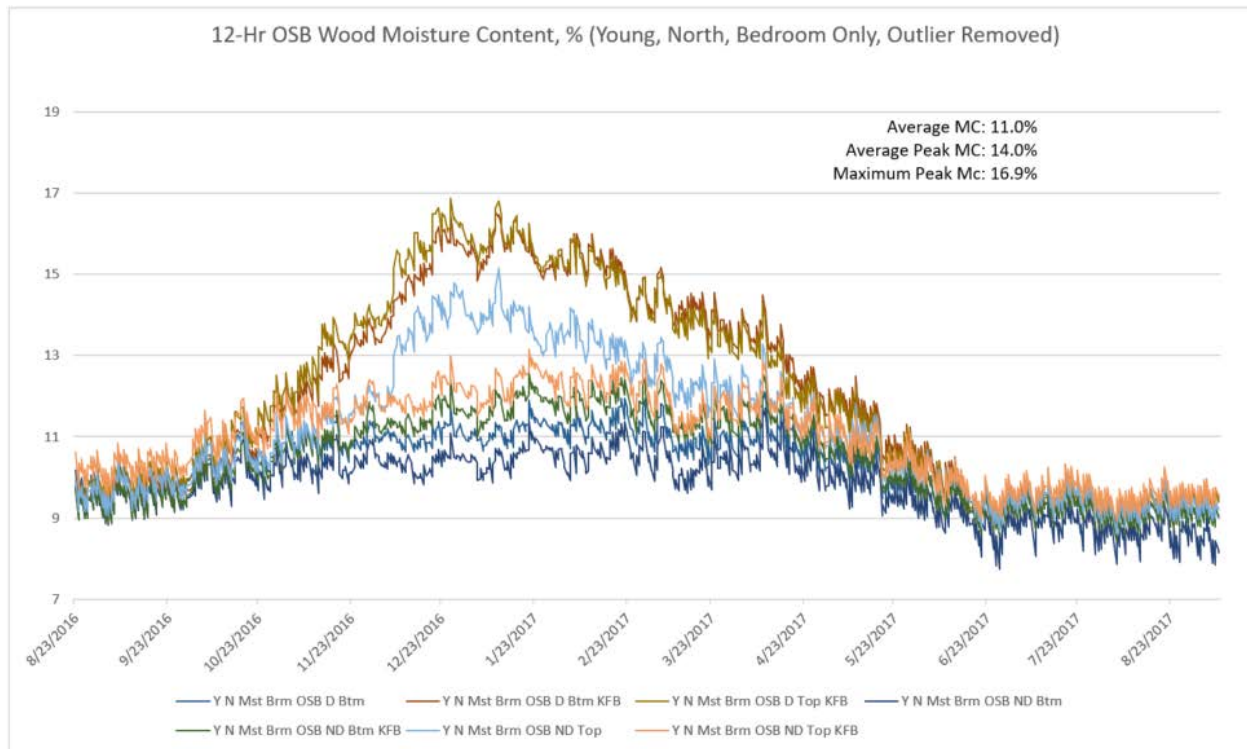
Figure 36. Moisture content for OSB in EP&B non-bathroom walls, north orientation only, House 2

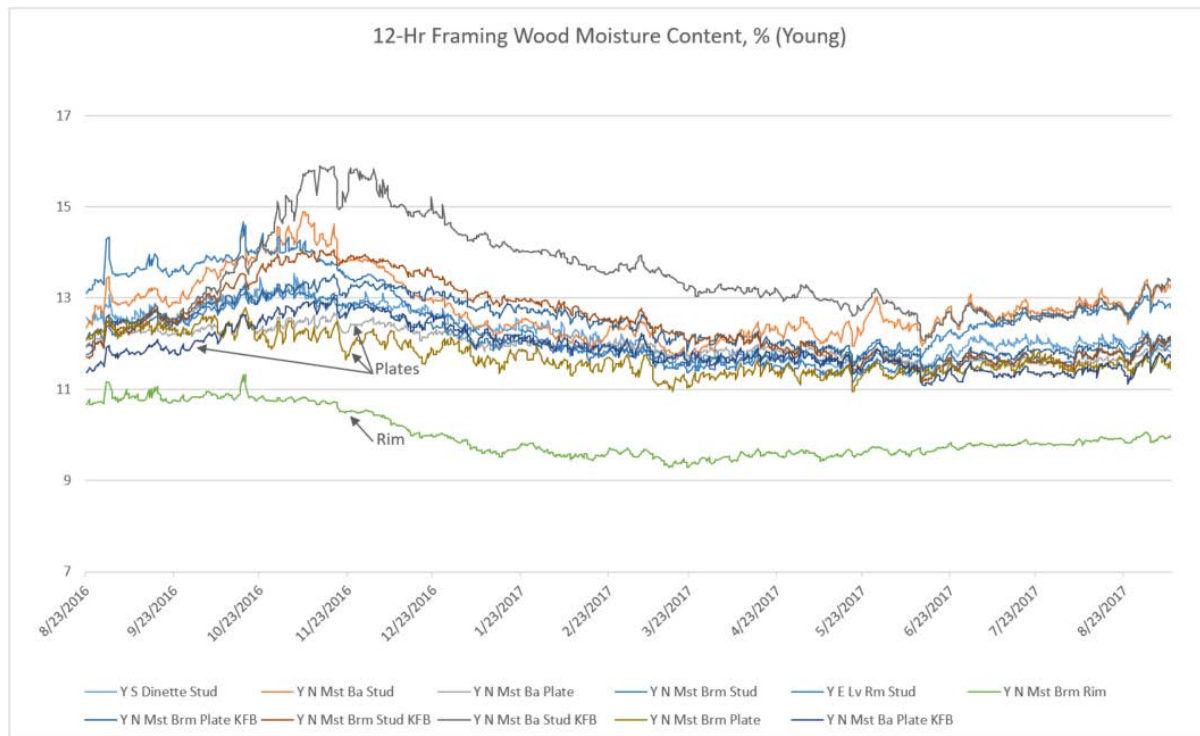
Figure 37. Stable moisture content for framing lumber in all EP&B studs, plates, and rim, House 2

All sensors monitoring studs, plates, and rim in House 2 exhibited excellent moisture performance—less than 16%—well below the percentage generally considered to indicate moisture durability risk. Sensors exhibit very little variation because of orientation, either of the two air-sealing methods, the two insulation materials, or seasonal psychrometric variations. The rim MC and the bottom plate MC are noticeably on the low end of all monitored lumber. See Figure 37.

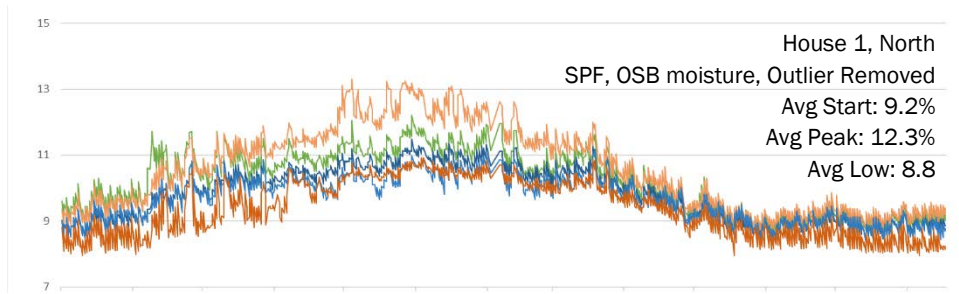
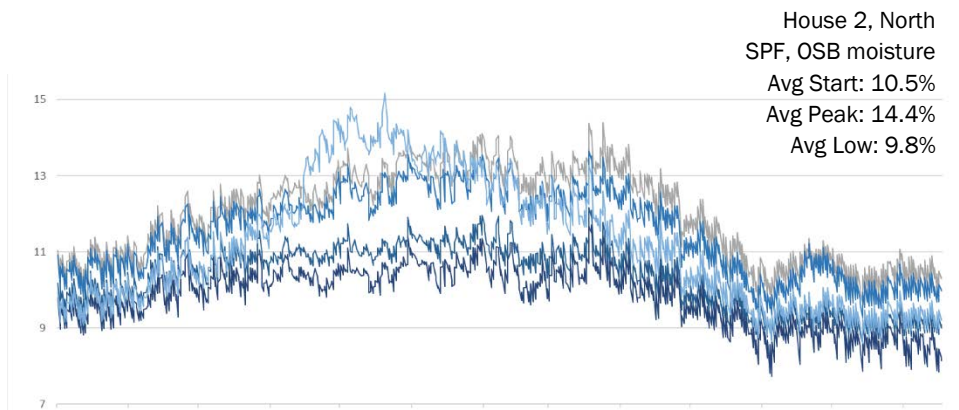
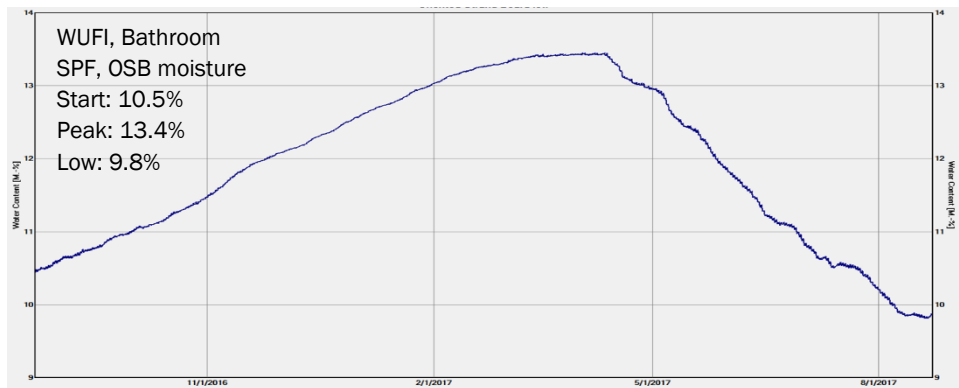
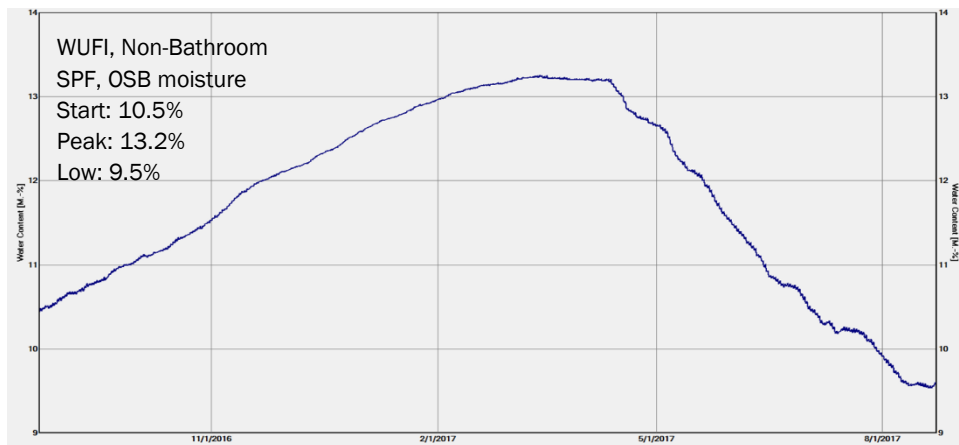
Figure 38. Comparing actual OSB MC to WUFI simulation, Grand Rapids test houses, spruce-pine-fur

- For walls with ccSPF flash coat with blown fiberglass insulation, the WUFI model prediction for peak OSB MC was very near to the recorded values.
- For walls with R-15 Kraft-faced batt fiberglass insulation, the WUFI model underpredicted actual peak OSB MC by 1.5 to 2 percentage points.
- For both insulation methods and both houses, MC under actual conditions peaked several months sooner than the WUFI simulation predicted.
- For both insulation methods and both houses, OSB dried out during the summertime to average MC very similar to the WUFI model prediction (between 9% and 10%).
- The bathroom conditions caused wintertime MC peaks in bathrooms that were slightly higher than non-bathroom peaks by less than 0.5% and lows that were higher than non-bathroom lows by less than 0.5%. These values are too small to be significant for WUFI.

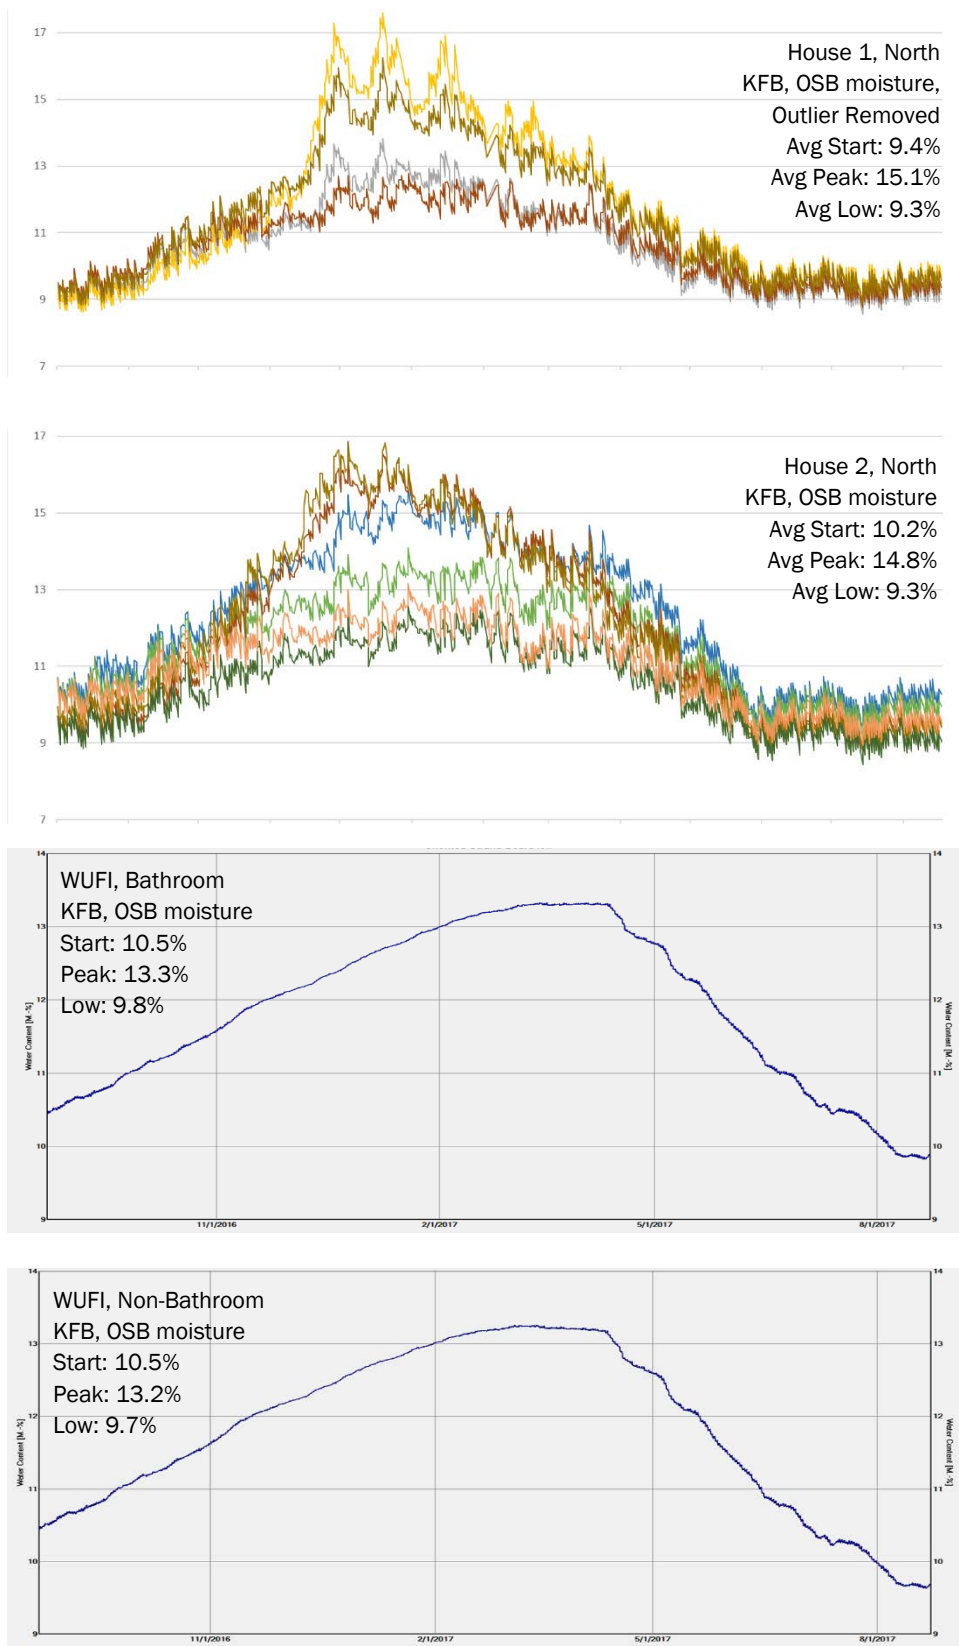
Figure 39. Comparing actual OSB MC to WUFI simulation, Grand Rapids test houses, Kraft-faced batt insulation

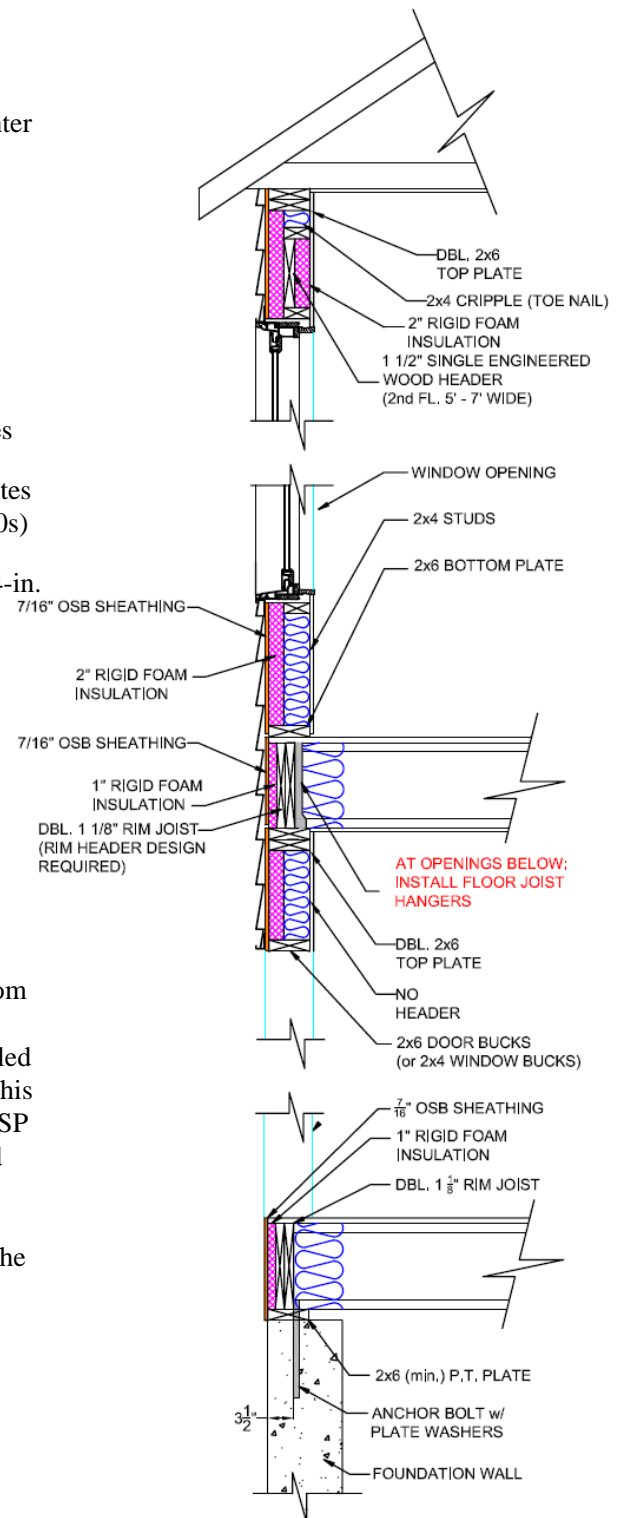
Figure 41. EP&B wall, section view

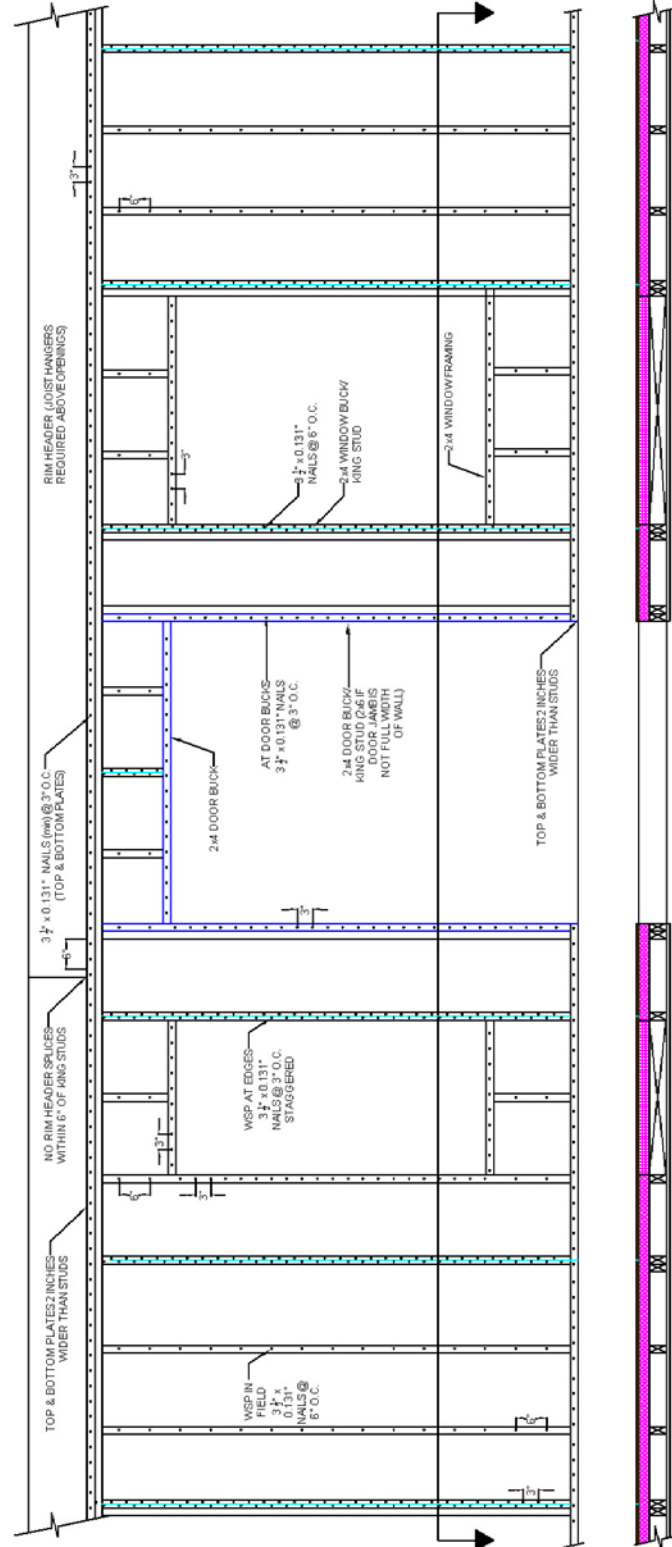
Figure 42. EP&B wall, interior elevation view

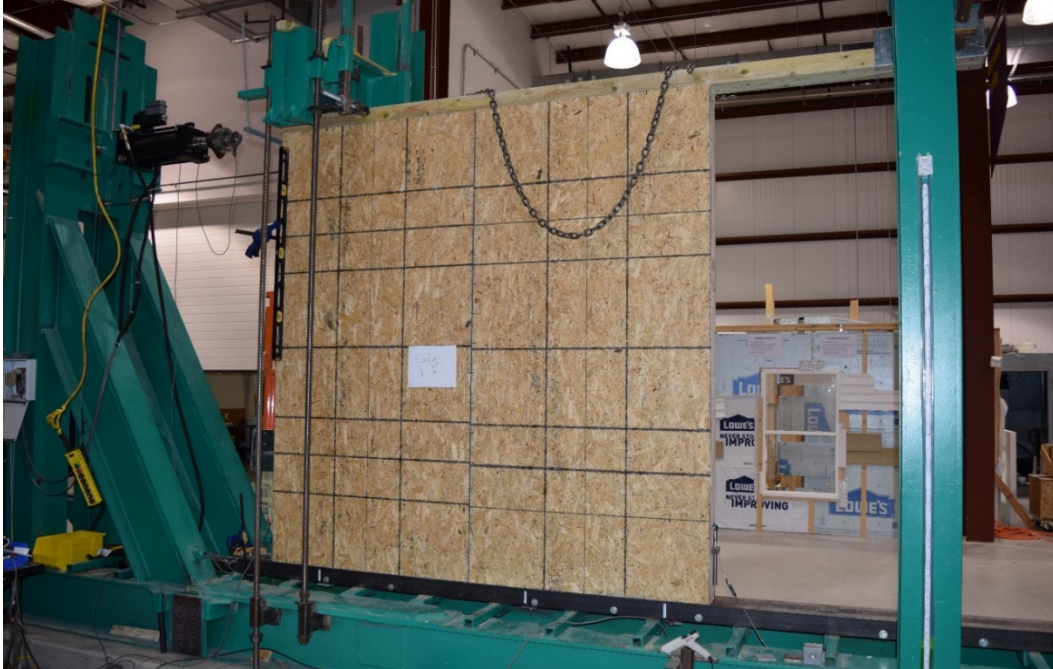
Figure 44. A 2x6 standard reference wall in testing apparatus prepared for ASTM 72 test

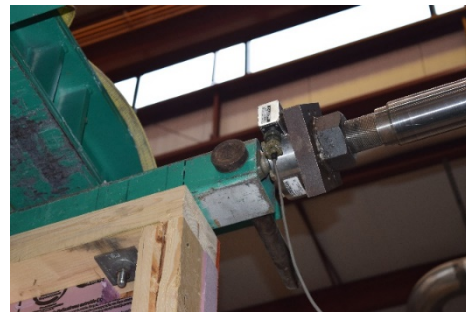
Boundary conditions:
loading beam, plate anchors

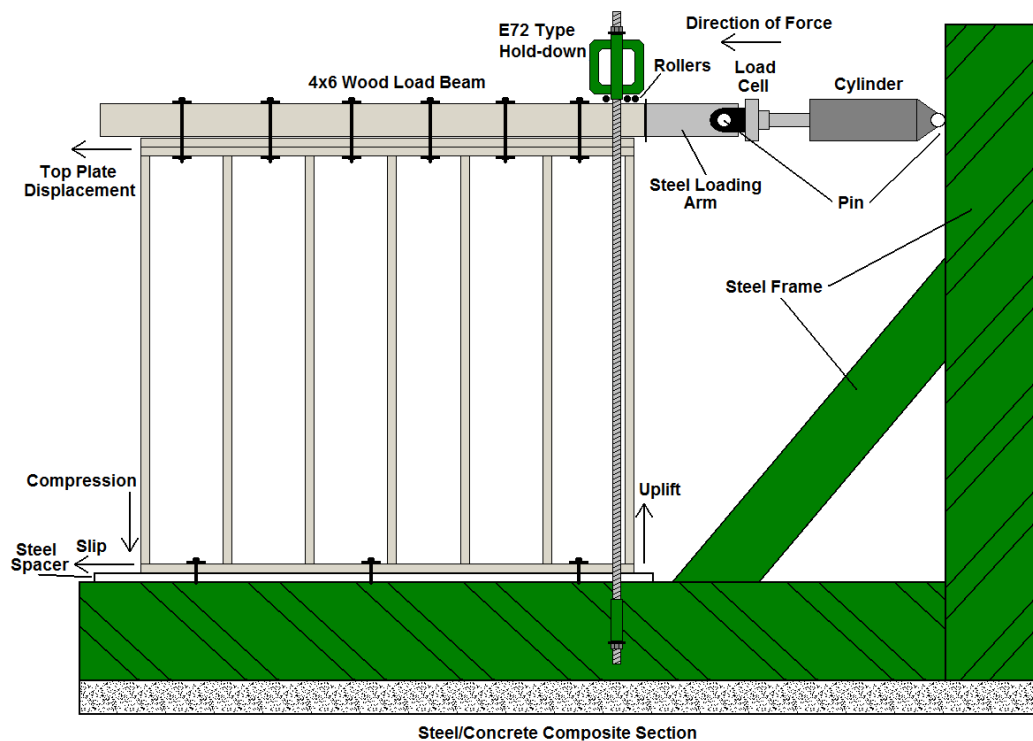
Figure 46. Test apparatus for AC209.1 Section 4.1, ASTM E72 tests

Loading was applied as a compressive force by pushing on the end of the timber attached to the specimen's top plate, per Figure 46.

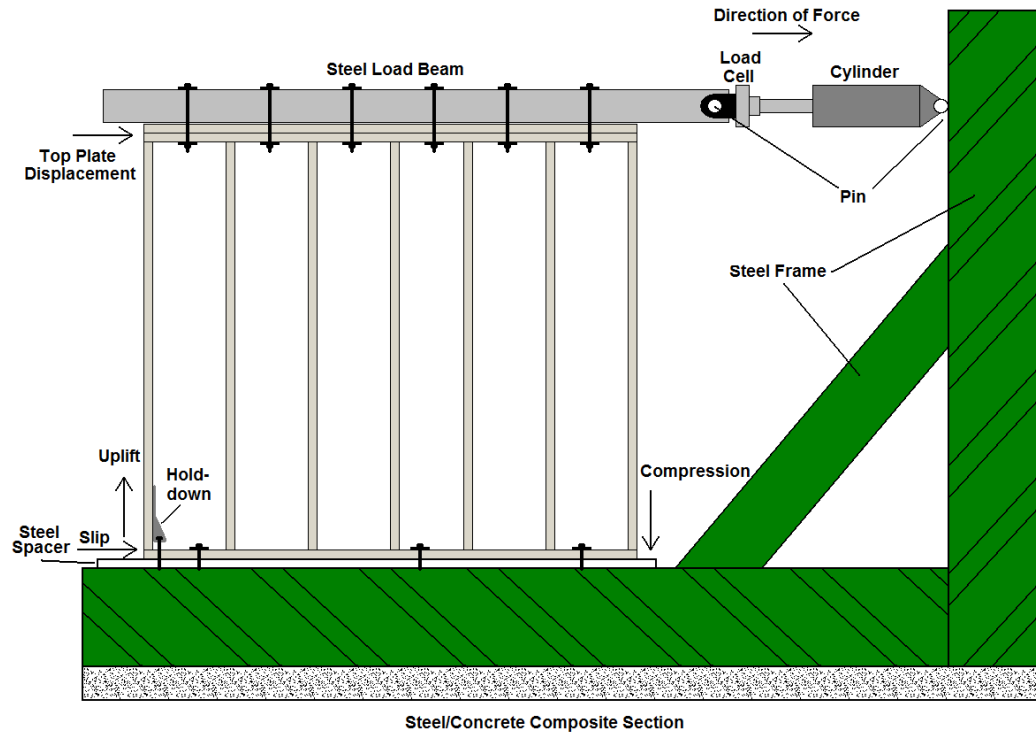
Figure 47. Testing apparatus for AC269.1 Section 4.2, E564 tests

Loading was applied as a tensile force by pulling on the end of the steel beam attached to the specimen’s top plate per Figure 47. The load was applied in a single, continuous motion at a constant displacement rate of 0.3 in./min. The sample rate for data collection was 5 Hz. All walls were tested either to failure or to a minimum of 4-in. deflection.

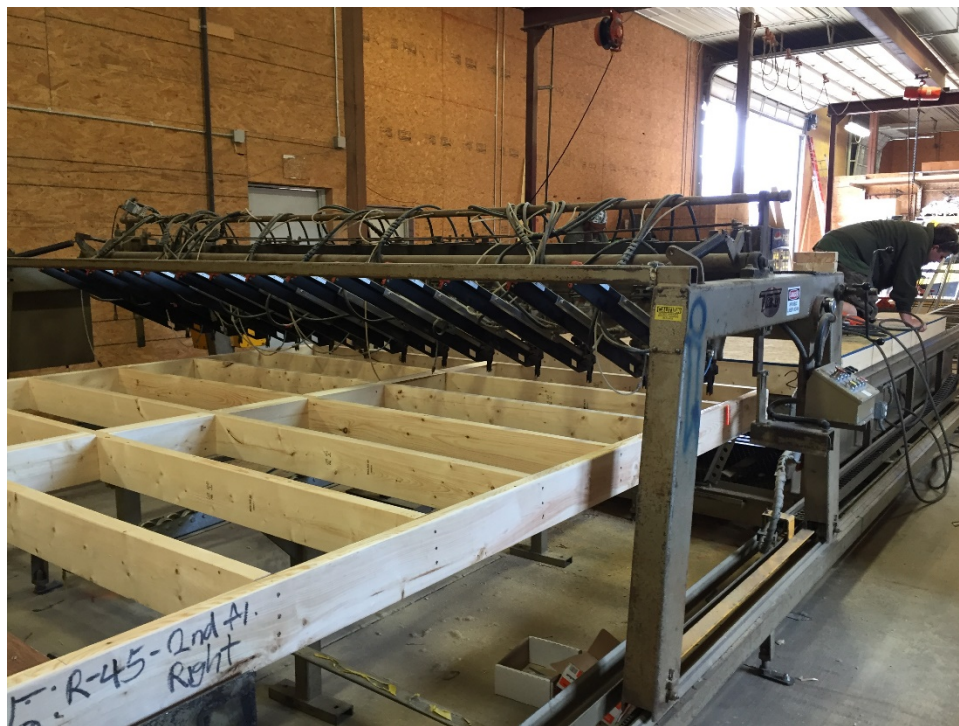
Figure 48. Bridge nailer, Zeeland Truss & Components

Figure 48 through Figure 50 illustrate the Zeeland wall panel production plant.

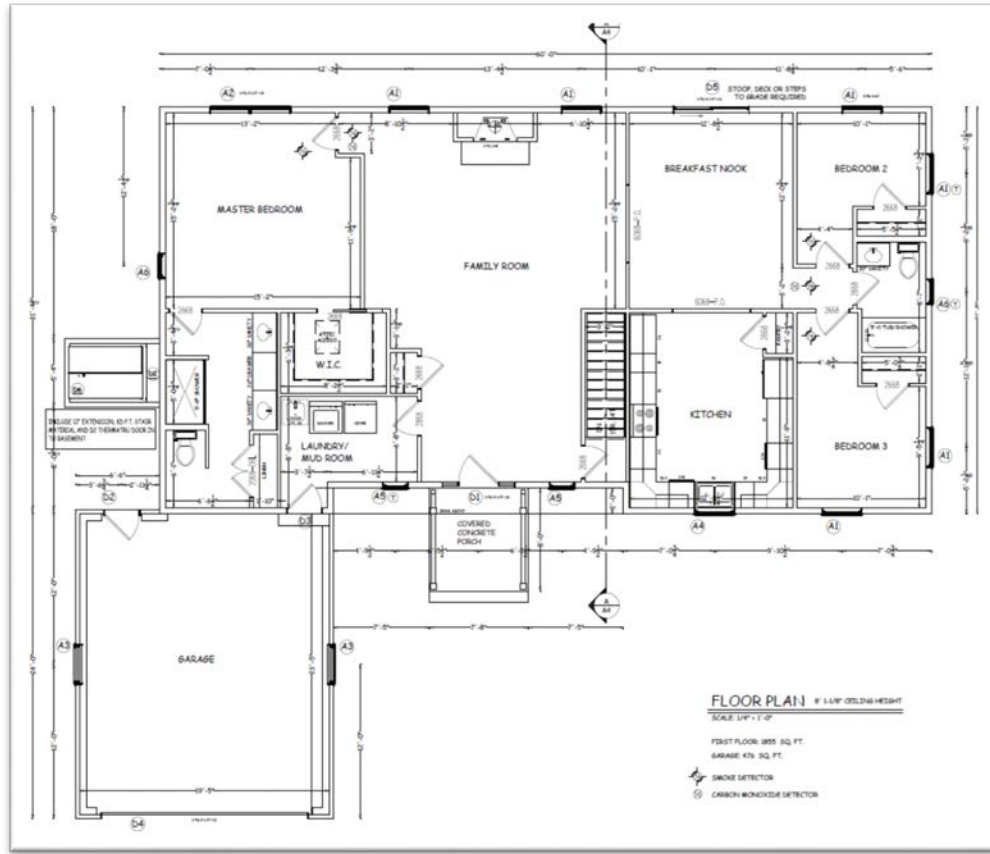
Figure 52. EP&B test home floor plan

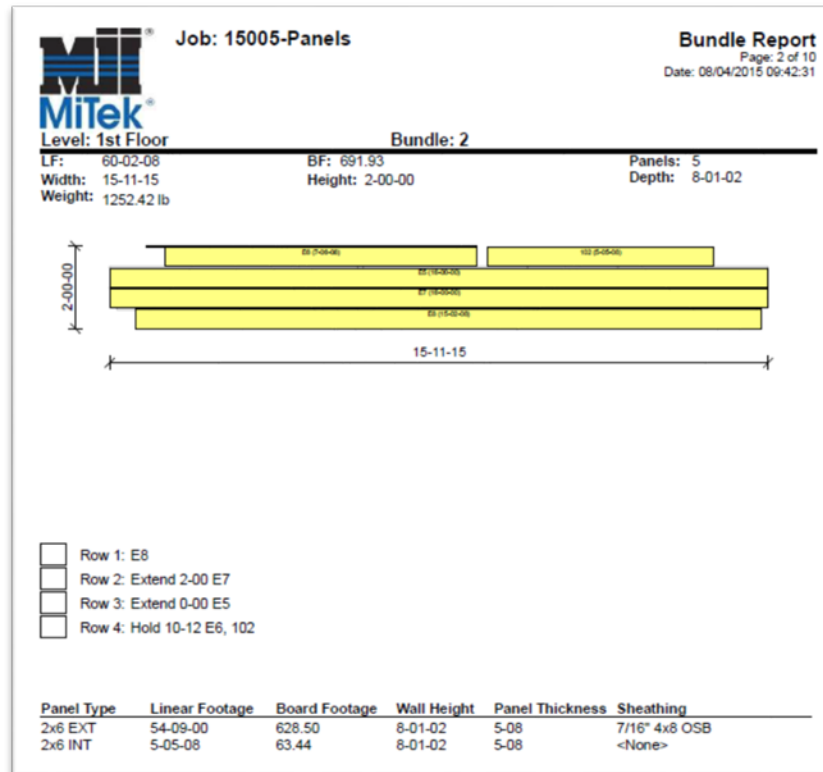
Figure 54. Example of construction drawing for bundling EP&B wall panels

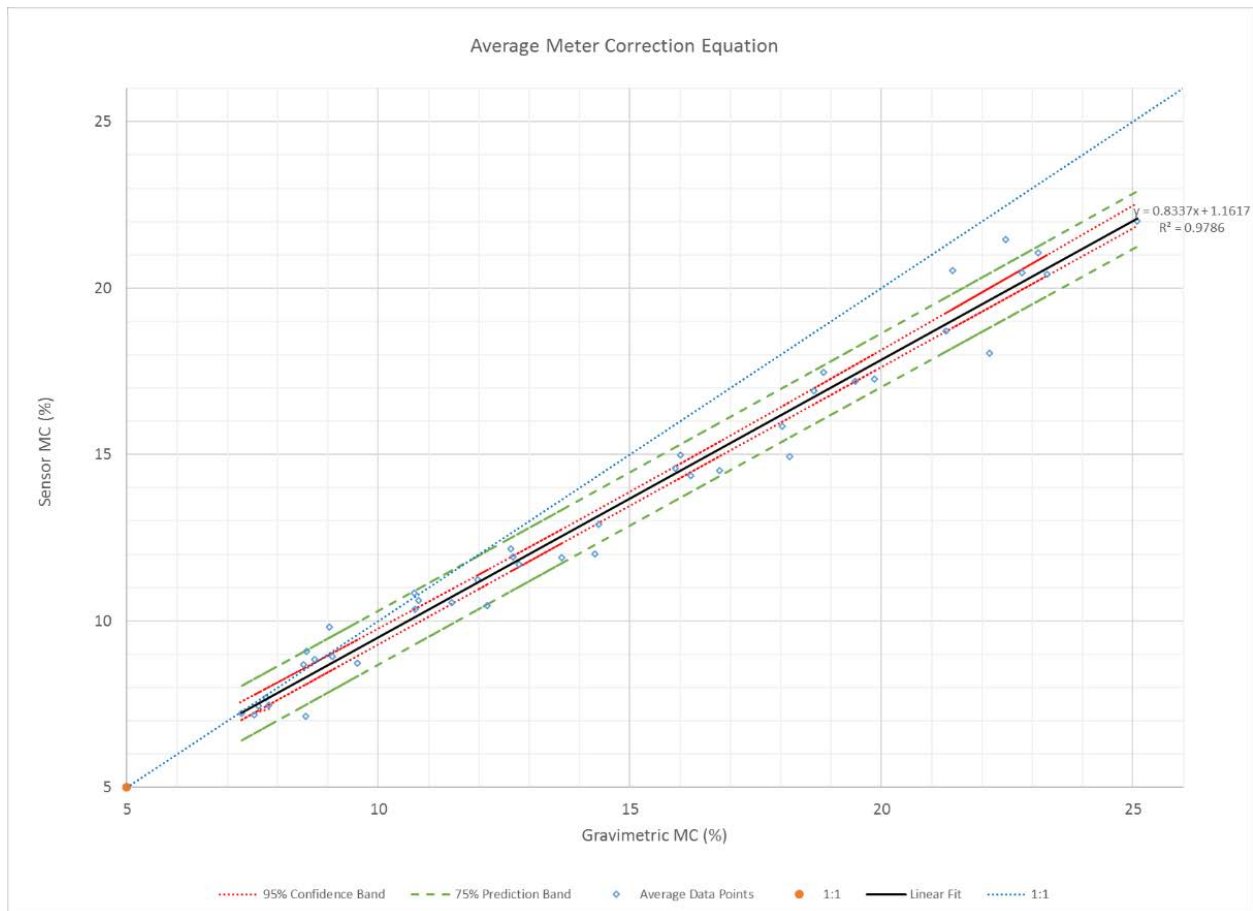
Figure 61. Curve fit chart for MC sensor calibration for all OSB data points

The sensors record temperature simultaneously with RH. The sensor measures the resistance across the sensor pins (the tips of the screws) to determine MC and automatically corrects for temperature (because the conductivity of wood increases with increasing temperature).

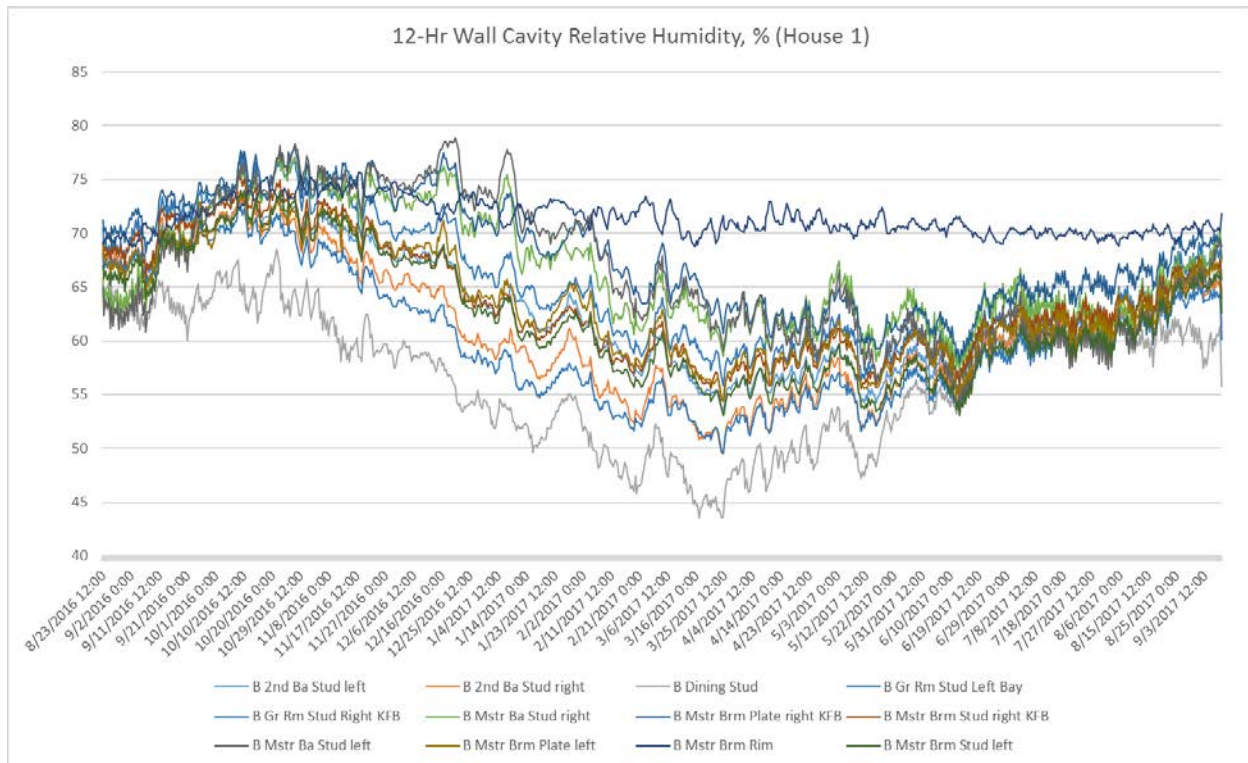
Figure 62. Wall cavity RH, House 1

- East-facing wall cavities (non-bathroom): local RH never rose above 70%
- West-facing wall cavities in bathrooms: local RH never rose above 78%
- West-facing wall cavities in non-bathrooms: local RH never rose above 66%
- South-facing wall cavities (all non-bathrooms): local RH never rose above 68%
- North-facing bathroom and bedroom wall cavities exhibited slightly different results for the two field test houses:
 - In House 1, the overall highest peak (78% RH) and the overall highest average (71% RH) occurred in north-facing *bedroom* wall cavities
 - In House 2, the overall highest peak (72% RH) and the overall highest average (68% RH) occurred in north-facing *bathroom* wall cavities.

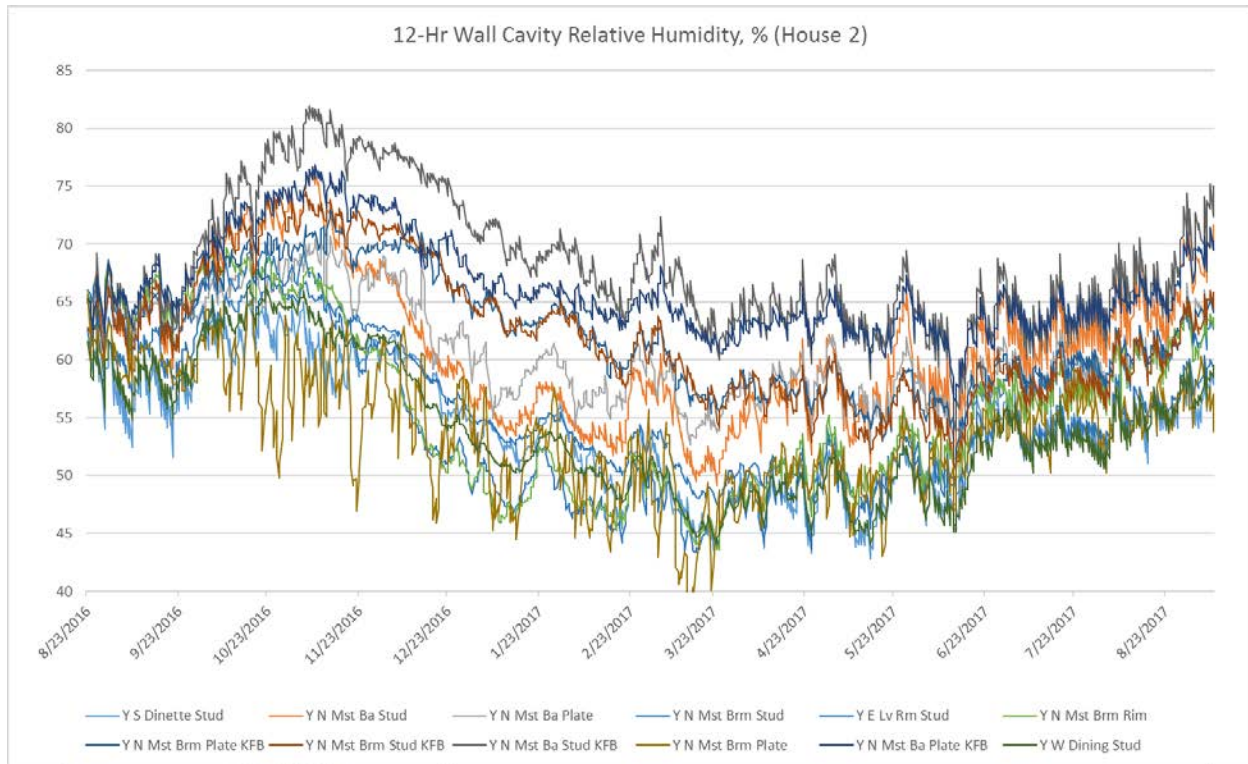
Figure 63. Wall cavity RH, House 2

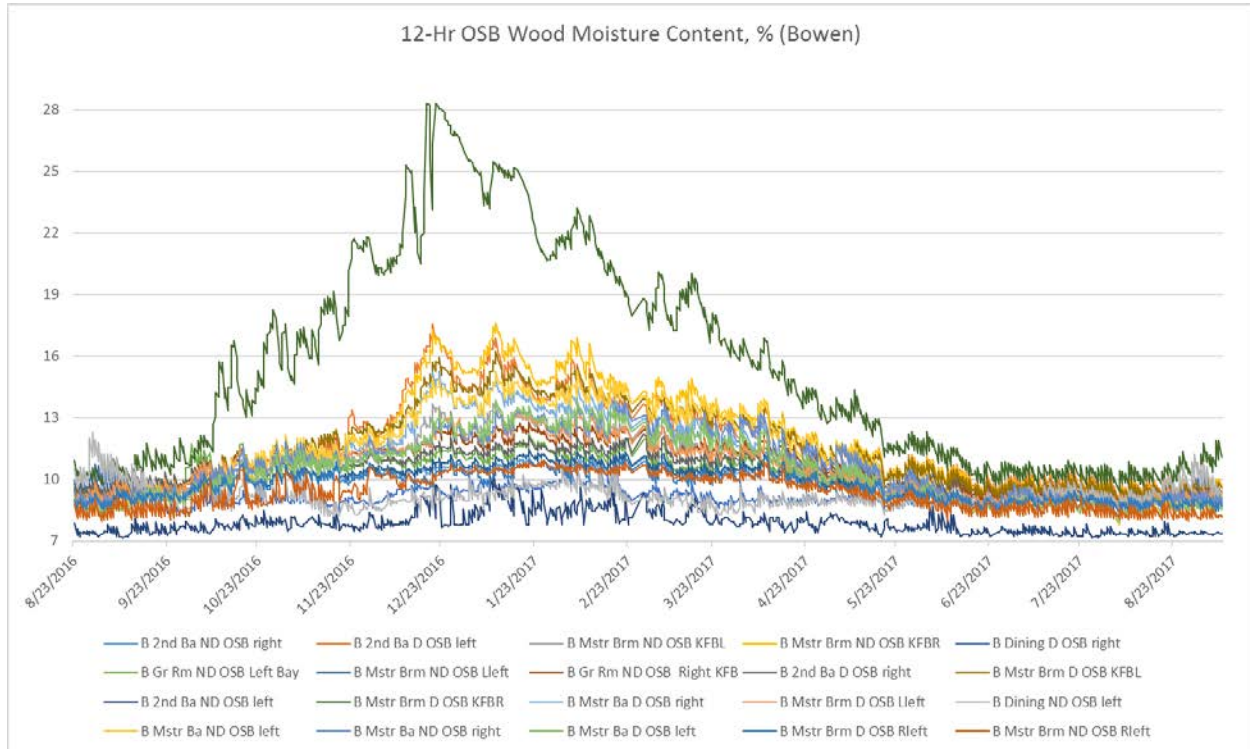
Figure 64. MC for OSB in all EP&B walls, House 1

Figure 64 graphs the 12-hour averaged MC readings for all sensors monitoring OSB in House 1 for a 12-month period starting in August, 2016 (outlier removed).

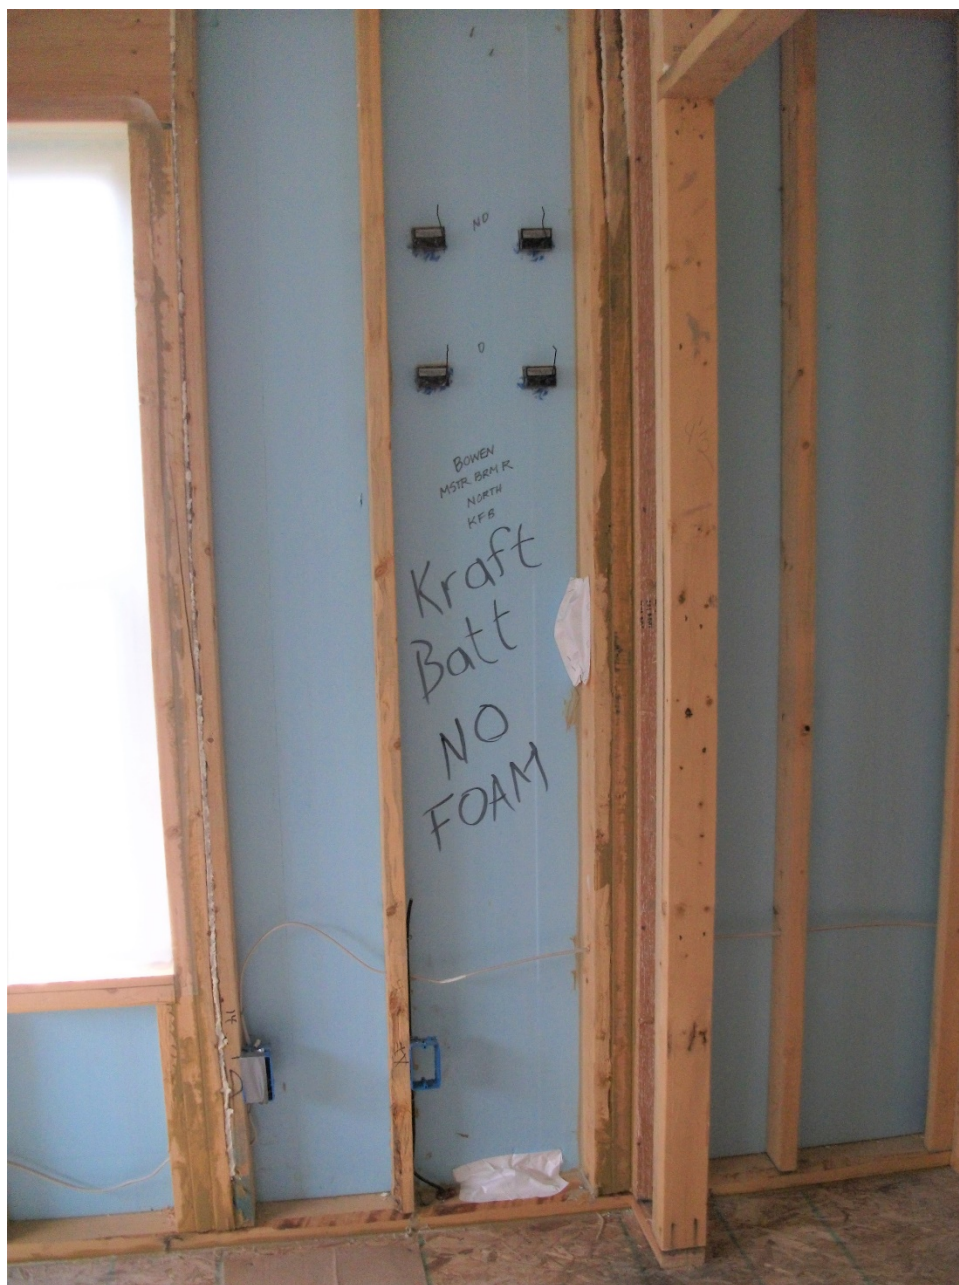
Figure 66. Bay containing outlier OSB sensor, House 1

- The WRB tape used to seal the sensor cabinet to the rigid foam may be imperfect, allowing moisture migration between inside and outside.
- Removal of the foam core below the sensor eye, if over-drilled, may have damaged the OSB, allowing moisture to enter from behind the cladding.

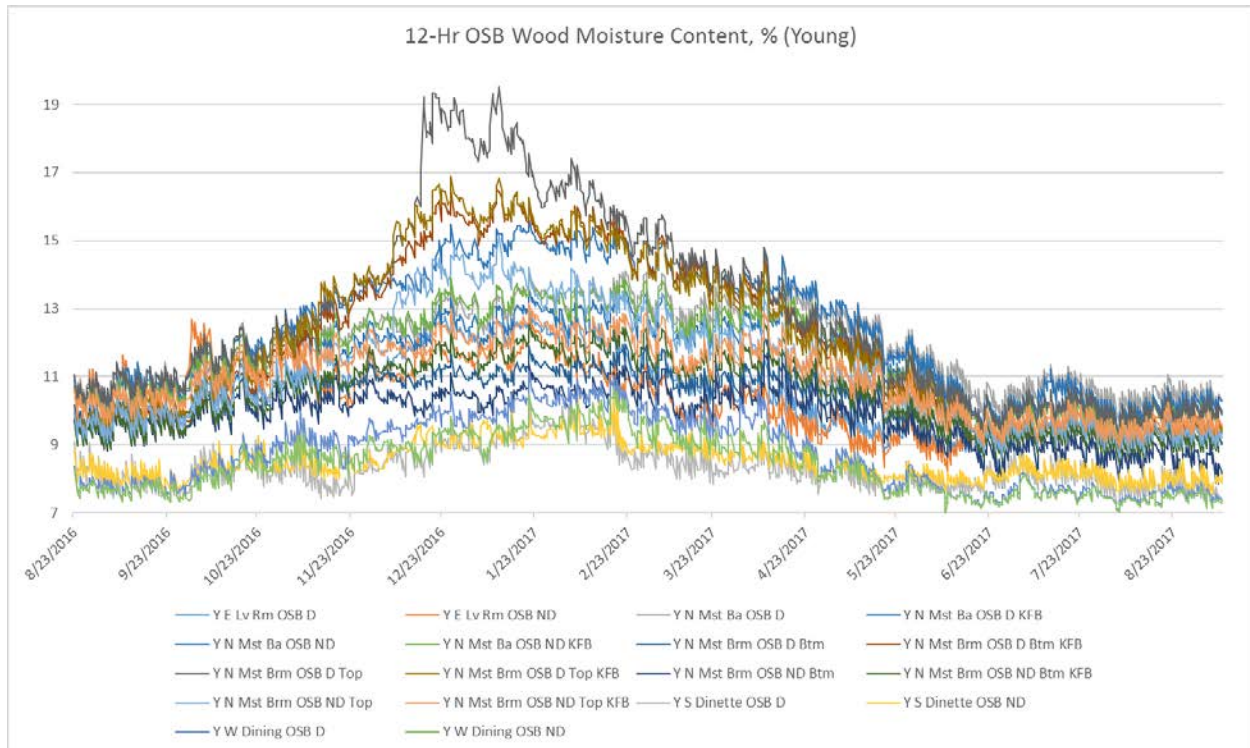
Figure 67. MC for OSB in all EP&B walls, House 2

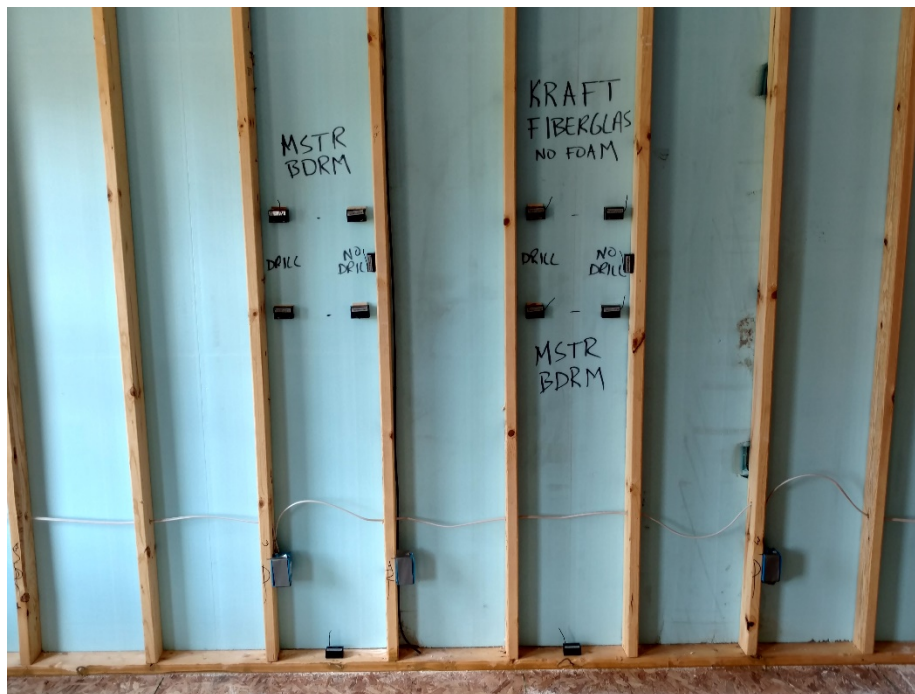
Figure 68. Wall containing outlier OSB sensor, House 2

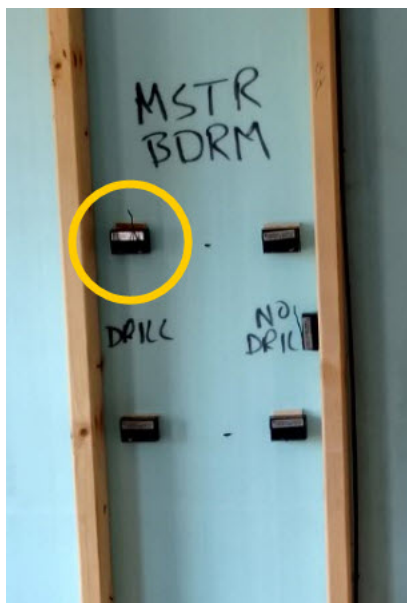
Figure 69. Detail of outlier OSB sensor, House 2

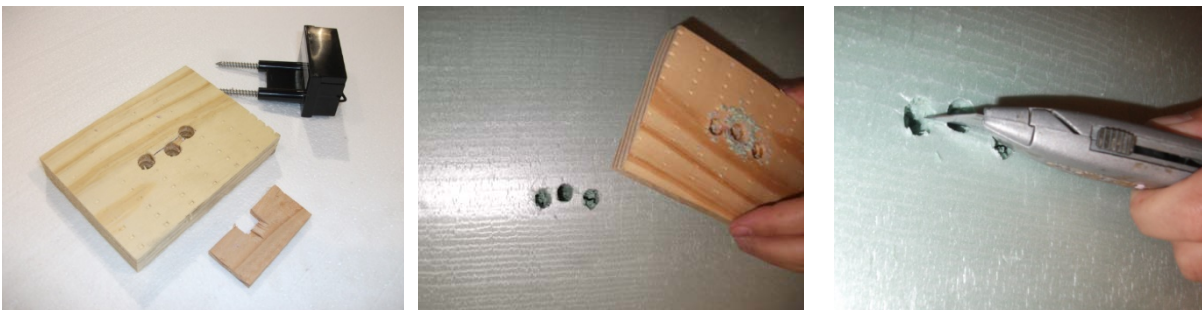
Figure 70. A jig ensures that the sensor's legs can be embedded in the 2-in. rigid foam layer without gaps.
