Extended Plate and Beam Wall System

May 2018

Patti Gunderson
Home Innovation Research Labs
EP&B Wall System Project Team
400 Prince George's Blvd.
Upper Marlboro, MD 20774

This report, "Extended Plate and Beam Wall System," explores the extended plate and beam wall system to determine its structural performance, moisture durability, constructability, and cost-effectiveness for use as a high-R enclosure system for energy code minimum and above-code performance in climate zones 4–8.

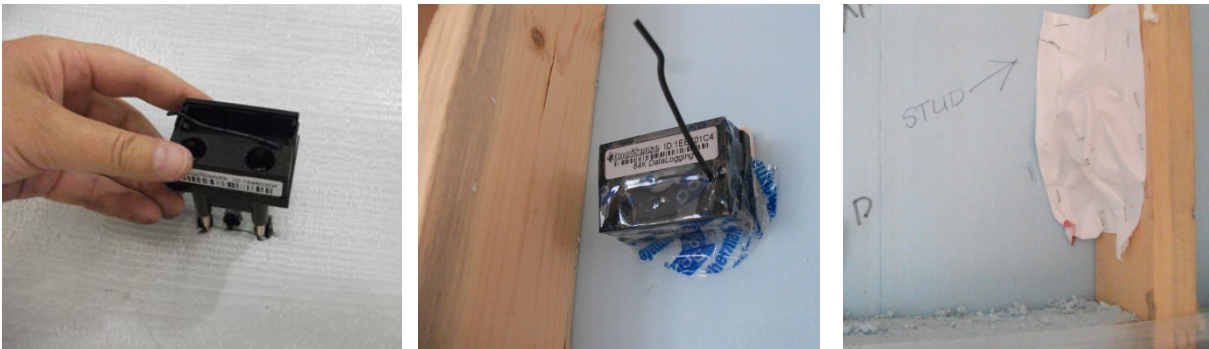
Figure 72. Sensor cabinets are protected from intrusion of moisture and debris with WRB tape

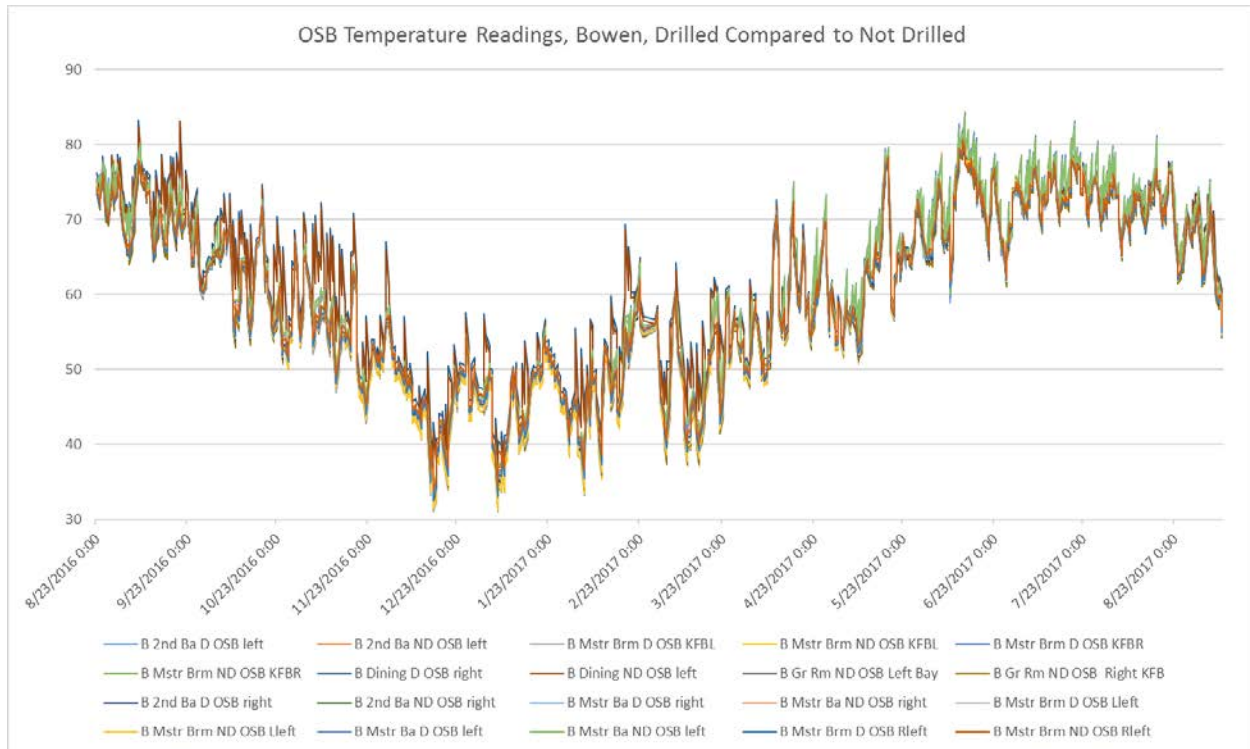
Figure 73. Comparing recorded temperatures, D and ND, House 1

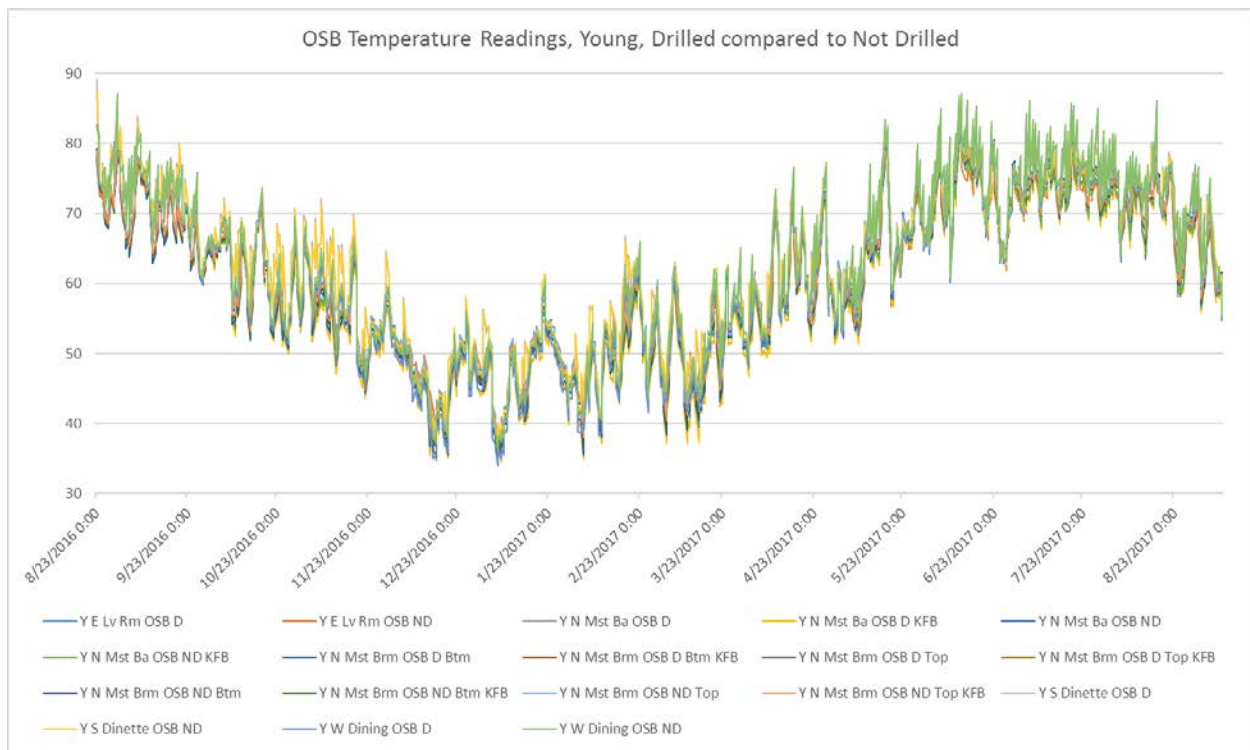
Figure 74. Comparing recorded temperatures, D and ND, House 2

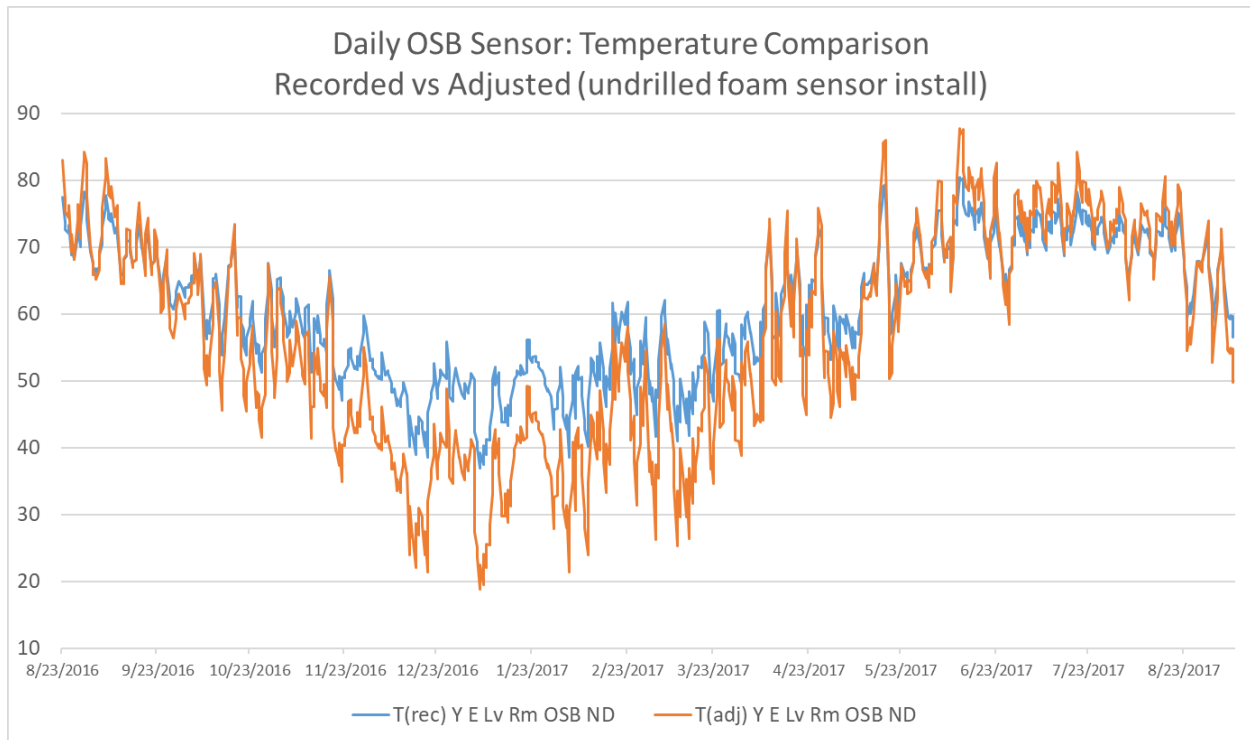
Figure 79. Example of OSB temperature adjustment to actual for sensor (undrilled foam)

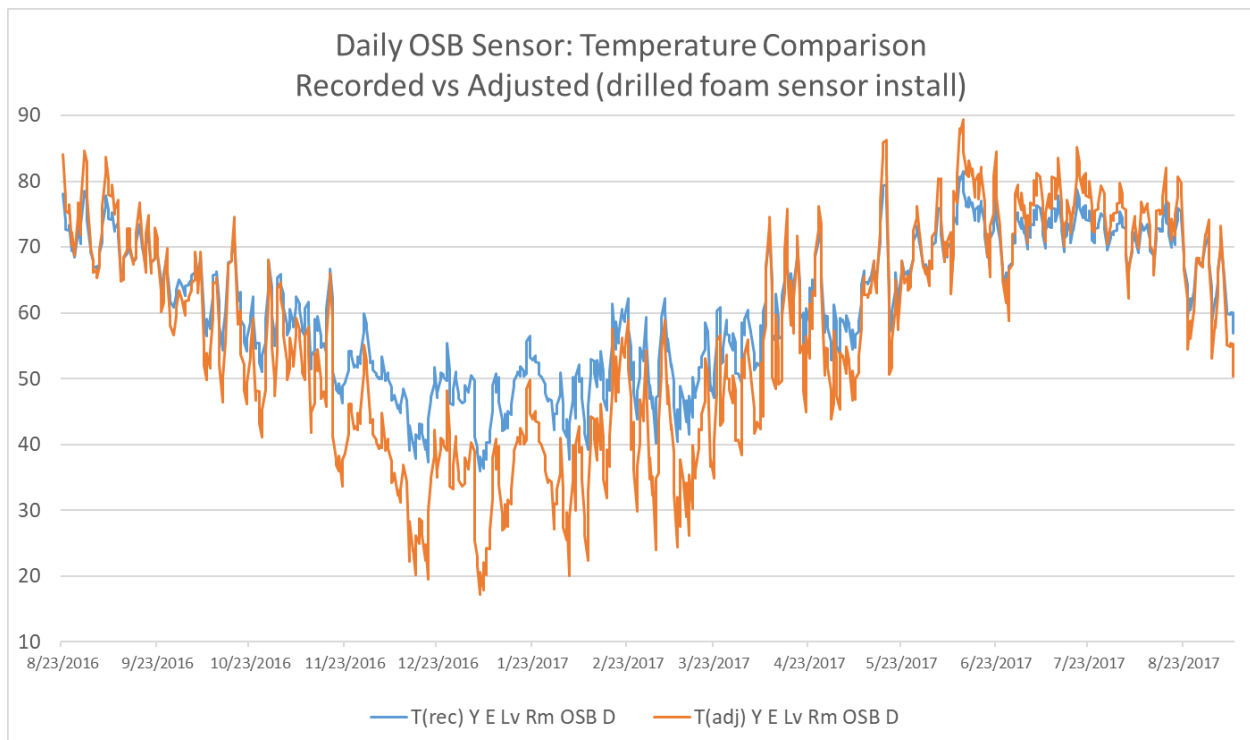
Figure 80. Example of OSB temperature adjustment to actual for sensor (drilled foam)

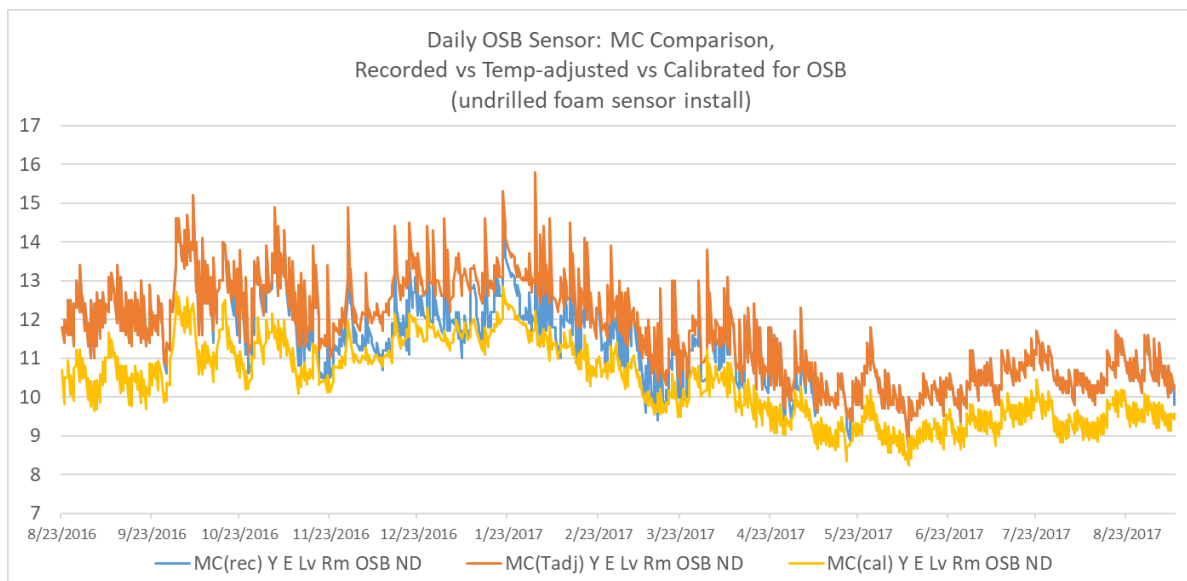
Figure 81. Example of MC adjustments for temperature and calibration (undrilled foam)

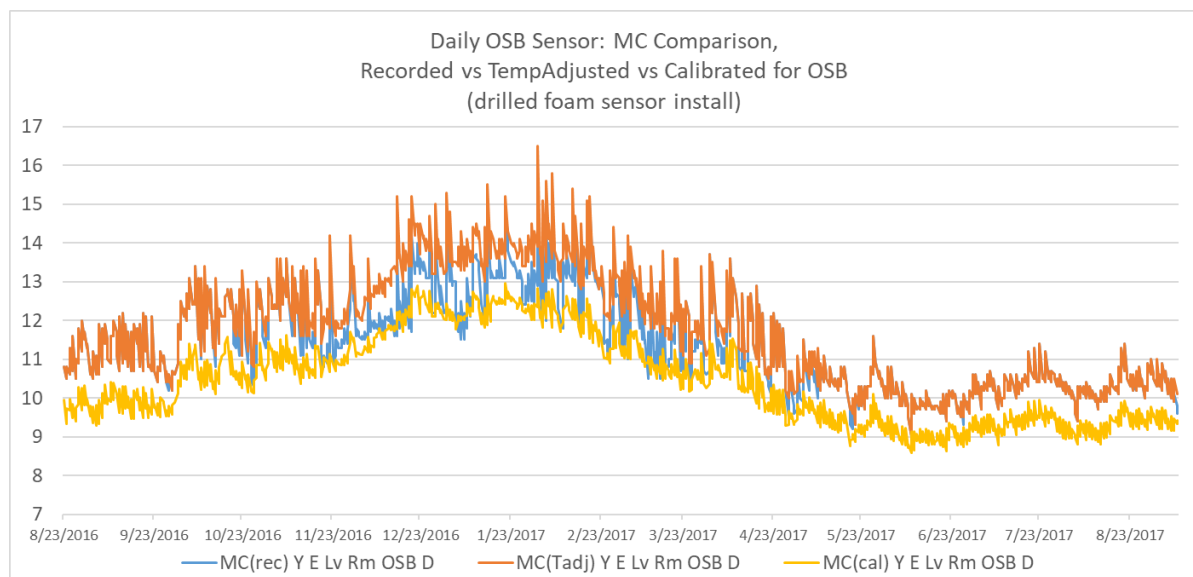
Figure 82. Example of MC adjustments for temperature and calibration (drilled foam)
