# NorthernSTAR 1-1/2-Story Demonstration House of Cold Climate Solutions for Affordable Housing

T. Schirber, C. Ojczyk, R. Jacobson  
*NorthernSTAR Building America Partnership*

March 2016

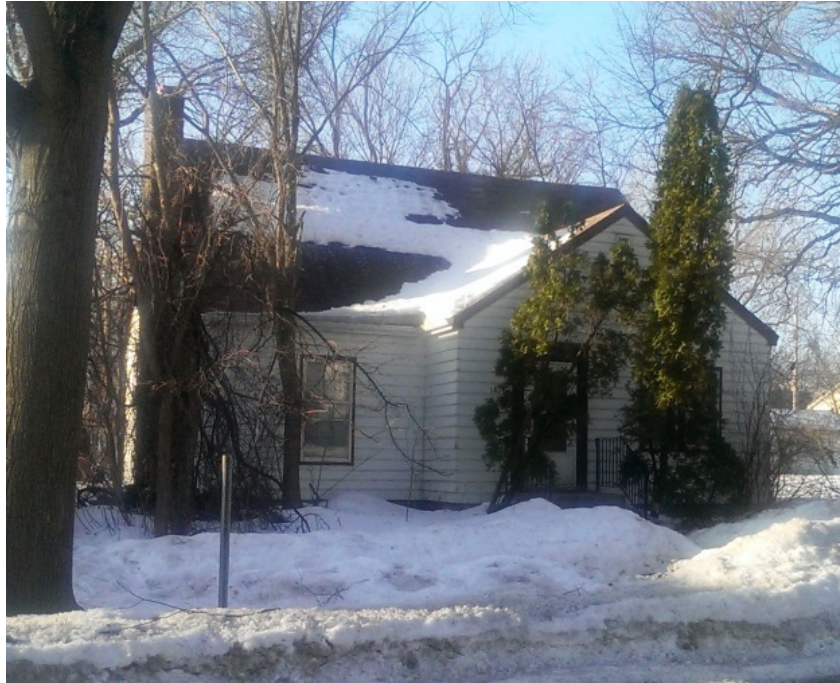
**Figure 1. Demonstration home in Minneapolis, Minnesota**

The demonstration house shown in Figure 1 was built in 1947. It was chosen by UHW for this project as it had positive features such as a solid framework, hardwood floors, and a good-sized living area in the upper ½ story. The concrete masonry unit foundation around the entire perimeter was sound. The basement had 7-ft-5-in. ceilings over a concrete slab floor. There were no constructed walls in the basement, which provides flexibility to the future homeowner to remodel the space as needed.

On the downside, the house had been vacant for about 1 year and was in extreme disrepair. Various openings in the roof and walls led to bulk water intrusion that caused rot in walls and ceilings and water stains in the basement. Three of the four corners in the basement leaked water due to improper landscaping and a sidewalk found to be sloping toward the foundation. Many items were unsalvageable. Garbage and rodent nests were found throughout.

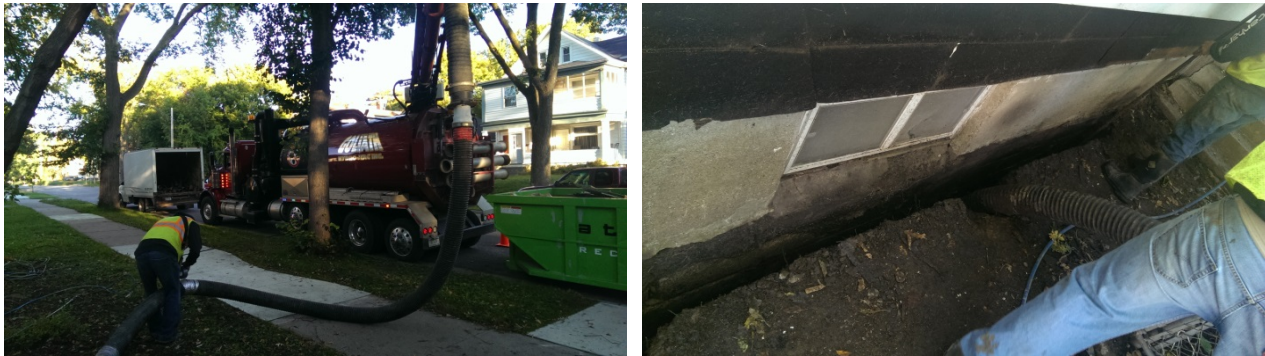
Figure 2. Hydro-vac truck and high pressure water nozzle cutting a narrow trench

The excavationless system shown in Figure 2 uses hydro-vac technology combining high pressure water and a large vacuum truck to create minimal-width trenches. Developed for the utility industry, it enables relatively precise trenching around a foundation to remove soil from a space 3- to 4-in. wide by 8-ft deep. The flexibility of the system enables tunneling under obstacles and around utilities without removal of the obstacles and with little damage to landscapes. The narrow trench can be filled with a combination of liquid/rigid insulating foam to insulate and air seal the foundation wall and rim (Schirber et al. 2014). This method works best for rough foundation surfaces or rubble foundations. For poured concrete and other smooth foundation walls, water and air seal can be accomplished by draping a membrane sheet (or liquid applied) waterproofing against the concrete wall and then inserting the appropriate thickness of rigid extruded polystyrene (XPS) foam and backfilling with dirt.

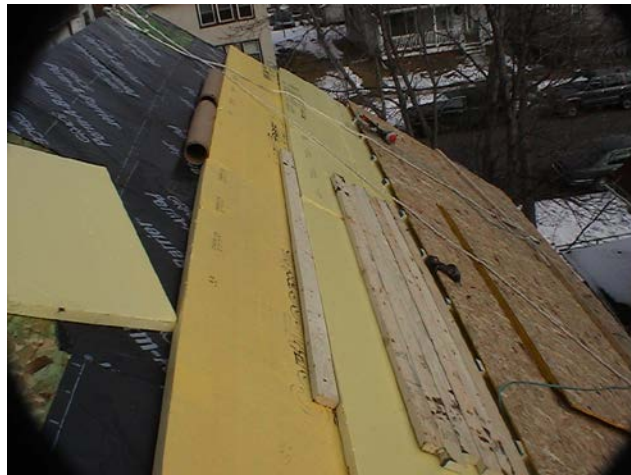
Figure 4. Details for roof overcoat applied to a 1-½-story home

Figure 4 shows the layering of the overcoat materials to create the continuous thermal/air/water barrier and ventilation as applied to the roof of a 1-½-story home.

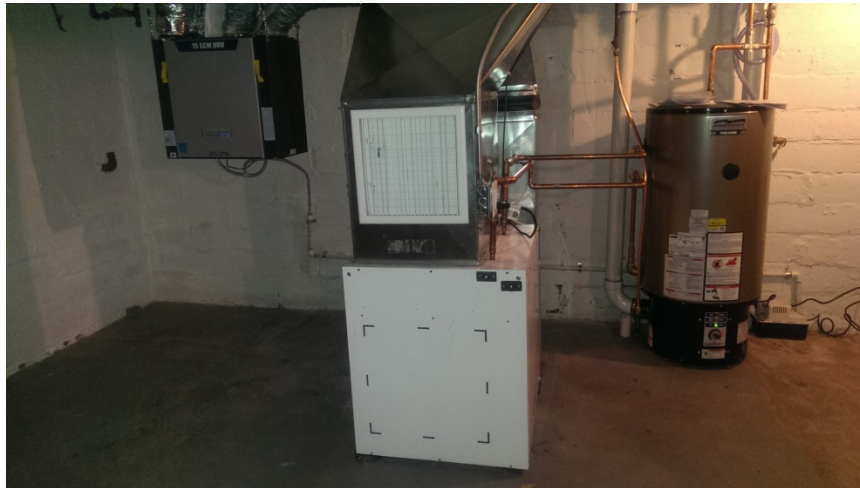
**Figure 5. Example of the combi space and water heating system**

Figure 5 is the actual natural gas-fired combi space and water heating system installed in the project house. The combi system is an existing technology tested and studied by the NorthernSTAR team and its research partner Center for Energy and Environment (CEE) (Schoenbauer et al. 2012). Using a large-capacity water heater as the “furnace,” water is heated then pumped through a coil in the air handler box. As a fan blows air over the coil, the heat from the coil is transferred to the air. The fan distributes the heated air throughout the house. During a laboratory study conducted by the team and CEE, nine different products by various manufacturers were tested for 2 years. The performance data was collected and analyzed. The two best systems were then selected for installation in more than 200 affordable homes participating in DOE’s Weatherization Assistance Program. The systems in 19 homes were monitored for 1 year. Overall energy savings of about 20% were achieved as compared to existing space and water heating (Schoenbauer et al. 2014).

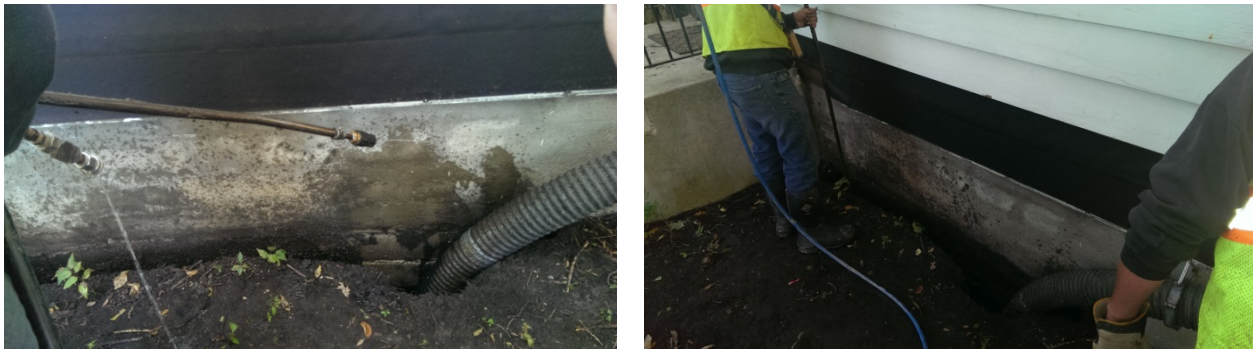
**Figure 6. The hydro-vac high-pressure water wand and vacuum used to create the trench**

The first measure installed on the demonstration home was the exterior foundation insulation. To prepare the home for the measure, the original concrete sidewalk located on one side of the house and connected to the foundation was removed as it was sloping toward the house. Two concrete entry stoops on the front and side of the house were left in place, as the hydro-vac process enables tunneling under obstacles. Figure 6 illustrates how high-pressure water delivered through a handheld wand was used by professionals from Goliath Hydro-Vac Inc. to cut into the soil. A large vacuum hose extracted the soil and water as it was loosened. The completed trench, 4-in. wide by 5-½-ft deep to expose the footing, ran along the perimeter of the house.

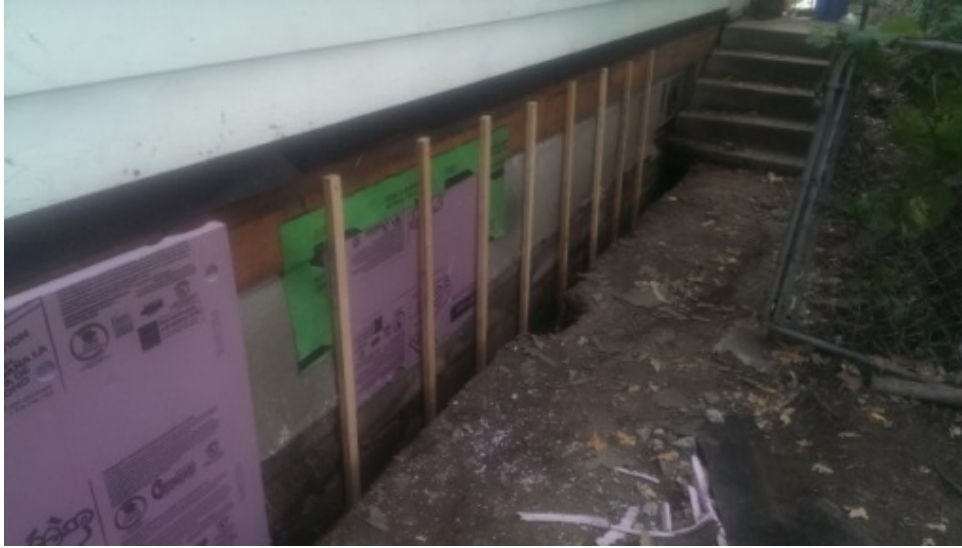
**Figure 7. Furring strips to hold the above-grade rigid form 1 in. from the foundation**

Upon completion of the trench, Cocoon contractors, who had prepared detailed drawings for the system, attached 1-in.-thick furring strips to the rim joist with screws 16 in. on center. Figure 7 shows how the strips were attached flush with the top of the rim and terminated about 1 ft below grade. The left side of the image in Figure 7 also shows how 1-½-in. XPS foam was attached to the furring strips from the top of the rim joist down to the footing.

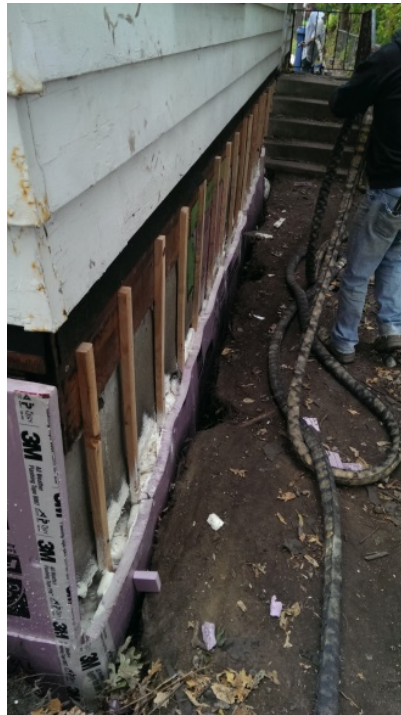
**Figure 8. Pouring the liquid foam into the 1-in. cavity**

The 1-in. cavity created by the furring strip insulation combination provided a closed system into which liquid foam could be “poured” and allowed to expand to fill the rough, imperfect surface of the foundation. The foam was a custom-designed product created by BASF with guidance from the NorthernSTAR team in consideration of climate and soil. After the first few feet of cavity were filled the team determined that the insulation wand was easier to control at shorter depths. Figure 8 shows how the rigid insulation was trimmed just below grade to gain more precise access to the footing while pouring the foam.

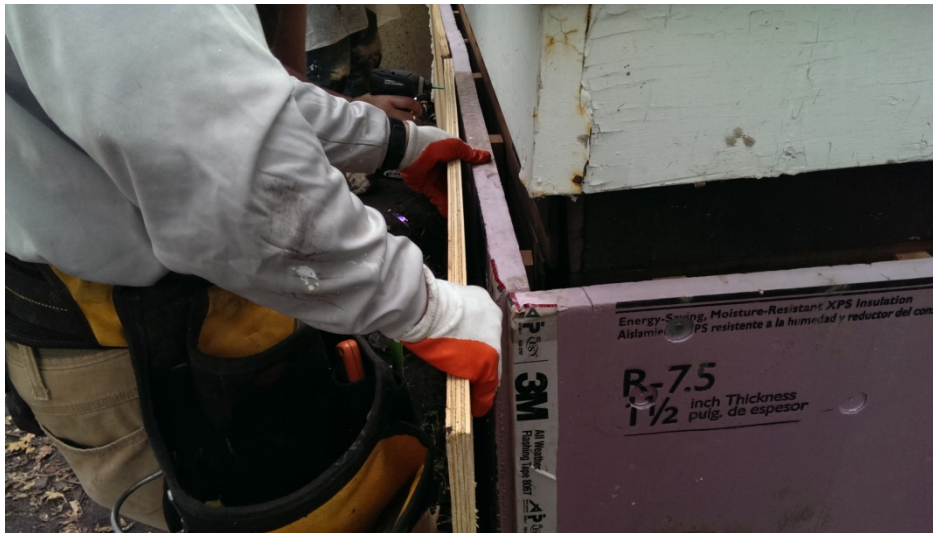
**Figure 9. Above-grade rigid XPS foam held flat with attached plywood**

Additional XPS foam insulation was attached to the furring strips above grade. A sheet of plywood was attached to the furring strips through the foam to prevent bowing of the rigid XPS foam during expansion of the liquid foam (Figure 9).

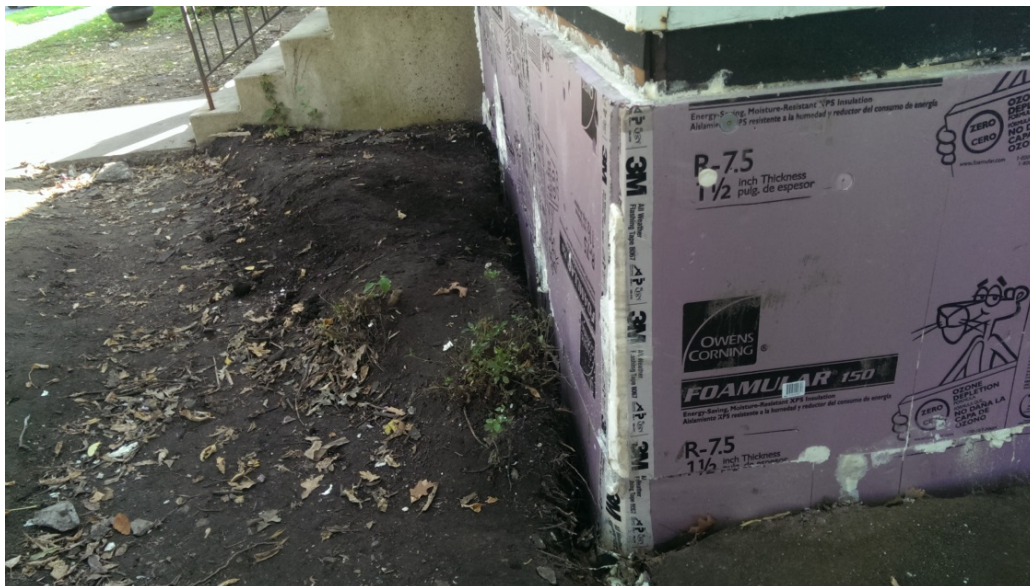
**Figure 10. Smooth, flat surface created by the rigid insulation**

After the liquid foam hardened, the plywood was removed exposing a smooth, plumb surface for a future stucco finishing layer (Figure 10). The rigid-liquid foam components created a one-piece system with a 2-1/2-in. layer of insulation fully adhered to the foundation. Two benefits were achieved: using XPS for part of the system reduced the cost compared to an all-liquid foam system, and enabled the contractor to more accurately estimate cost prior to the application.

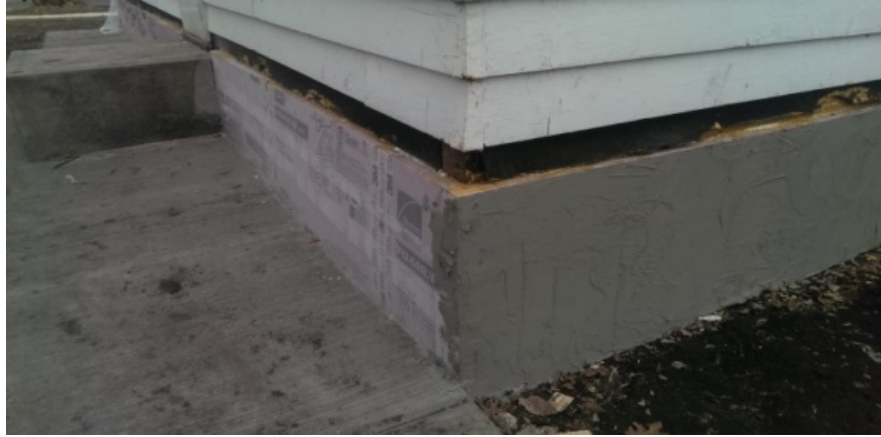
**Figure 11. Foam system with stucco applied to one side**

The final step required a transition from the top of the foam to the siding. Figure 11 shows how the exposed face of the above-grade foam was covered with a trowel-applied stucco product. A volunteer crew from UHW applied the stucco to the smooth side of the XPS.

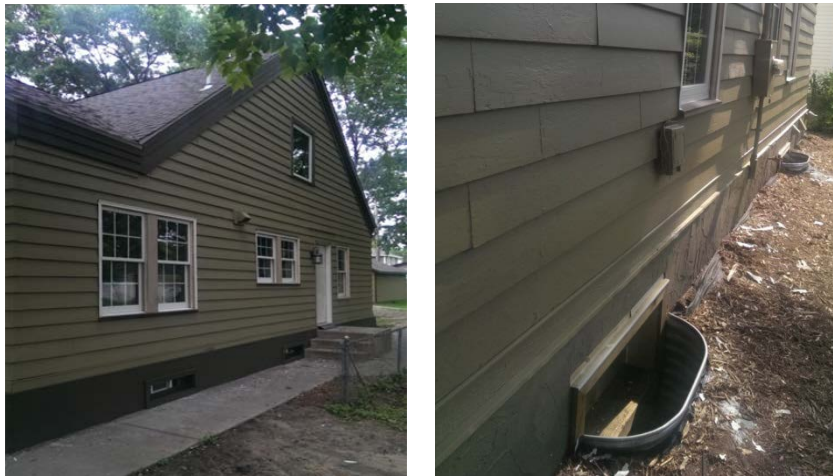
**Figure 12. Completed foundation insulation with trim and windows**

A metal flashing strip was used to divert water from behind and in front of the siding over the foam. It was fashioned to protrude horizontally over the top of the foam to the outer edge and then vertically downward  $\frac{3}{4}$ -in. over the foam. It was attached flat against the house and tucked under the existing building paper and siding. A narrow plank or freeze board painted to match the cedar siding covered the metal flashing. The volunteer crew also cut in the basement window openings and installed windows and wells. Figure 12 shows the finished appearance of the excavationless process with the newly installed sidewalk sloping away from the house and the exterior foundation insulation integrated into the existing siding.

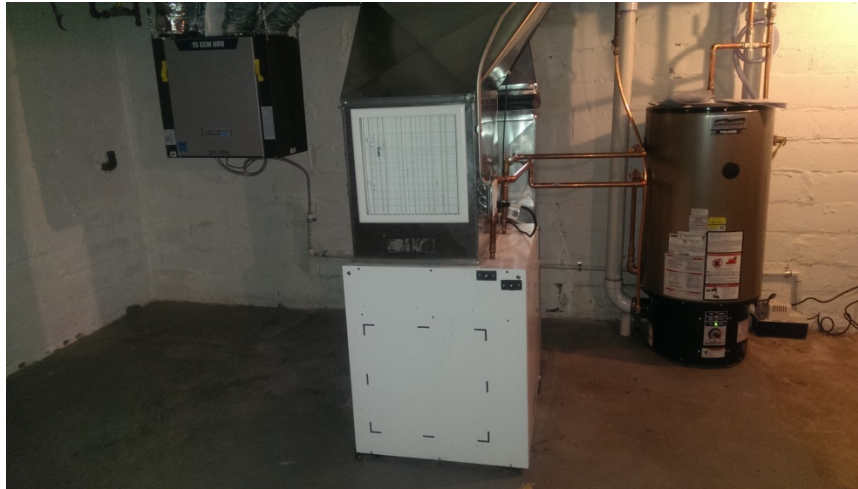
**Figure 13. Combi system installed in the project house, including an HRV**

Figure 13 shows the finished installation of the combination space and water heating system in the demonstration house. The system was chosen for the project as it was one of the best-performing systems in the aforementioned combi study and would meet the needs of the demonstration house in consideration of the performance upgrades and proposed weatherization. A Polaris water heater serves as both the water heater and furnace with a 100,000 Btu output. Air is delivered through the existing duct system with the help of an Enerzone air handler and

hydronic coil, a deep-pleated minimum efficiency rating value (MERV) 13 air filter system to improve comfort and indoor air quality, and an E15 ECM Venmar heat recovery ventilator (HRV).

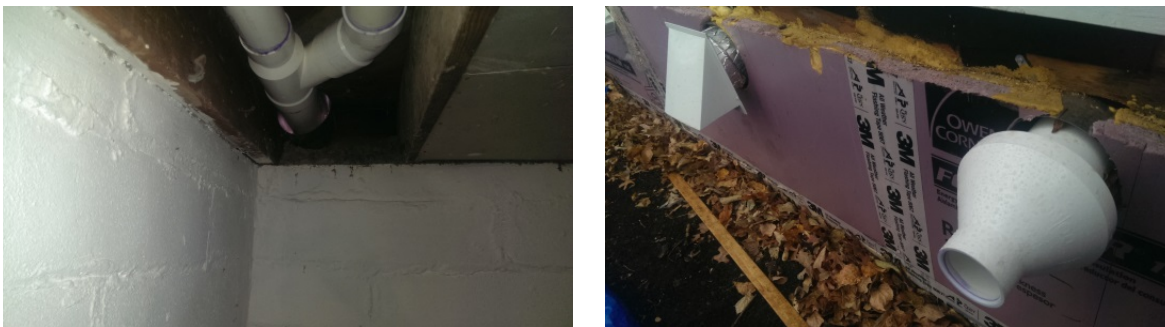
**Figure 14. Exhaust system sleeve installed prior to application of exterior insulation**

The combi system was installed by a local contractor who had participated in the combi study and gained significant experience with the installation. He understood the importance of a tight building enclosure and took measures to ensure that penetrations through the rim would be air tight upon completion of the excavationless system. Figure 14 shows the exhaust system from both inside and outside the home through a specified sleeve installed prior to installation of the excavationless system, which was made airtight before stucco was applied to the rigid insulation.

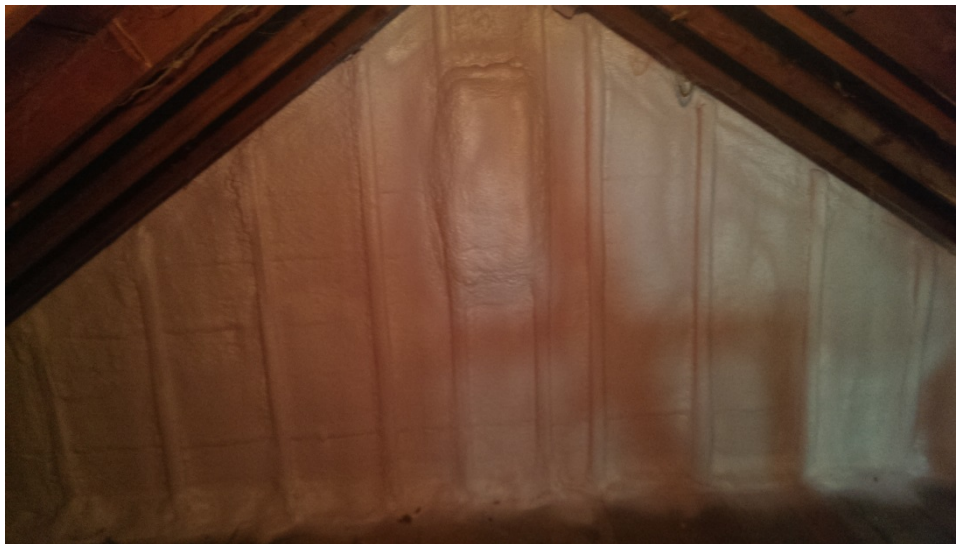
**Figure 15. Interior-applied foam on the gable end**

Because the gable walls of the ½-story could not be insulated from the exterior, insulation was installed on the interior. To do so, the ceiling sheetrock, walls with sheetrock, and wall insulation were removed. The short side walls with tongue and groove pine boards were left in place. Figure 15 shows how Cocoon applied 3 in. of closed-cell spray polyurethane foam (ccSPF) to the interior of the three gable walls between the studs. The entire floor perimeter (including side attic areas behind the knee walls) was also insulated with ccSPF from the top of the floor joists continuous to the top plate of the lower-level wall.

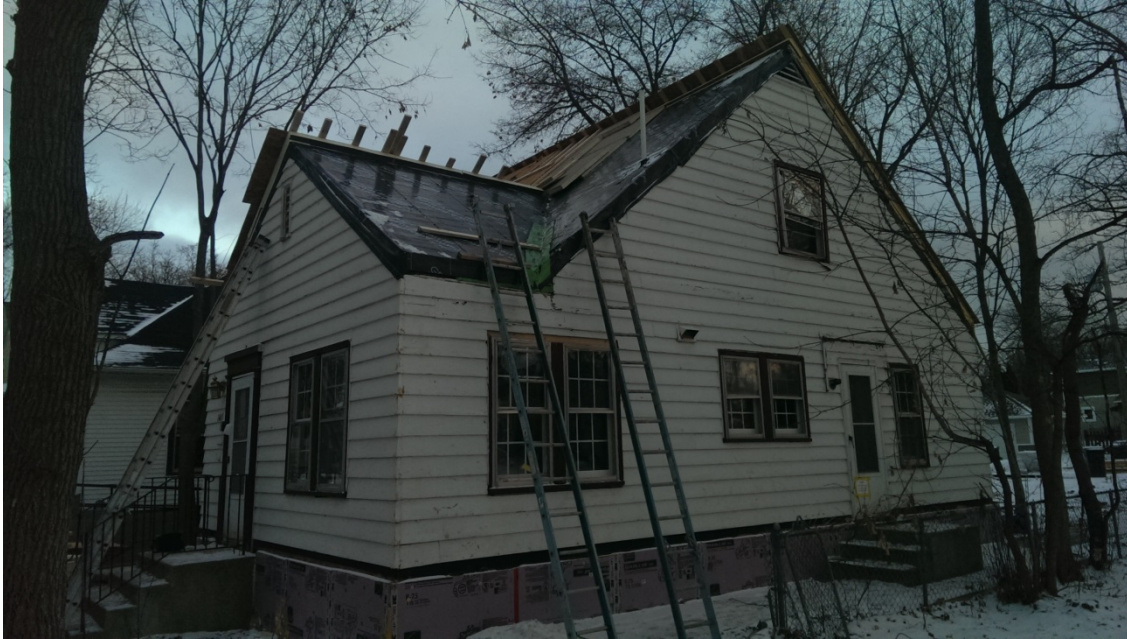
**Figure 16. The air/water membrane applied to the existing roof deck**

flush to the sheathing. Figure 16 shows the W.R. Grace Perm-A-Barrier peel-and-stick membrane applied to the entire roof and lapped over all the roof edges to above the siding.

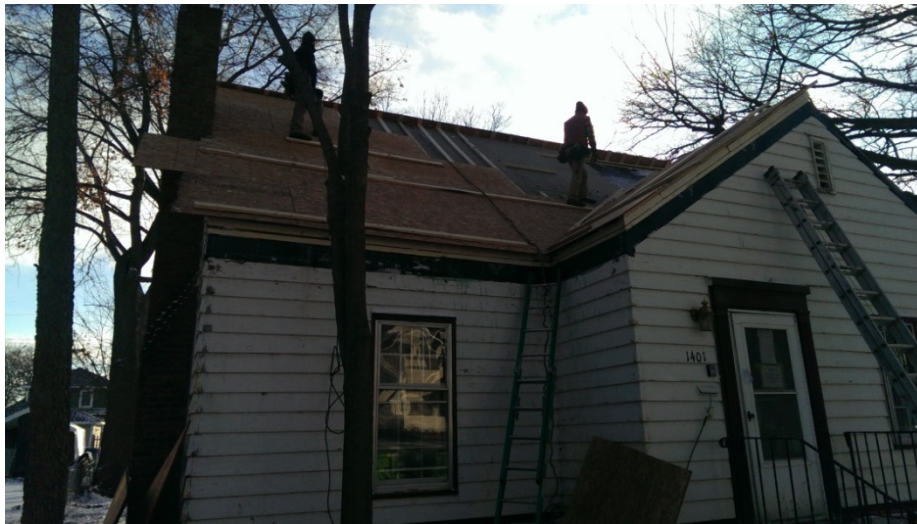
**Figure 17. Installation of the insulation, furring strips, and new roof deck**

Figure 17 below shows how the 5 in. of polyisocyanurate (also referred to as polyiso) rigid foam were attached to the roof deck with all the seams offset to help manage air and water. The 2-in. by 4-in. furring strips were fastened into each rafter with 10-in. GRK lag screws. The rafters were 16 in. on center, and the screws were installed 16-in. vertically apart on the sleeper. Finally, a new roof deck was attached to the furring strips using ½-in. oriented strand board (OSB) sheathing.

The roof insulation was originally specified to be 6 in. (two 3-in. panels, R-6 per inch) of polyiso. The total thickness, however, was reduced to 5 in. because the rafters below the roof deck already contained R-5 batt insulation. This helped save some money for the roof overcoat component.

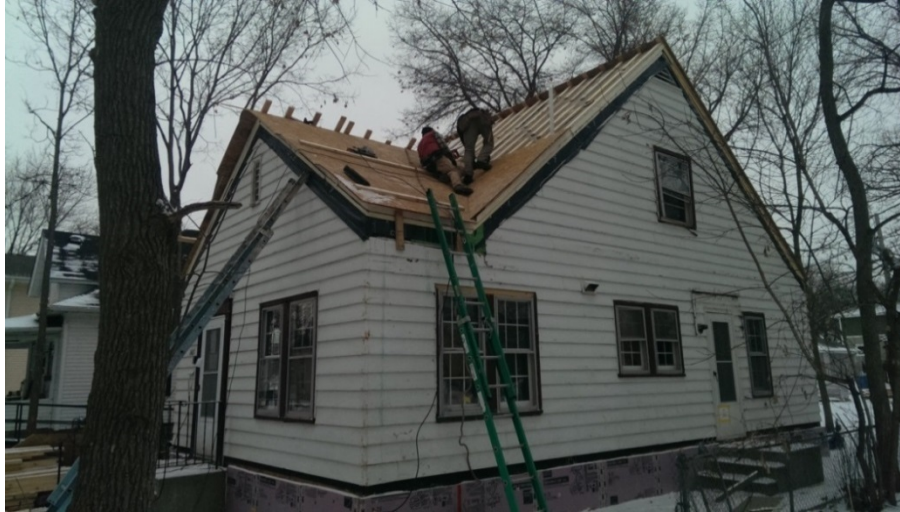
**Figure 18. Furring strips and roof sheathing forming an air channel for ventilation**

When the new roof sheathing was attached to the furring strips, the gap formed an air channel for ventilation (Figure 18).

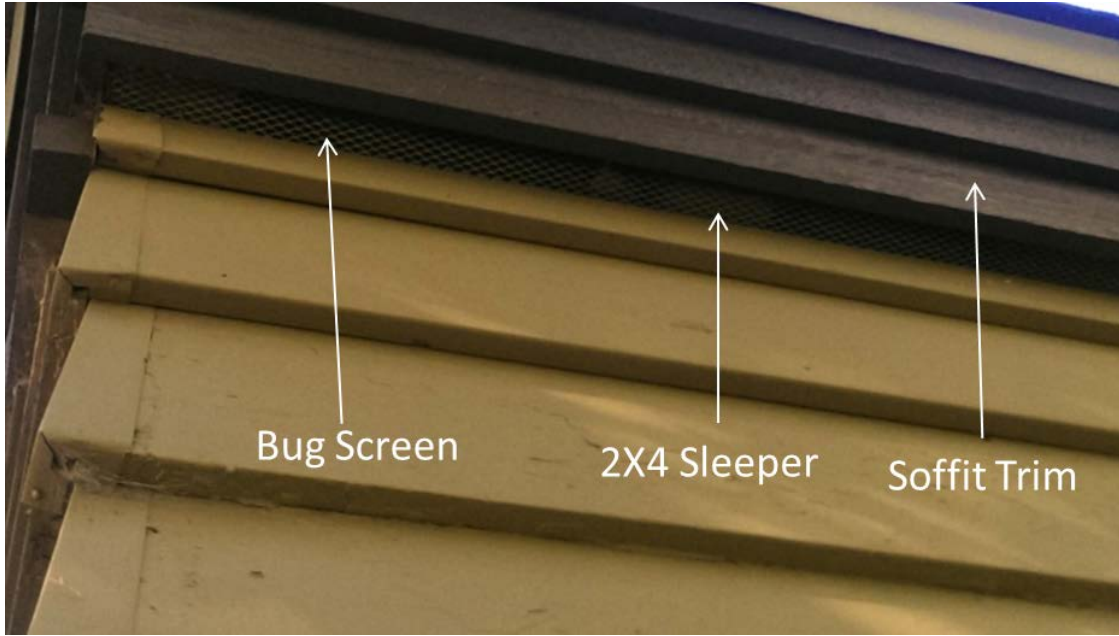
Figure 20. Trim boards attached to the vertical sleepers form air intake channels to the ridge

The short vertical sleepers attach to the wall to create a “soffit” cavity. They are placed directly below the roof furring strips (sleepers) and form a 1-½-in. air channel to move air from the soffit to the roof ridge vent. They were covered with stepped trim boards to finish it off. Next a bug screen was installed on the underside to complete air intake channels from soffit to ridge (Figure 20).

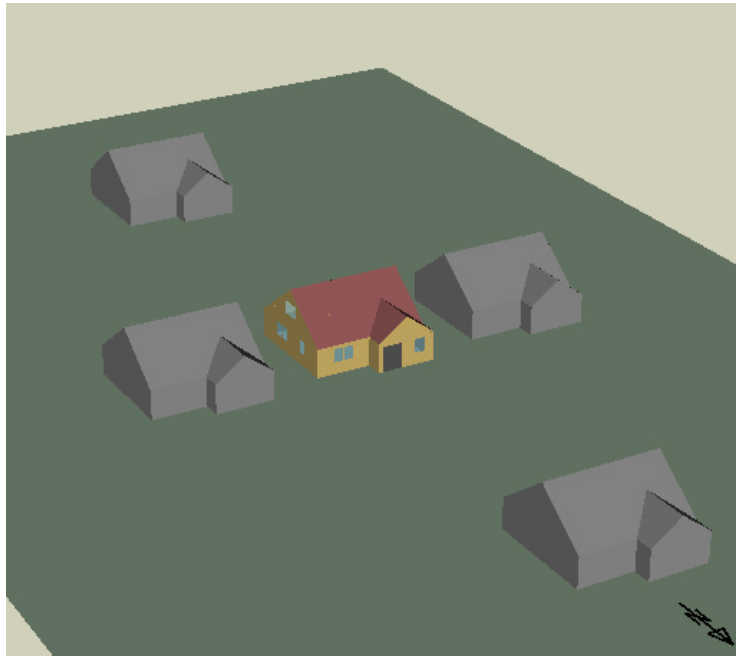
**Figure 22. BEopt model orientation, geometry, and neighboring structures**

Because the research grant period was scheduled to end before the house could be occupied, actual energy use following the rehab efforts could not be measured. To quantify the energy savings, two BEopt building energy optimization software models were completed: a pre-retrofit model based on blower door tests and a survey of the initial conditions, and a post-retrofit model incorporating all the energy and airtightness upgrades. For the pre-retrofit BEopt model, the second floor was modeled with a thermal boundary following the insulated floor joists, knee

walls, slants, and a micro-attic, matching pre-existing conditions. For the post-retrofit BEopt model, the second floor was modeled with the thermal boundary at the roof plane, matching the overcoat retrofit. The exterior geometry and finished square footage of the BEopt model did not change. BEopt’s Minneapolis-St. Paul International Airport climate file was selected for the simulations.

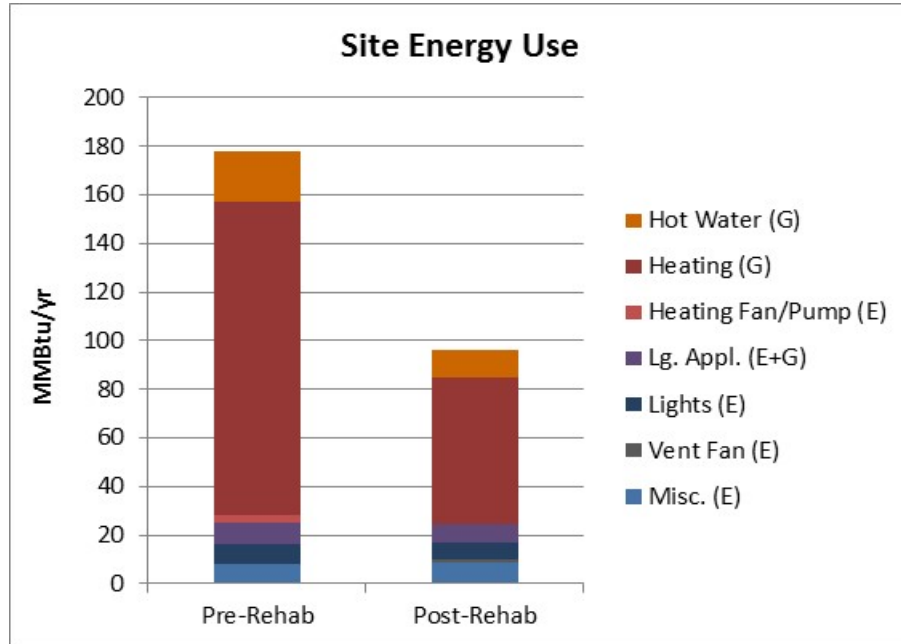
**Figure 23. Modeled pre- and post-retrofit site energy use and savings**

Simulation results showed a large reduction in site heating energy use, which dropped by more than 50%. This reduction was due to both a drop in heat loss through the roof, windows, and air leakage, as well as efficiency gains with the mechanical system. A smaller but still significant reduction in energy use was achieved for DHW heating, due primarily to improvements in the efficiency of the mechanical system. Simulation results showed smaller savings for the air handling unit fan, lighting, and large appliances. Very small increases in ventilation fan energy use resulted from the addition of the Venmar HRV, which provided approximately 60 cfm continuous (meeting the requirements of ASHRAE 62.2 2010) and an increase in miscellaneous energy use such as plug loads. Simulated site energy savings (total) amounted to slightly more than 80 MMBtu/yr, almost a 46% drop in energy use.
