# Short-Term Monitoring Results for Advanced New Construction Test House— Roseville, California

D. Stecher, K. Brozyna, and C. Imm  
*IBACOS, Inc.*

September 2013

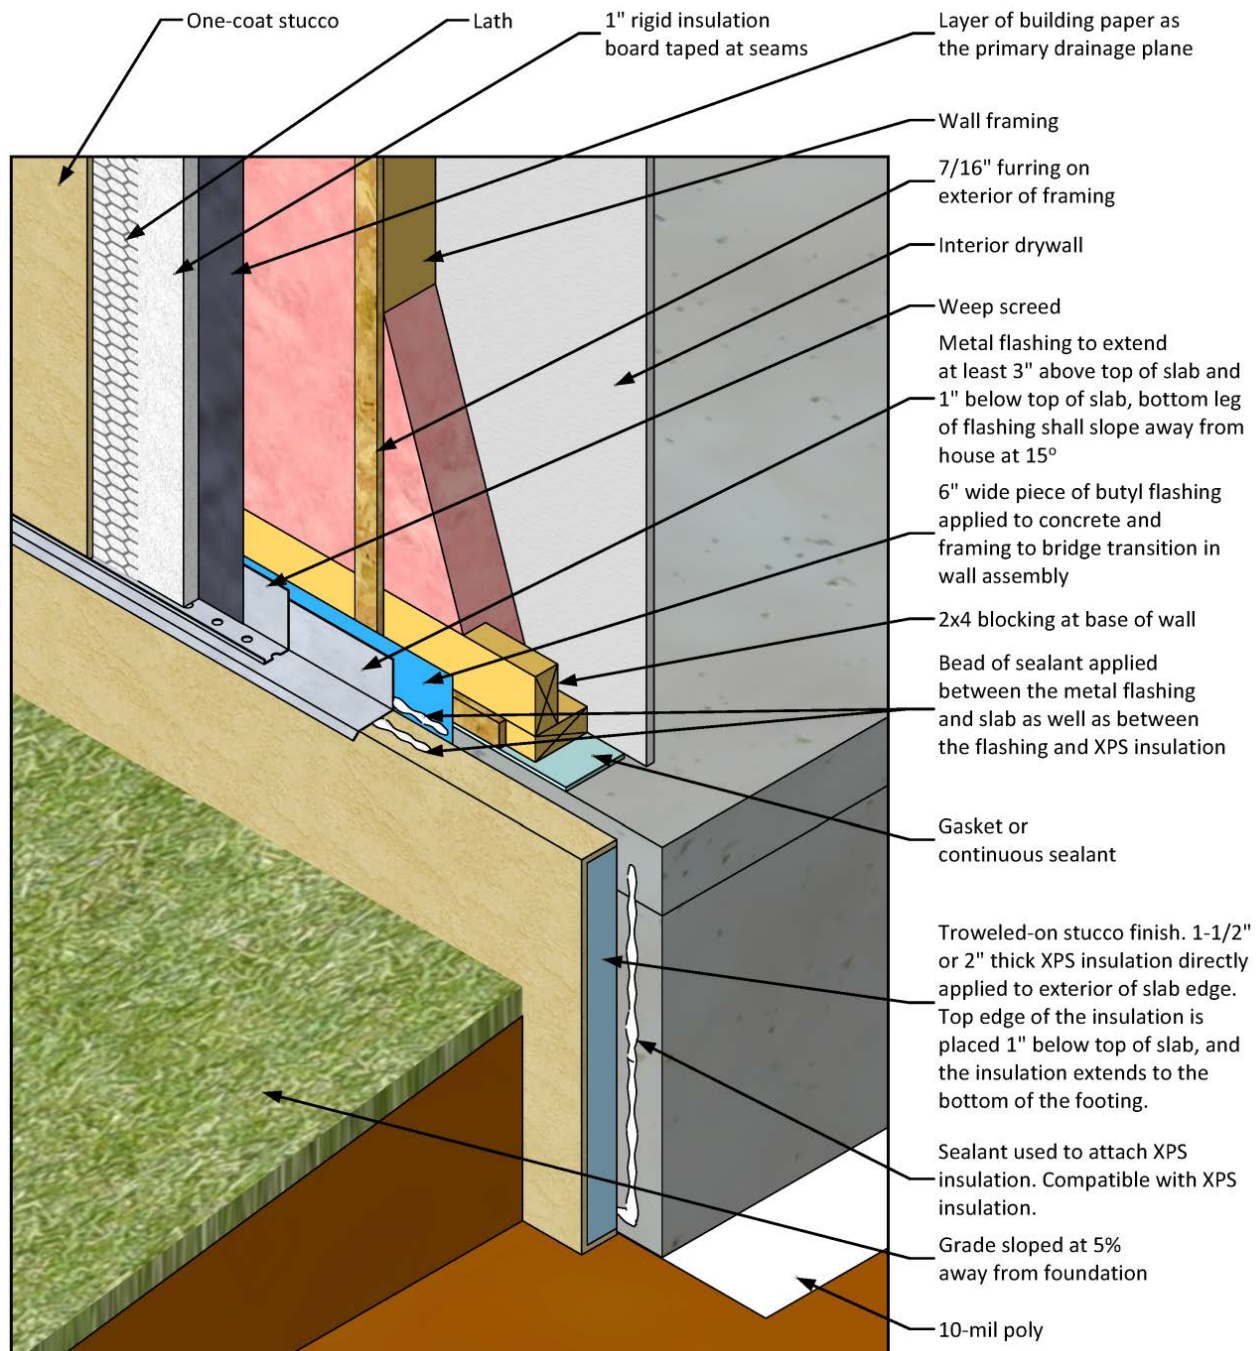
**Figure 2. Slab edge insulation detail**

After discussions with the builder, it was determined that the strategy with the best energy performance—insulating the slab edge and underside of the footing—would not be practical to construct in a reasonable time frame due to perceived difficulties in receiving approval from local code officials for the use of foam under a load-bearing portion of the foundation. The builder's team agreed to the slab edge insulation strategy shown in Figure 2.<sup>1</sup> The strategy consists of insulating the slab edge on the exterior from 1 in. below the finished floor (FF) to a depth of 15 in. below the FF with 2-in.-thick extruded polystyrene (XPS; R-10 total). Although

<sup>1</sup> The open stud framing method shown in Figure 2 is prevalent in the southwestern United States (e.g., Southern California, Nevada, Arizona, and New Mexico). For the most part, the building paper is unsupported (i.e., there is "let-in" bracing and/or shear panels but no wood sheathing over most of the wall plane).

the XPS does not cover the entire height of the slab edge, it is the solution that provided the best insulation for its installation efforts.

To implement this strategy, the foundation contractor was asked to install an additional 8-in.-high form board to the bottom of the existing one to ensure that there was a minimum of 18 in. of smooth slab edge down from the FF. After the form work was removed, the foundation contractor applied the foam to the edge of the slab. To allow for the detailing of the termite break

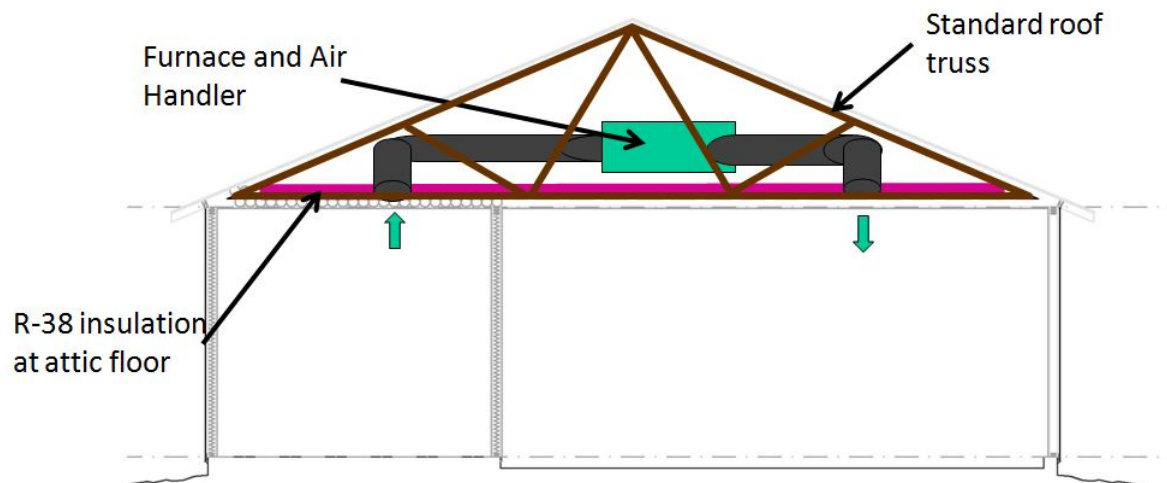
**Figure 3. Mechanical equipment and ductwork within unconditioned space of the vented attic**

In design meetings with the mechanical and framing trade contractors, the group discussed inverting the bulkhead or soffit space that typically would be installed below the ceiling plane and instead locating it at the attic floor, as shown in Figure 3 and Figure 4.

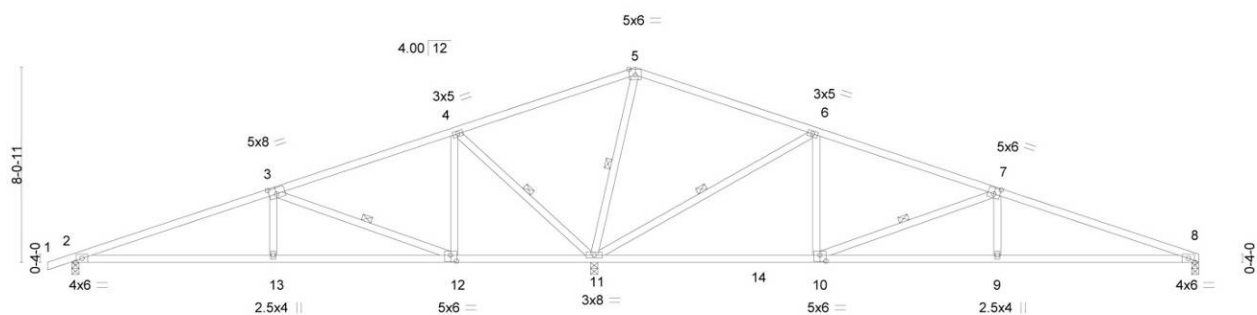
**Figure 5. Standard roof truss for the builder's Plan 4 houses**

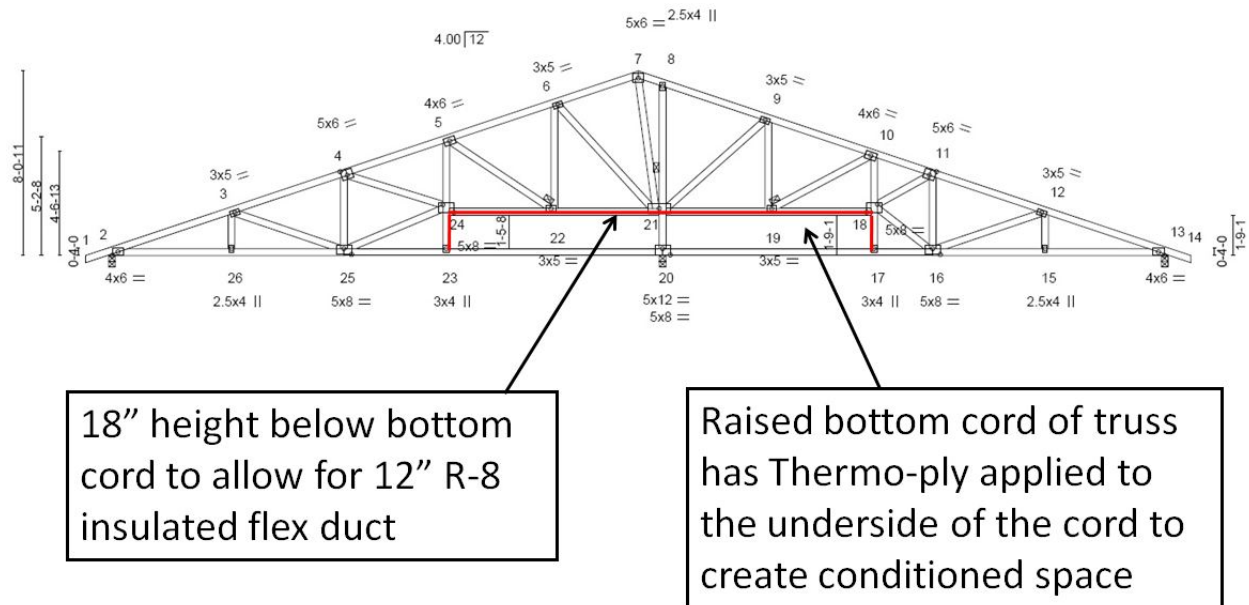
**Figure 6. Modified roof truss for the Plan 4 test house, which provides a chase for ductwork at the ceiling plane and has 16-in. raised heels along the perimeter**

The roof truss manufacturer also participated in the design discussions and was able to provide a proposed redesign of the roof truss within the time allotted. By modifying the original design (see Figure 5), the proposed design as shown in Figure 6 provided a centrally located chase along the floor of the attic. To provide the central bearing location that was consistent with the existing structural design for the home, a framing member was dropped from the truss web to bear on the interior load-bearing partition wall. Figure 7 shows in plan view the approximate area of the cavity created by the new truss design and the ductwork layout. Not all the duct runs terminate within the centralized bulkhead. Due to the layout of the girder trusses, the bulkhead area was limited to the area shown. To maintain register locations at the ceiling plane, rather than dropping down into a high sidewall register (a recommended change for future projects), some runs had to penetrate through the side of the bulkhead and extend up to 7 ft outside of it. Approximately 15% of the total installed duct length was outside conditioned space; this was not accounted for in the final BEopt models because that software does not allow for a fractional ductwork location.

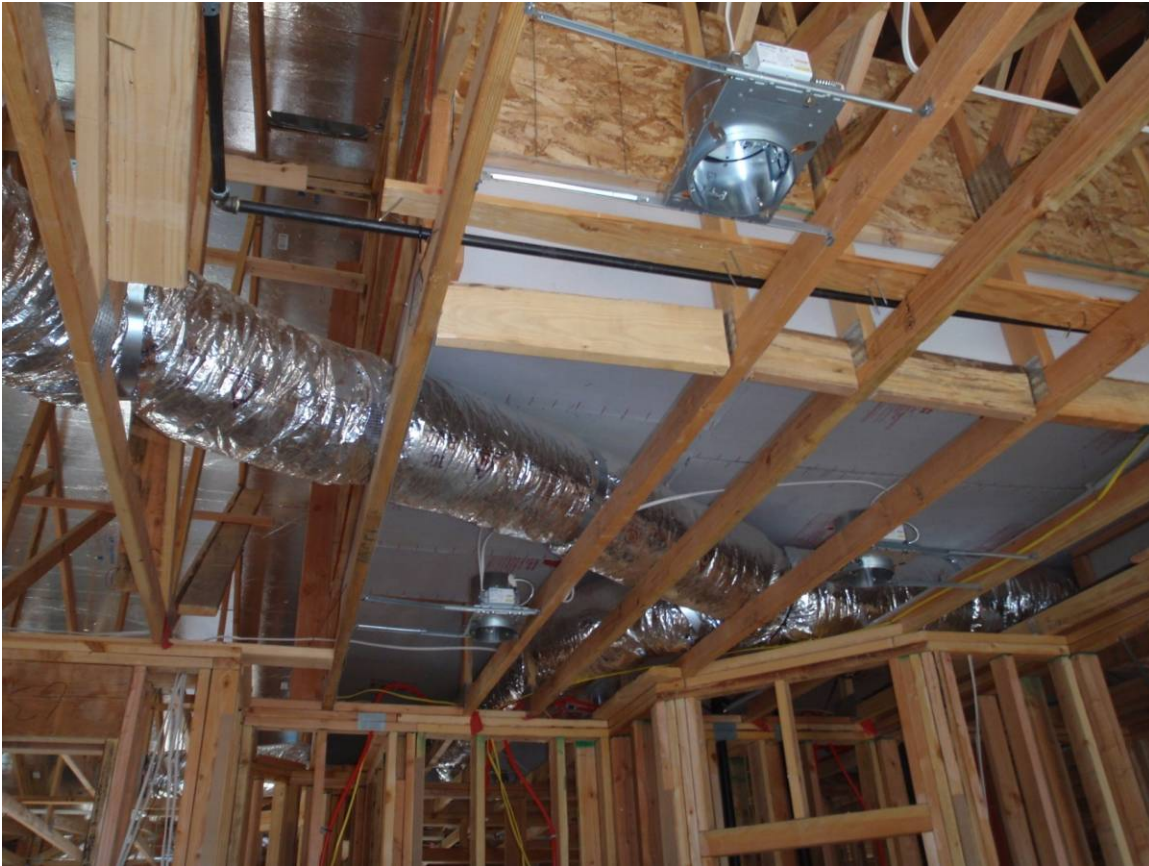
**Figure 8. Ductwork centrally distributed within the conditioned space of the bulkhead at the attic floor**

Although not all of the ductwork fit in the area of the cavity, care was taken during installation to ensure that any ductwork passing out of the cavity (see Figure 8) was well sealed at the penetration, and the portions outside the cavity were buried in the full depth of loose-fill insulation.

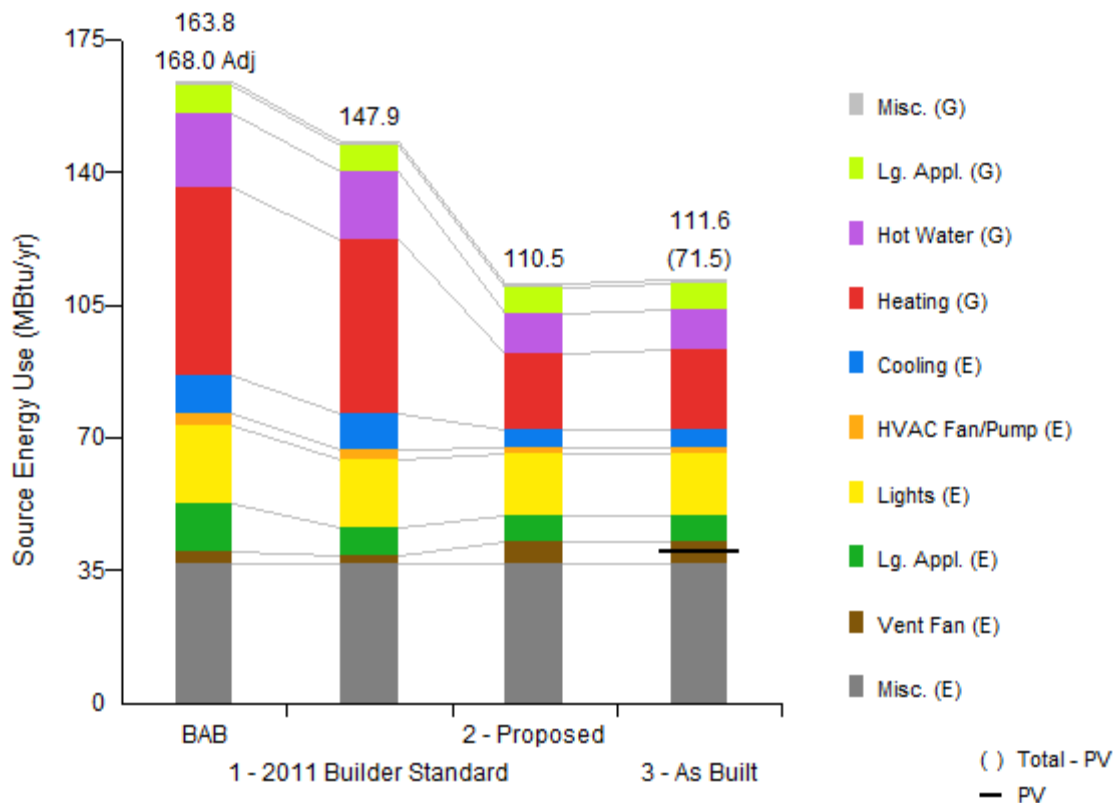
Figure 9. Output from BEopt source energy modeling by subcategory

BEopt models predicted that the builder's standard inputs would provide a savings of 11.8% relative to the BA House Simulation Protocols (Hendron and Engebrecht 2010), whereas the prototype house specifications provided savings of 35% without PV and 60% with PV (both relative to the BA House Simulation Protocols) (Hendron and Engebrecht 2010). Figure 9 illustrates this comparison.

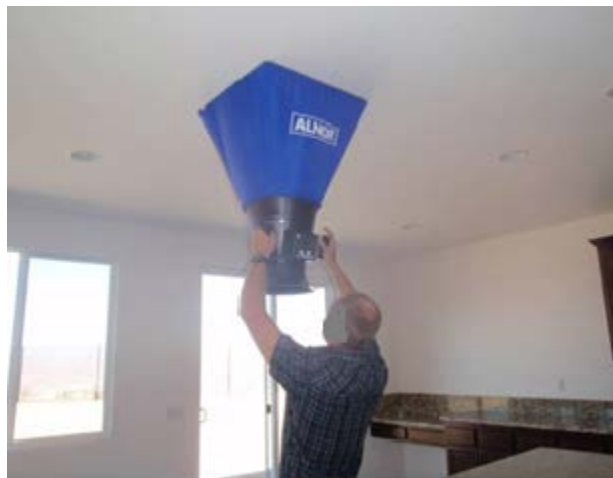
**Figure 10. Low-flow balometer testing**

The airflow from each supply register in each room was measured in cooling mode using a calibrated low-flow balometer as shown in Figure 10. The readings are documented for comparison to the design values for airflow. If necessary, flows can be adjusted and balanced to meet the design values through the use of balancing dampers in the ductwork. Flow hood measurements at each register will quantify airflow at those registers and will allow a comparison to be made against design values and to determine the existence of any potential low airflow situations that may affect occupant comfort.

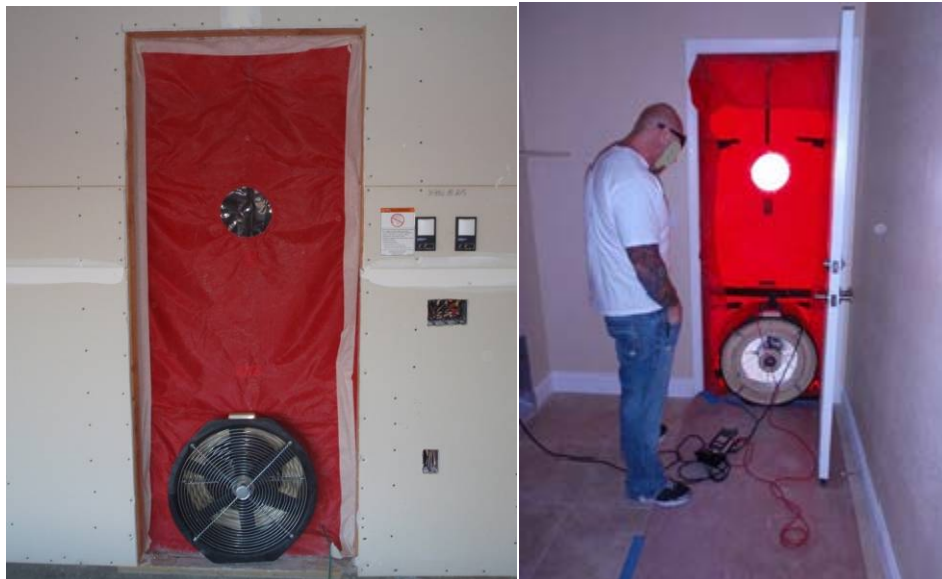
**Figure 11. Blower door testing**

An intermediate blower door test (shown in Figure 11) was performed after drywall was installed but before trim, floors, and ceiling penetrations were sealed to measure the amount of air leakage in the whole house.

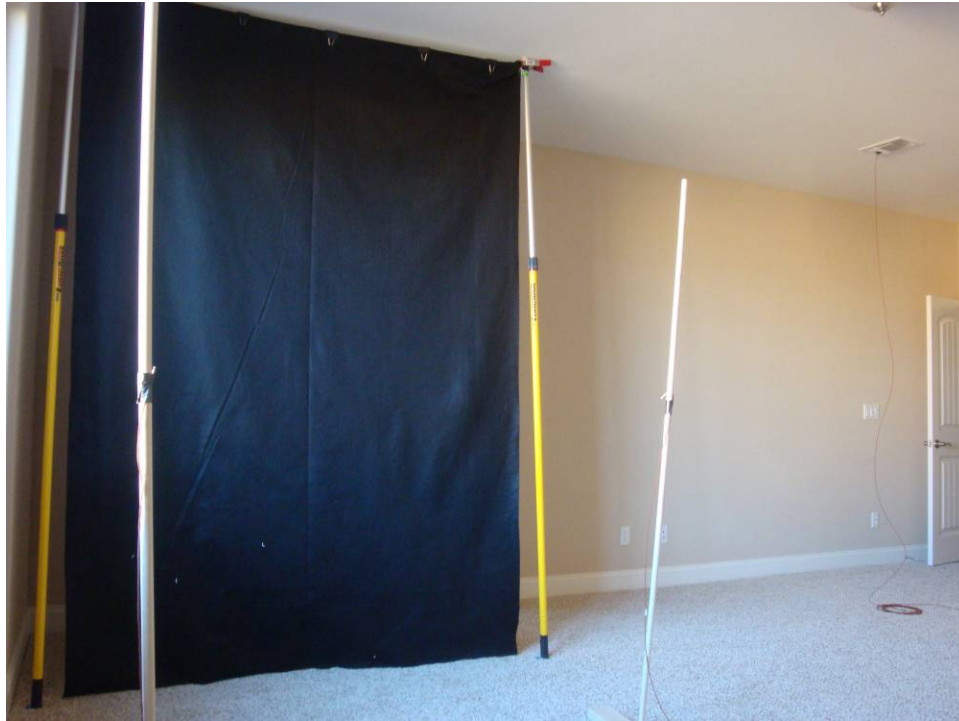
**Figure 12. Black felt IR viewing screen positioned adjacent to an exterior wall and parallel to the primary register airflow path**

Infrared cameras “see” the temperatures of surfaces but not air. For the camera to be able to see the flow pattern of the air, a “screen” was created from a 6-ft × 9-ft black sheet of felt, mounted on two paint-roller extension poles and a shower rod, with sufficient clamps to hold the assembly together (see Figure 12). When this black felt screen was placed parallel to the primary flow path from the register, its surface temperature responded based on the temperature and flow pattern of the air leaving the supply register. Then IR pictures of the felt were taken to visually observe flow patterns. Test equipment consisted of an IR camera and the black felt screen assembly.

The purpose of this testing was to observe if flow from the ceiling-mounted registers located toward the interior walls could provide sufficient “throw” to ensure that conditioned air reached the exterior walls. Flow was observed in both the heating mode and the cooling mode.

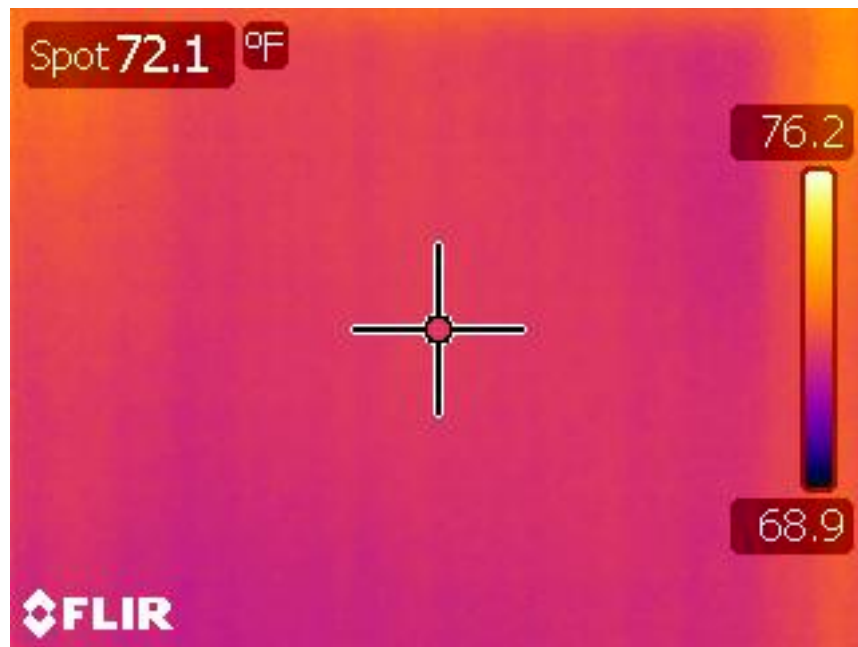
Figure 13. IR photo of black felt screen during cooling system operation (temperature scale in °F)

Conditions during the test were clear, 50°F outdoor temperature, and 70°F indoor temperature, and the testing was performed between 6:00 p.m. and 8:00 p.m. Because outdoor conditions were mild, it was possible to operate the HVAC system in both the heating mode and the cooling mode. During the cooling mode, the observed flow behavior from the register indicated that air was mixing uniformly upon leaving the register, as shown in Figure 13.

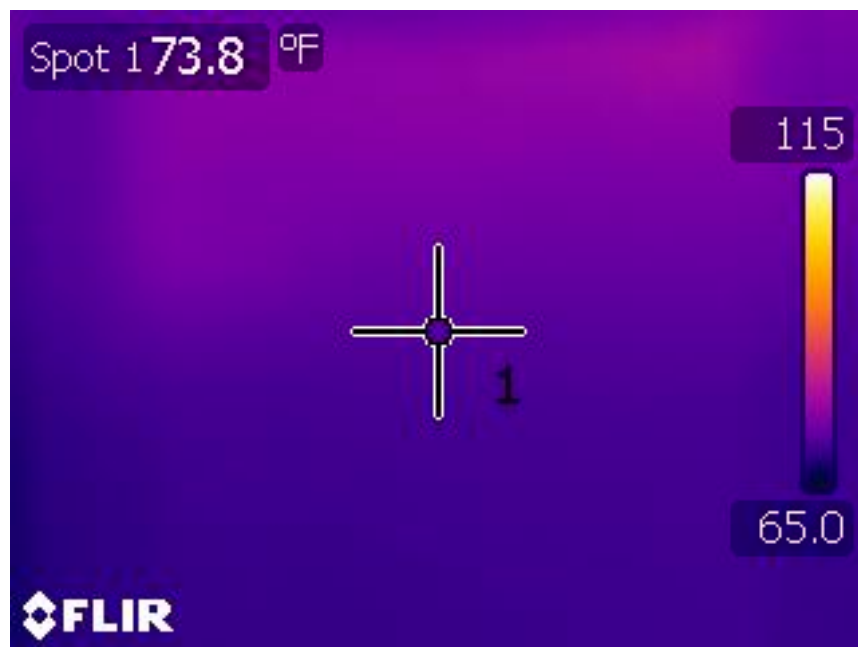
Figure 14. IR photo of black felt screen during heating system operation (temperature scale in °F)

The flow in heating mode was observed to reach the exterior wall of the room, as shown in Figure 14 and Figure 15. Note that the use of a wide range for these two photos prevents sharp visual contrast between the hot and cool areas. However, significant stratification was observed, with an obvious layer of cooler air extending upward about 4 ft from the floor. Further testing was performed in other rooms of the house (see Figure 16 and Figure 17) and revealed behavior consistent with that observed in the master bedroom. These measurements were taken by IR photographing of the walls of the house, revealing a clear pattern of stratification.

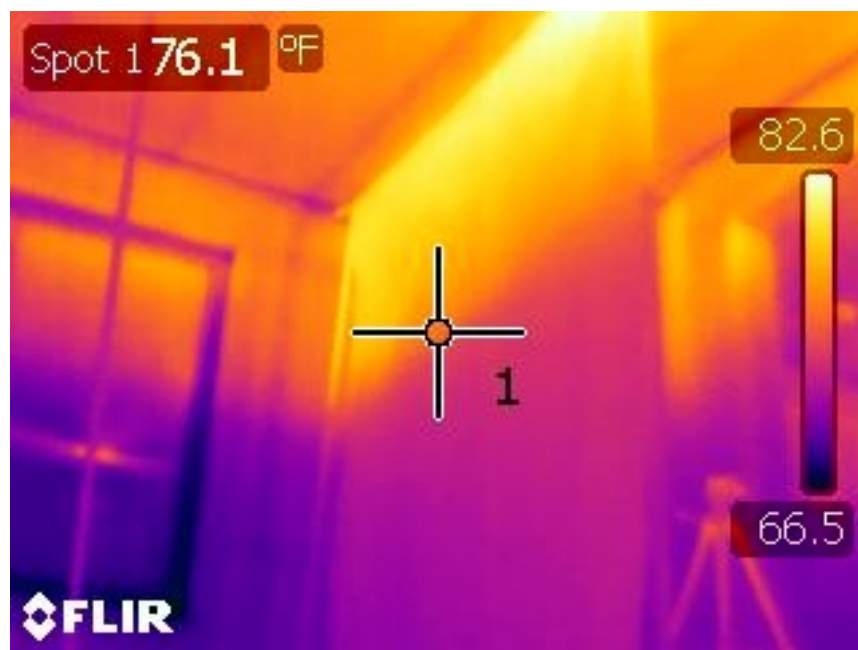
Figure 15. IR photo of black felt screen shortly after system turnoff, clearly showing stratification (temperature scale in °F)

Temperature stratification observed via IR photography during and after heating system operation indicated a difference of approximately 7°F (3.9°C) between the head and ankles of a standing occupant. According to ASHRAE Standard 55, this house would fall into Class C of Section 5.2.4.3 Vertical Temperature Difference, and approximately 15% of the occupants would be dissatisfied (ASHRAE 2010b).

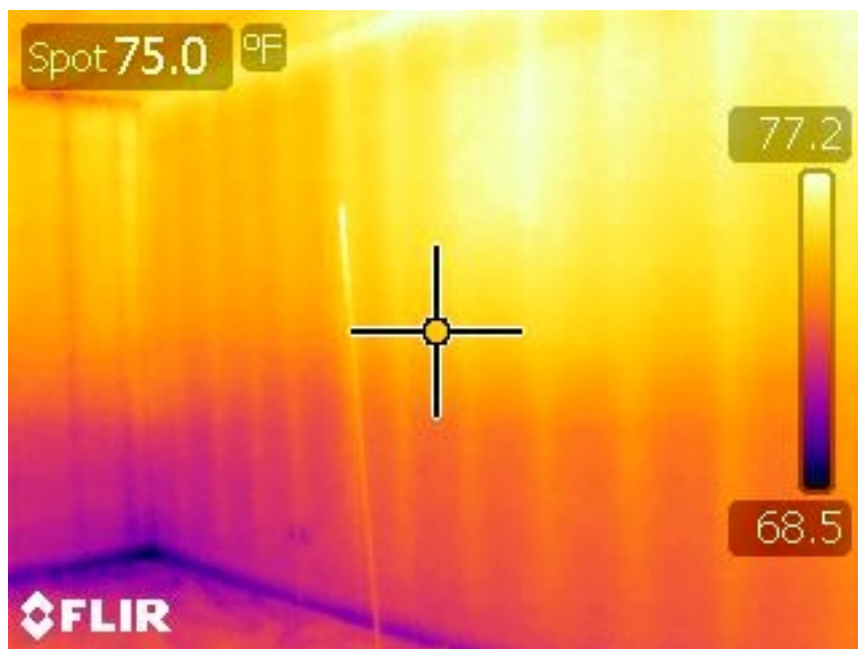
Figure 16. IR photo showing vertical stratification (temperature scale in °F)

To help determine the cause of this behavior, IR photography during heating system operation also was measured in a nearby house built to the builder's typical practices with respect to the construction of the thermal enclosure and the placement of the HVAC registers. Both houses shared the same floor plan and orientation, and testing was performed after dark. Observations from the house built to the builder's typical standard showed the same behavior. No black felt setup was required in the nearby house because taking an IR picture of the walls was sufficient to observe the stratification.

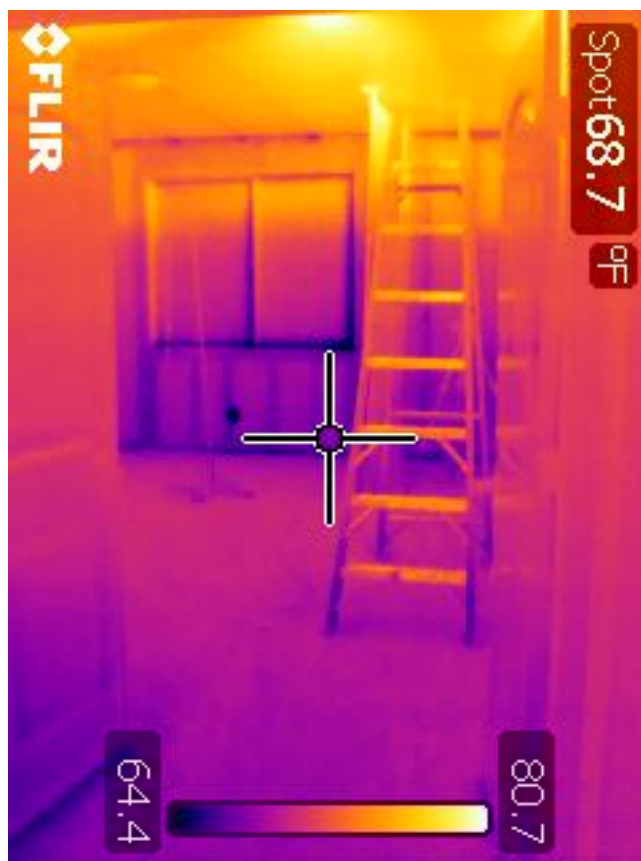
Figure 17. IR photo showing uniform horizontal distribution of heated air (temperature scale in °F)

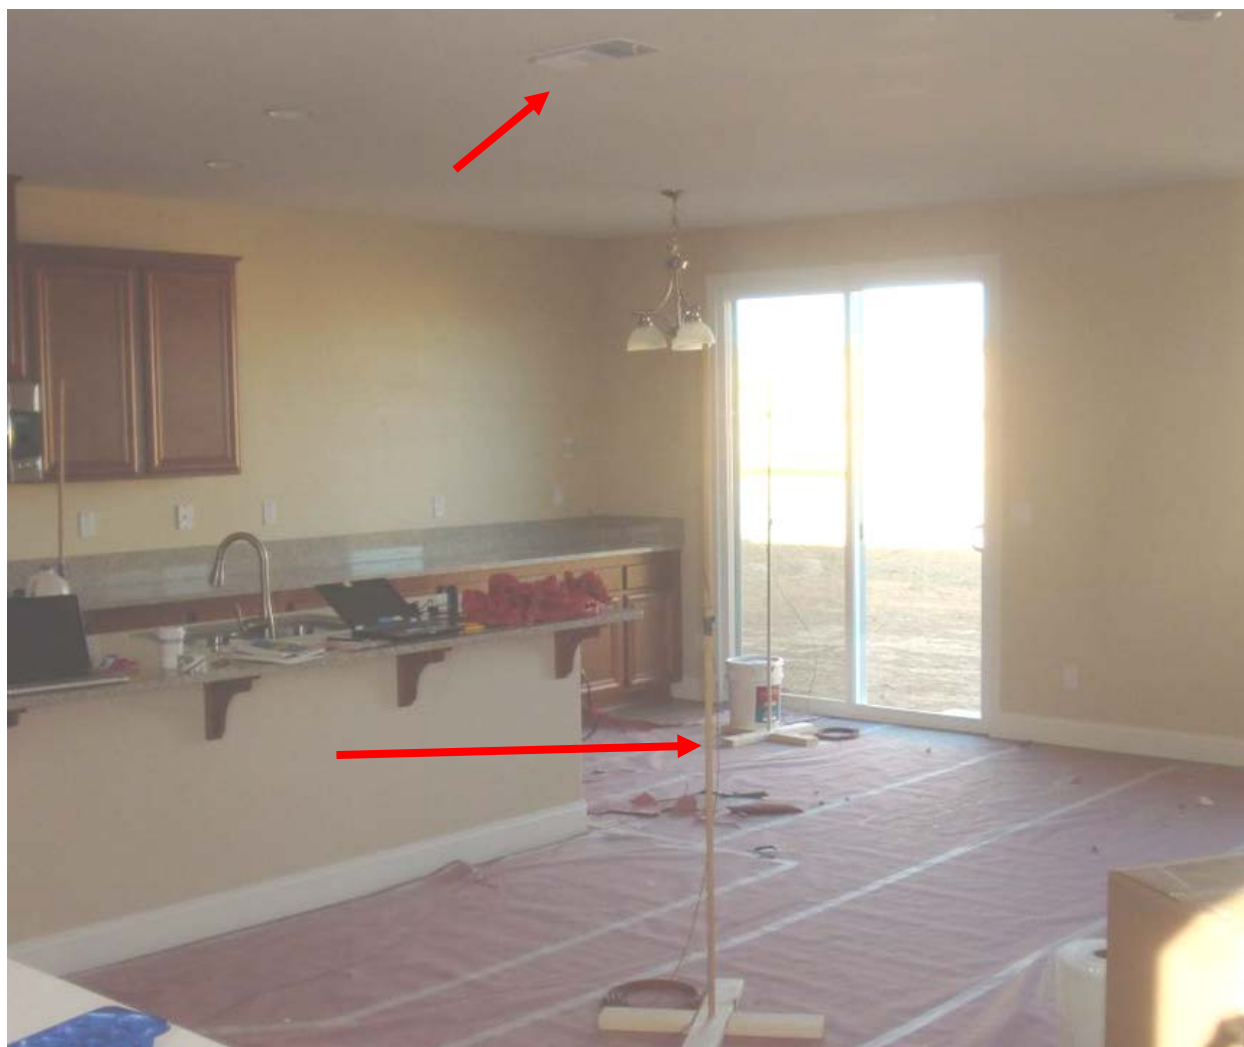
**Figure 19. Sensor stands and a supply register in the kitchen/family room area**

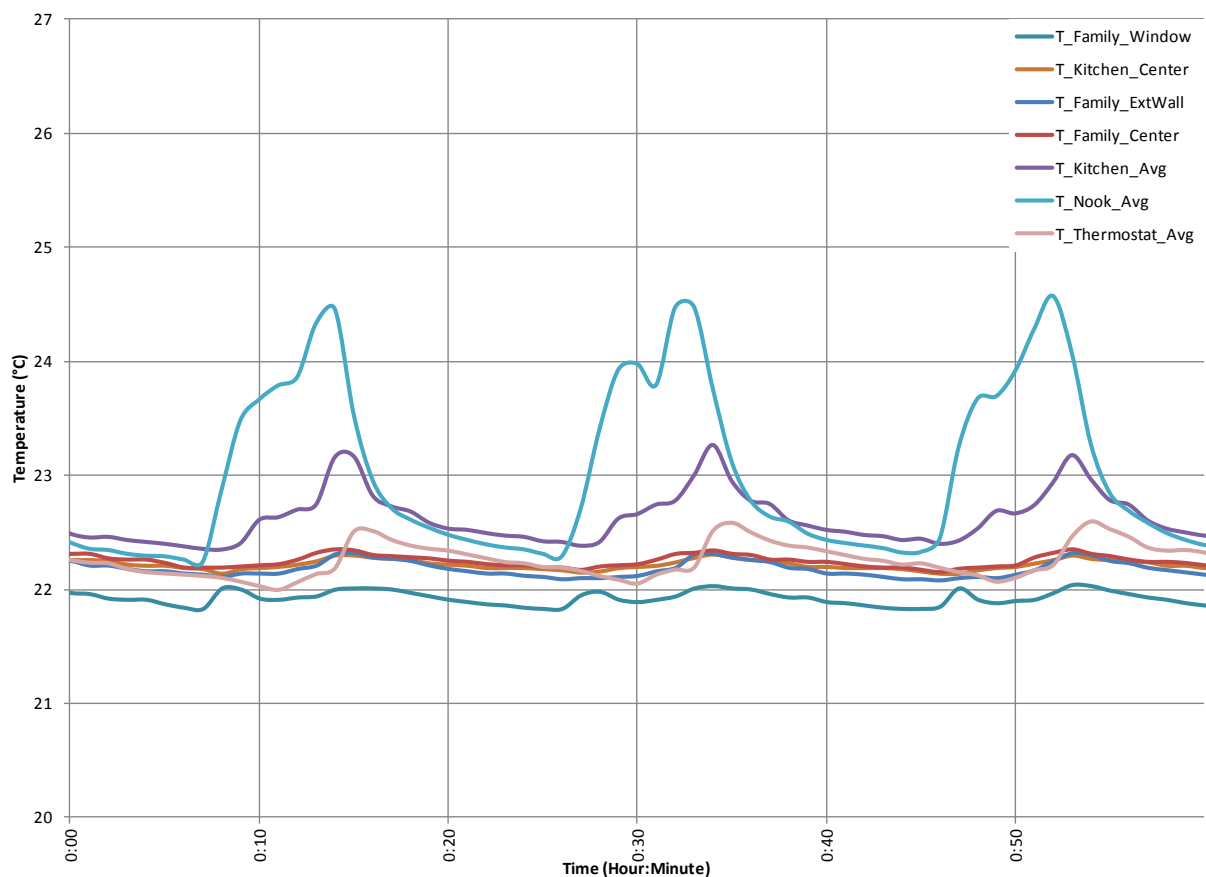
**Figure 20. Temperatures (°C) at various sensor locations in the kitchen/family room area during 1 h**

partition wall near the exterior wall and approximately 10 ft horizontally from the register, its intended purpose was to measure the conditions near the exterior wall. Although it was unintentional that this sensor was hit by the register airflow, it is indicative of the ability of conditioned air to reach the exterior wall. Figure 20 shows an example of the variation observed in sensor locations in the kitchen/family room area during the course of a typical hour when three heating cycles occurred. The temperature measurements in the master bedroom did not display this behavior (see Figure 21) because their locations were not directly in line with the airstream from the heating supply register. Ignoring this behavior, intraroom variation in temperature in the kitchen/family room area was within 1.8°F (1.0°C).

The maximum temperature of air leaving the heating register was 118°F (48.0°C). Cyclical behavior observed in Figure 20 and Figure 21 was consistent throughout the 11-h test period.

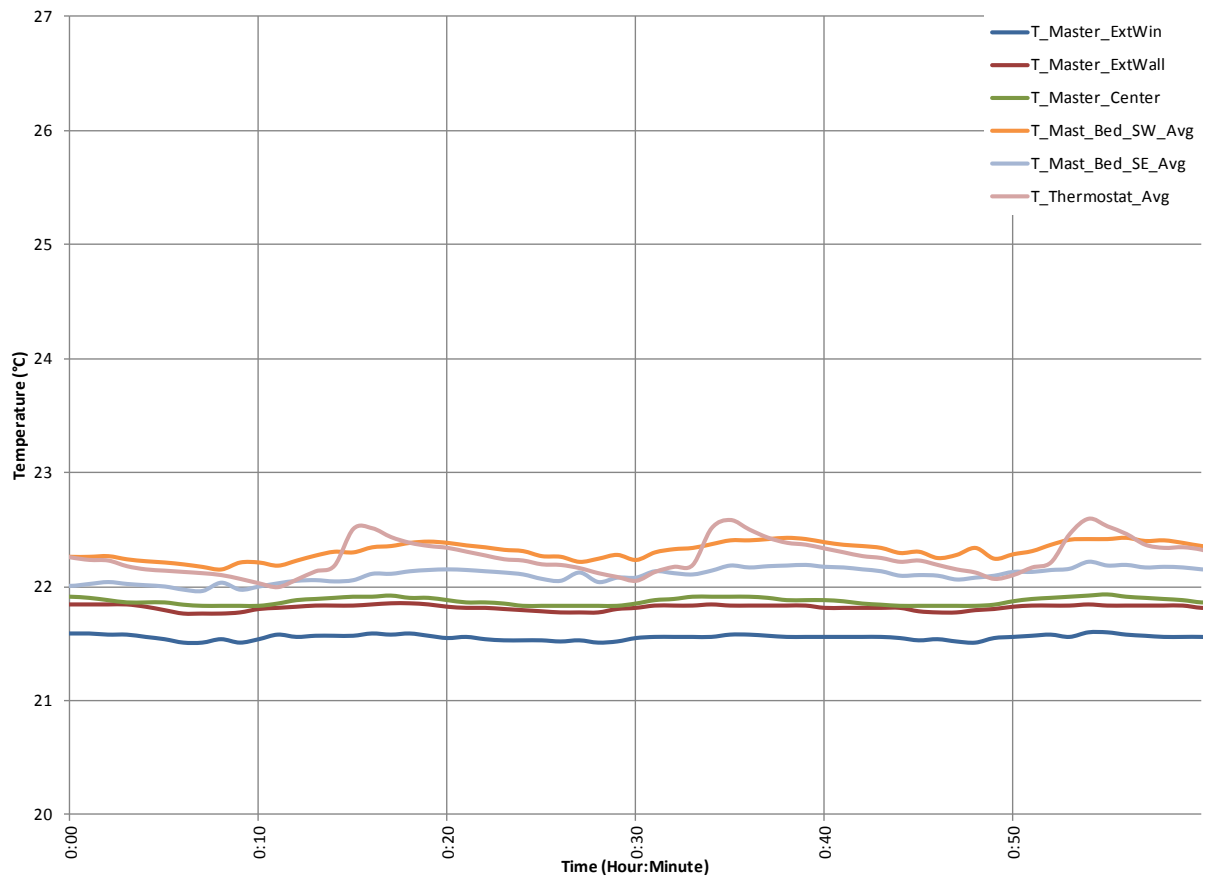
**Figure 21. Temperatures (°C) at various sensor locations in the master bedroom during 1 h**
