WALLS BEHIND TUBS AND SHOWERS

WALLS BEHIND FIREPLACES

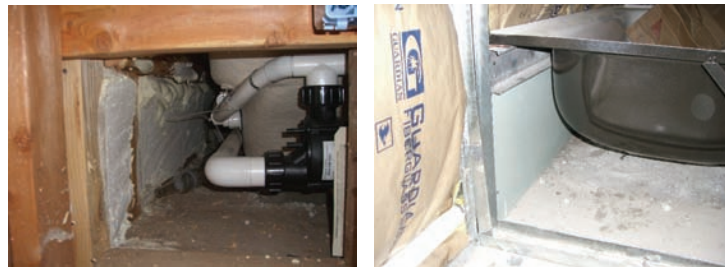
When installing a shower/tub, the builder needs to ensure that an interior air barrier is provided for exterior walls prior to the shower/tub being set. Either the builder or the designated trade (typically the framer) needs to provide the air barrier. This could be as simply as a thin board sheathing product (Thermo-ply or equivalent) or could be rigid insulation or spray foam. If utilizing spray foam, the entire cavity up to the lip of the shower/tub should be filled.

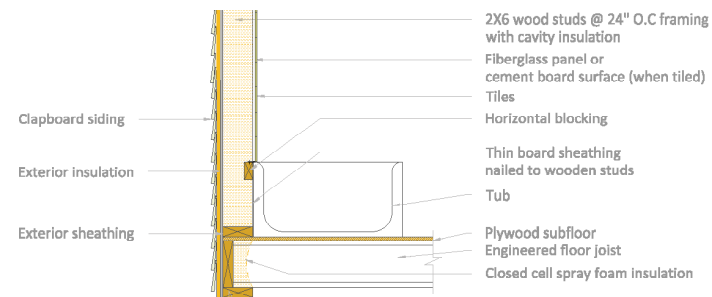
When tiling the shower/tub on an exterior wall, it is recommended that the builder include installation of a thin board sheathing product (Thermo-ply or equivalent) in the framer's scope of work. This would allow the same sequencing of the trades to occur, but a continuous air barrier would be provided on the exterior shower/tub wall prior to the shower/tub being set.

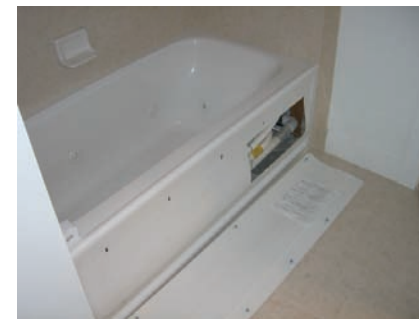
During a blower door test (depressurizing the house to 50 Pascals), the panel on this tub fell off due to the amount of air that was being pulled from the space behind this tub, so this is clearly connected to the exterior in some manner. In this case, it wasn't an exterior wall, this was a 2nd floor partition wall that was connected to the vented attic through penetrations that were made in the top plate and weren't sealed. It is recommended that all shower/tubs have an air barrier behind the tub regardless if it is an exterior or interior wall.

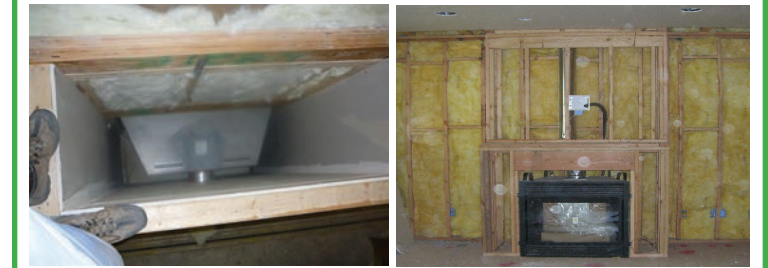
Just like the void behind showers/tubs, it is common for the furred out space behind fireplaces to be missing the interior air barrier. It is recommended that the builder include installation of this air barrier in the framer's scope of work. Again this can be a using numerous products, such as thin board sheathing (Thermo-ply or equivalent) or drywall.
