Reaching for Peak Performance in Existing Homes – A Cold Climate Study With Synergy Construction

C. Gates and R. Osser
Building Science Corporation

December 2011

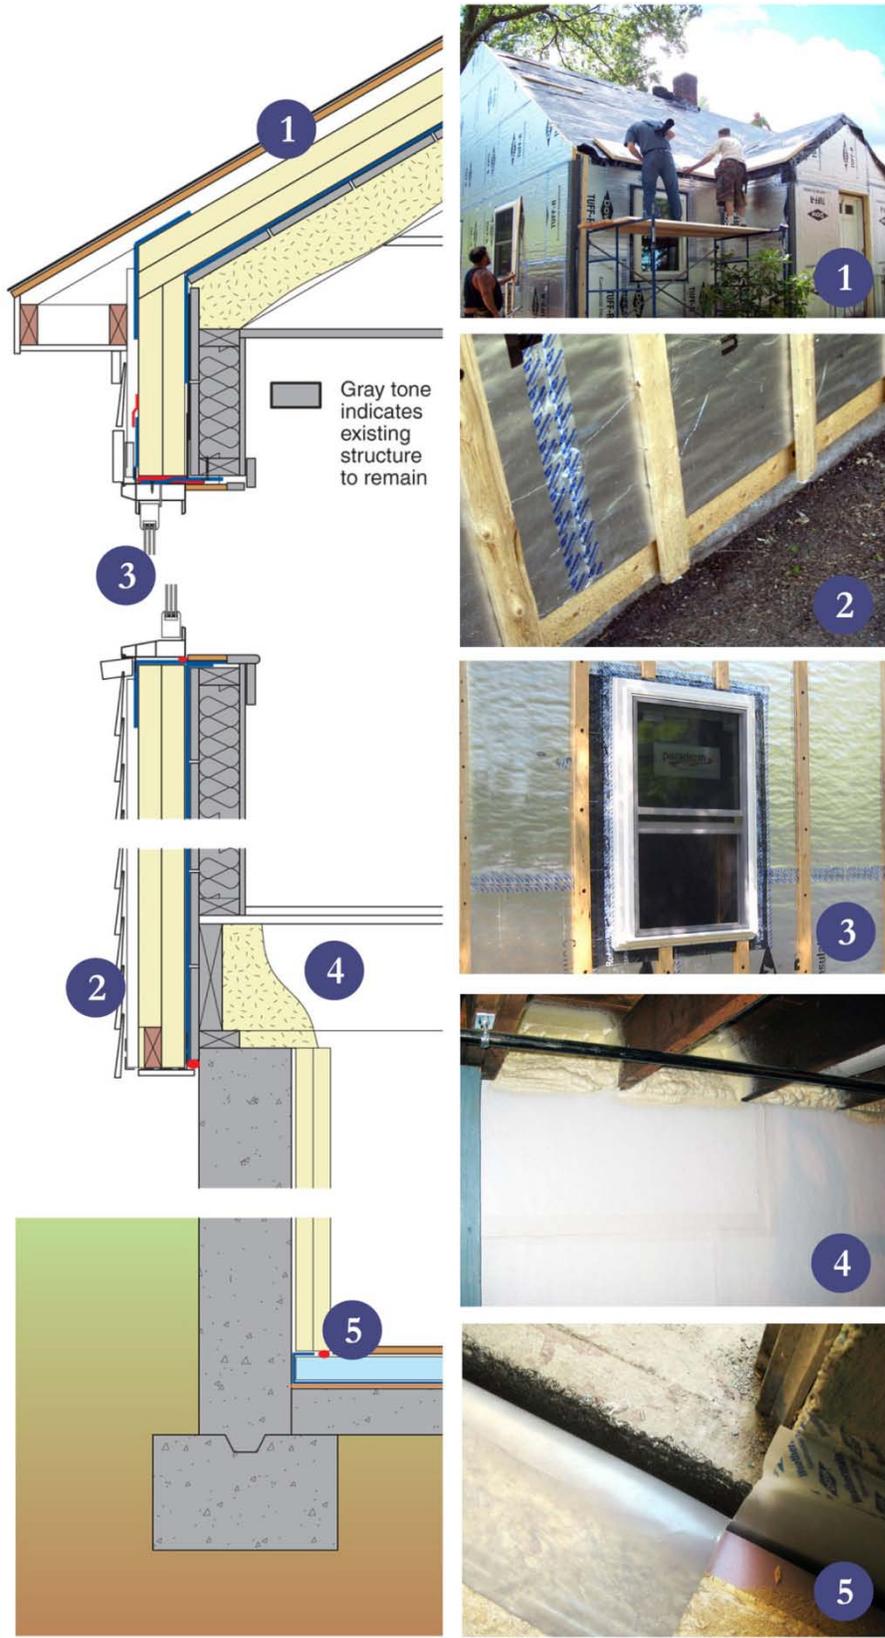
Figure 4. Enclosure profile for the Millbury Cape

ENCLOSURE DESIGN

1 Roof Assembly: Unvented attic assembly with existing rafters filled with spray foam and two 2” layers foil-faced polyisocyanurate exterior insulating sheathing, joints staggered; ventilation under outer layer of roof sheathing created by 2X4’s on the flat.

4 Air Infiltration: Taped roofing membrane over existing sheathing for roof; taped housewrap over above grade walls; taped interior insulation board for foundation wall and basement slab; transition from roof to wall by overlapping roof membrane onto wall housewrap; from wall to foundation through mudsill by applying spray foam insulation on inside; from foundation wall to basement floor by sealant.

5 Foundation Assembly: 3” polyisocyanurate insulation applied to concrete foundation walls; drainage mat applied over existing slab, covered by polyethylene, taped rigid insulation, and then floating subfloor.

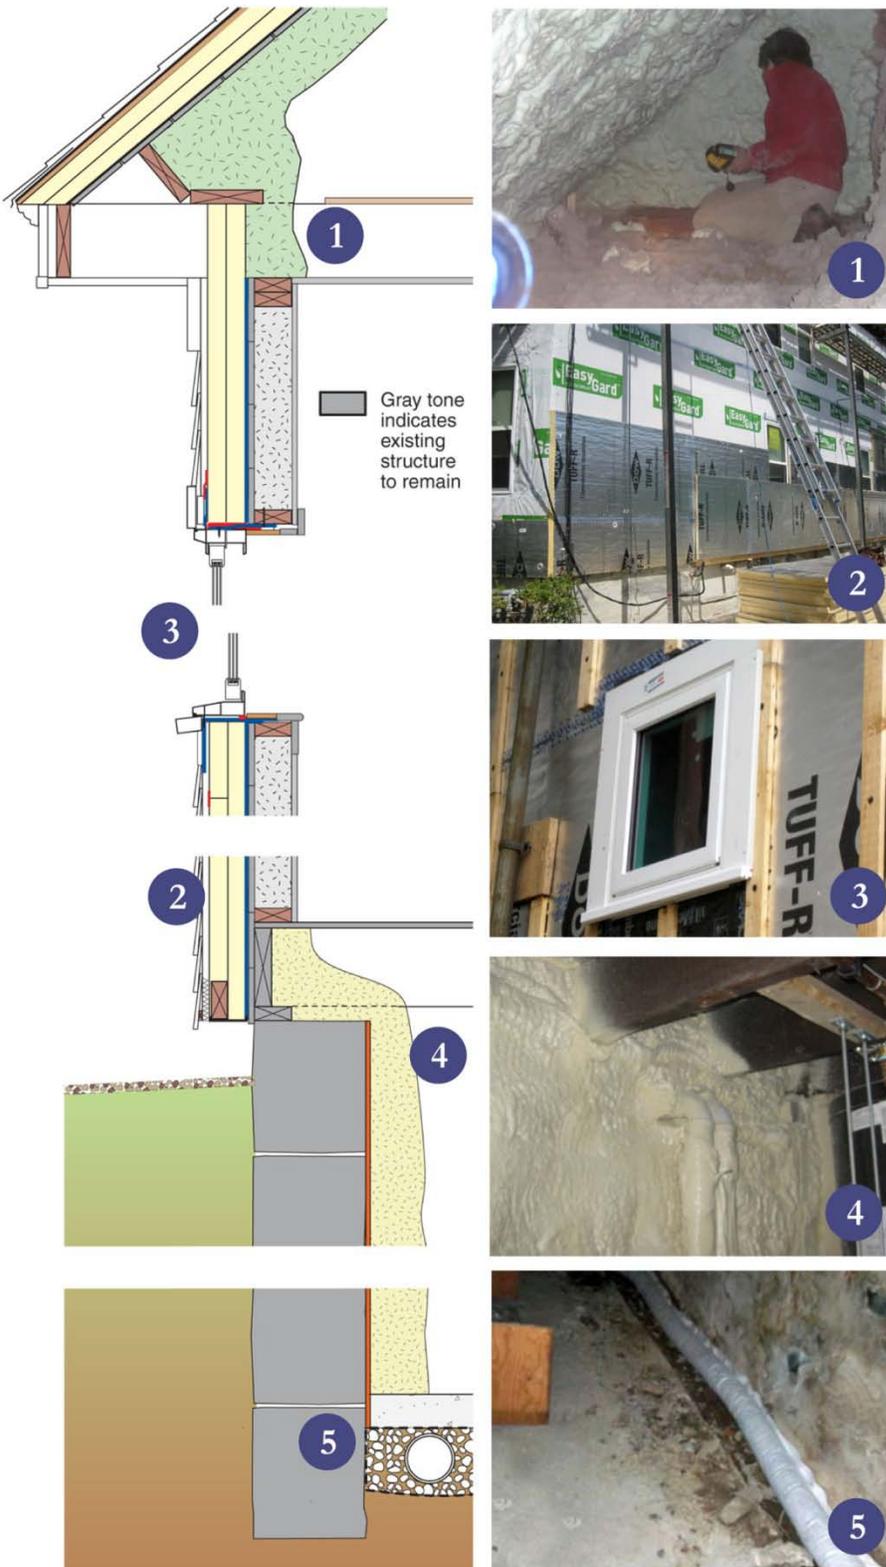
ENCLOSURE DESIGN

1 Roof Assembly: Unvented compact roof assembly with existing rafters filled with spray foam and two 2" layers foil-faced polyisocyanurate exterior insulating sheathing, joints staggered.

4 Air Infiltration: Taped roofing membrane over existing sheathing for roof; taped housewrap over existing sheathing for above grade walls; closed cell spray foam on interior side of foundation wall; existing concrete slab for basement; transition from roof to wall by filling the intersection with spray foam on the inside; from wall to foundation wall through mudsill by applying spray foam insulation on inside; spray foam on foundation wall seals to existing slab floor.

5 Foundation Assembly: Closed-cell spray foam with ignition barrier coating applied to rubble wall with drainage mat behind; spray foam extends up over the mud sill; perimeter sub-slab drainage and passive soil gas system added; no treatment of existing slab.

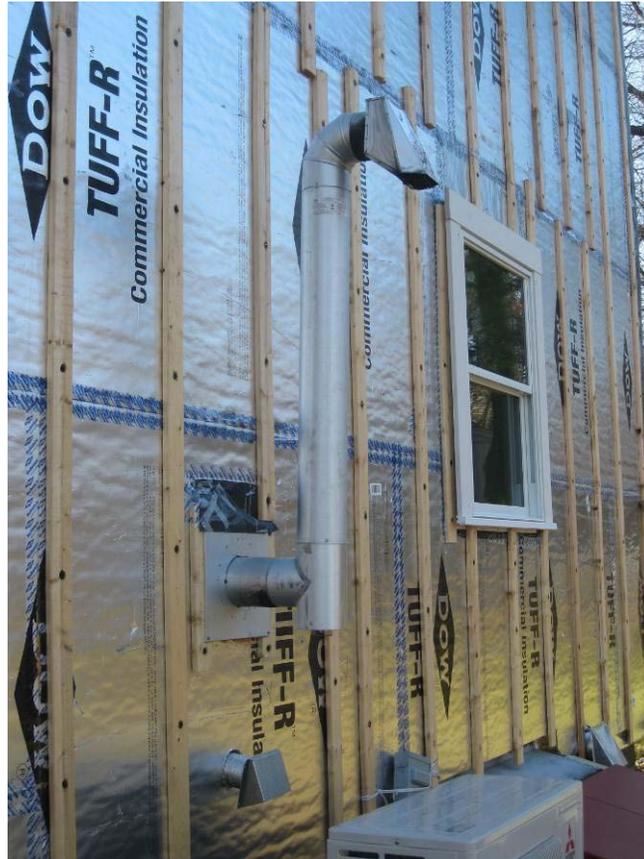
Figure 6. Insulating sheathing on the Millbury Cape

- Vertical wood strapping was applied over the insulating sheathing and attached to the wall studs using long screws (Figure 6).
- Fiber cement lap siding was attached to the wood strapping.
- Wall cavity insulation was added as needed.

To provide at least nominal R-40 walls, insulating sheathing was applied over the exterior wood sheathing and wall cavity insulation was upgraded as needed (BSC 2007). In both test homes, two layers of 2-in. foil faced polyisocyanurate exterior insulating sheathing were applied. At the Millbury Cape, the wall cavities had existing fiberglass batt insulation; this was replaced only in sections where the interior wall was opened for other reasons. For the Somerville Triple Decker, there was no wall cavity insulation so cellulose was retrofitted from the exterior.

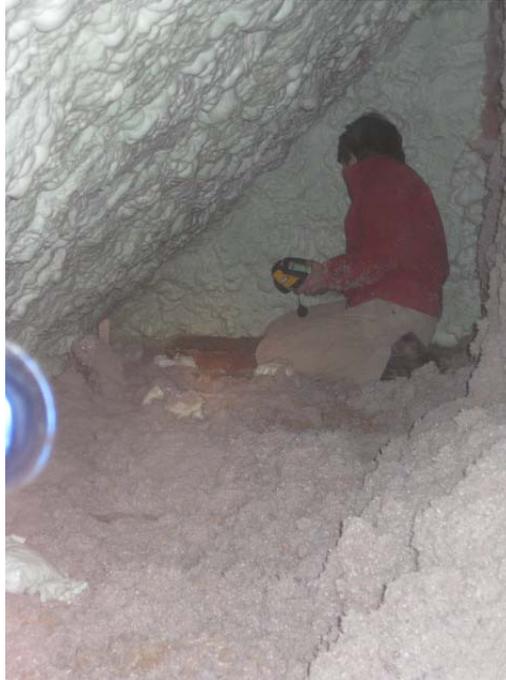
Figure 7. Attic insulation for the Somerville Triple Decker

With a targeted nominal R-value of 60 for the roof, the approach used for both houses was to apply two layers of foil-faced polyisocyanurate insulating sheathing over the existing roof sheathing and to apply open cell spray foam in the rafter bays from underneath the roof deck, accessed from knee wall and unfinished attic spaces (Figure 7).

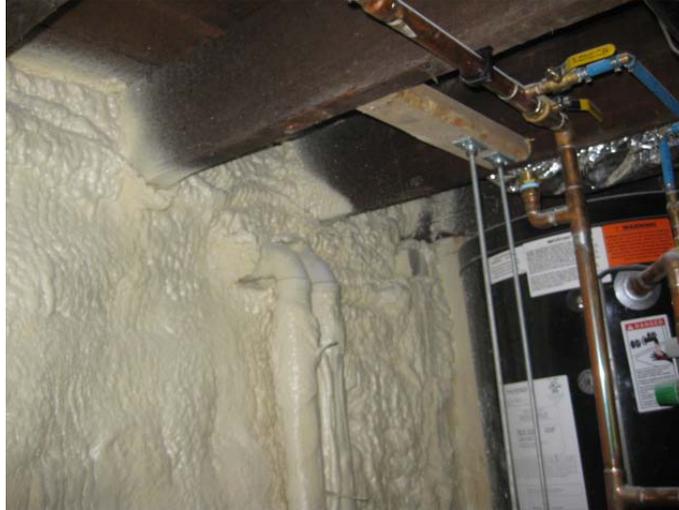
Figure 8. Somerville Triple Decker basement wall insulation before application of ignition barrier

- 3 in. of polyisocyanurate insulation board was applied to the interior side of the foundation wall.
- Closed cell spray foam was applied along the top of the foundation wall covering the rim joist.
- For the Millbury Cape, the spray foam was used to establish the continuity of the thermal layer and of the air barrier between the above-grade walls and the foundation walls (BSC 2009e).
- The Somerville Triple Decker has a parged rubble stone foundation wall with brick at the top. The foundation wall treatment was as follows (from exterior to interior):
 - A drainage mesh was applied over the interior side of the foundation wall;
 - 3 in. of closed cell spray foam was applied over this and extended up to the bottom of the subfloor above (Figure 8);
 - An ignition barrier paint was applied over the spray foam.

The drainage mesh applied to the foundation wall for the Somerville Triple Decker is part of the water management system. Its purpose is to direct any water that passes through the foundation wall down below the floor. Because water does not pass through the closed cell spray foam, it would have sufficed to apply the drainage mesh just at the bottom of the wall. If the drainage mesh is extended up the wall, as in this case, it should not cover any wood framing.

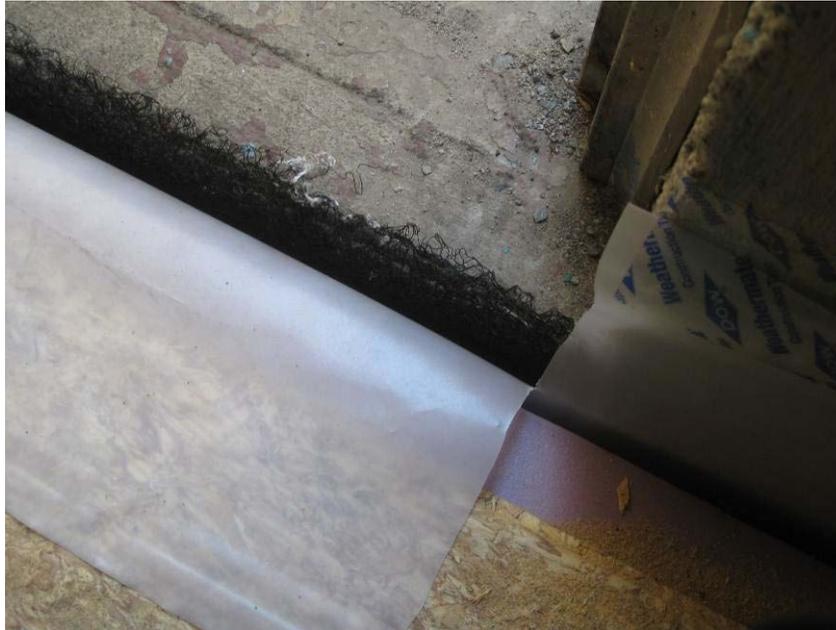
Figure 9. Millbury Cape basement floor construction

- Existing concrete slab
- Drainage mesh
- 2-in. layer of extruded polystyrene (XPS) with seams taped to create an air barrier
- Vapor barrier of polyethylene
- Floating oriented strand board subfloor.
- The drainage mesh in this assembly for the Millbury Cape provides some storage capacity for any water that does get through the foundation walls (Figure 9).

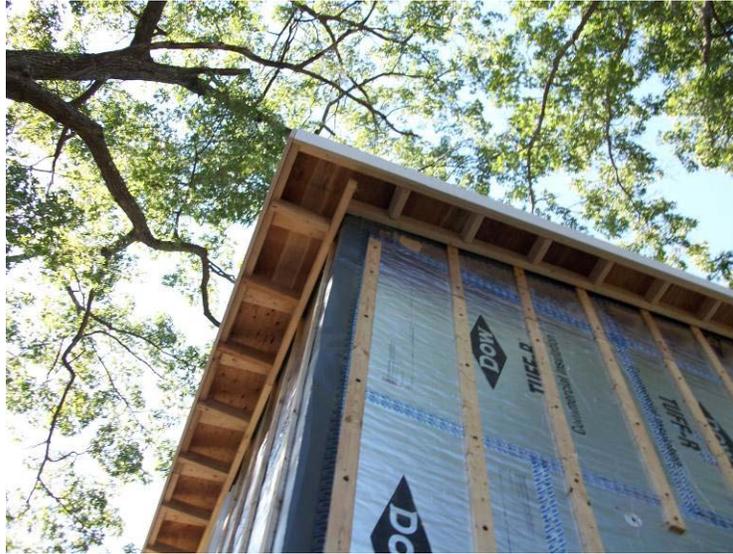
Figure 12. The Millbury Cape eave and rake overhang

For the roof assemblies of both houses, the ice and water shield underlayment over the plywood sheathing provides water management and the eave overhangs extend the system beyond the roof/wall intersection. The Millbury Cape did not originally have sufficient overhangs to protect the walls, and existing water damage was discovered during the construction. As part of the retrofit, new overhangs and rakes were attached to the house after the exterior insulation layers had been applied to the roof and walls (Figure 12). For the Somerville Triple Decker, the existing overhangs were generally deep enough to cover the thicker walls, though a rafter extension was applied in certain portions of the eaves where more depth was desired.

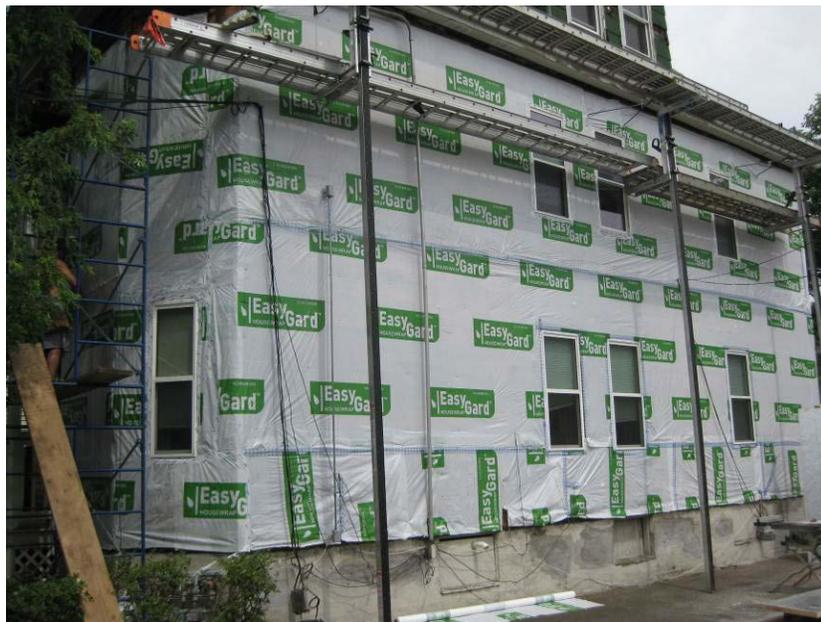
Figure 13. Somerville Triple Decker exterior wall air barrier

- Self-adhered roofing membrane lapped and taped over the existing roof sheathing (roof)
- House wrap lapped and taped over the existing wall sheathing (walls)
- Insulation board with seams taped over the inside of the foundation walls and over the basement slab (foundation wall and floor).

The transition between the roof and exterior wall was sealed by extending the roofing membrane down and sealing it onto the wall house wrap—this was possible as there were no overhangs or eaves. The transition between the above-grade wall house wrap and the interior insulation on the foundation wall was accomplished by applying closed cell spray foam on the interior of the rim joist and sill plate and by sealing the bottom of the wall sheathing to the outside of the foundation wall. An application of sealant in the seam between the foundation wall and the basement floor transitions the air barrier between the foundation wall and basement floor. Sealant applied around the outer frame of the windows and doors established a connection between the doors and windows and the wall air barrier.

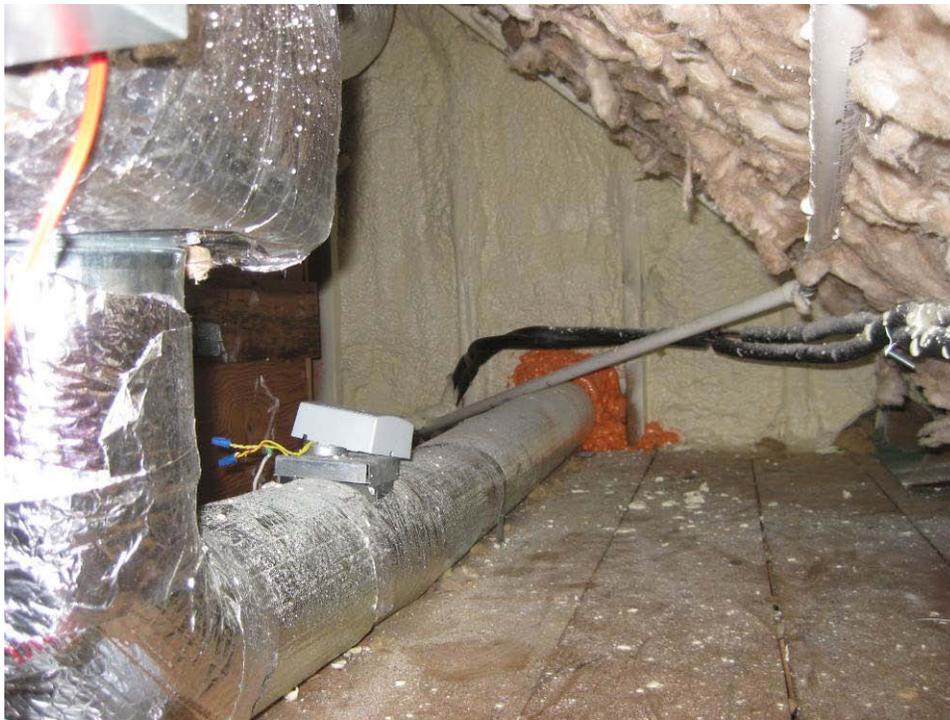
Figure 14. Millbury Cape ventilation system in kneewall

Ventilation is integrated with each air handler using a 6-in. outdoor air supply duct connected to the return side of the air handler with a motorized damper, connected to a fan cycling control (Figure 14). The fan cycling control ensures that the fan runs a programmed minimum amount of time to provide sufficient supply ventilation air, which is in turn distributed to the indoor spaces using the air handler's duct system. The motorized damper in the outdoor air supply duct is controlled by the fan cycling control to prevent over ventilation during times of significant space conditioning demands (BSC 2009g).

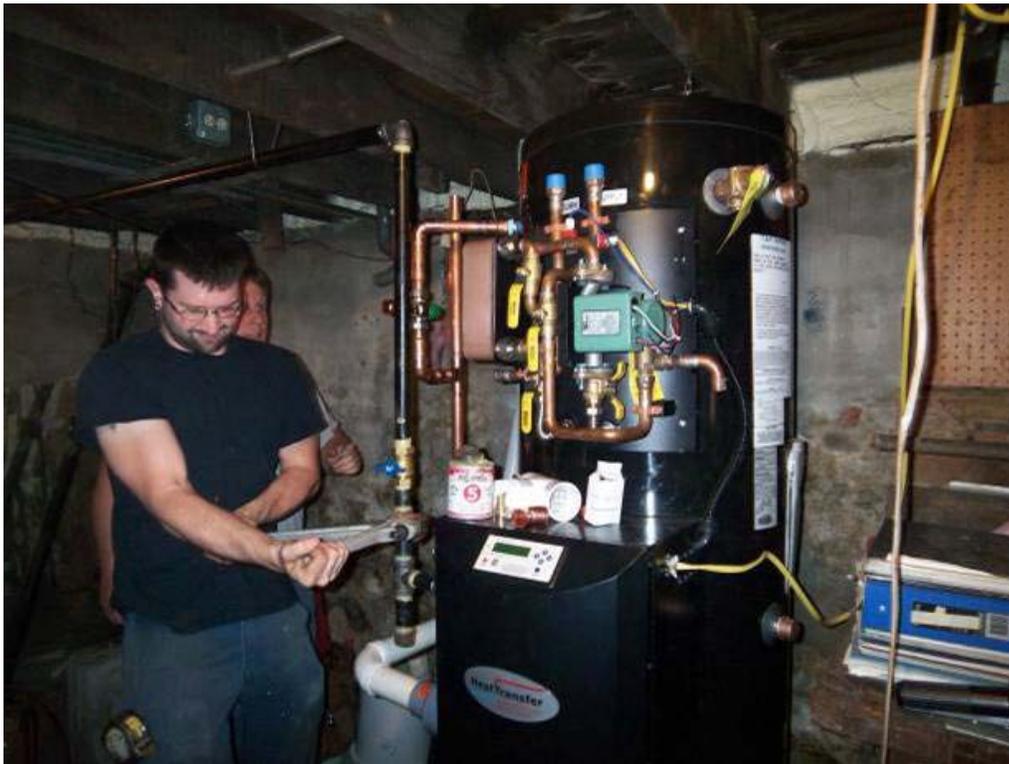
Figure 15. Somerville Triple Decker Phoenix Versa Hydro installation. Photo used with permission from homeowner.

For the final design, the project team elected to consolidate the space and DHW by replacing the furnaces, boiler, and water heaters with a single 80 gallon Phoenix Versa Hydro unit (Figure 15). The Versa Hydro is a modulating and condensing system that can also be integrated with solar DHW (a future project planned by the homeowner). From the experience of BSC, it may be difficult to achieve high efficiencies (as advertised) due to flue gas condensation limits. The temperature of water in the storage tank needs to be low enough for exhaust gas condensation to occur, which means that lower DHW and heating loop temperatures are required. BSC is interested in observing the long-term performance of the system in this home.

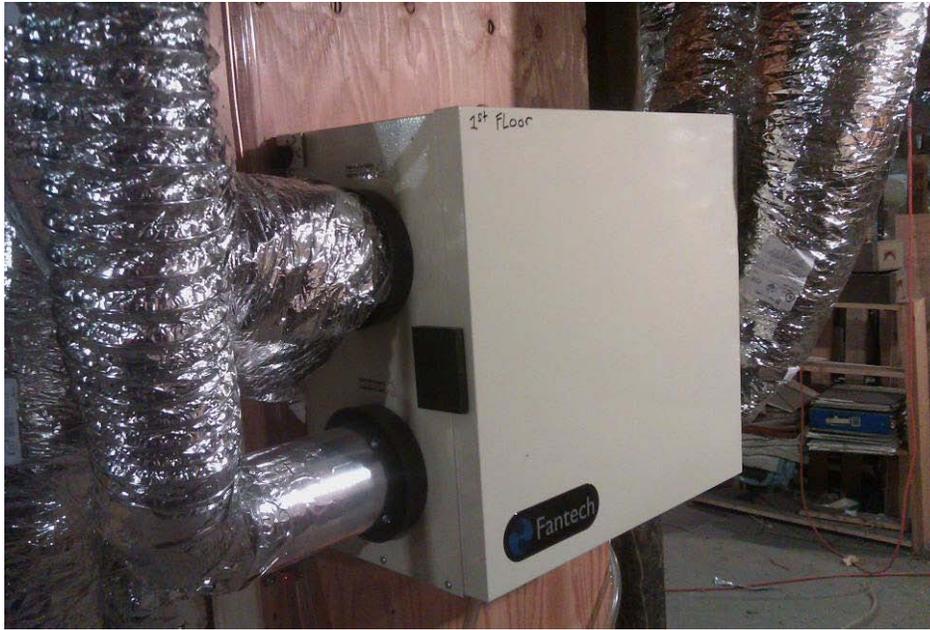
Figure 16. Somerville Triple Decker Fantech HRV. Photo used with permission from homeowner.

Mechanical ventilation is provided by a Fantech VH704 HRV for each apartment (Figure 16). Each is capable of supplying 67 CFM and has a rated recovery efficiency of 53%. In addition to the outside air supplied by the HRV, makeup air is supplied over the gas stove hoods in each apartment. Both the stove exhaust and the makeup air supply ducts are run through the new chase, made from the shaft formerly occupied by the chimney.

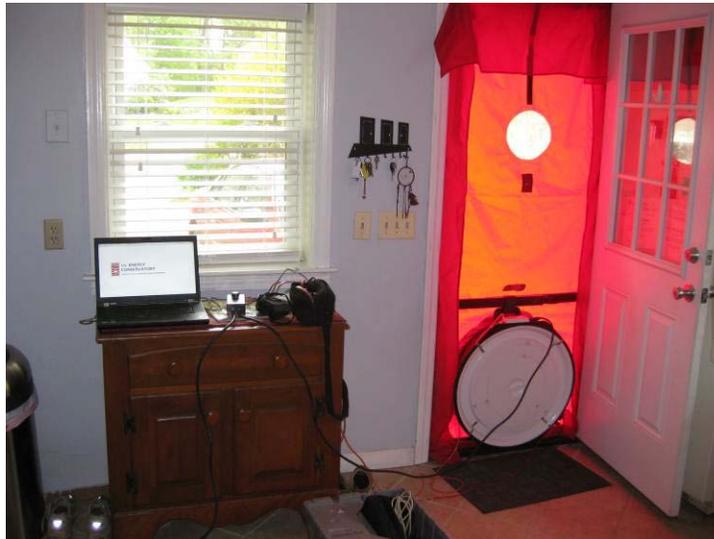
Figure 17. Blower door testing for the Millbury Cape

For the Millbury Cape, BSC conducted blower door testing before the retrofit project started in April 2010, at substantial completion in November 2010, and again in May 2011 (as a final test after completion of air sealing corrections). The expected information from this testing included air leakage rates at the different points in the project and an assessment of how effective the blower door testing could be as a tool to improve airtightness at the end of the project. Appendix C contains all blower door test reports.

The following input information used to interpret the blower door test results was provided by the owner: 4,278 ft² total enclosure (six sides), 16,500 ft³ volume. With the small addition made during the retrofit, the total enclosure would not change significantly but the volume would increase by about 500 ft³.

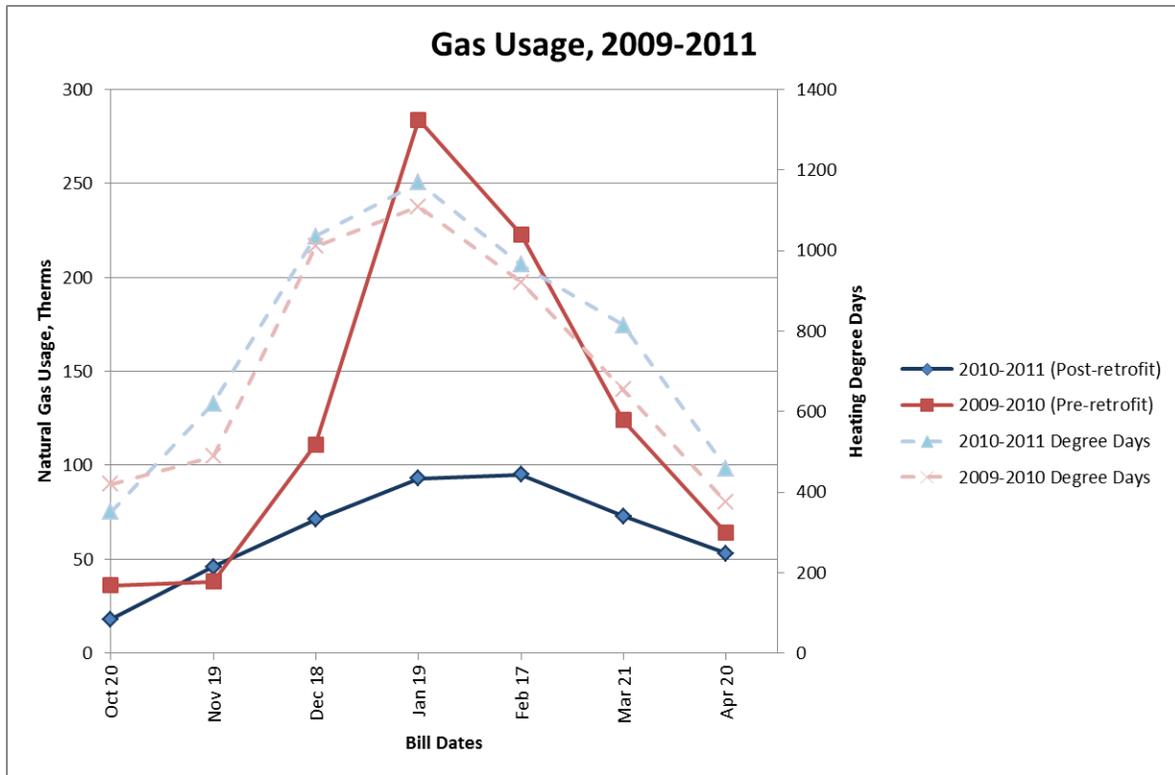
Figure 19. Somerville Triple Decker from October to April before and after the retrofit

Gas usage during the two periods shows a significant decrease after the retrofit, especially considering the fact that the post-retrofit winter was colder than pre-retrofit. It is interesting to note that the difference between pre- and post-retrofit gas usage is much more extreme during colder than warmer or shoulder months.

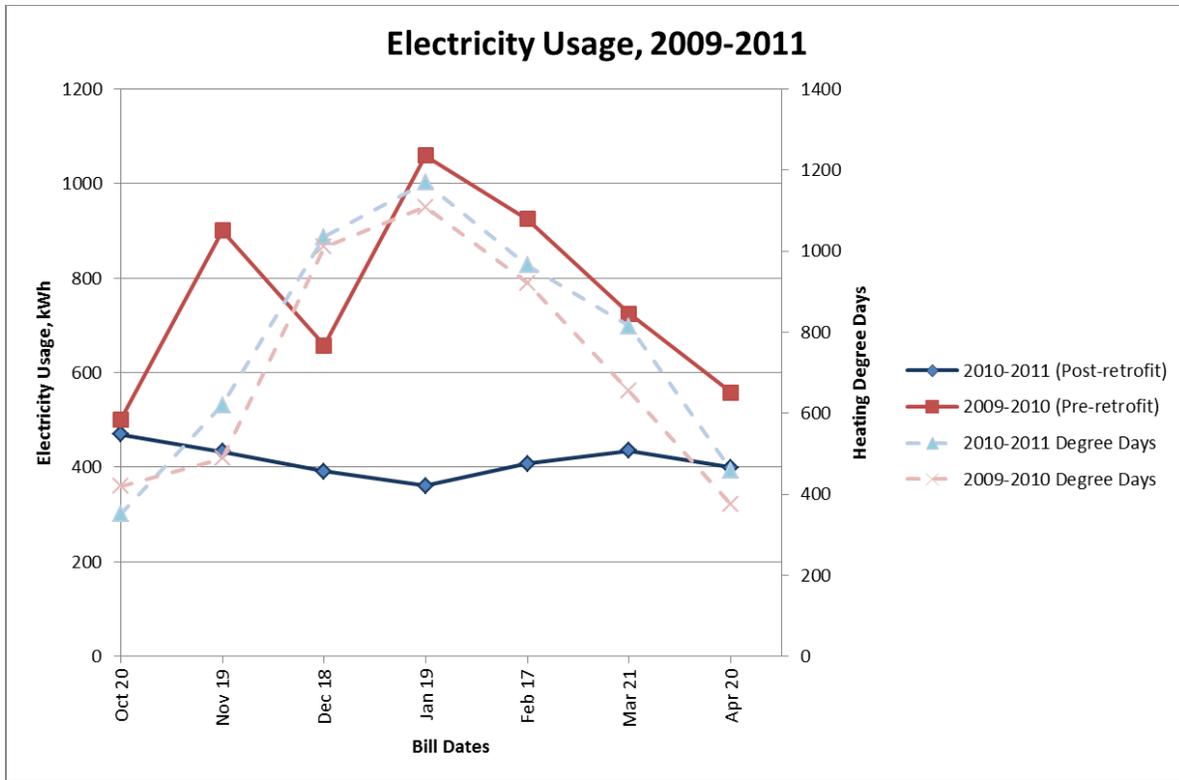
Figure 20. Somerville Triple Decker electricity usage from October to April before and after the retrofit

Electricity in the Somerville Triple Decker has more end uses than gas, making it more difficult to make conclusions about space conditioning savings from the retrofit. End uses such as lighting, appliances, and mechanical ventilation tend to make up a significant portion of electricity usage. When a year of post-retrofit data becomes available, the electricity usage during swing seasons (when little heating or cooling is needed) will allow base load to be determined. The base load can then be subtracted during heating and cooling seasons to determine space conditioning electricity usage. However, it should be noted that the fan energy formerly associated with the ducted hot air heating systems switched to pump energy for the post-retrofit hydronic system. In addition to the reduction of heating energy required due to the improved enclosure, this switch from fan to pump energy is a likely contributor to savings.

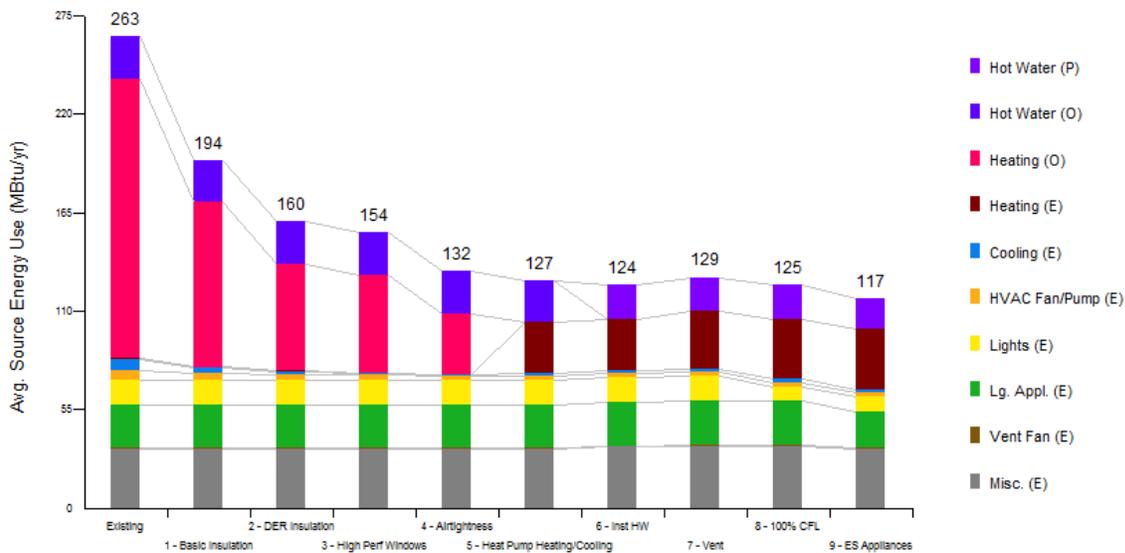
Figure 21. BEopt incremental modeling results for the Millbury Cape

Figure 21, shows a graph of the average yearly source energy use. It was generated for the BEopt model for the Millbury Cape showing incremental inclusion of the retrofit measures. This model projects an average yearly 45% reduction in source energy use following the retrofit.

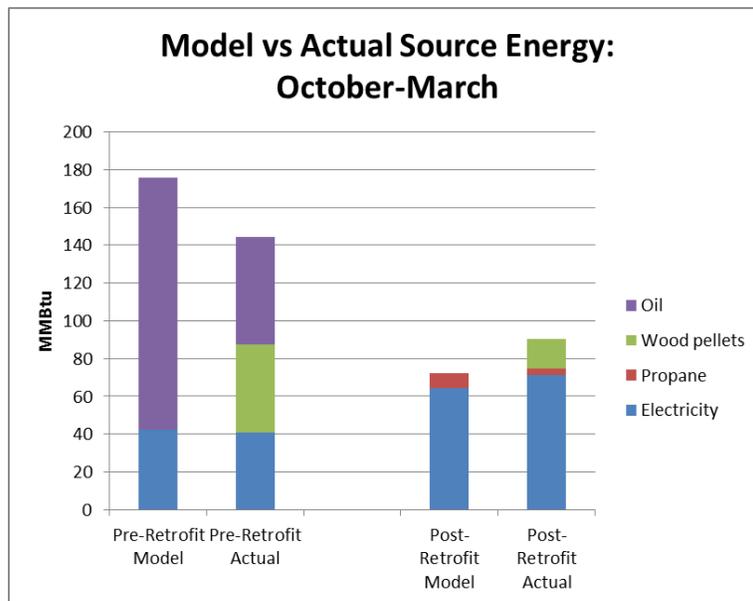
Figure 22. Millbury Cape source energy use pre- and post-retrofit

As part of the energy modeling analysis, BEopt’s hourly results were used to project site energy use for the existing and post-retrofit model for October through March. These were then compared to the actual site energy use for the existing conditions (October 2009 through March 2009) and to the actual site energy use for the retrofit (October 2010 through March 2011).

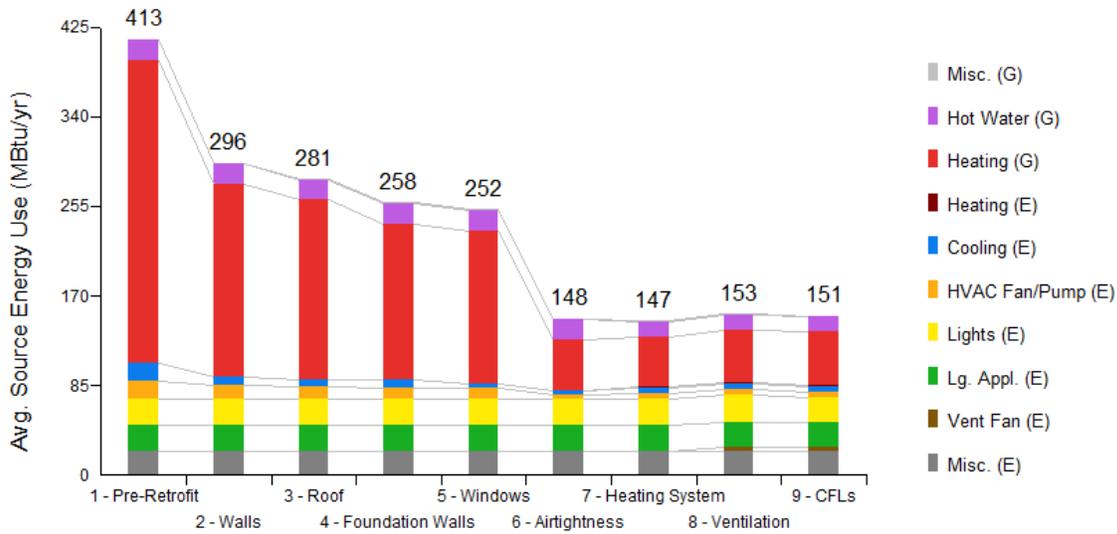
Figure 23. BEopt incremental modeling results for the Somerville Triple Decker

however, the resultant improvement in indoor air quality is an important benefit to the homeowner. Incremental source energy reductions with each retrofit step are shown in Figure 23.

BEopt modeling results predict a yearly source energy reduction of 63% due to the retrofit. These results are compared to yearly energy use reported by utility bills in Section 3.2. For the Somerville Triple Decker, a decision was made to compare complete years of data since a year of pre-retrofit bills was available. Additionally, the seven months of available post-retrofit bills cover the heating season in which the most effect from retrofit upgrades should be observed. This is due to the lack of an air-conditioning system upgrade and the fact that occupants report using air conditioning and the HRV extremely sparingly. The pre-retrofit utility bill summation spans the period from May 2009 to April 2010 while the post-retrofit utility bill summation spans the period from May 2010 to April 2011. During this second period of time, the retrofit measures were in place from October 2010 to April 2011. The source energy reduction reported by utility bills during these two full years is calculated at 37%.

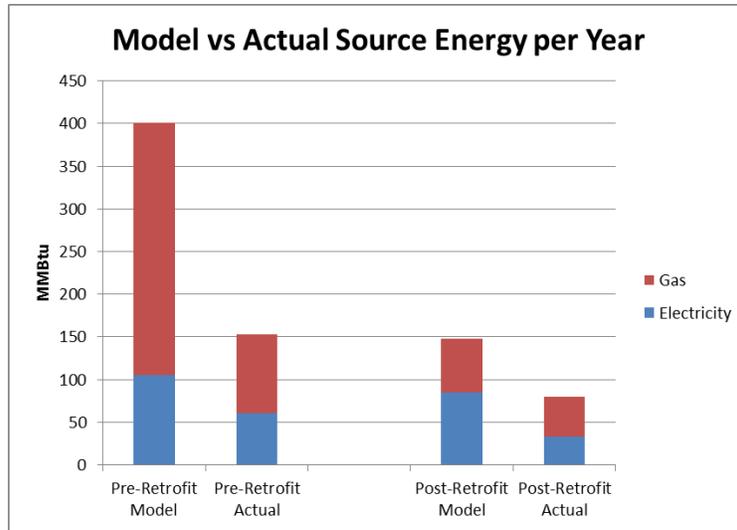
Figure 24. Somerville Triple Decker pre- and post-retrofit source energy breakdown

As observed in Table 15 and Figure 24, the model in all cases overpredicts energy usage compared to the values reported in occupant utility bills. In the post-retrofit case, the model overpredicts electricity usage by 20%, gas usage by 9%, and total source energy by 15%. In the pre-retrofit case, the model overpredicts electricity usage by 12%, gas usage by 65%, and total source energy by 51%. BSC and other practitioners have frequently observed such drastic modeling overpredictions of gas usage in pre-retrofit homes. The possible reasons for this observed discrepancy are an area of ongoing interest for BSC. In this case, heating was reported to have been used very sparingly before the retrofit, so average heating set point temperatures may have been significantly lower than modeled.

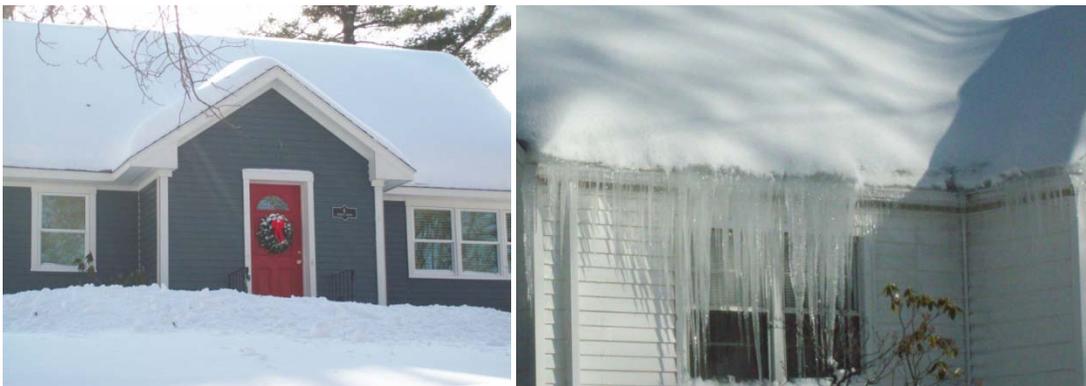
Figure 25. Left: Post-retrofit Millbury Cape; Right: Neighbor’s home with ice dams

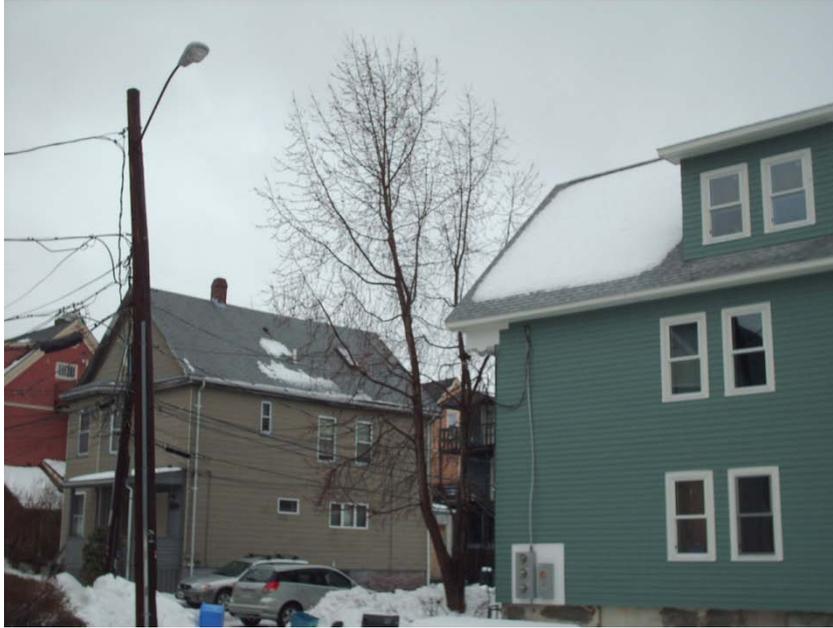
In addition to interior comfort observations, the owner shared photos of the roof in winter following the retrofit and reported that few or no ice dams formed. The snow also took longer to melt than on neighboring roofs (Figure 26).

Figure 26. Post-retrofit Somerville Triple Decker, slow snow melting and no ice dams

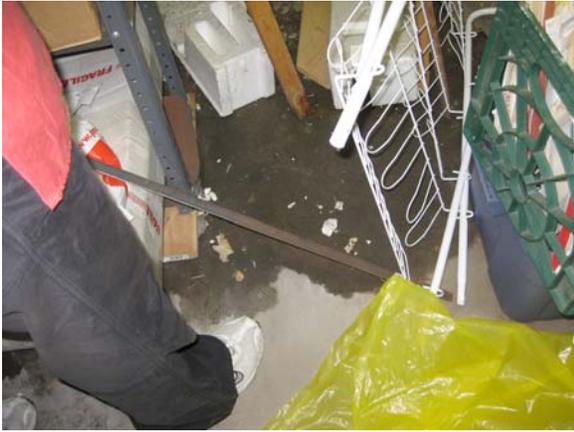
Evidence of water as well as damp surfaces were observed on both of two visits to the building.

Figure 1: Damp floor in basement storage area

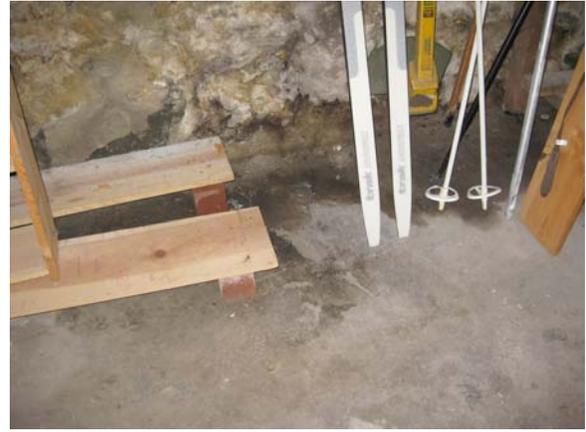
Figure 2: Damp floor and wall in basement

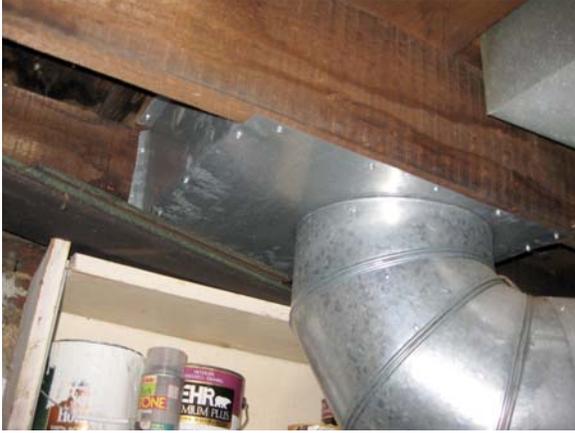
The return for this system is a panned return located at the first floor landing of the back stairs. Some of the ductwork is rusty.

Figure 3: Panned return for 2nd floor heating system

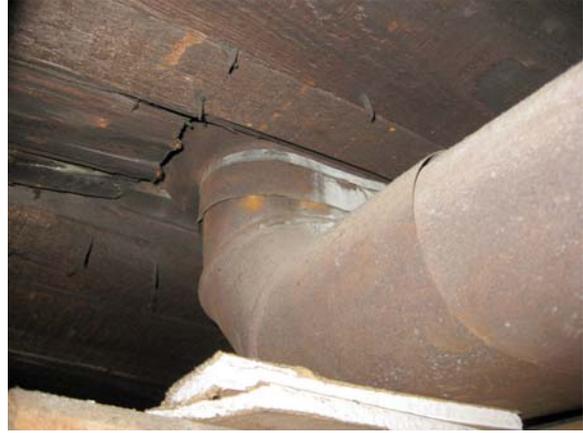
Figure 4: Supply ductwork serving 2nd floor

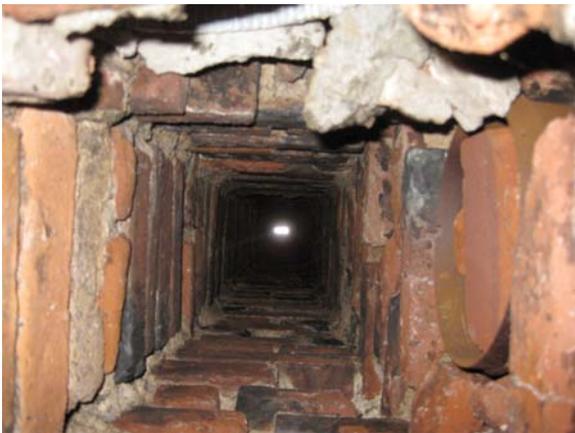
The boiler, one of the furnaces and all three of the water heaters are vented through an unlined brick chimney. Each flue in this chimney is approximately 8" square.

Figure 5: East chimney flue

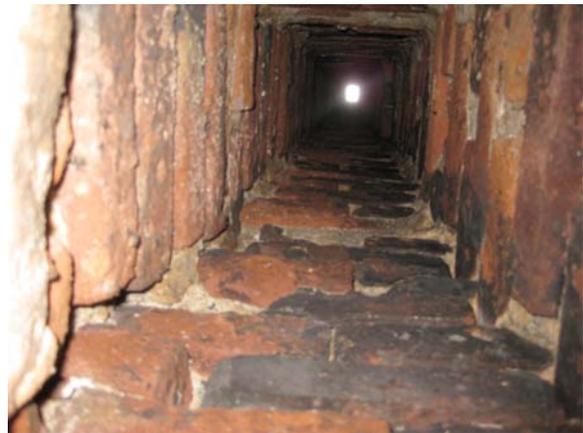
Figure 6: West chimney flue
