# Measure Guideline: Internal Insulation of Masonry Walls

J.F. Straube, K. Ueno, and C.J. Schumacher  
*Building Science Corporation*

July 2012

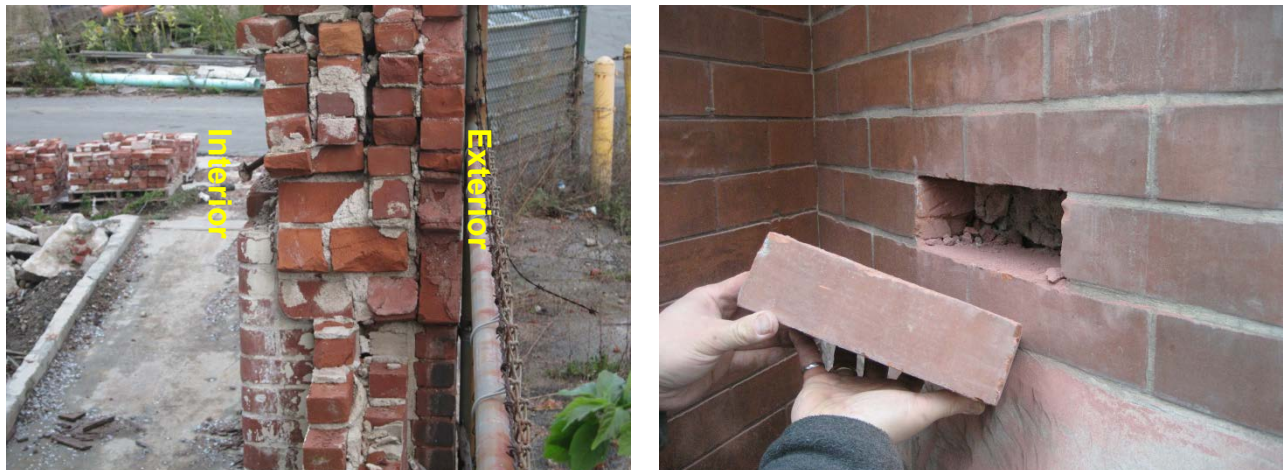
The wall assemblies described as solid masonry may in fact contain many hollow spaces (Figure 14). Voids, sometimes full-height, sometimes story height, and sometimes only 16–24 in. high are often found between layers of masonry. These voids act as capillary breaks, and may allow water to accumulate or concentrate, as they are invariably not intentionally drained.

**Figure 14. Voids commonly found between wythes of brick in masonry walls**

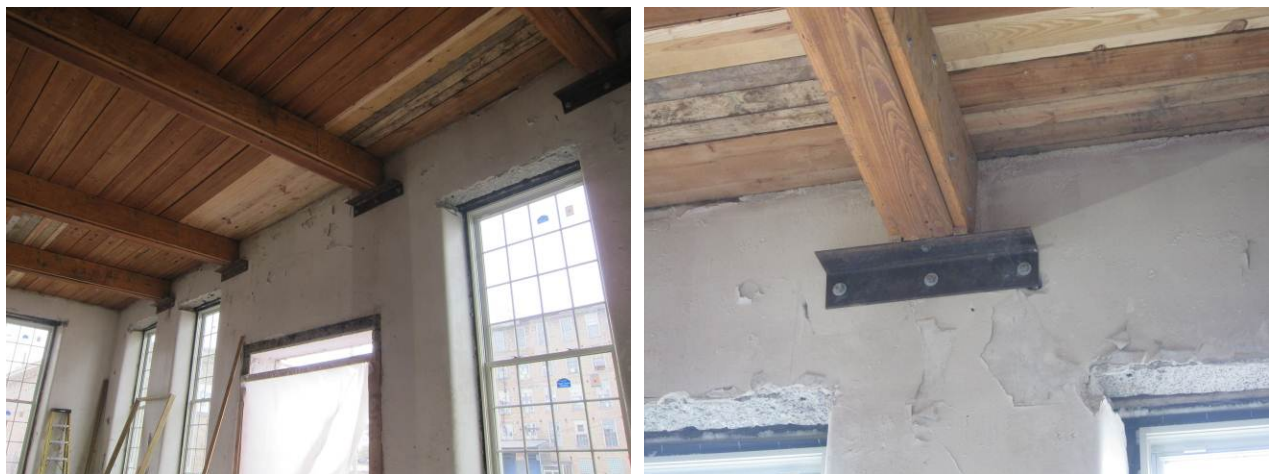
Embedded wood timbers are a common embedded element with durability concerns. A number of solutions are being pursued, including borate injections into the wood, metal wedges next to the member (to provide passive heat flow), active heating, or construction of a load-bearing structure inside the masonry (Figure 16), and cutting off the end of the beam.

**Figure 16. Steel angle bolted to masonry to transfer load out of beam pocket**

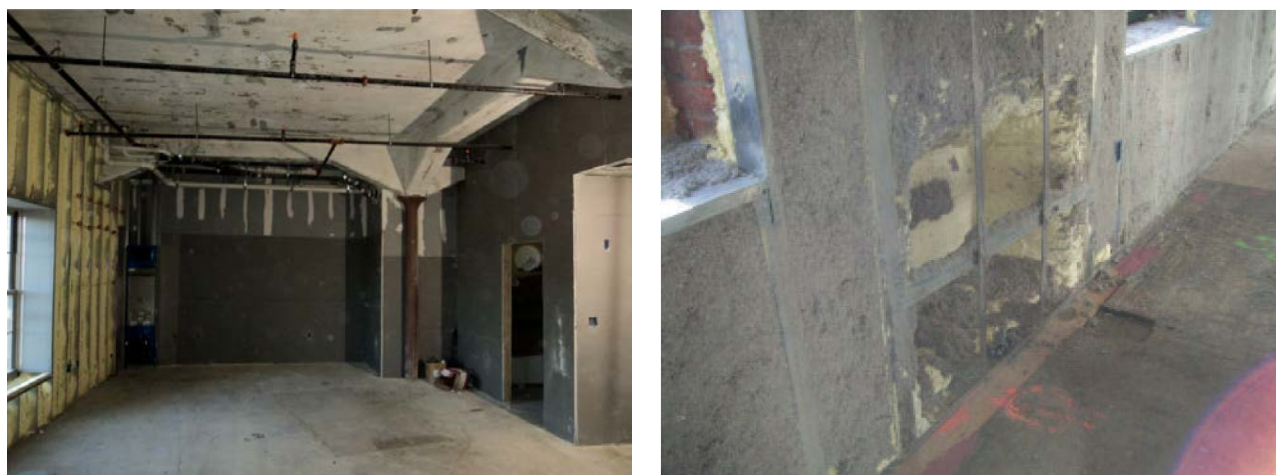
The examples shown below in Figure 23 use steel framing with damp spray cellulose insulation, inboard of 2 PCF ccSPF insulation. There is significant thermal bridging through the steel studs, which diminishes the value of the cavity insulation.

**Figure 23. Hybrid spray foam/damp spray cellulose assembly (steel stud not recommended)**

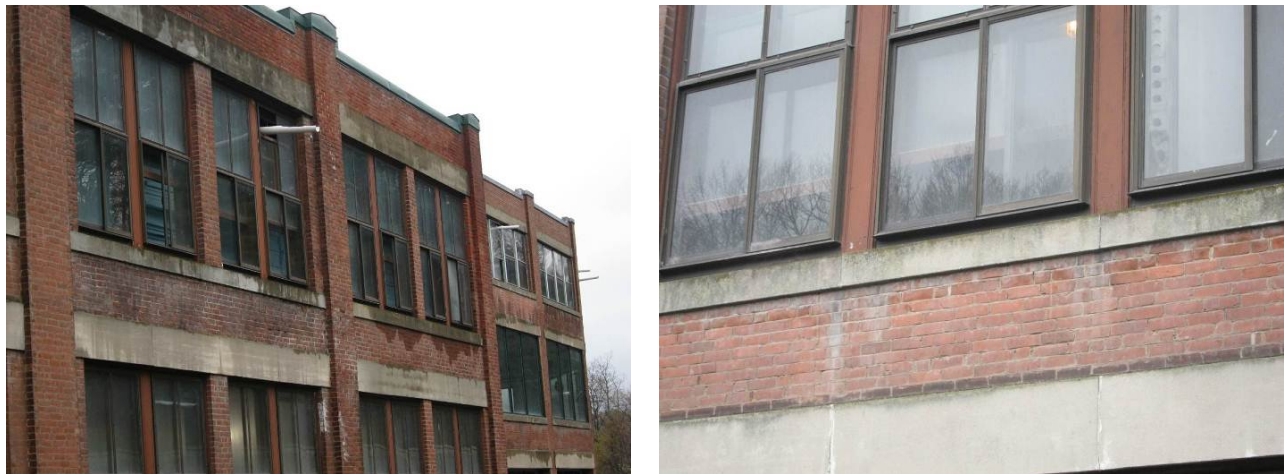
Windows and doors are nonabsorbent, and hence shed all the rainwater (wind-driven rain) that strikes them. The shapes of windows and doors also tend to concentrate water, especially at the lower corners (Figure 29). To maximize durability, a critical requirement is to avoid concentration of rainwater surface drainage, and to encourage the shedding of water away from the face of the building.

**Figure 29. Improper drainage off window faces, and staining at window sill grout joints**

Windows and doors are nonabsorbent, and hence shed all the rainwater that strikes them. To prevent masonry durability problems, rainwater surface drainage must not be concentrated on the wall below, and this water should be shed from the face of the building. Drainage and shedding are accomplished by a sloped sill detail with end dams, and a sufficient drip edge beyond the wall below. Rowlock window sills are especially vulnerable, as they are composed of individual bricks with mortar joints, which will be a source of water leakage. One possible solution to reduce water loading into the wall below is to overclad the rowlock course with metal flashing.

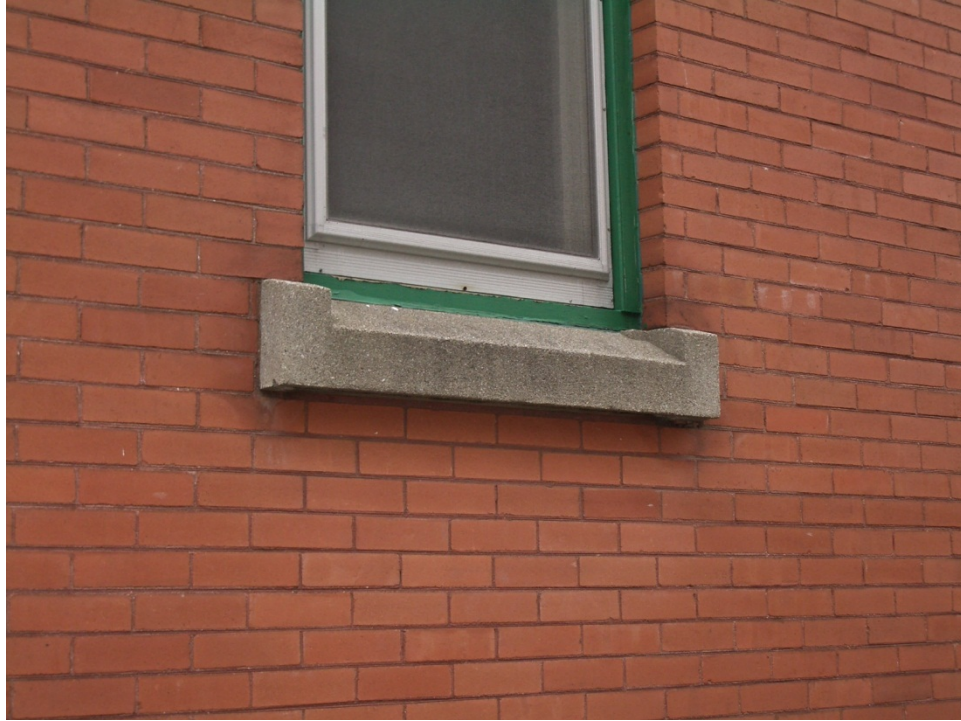
**Figure 32. A high performance window sill, exhibiting end dams, steep slope, large projection, jamb extensions, and drip edge**

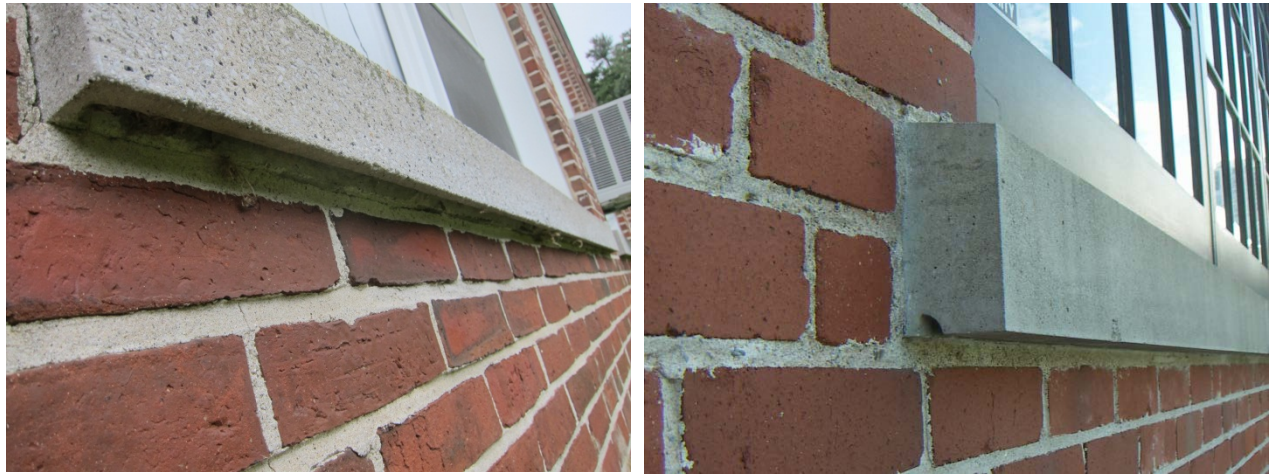
Many existing precast window sills have drip edge details built in to their undersides, as shown in Figure 36. These types of details typically provide excellent performance and durability.

**Figure 36. Precast window sill drip edge details**

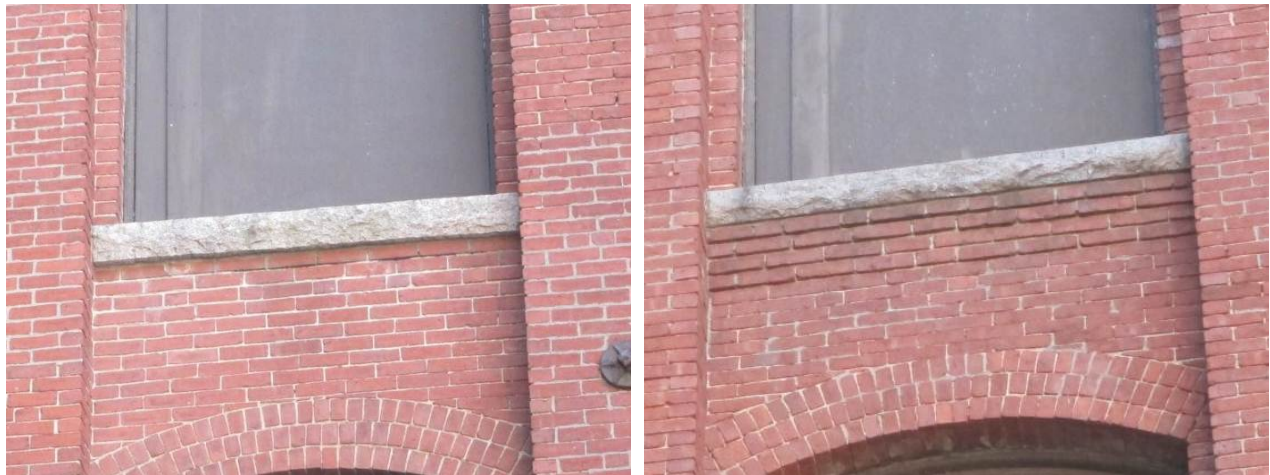
Informative patterns of water deposition can be seen in this building with granite sills: some of the sills have no corbeling below them (Figure 37, left); others have a brick corbel detail (Figure 37, right). Staining and mortar erosion was more severe at the corbeled detail (right), as the water draining from the sill is more likely to run onto the brick below from surface tension, as opposed to dripping free from the noncorbeled sill “lip” (left). This shows the importance of a projecting overhang at the sill.

**Figure 37. Left: Window sill without brick corbeling (left); Right: Window sill with brick corbeling, showing different mortar erosion patterns**

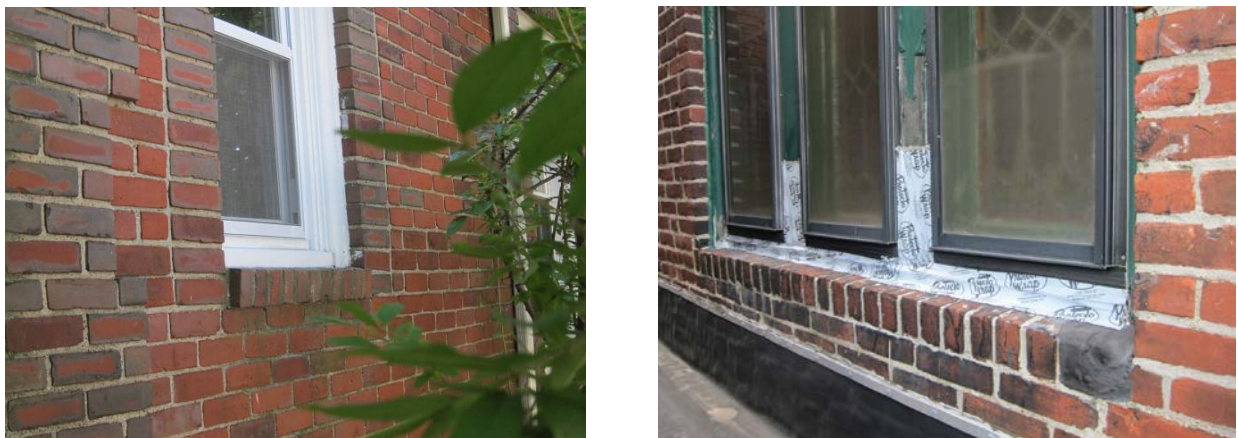
Another problematic sill detail is the rowlock brick sill (Figure 39). Recommended construction details for a rowlock sill are provided by BIA (2005). Rowlock sills are more vulnerable than the previously described stone or cast sills, as they are composed of individual bricks with mortar joints, which will be a source of water leakage.

**Figure 39. Rowlock window sill examples**

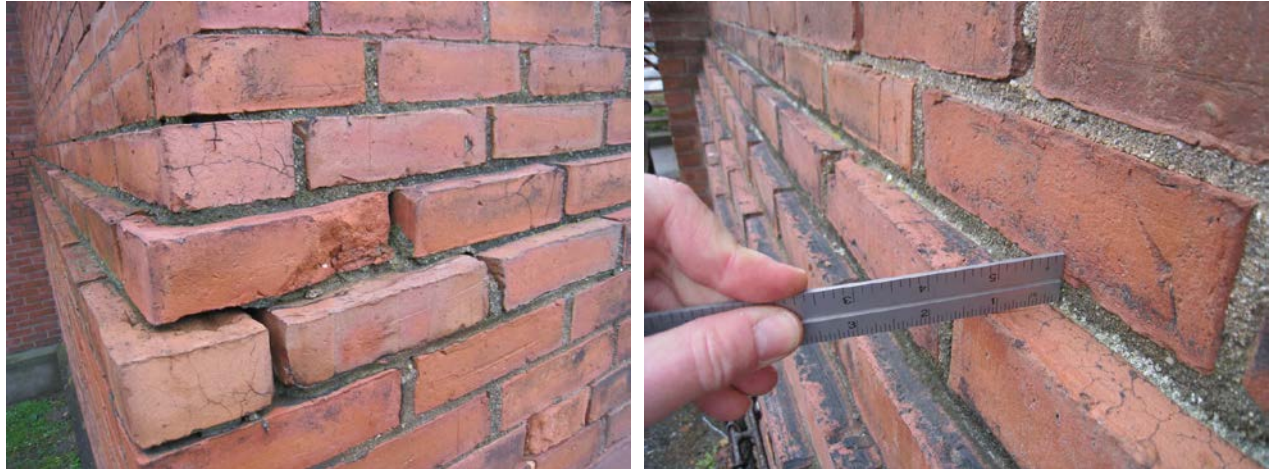
**Figure 50. Steps in brickwork, and related cracking/FT damage**

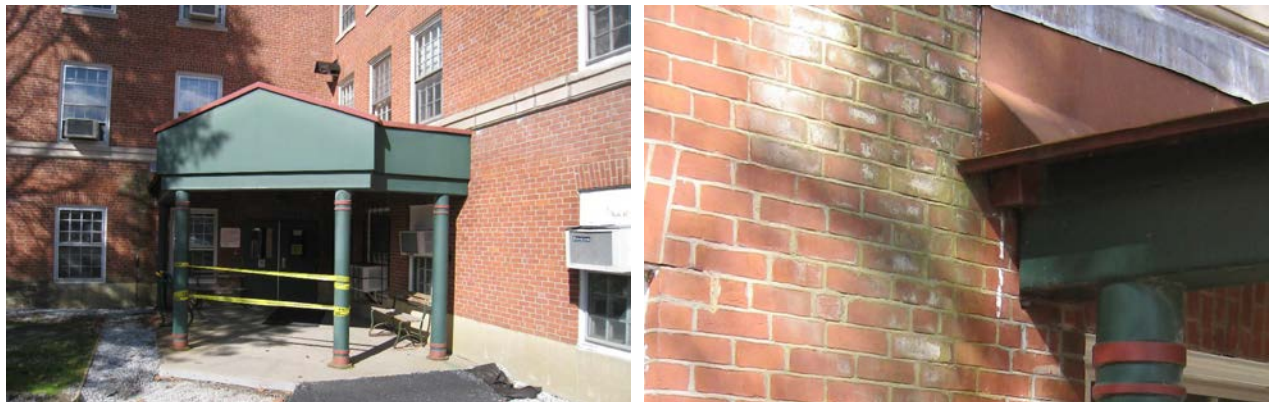
**Figure 53. Left: Retrofit roof over entrance; Right: Water runoff concentration at roof-wall interface**

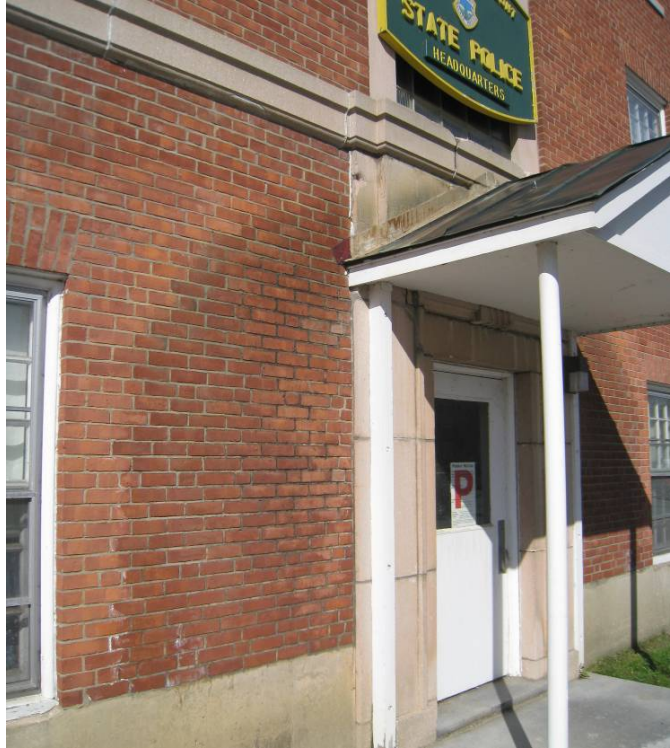
**Figure 54. Water runoff concentration at roof-wall interface (kickout flashing required)**

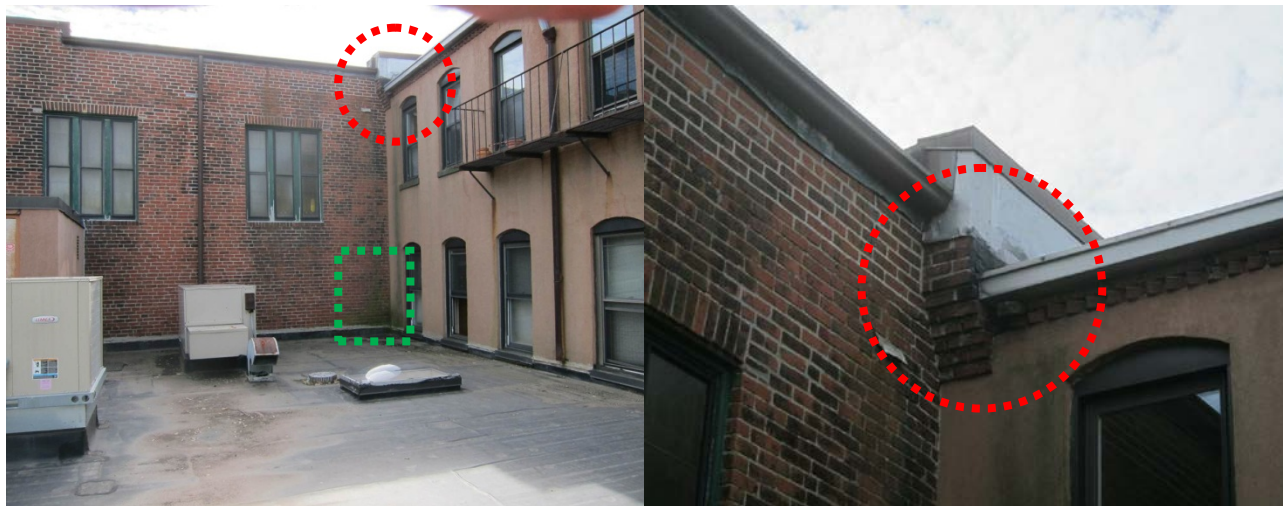
**Figure 55. Water runoff concentration at roof-wall interface (kickout flashing required)**

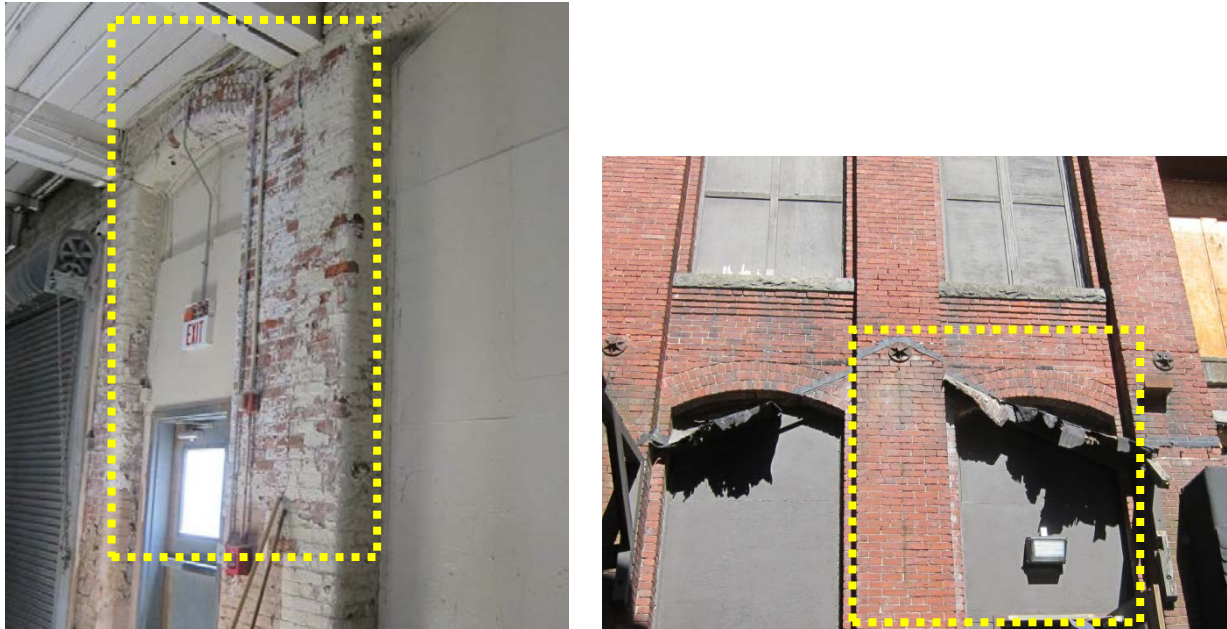
**Figure 56. Left: Interior paint/parging delamination; Right: Exterior conditions for comparison**

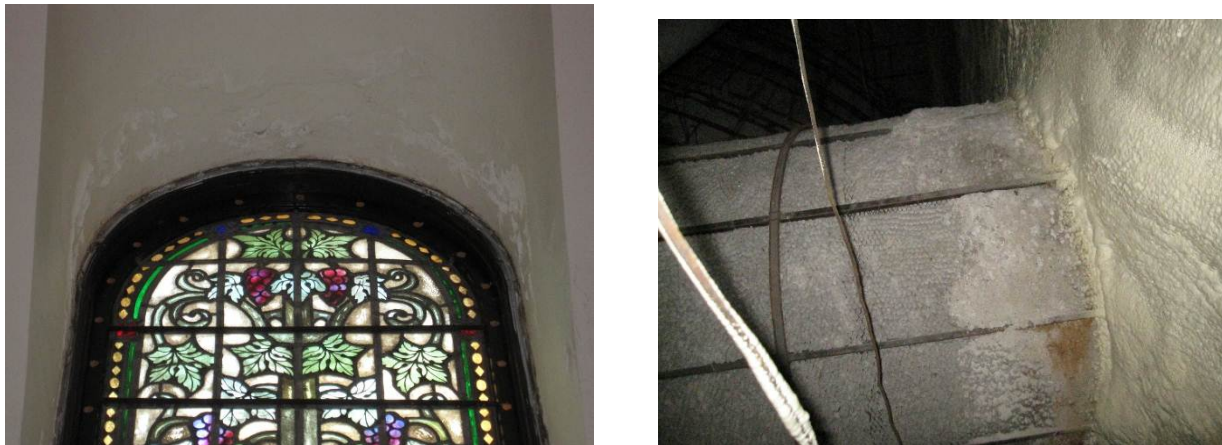
**Figure 58. Moisture issues at chapel windows**

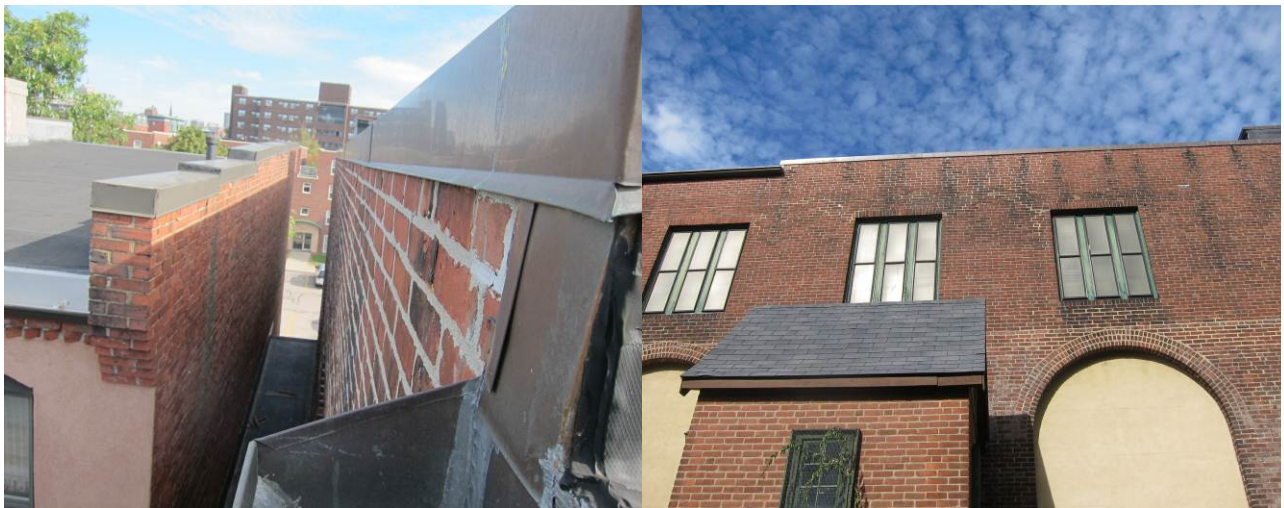
**Figure 60. Coping detail and runoff staining at joints of previous coping design**

Copings and parapet caps can suffer from problems such as inadequate slope, incorrect slope, inadequate overhangs, and inadequate drip edges: they can all cause accumulation of bulk water on the masonry below. Projecting drip edges and waterproofing under the cap are vital details to implement at these assemblies.

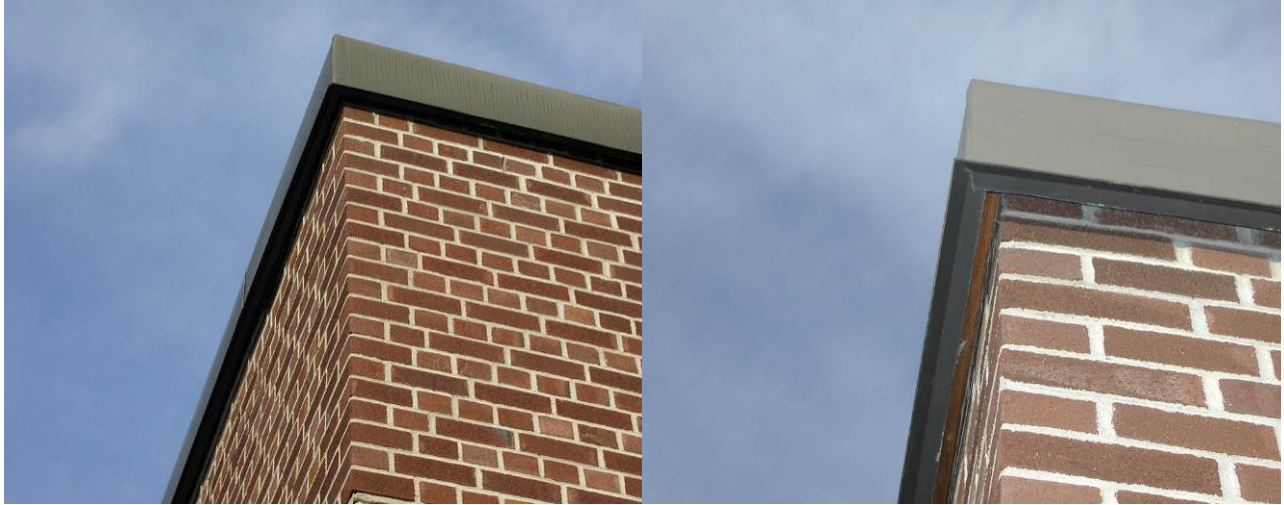
Examples of the built-out drip edge detail are shown in Figure 62.

**Figure 62. Improved drip edge overhang at coping**

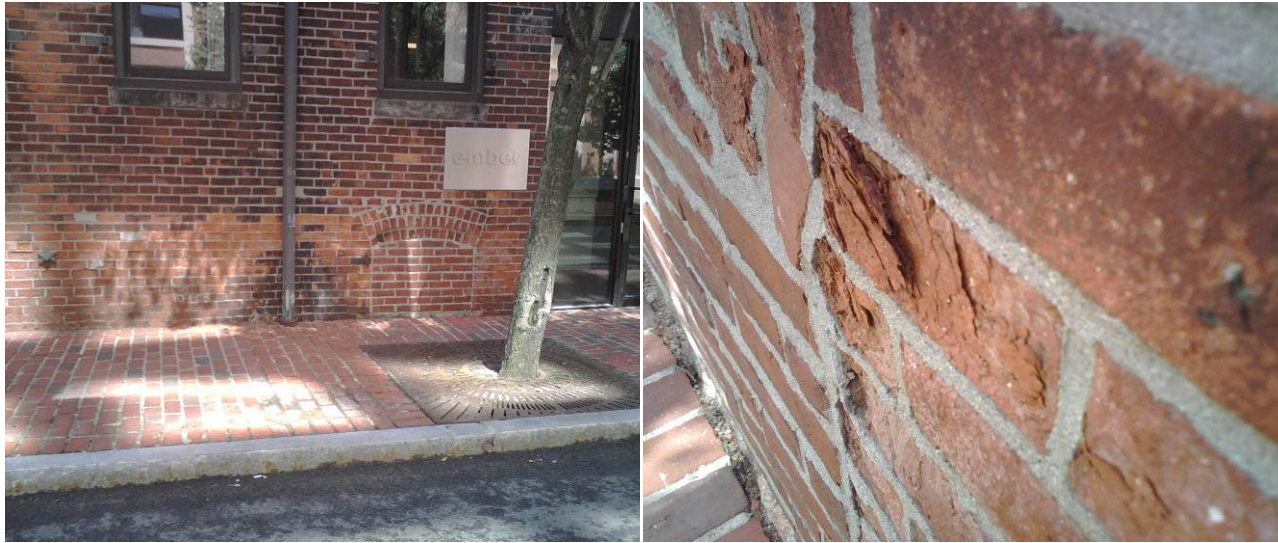
**Figure 65. Left: FT damage at downspout disconnection; Right: delamination of brick**

Downspouts, rainwater leaders, and scuppers, when improperly designed or when they fail to function, can concentrate a tremendous amount of water, making freeze-thaw (FT) damage very likely.

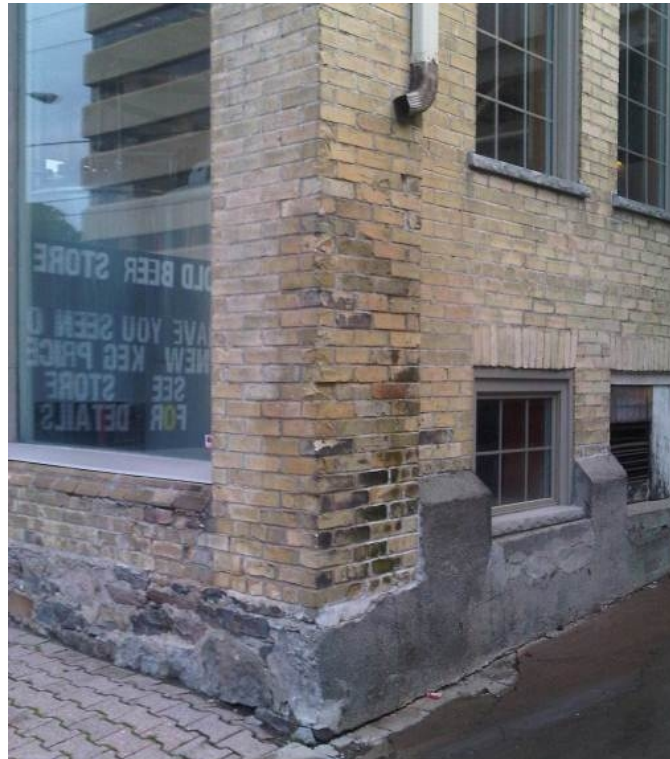
**Figure 66. Disconnected downspout and related damage to masonry**

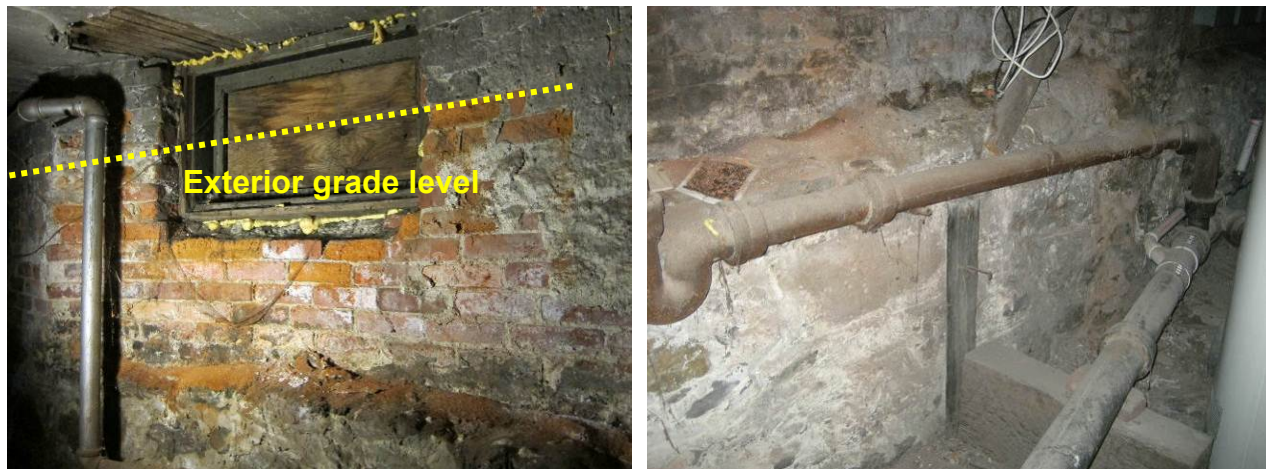
**Figure 69. Left: Severe subfluorescence and spalling at basement window; Right: Stone shelf below grade**

When brick is buried below grade, severe subfluorescence and spalling may result from capillary water uptake (moisture wicking) through the brick. The recommended solution to these buried brick issues is to eliminate capillary contact between the soil and the brick. Another risk close to grade is splashback; this is reduced with softer landscaping (not pavement), or by keeping roof and wall drainage away from the adjacent ground.

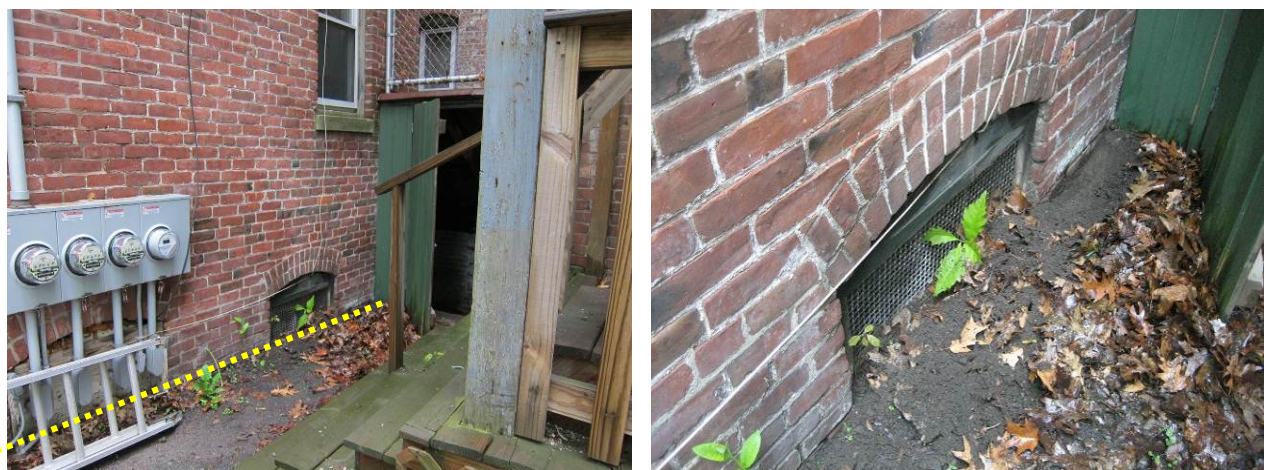
**Figure 70. Left: Rear wall near subfluorescence damage visible in basement; Right: Buried window**

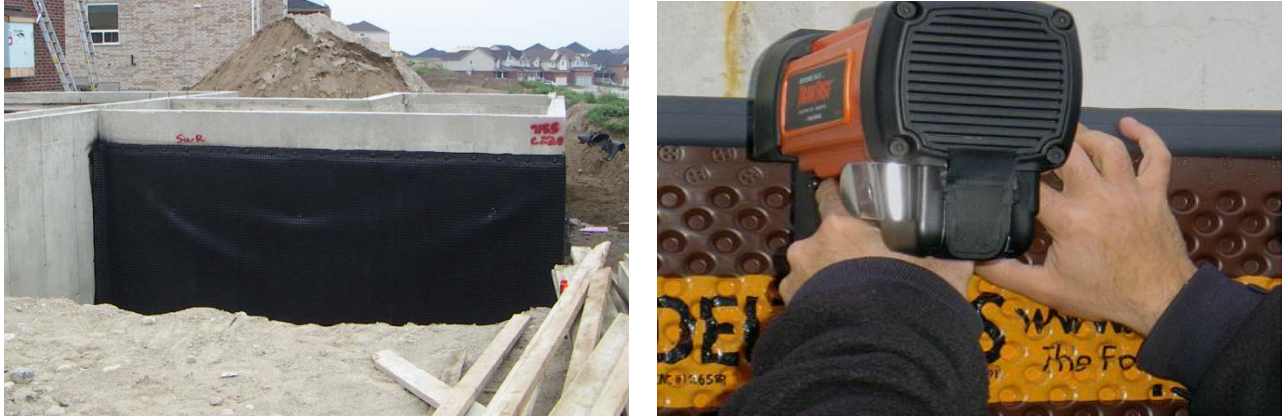
**Figure 73. Air gap membrane below grade and top closure strip**

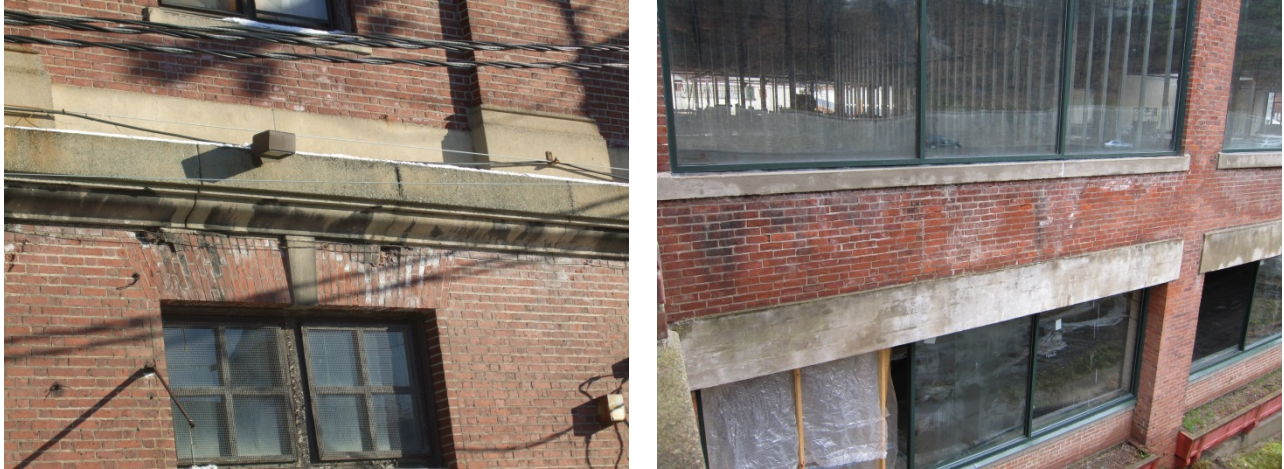
**Figure 83. Exterior details that demonstrate FT damage in existing masonry buildings**

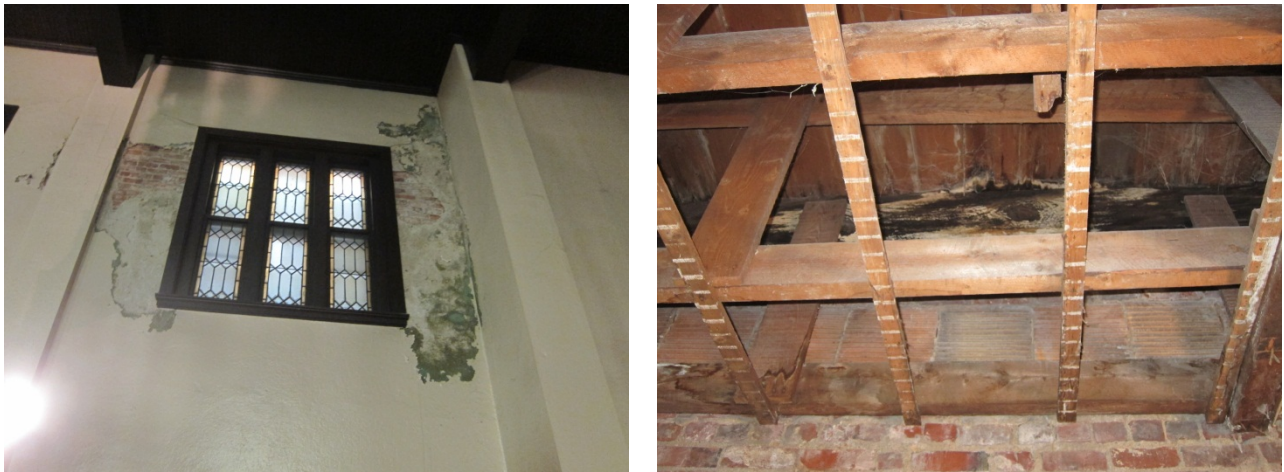
**Figure 84. Interior details showing previous moisture issues at window and roof-wall interface**

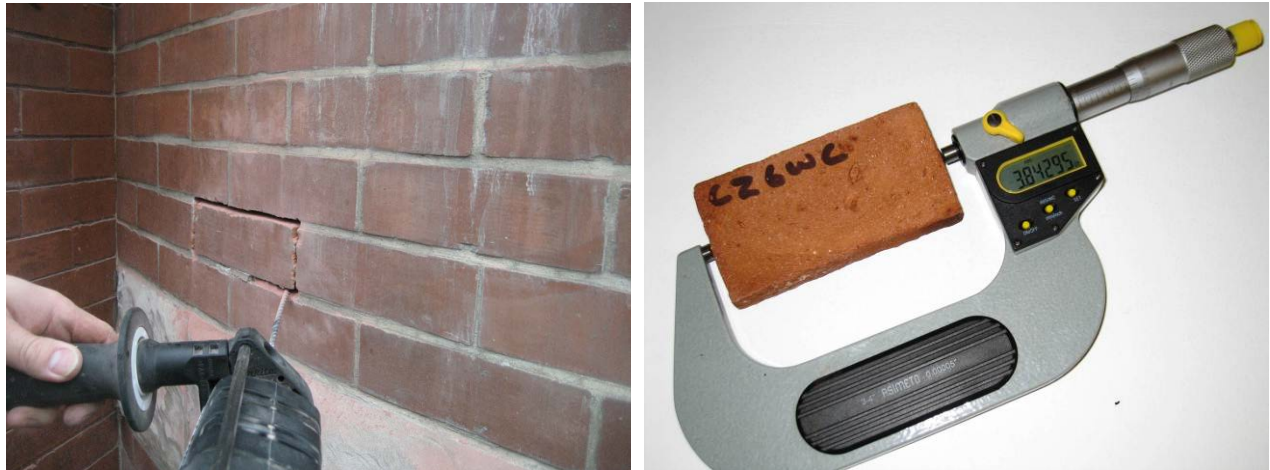
**Figure 88. Left: Removal of brick sample; Right: dilatometry (dimensional change) measurements**
