# Monitoring of Double-Stud Wall Moisture Conditions in the Northeast

K. Ueno  
*Building Science Corporation*

March 2015

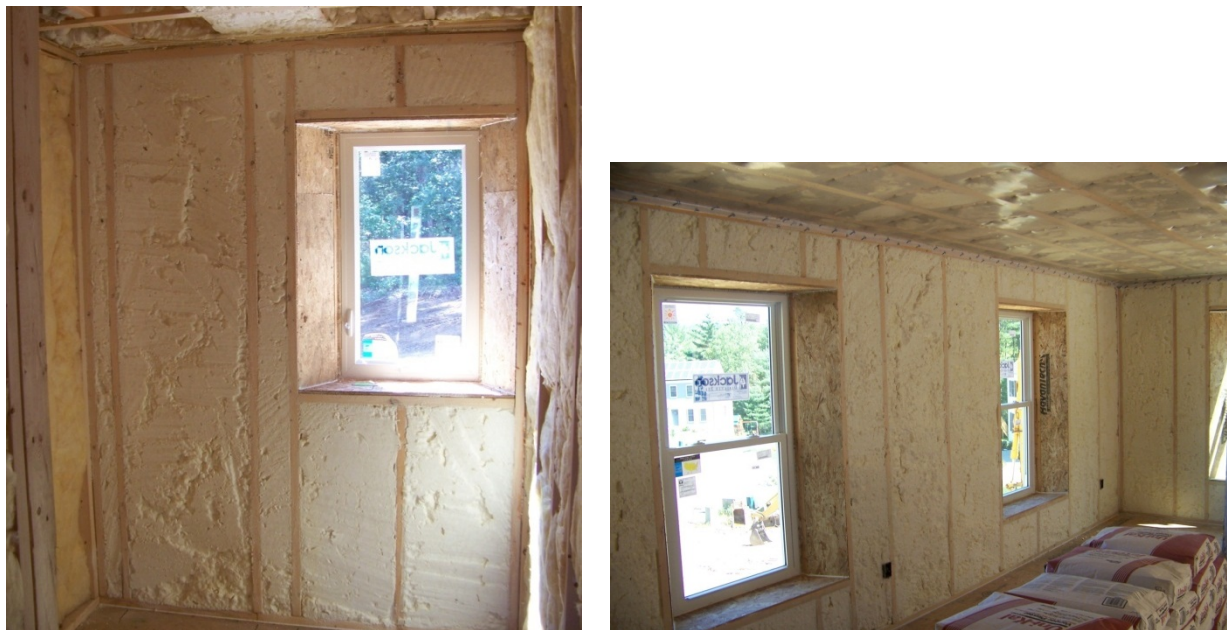
**Figure 2. Typical installation of 0.5 lb/ft<sup>3</sup> (PCF) ocSPF in double-stud walls**

Part of Transformations Inc.'s strategy of producing high performance homes without a significant cost increase is to offset the cost of upgrading the building enclosure/shell by reducing the size and cost of the mechanical systems. Double-stud walls with ocSPF have been standard components of Transformation's production-level high performance houses (Figure 2).

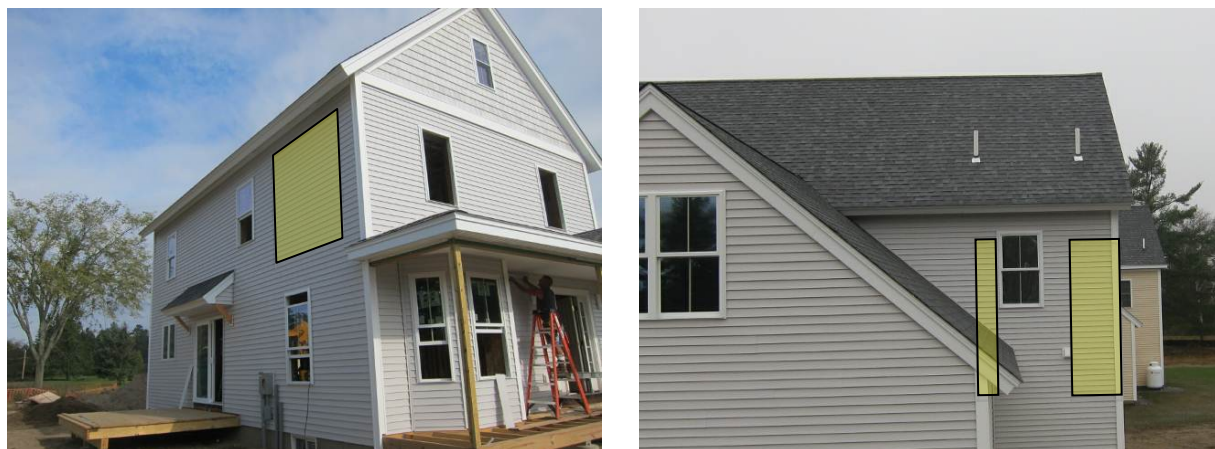
**Figure 8. Test wall locations shown on exterior of house; south (L) and north (R) orientations**

As shown in Figure 8 (right), the third bay (“control”) on the north side is partially sheltered at the bottom by the sloping garage roof. No better location was available, because of the positioning of windows, bathrooms, and garage.

The base of wall N3 was shielded by the garage roof (Figure 8); the sensors at the “lower” sheathing location were shifted upward, to the lowest exterior exposure in the stud bay.

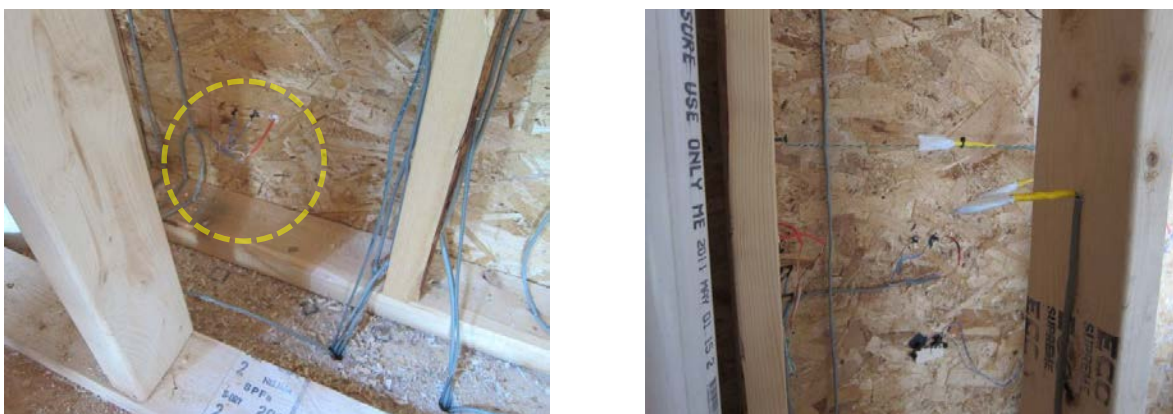
**Figure 9. (L) Temperature and MC sensor at sheathing; (R) sensors at mid-height of stud bay**

The right-hand image (Figure 9) shows typical conditions mid-height in the study bay, with T/RH, sheathing MC, and stud MC sensors visible. The T/RH sensor can be identified by the yellow heat shrink tubing; the sensor consists of a vapor-permeable polyolefin house wrap envelope around the T/RH sensor.

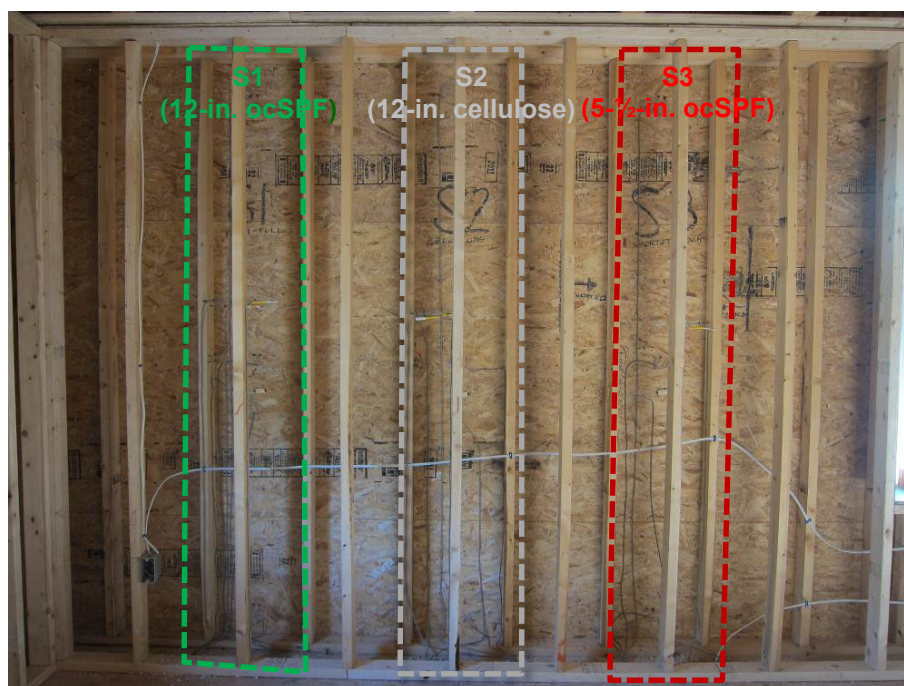
**Figure 11. South test walls after installation of sensors, showing double-stud layout**

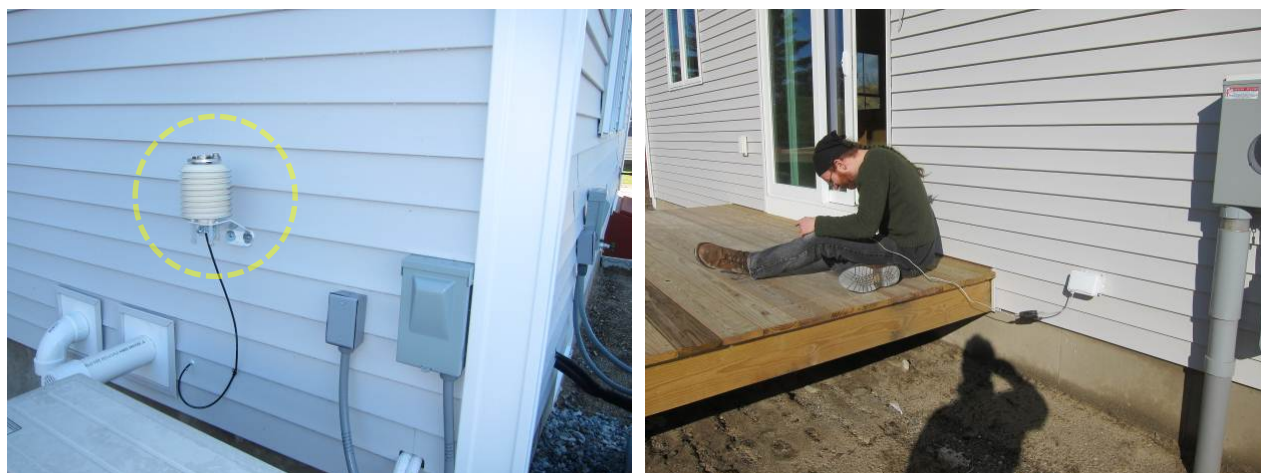
**Figure 14. (L) Exterior T/RH sensor; (R) data collection from exterior connection port**

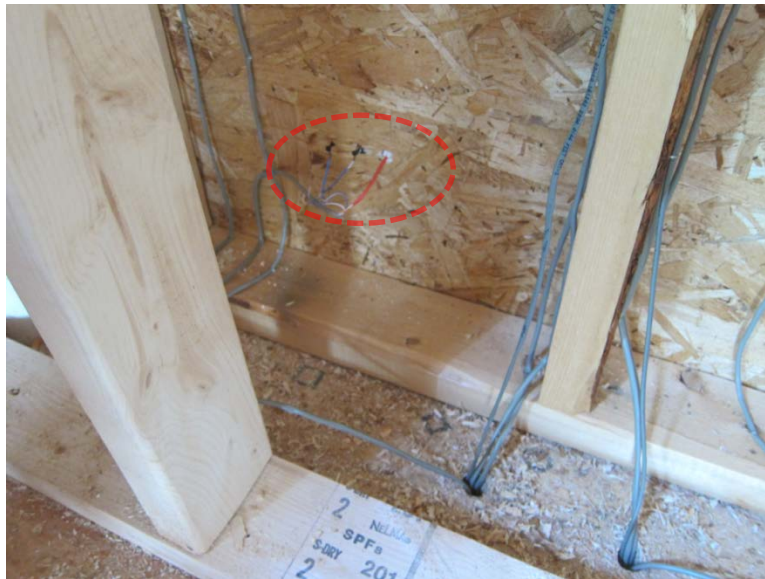
**Figure 19. Sheathing MC/temperature sensor locations (bottom shown in picture)**

Sheathing MCs are often used as a primary performance indicator of moisture risks. The sheathing is typically used because it operates near outdoor temperatures, and is often the vulnerable condensing surface for interior moisture in wintertime. The sheathing MC sensor locations are shown in Figure 19.

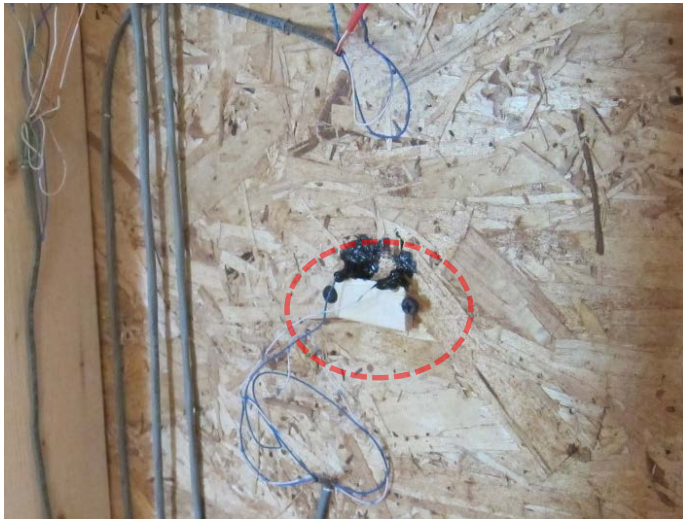
**Figure 22. Sheathing-insulation interface wafer sensor location**

Other sensors were used to corroborate the sheathing MC behavior. The wafer sensors reflected conditions at the exterior sheathing-to-insulation interface (Figure 22).

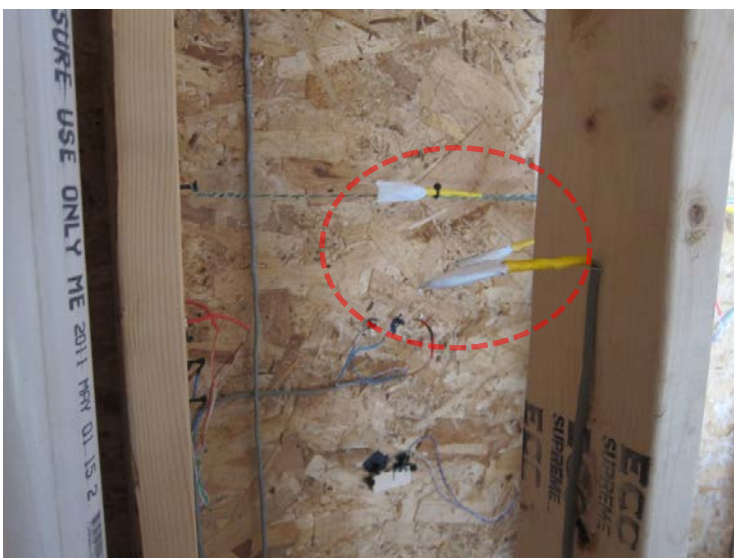
**Figure 27. Stud bay cavity T/RH sensor locations**

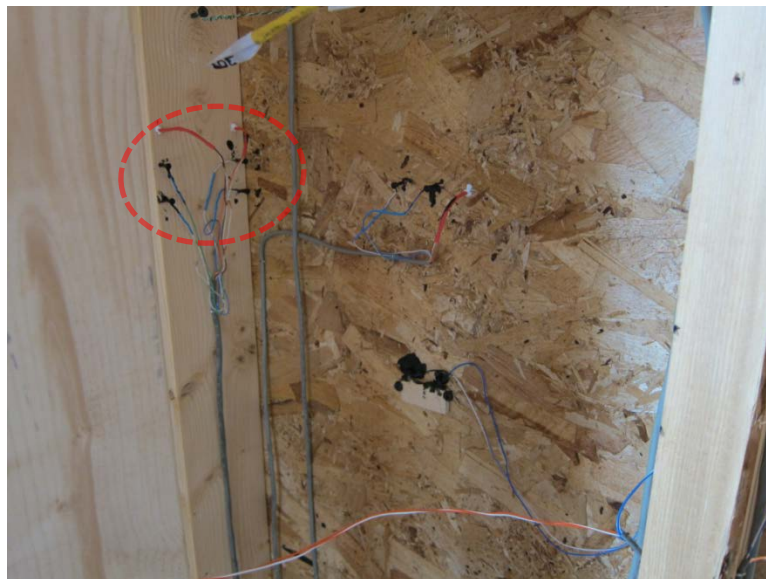
**Figure 30. Framing MC/temperature sensor locations**

The framing MC sensors (inboard/outboard side of outer stud) are shown in Figure 30; they were compared to previous measurements for consistency.

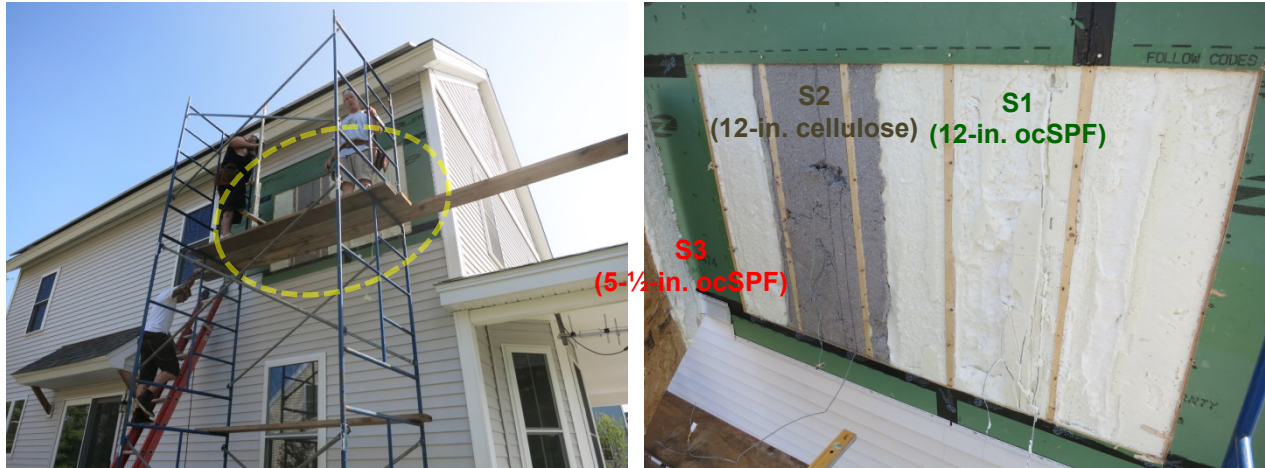
Figure 39. South-facing wall disassembly, showing test bay cavities

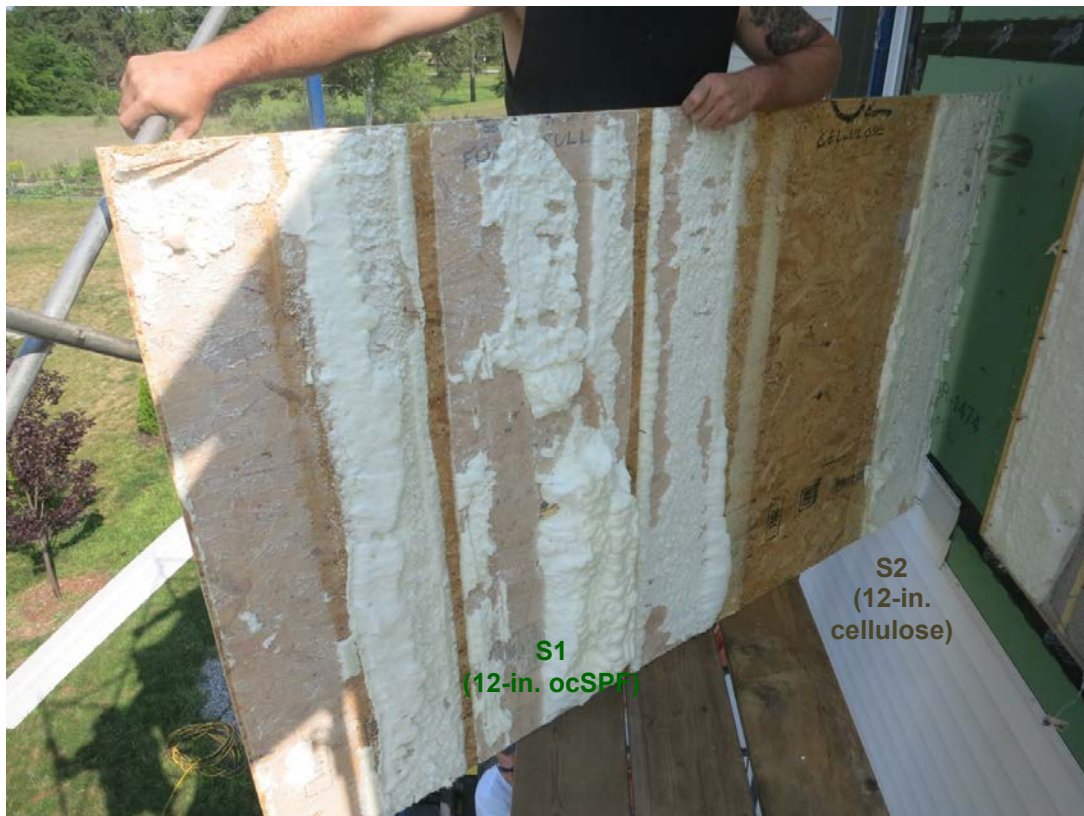
Figure 40. South-facing wall sheathing conditions

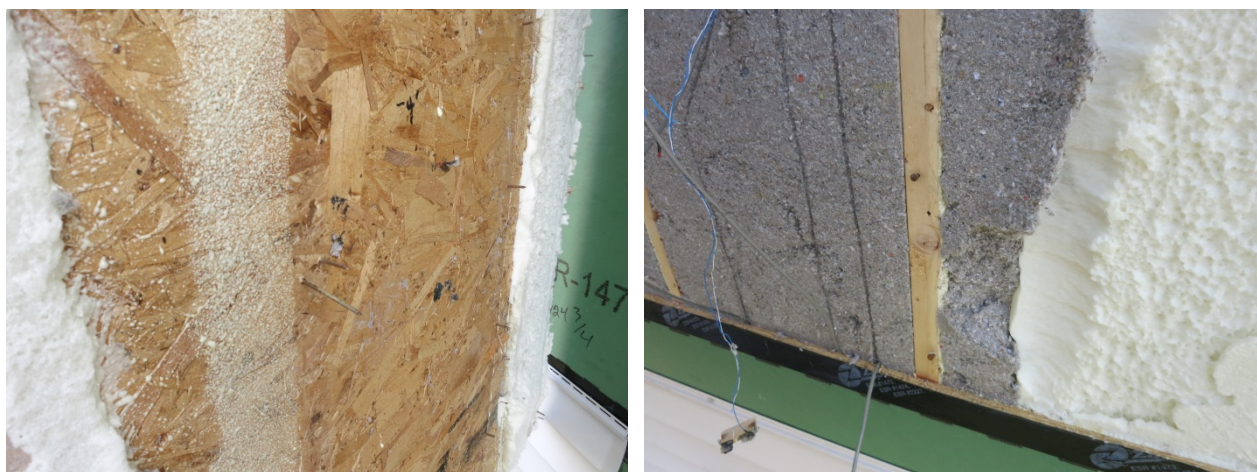
**Figure 41. Sheathing and framing conditions at south-facing walls**

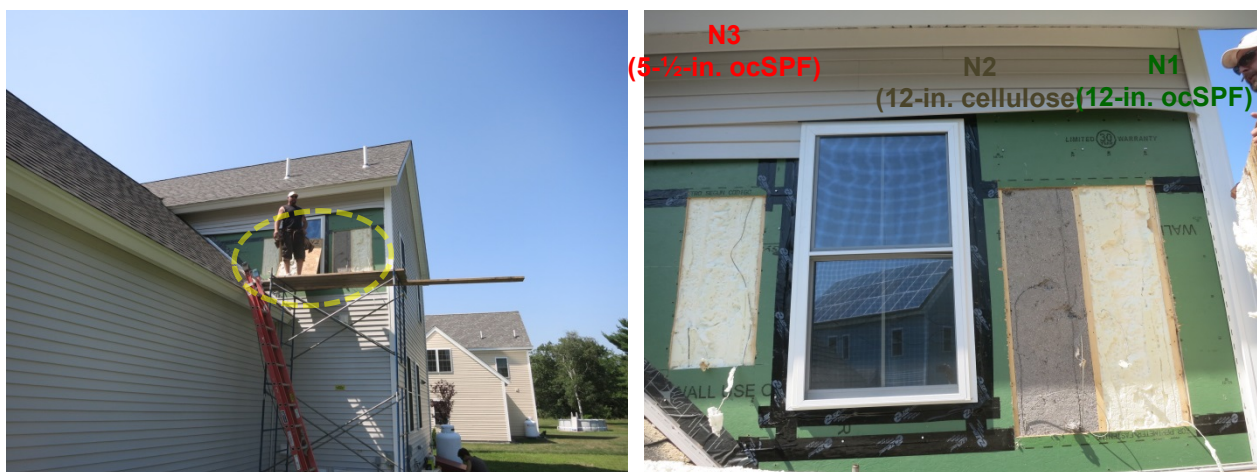
**Figure 42. North-facing wall disassembly, showing test bay cavities**

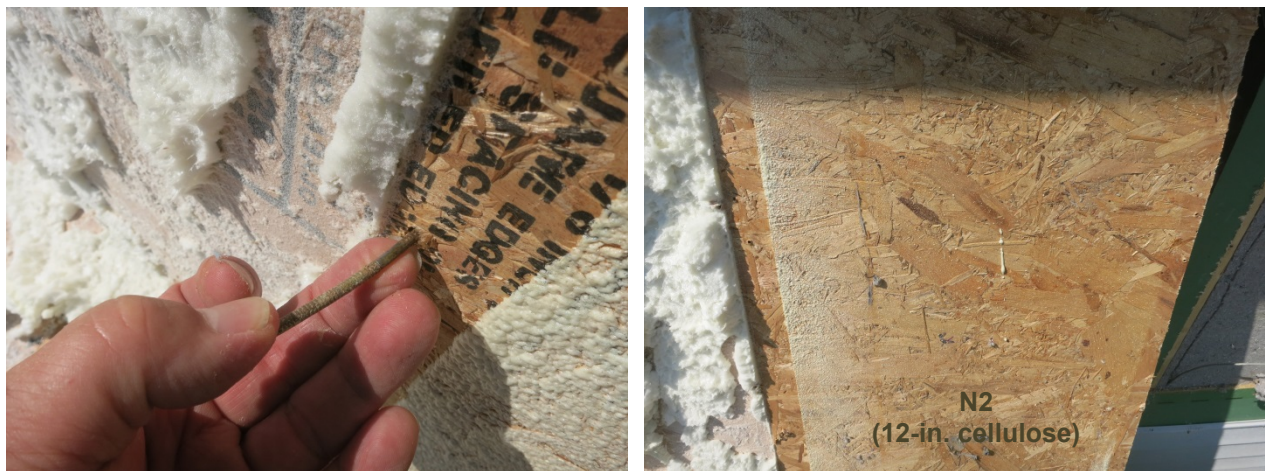
Figure 44. North-facing wall conditions at fastener and sheathing at cellulose bay (N2)

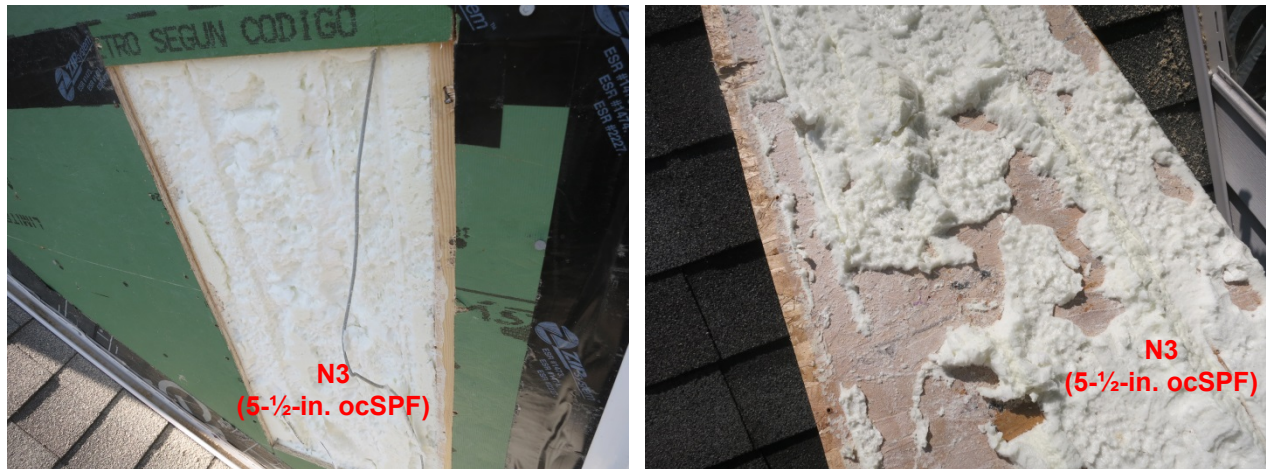
**Figure 45. Stud bay cavity and sheathing conditions at 5-1/2-in. ocSPF north-facing wall (N3)**
