Are Your Buildings Accessible?

Multi-family developers take notice...or you could be next

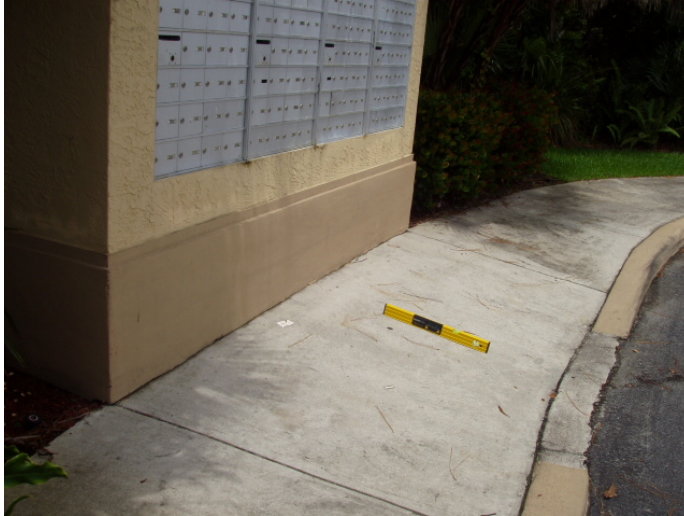
In this picture, cross slope is measured by placing the digital level perpendicular to the direction of travel. The excessive cross slope renders the route inaccessible and creates a difficult condition for anyone with a disability to negotiate.

Cross slopes of accessible routes are required to be no more than 2 percent, which is flat to the unassuming eye. It is not uncommon during a site inspection to find cross slopes in excess of 10 percent or more, a path not easily used by many.

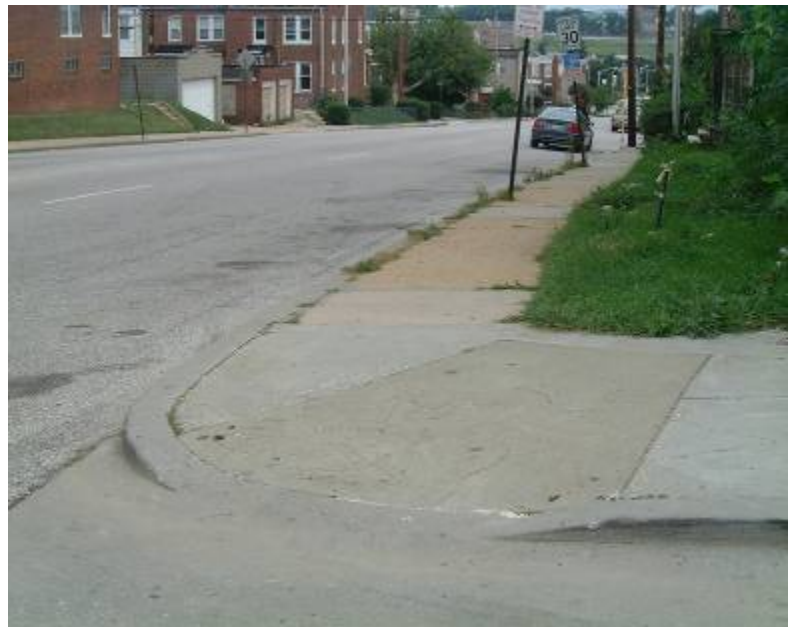
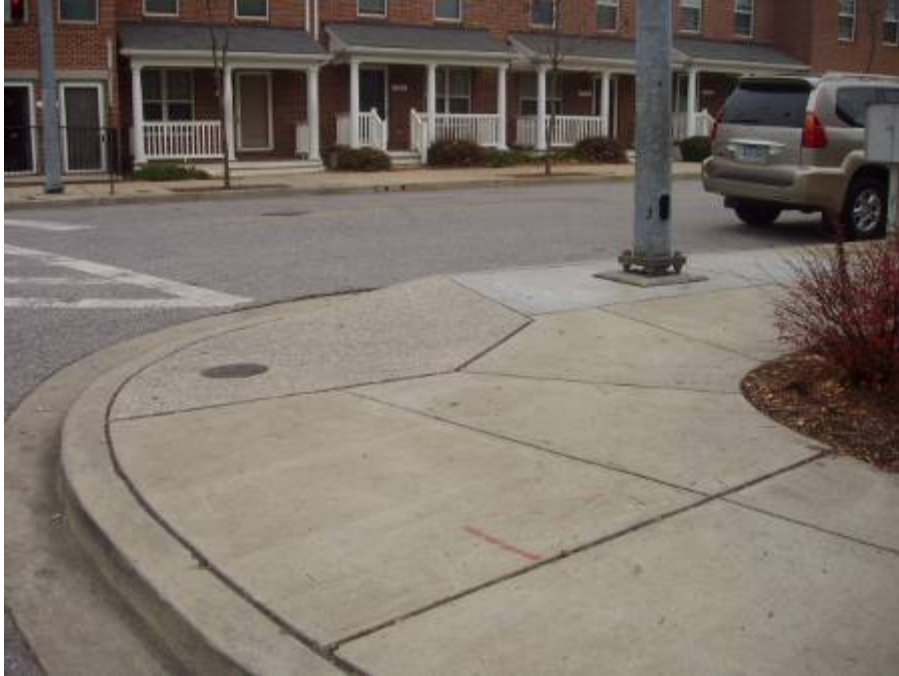
The common corner curb cut is often constructed incorrectly. In this case, the slope of the curb ramp creates difficulty for some people with disabilities when negotiating the slope as they travel along the sidewalk. When a person who uses a wheelchair makes the turn around the corner, the wheelchair can tip toward the street creating a dangerous condition.

The accessible route is brought around the top of the curb ramp slope.

Typically, extreme cross slopes occur at the intersection of a sidewalk and a curb ramp where the route along the sidewalk continues across the slope of the curb ramp (see photo below). In this case, the running slope of the curb ramp, which is permitted to be up to 1:12 (8.33 percent), is also the cross slope of the accessible route across curb ramp; cross slopes are not permitted to exceed 2 percent.

Providing a pathway around the top of the curb ramp so that a person is not required to negotiate across the slope of the curb ramp is one way to eliminate this common violation.

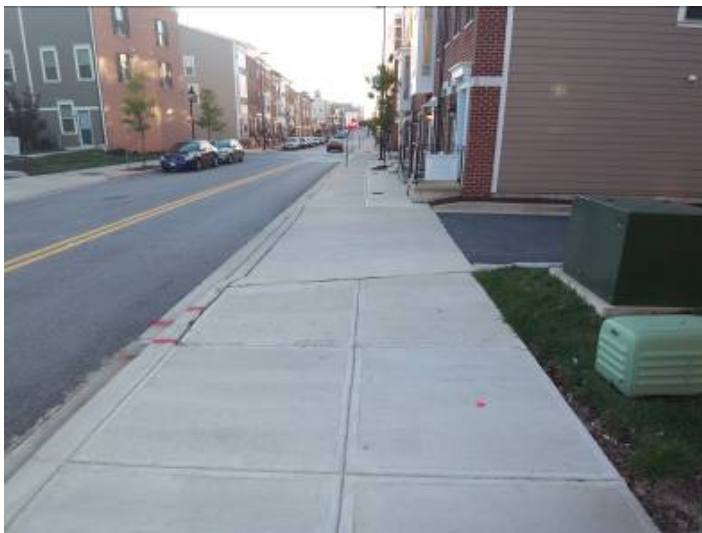
The picture at left demonstrates the excessive cross slope of the route as it negotiates across the driveway.

The picture at right shows the accessible route provided across the driveway entrance first, and then the sloped vehicular entrance is added. This design ensures that the accessible route as it negotiates across the driveway is kept level.

Additionally, cross slopes of accessible routes typically exceed 2 percent where those routes are provided across driveway aprons, which often slope steeply. If an accessible route is designed to cross a driveway, a minimum 36-inch wide route with a maximum cross slope of 2 percent must be maintained (code may require these routes to be wider than 36 inches). One way to remedy this inaccessible condition after the project is complete is to create a built-up route across the sloping driveway with a maximum 2 percent cross slope. Where driveways are concrete, a more expensive replacement and relocation of the flared driveway entrance may be required.

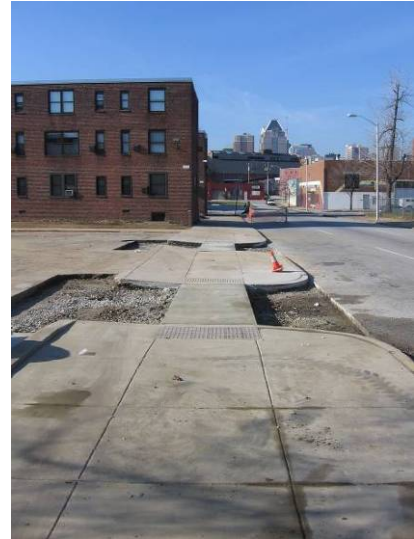
The picture at right demonstrates the challenges with providing accessibility throughout steeply sloping sites.

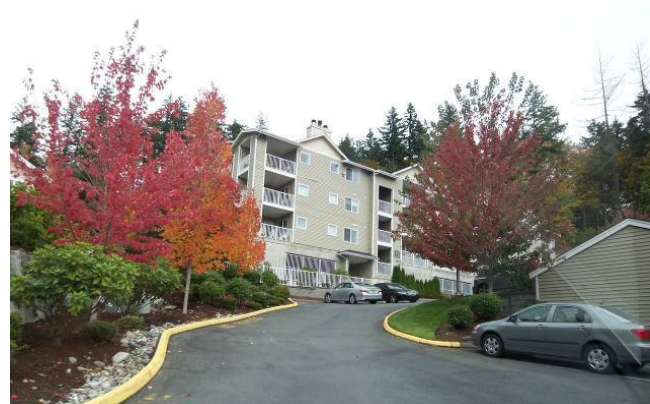
Depending on the site conditions, it may not always be possible to achieve compliant running slopes. For example, extremely hilly terrain may prevent the installation of a route with a compliant running slope.

Considerations for these conditions are made, but in any case where a compliant route is achievable, it must be provided. For example, a site may have an extremely hilly area and an area which is relatively flat. Locating dwelling units in the area of the site which is hilly to avoid the inclusion of accessible routes may be considered deliberate manipulation to avoid compliance, which must be avoided. In all cases, where accessible routes are possible, they must be provided.

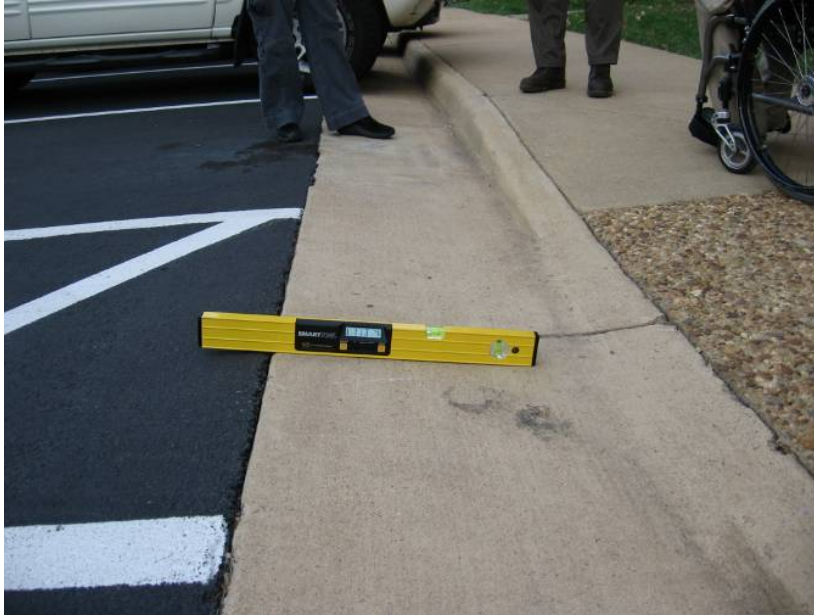
The picture at left shows the slope of the gutter which must be kept minimal to avoid creating hazardous conditions. The digital level in this photo indicates a slope of over 11% which is more than two times the maximum slope permitted.

For example, the bottom of a curb ramp often meets a gutter; the flares of a flared-type curb ramp meet a curb; and the top of the curb ramp meets the route which continues through the site. Each of these components has an affect on curb ramp construction. For example, gutters, or the area where the bottom of a curb ramp meets the street, are often sloped toward the curb ramp. As one might imagine, an excessive counter slope of the gutter makes it difficult for a person in a wheelchair to maintain the momentum needed to move across the slope of the

gutter and onto the running slope of the curb ramp. It is important to keep the slope of the gutter gradual so that the transition between the gutter and the running slope of the curb ramp is easy and does not require excessive effort to negotiate. For the most part, remediation often requires removal and replacement of the curb ramp.

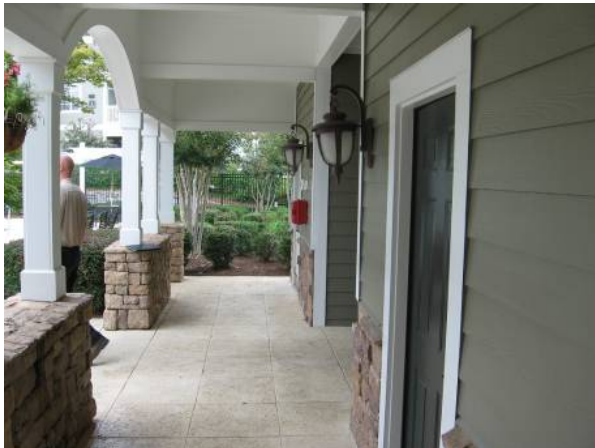
When located below 80-inches above the floor or ground, wall-mounted scones are a common hazard for people with visual disabilities if they protrude from walls more than 4 inches.

Wall-mounted object, such as lighting, which are installed lower than 80 inches and more than 27 inches above the finished floor must not project more than 4 inches into the circulation path. Commonly, designers focus on eliminating unsafe protruding objects from accessible routes, but criteria developed to address the needs of people with visual disabilities apply to “circulation paths” and are not always limited to the accessible route. Typical fixes when unsafe protruding

objects are identified include replacing features with similar low-profile models, such as low profile lighting, or where remounting or replacing the feature is not feasible, providing a permanent cane-detectable barrier below will suffice, in most cases.

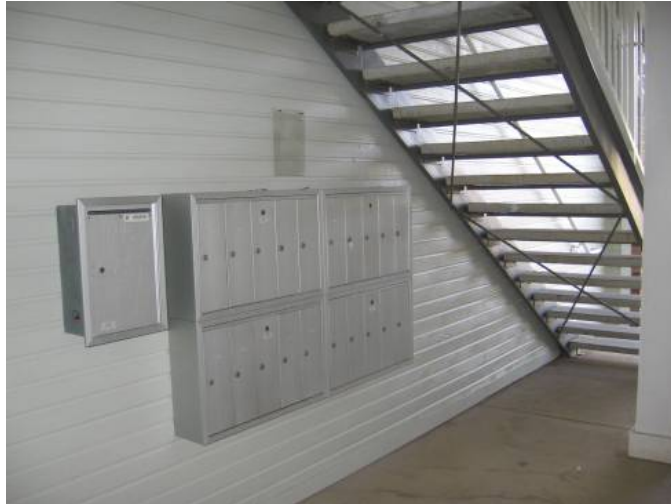
Common-use areas such as the one picture to the left should never be located below open stairs.

The lack of a cane-detectable barrier below an open stair run is a common violation of headroom criteria developed to address the needs of people with visual disabilities. Open stair runs, which are not permitted in many jurisdictions due to the potentially unsafe conditions they pose, must include a cane-detectable barrier to prevent people with visual disabilities from walking below.

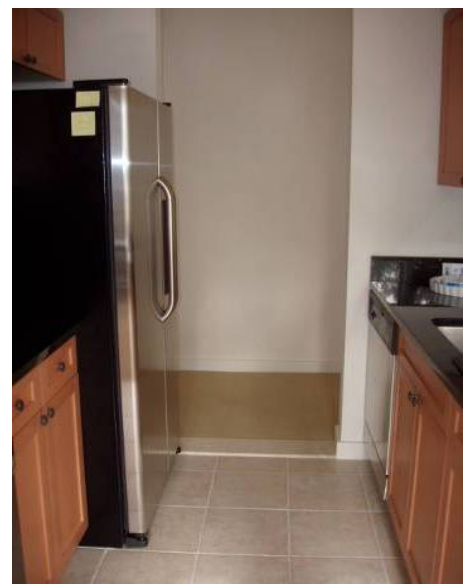
In the kitchen pictured to the right, the distance between the face of the refrigerator and the opposing countertop must be no less than 40 inches. In this instance, value engineering resulted in a violation of clearance requirements. The original refrigerator was replaced with one which is less expensive; however, the less expensive model pictured here is deeper than the original resulting in a clearance of less than 40 inches.

Although kitchen plans may show that 40 inches are provided, appliances selected later on in the process or appliances which are substituted for those included in the initial design may compromise clearance requirements. It is important for designers to consider the dimensions of appliances to ensure that once installed proper clearance will be maintained.
