Multifamily Ventilation Retrofit Strategies

K. Ueno, J. Lstiburek, and D. Bergey
Building Science Corporation

December 2012

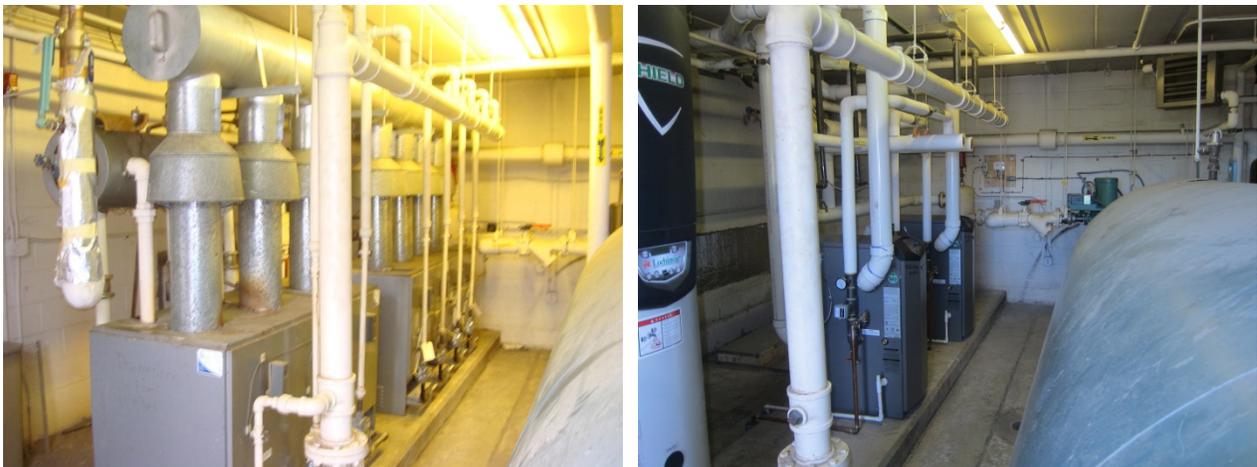
Figure 8. Replacement of atmospheric boilers (L) with condensing sealed-combustion boilers (R)

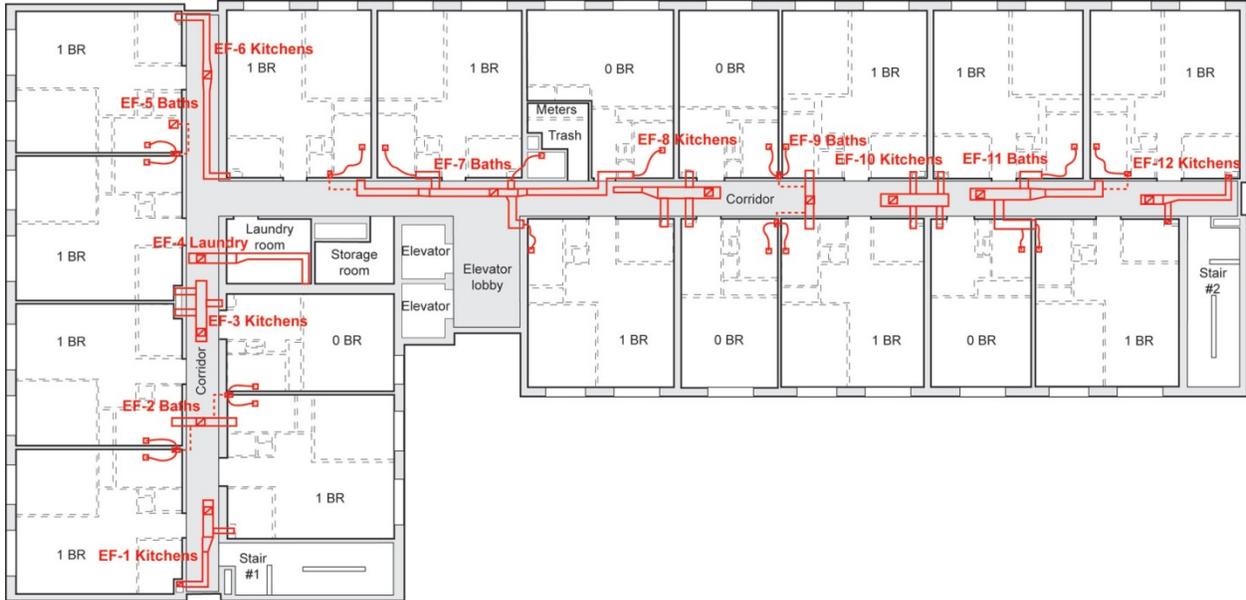
Figure 16. Typical floor plan, showing kitchen/bath exhaust systems and risers

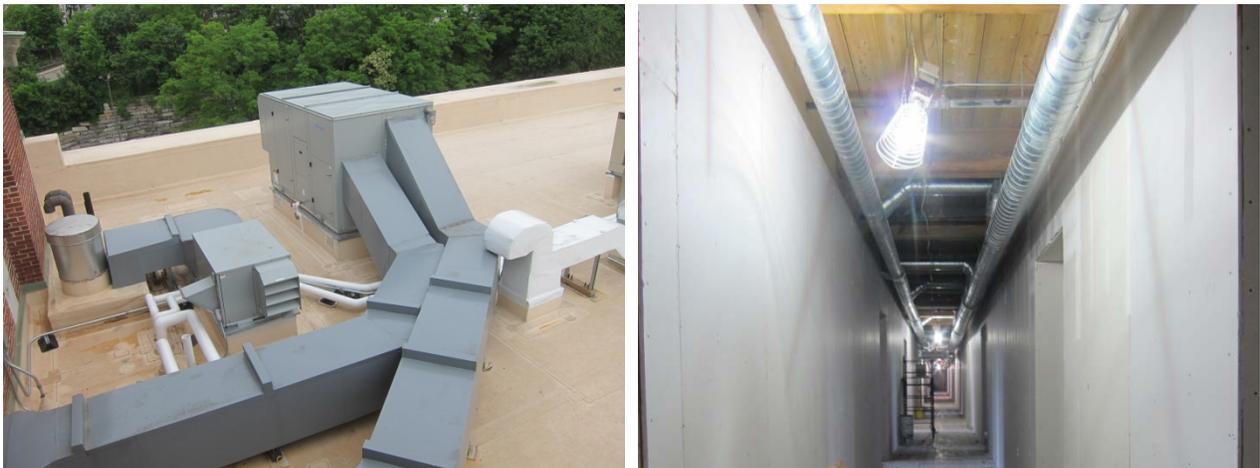
Figure 20. Rooftop HRV, with supply/exhaust ducts (L); supply and exhaust ductwork in corridor (R)

A central HRV system can deliver excellent performance (with some caveats); however, it requires a fully ducted supply and exhaust system that connects each apartment unit to the rooftop unit (see Figure 20). Retrofitting a second set of ductwork into an existing building is typically not feasible in terms of cost. The representative images of a central HRV system in Figure 20 are from a different project (not the current Innova work).

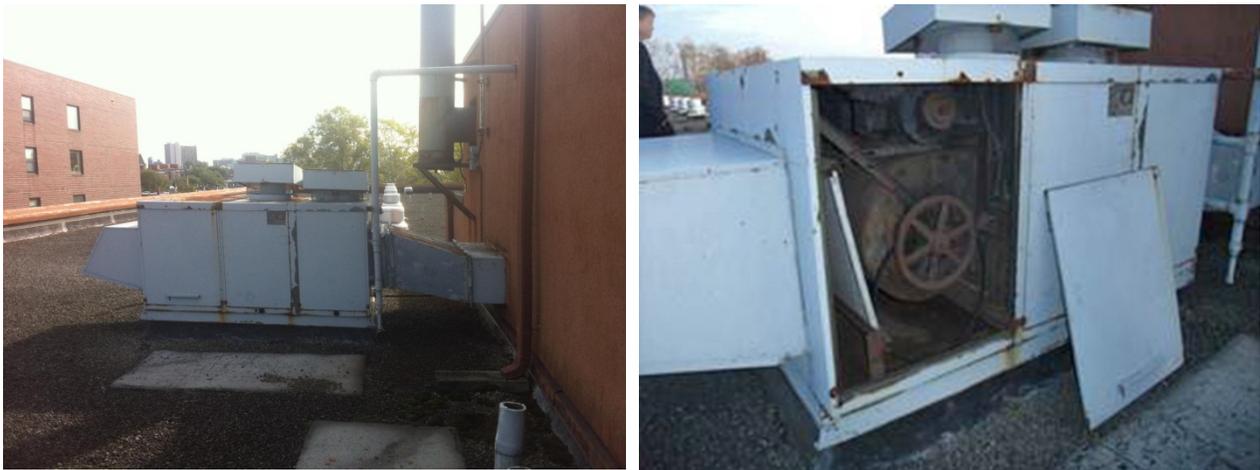
Figure 22. Nonoperational rooftop MAU

Existing rooftop make-up air unit has been disabled for approximately two years, resulting in poor indoor air quality and a fire safety hazard due to depressurization. (Innova 2011)

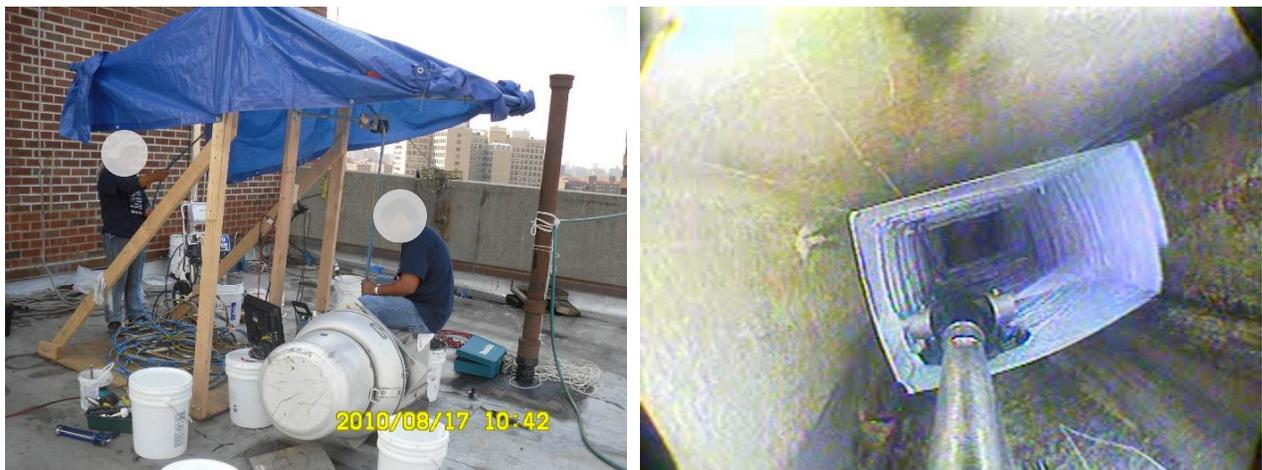
Figure 25. Remote shaft-sealing spray mastic system (Photo from Consolidated Environmental, Inc.)

One option for air sealing is a remote shaft spray mastic system, developed by Consolidated Environmental, Inc., and shown in Figure 25. A segmented pole is lowered down through the rooftop fan opening; a remote camera allows inspection of the exhaust shaft for seams and penetrations. Targeted retrofit sealing is accomplished using spray-applied mastic, as shown in Figure 25 (right)

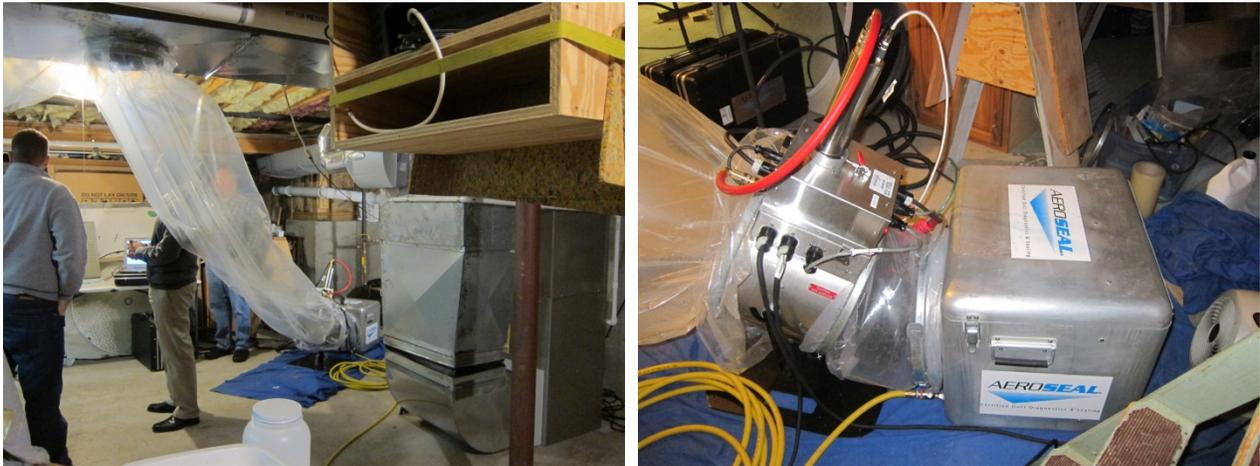
Figure 26. Aerosol duct sealing of residential HVAC system (L); with close-up of equipment (R)

An alternate duct sealing solution is the use of a commercially available aerosol-based duct sealing system, as described by Modera et al. (1996). This technique involves the injection of a fine aerosol spray of a vinyl-acetate (water-based) polymer that preferentially deposits on leakage locations (see Figure 26). The manufacturer furnishes studies showing significant reductions in exhaust shaft leakage (from 326 cfm 25 to 12 cfm 25 in a Boston-area study). Zuluaga and Fitzgerald (2010) present results showing a reduction from 220 cfm 25 to 19 cfm 25 in one building, and from 1,606 cfm 25 to 30 cfm 25 in another building. These results essentially tighten the ducts enough that leakage is close to insignificant.

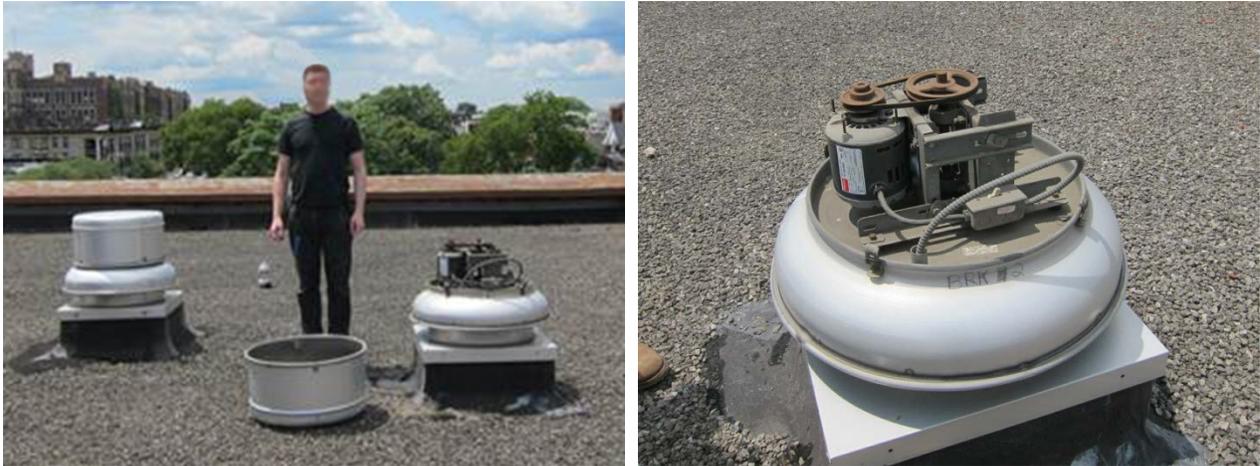
Figure 27. Typical rooftop exhaust units (L); cover removed from exhaust fan (R)

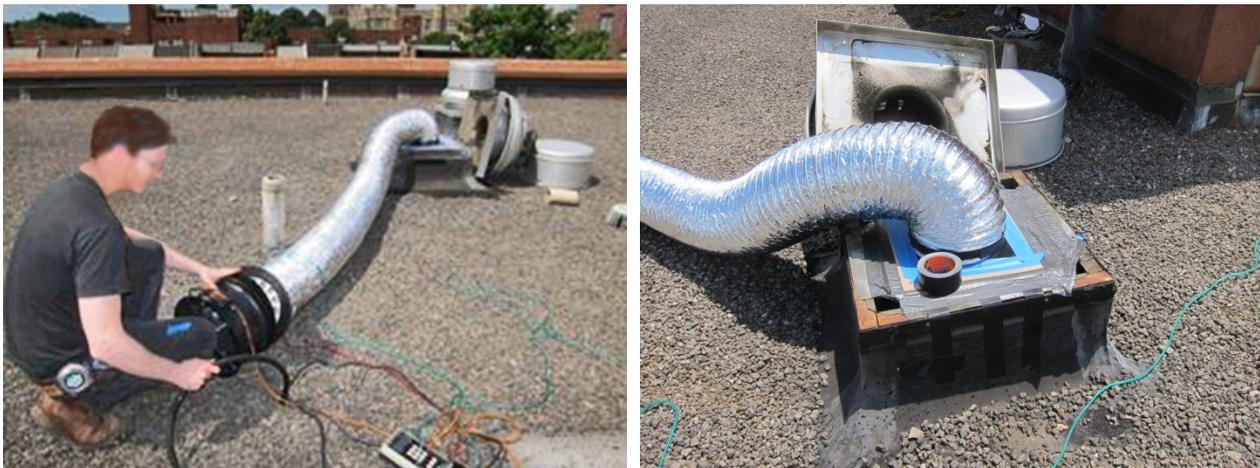
Figure 28. Air leakage testing of exhaust fan (EF) shaft 5 (EF-5)

The exhaust shafts were then tested for air leakage, using fan depressurization and pressurization testing from the roof curb (Figure 28).

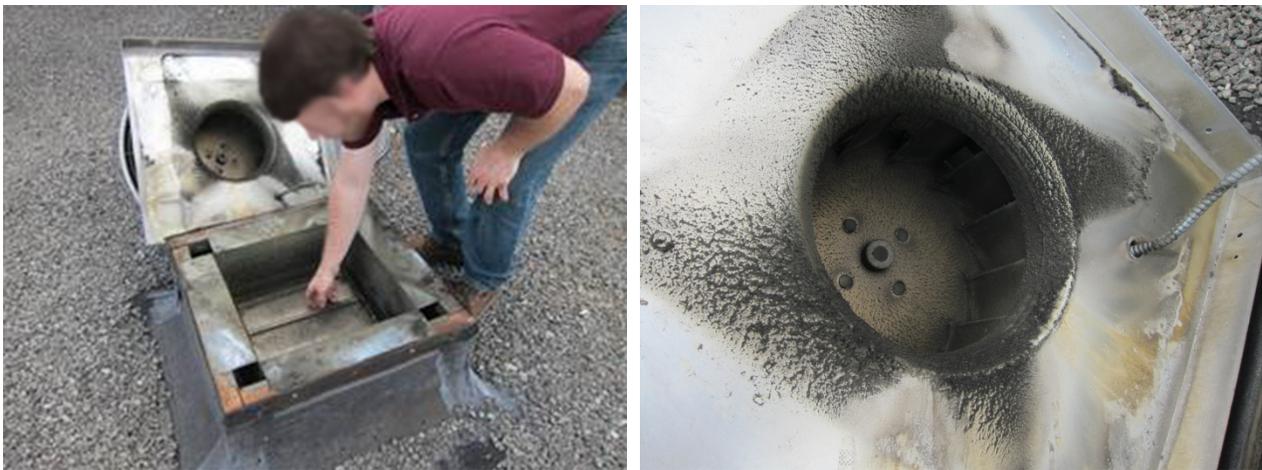
Figure 29. Open corners at exhaust shaft rooftop curb (L), with dust marking patterns (R)

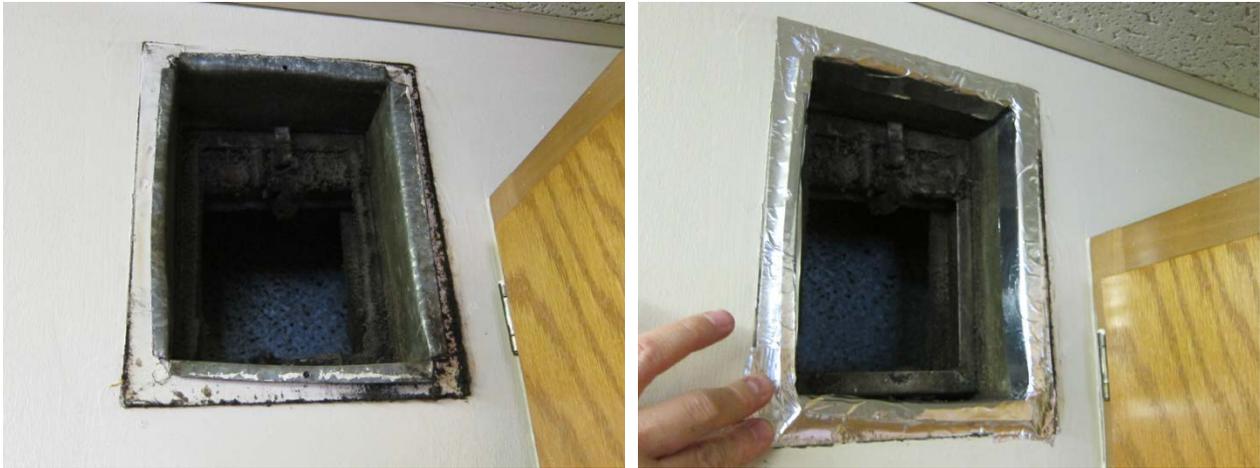
Figure 30. Kitchen exhaust boot-to-drywall as found (L) and retrofit seal (R) state

Significant leakage was noted around the duct boot attachment through gypsum board (similar to observations by Zuluaga and Fitzgerald [2010]); air leakage is evidenced by the dust deposition under the sheet metal register outline (see Figure 30, left). The junction from the sheet metal to drywall was sealed with foil tape (see Figure 30, right), and the shafts were retested.

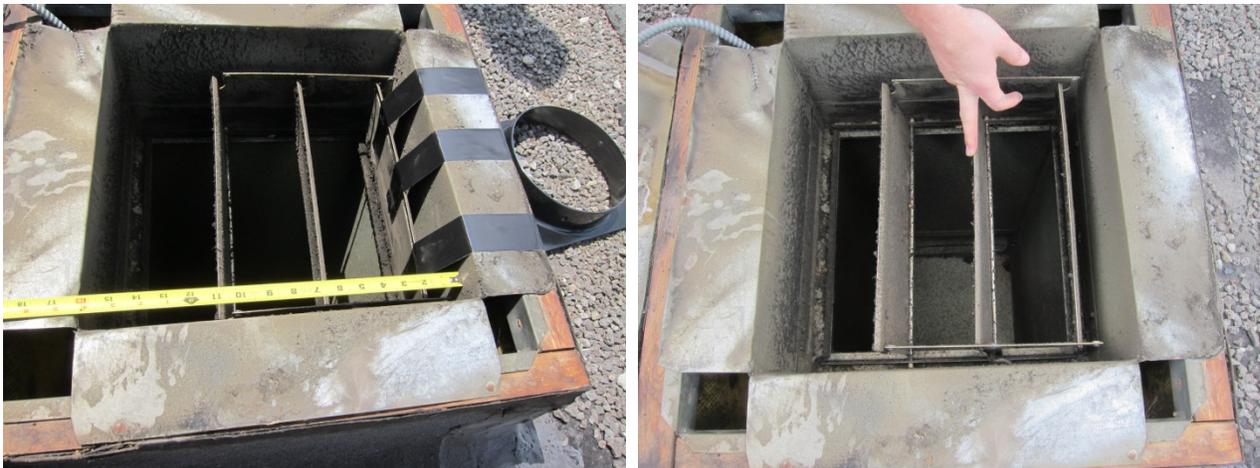
Figure 31. Spring-loaded louvers on exhaust fan rooftop curb blocked open at EF-1 testing

The flow versus depressurization curve obtained at EF-5 demonstrated that the louvers were closing incrementally as the multipoint fan depressurization dropped from 60 Pa to 25 Pa. As a result, multipoint testing from this shaft was ignored and only the highest pressure was used, assuming that the louvers were at their most open position at this test point.

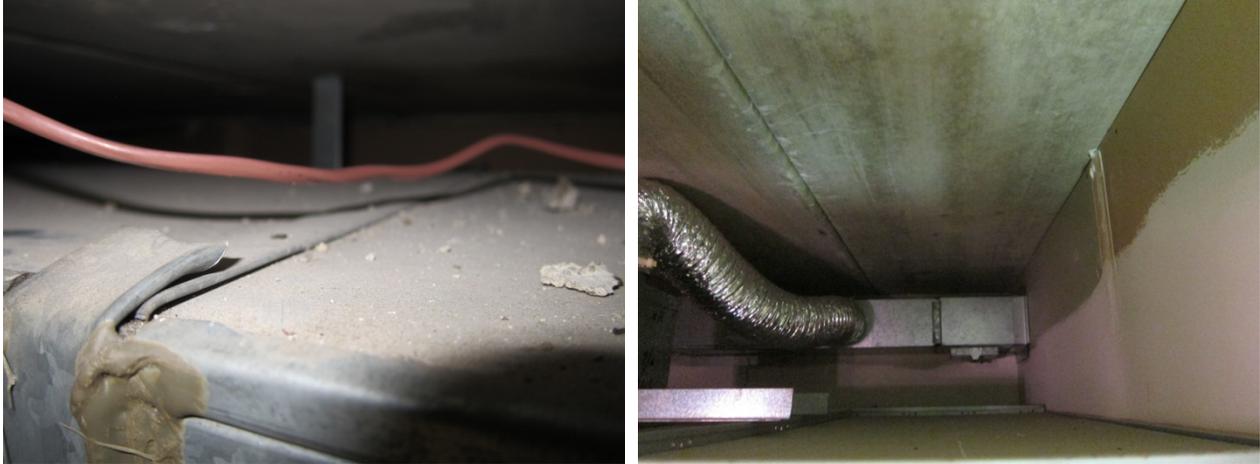
Figure 33. Limited mastic sealing at sheet metal joints (L); connection to flex runouts (R)

Examination of the ductwork revealed that the sheet metal joints were sealed with limited amounts of mastic (see Figure 33); however, there were many other unsealed joints, as well as inaccessible joints, which would have been difficult to seal during construction.

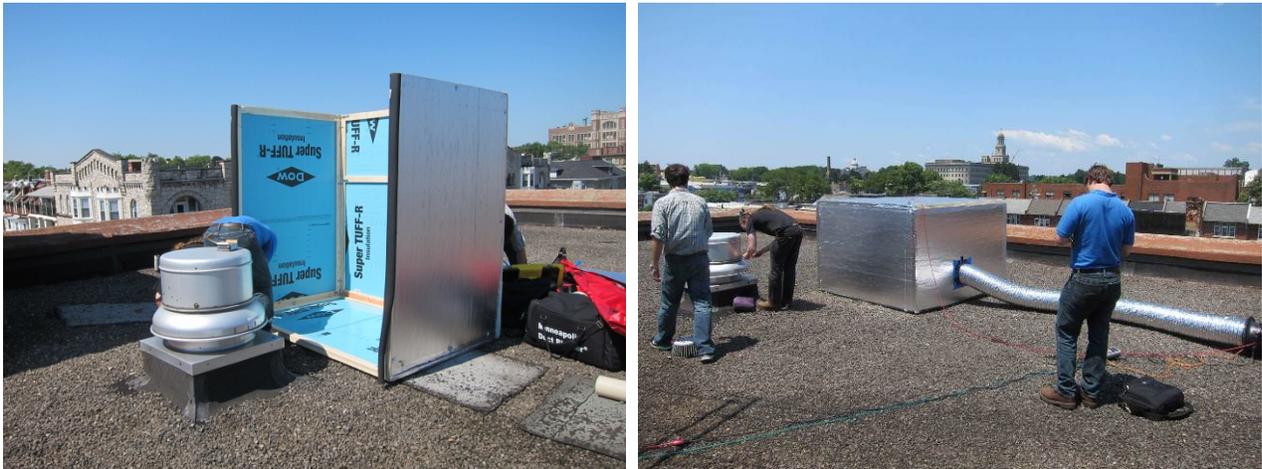
Figure 34. Powered flow capture enclosure for rooftop exhaust fans showing construction

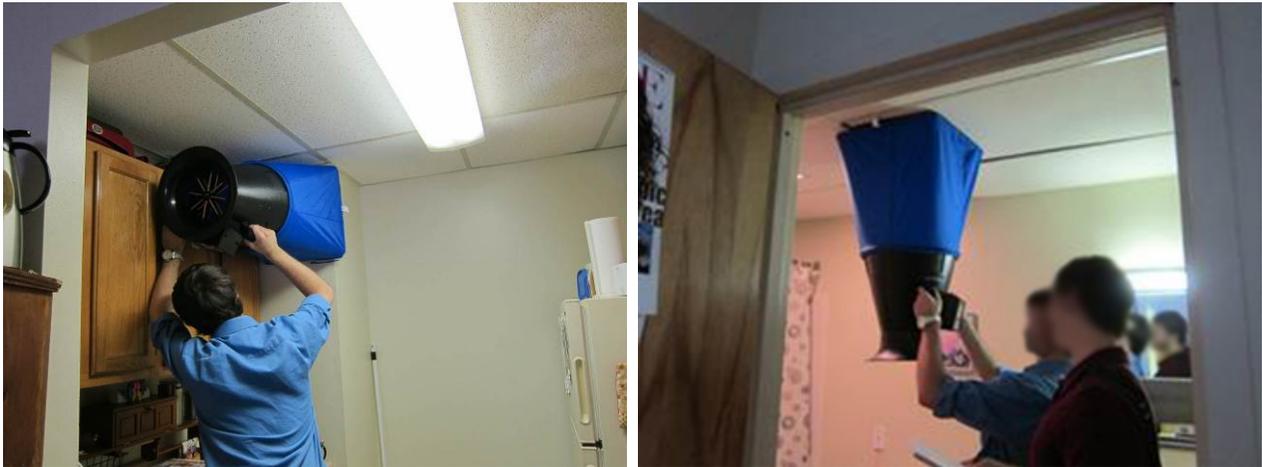
Figure 37. Airflow testing of unit exhausts with flow capture hood; kitchen (L) and bath (R)

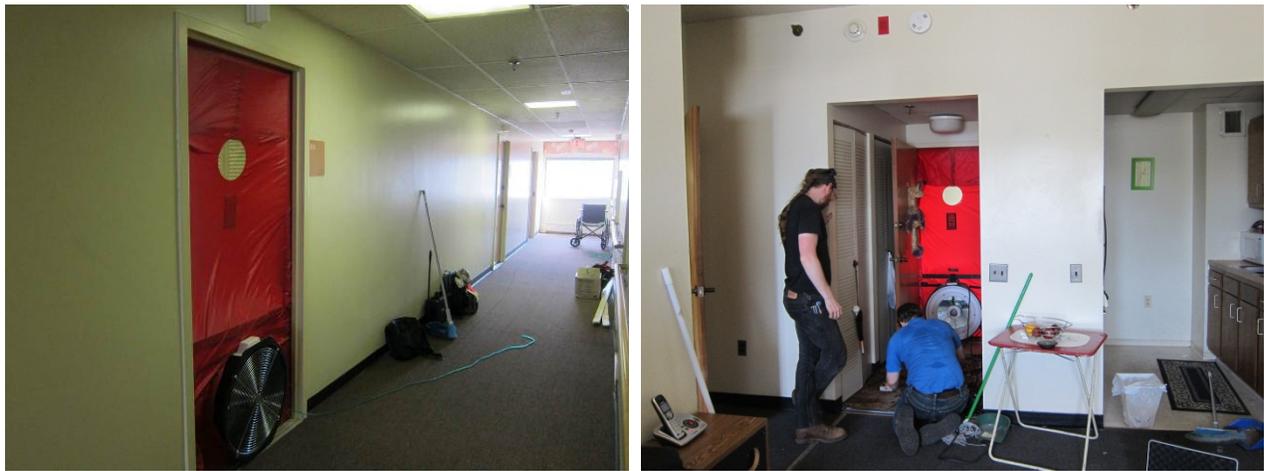
Figure 43. Air leakage testing of units from hallway (L) and interior of unit (R)

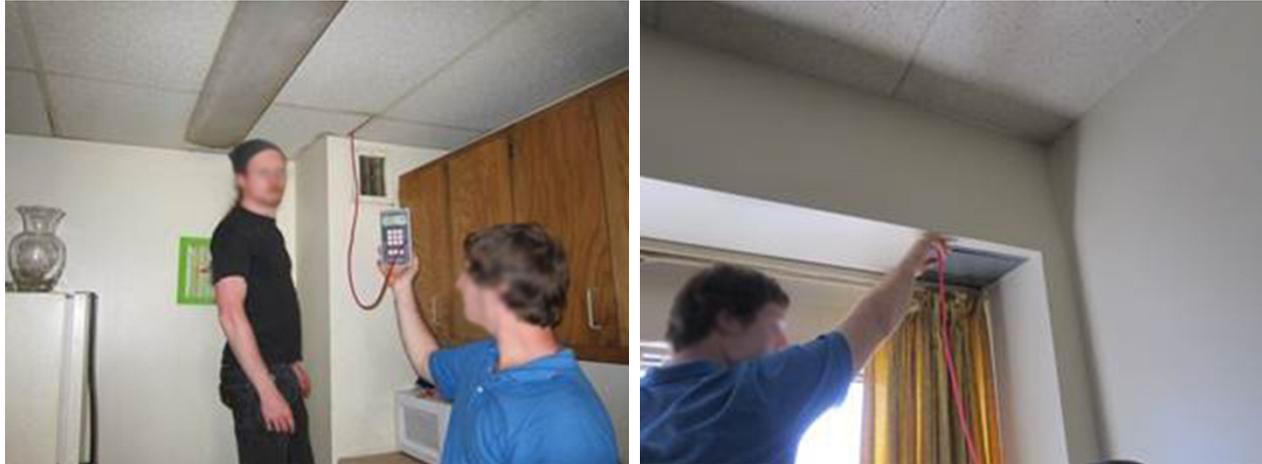
Figure 45. Interzonal pressure measurements (suspended ceiling, L; mechanical access, R)

In addition, in the BSC/Innova study, interzonal pressure measurements/mapping was used to characterize the leakage paths in these units, as shown in Figure 45.

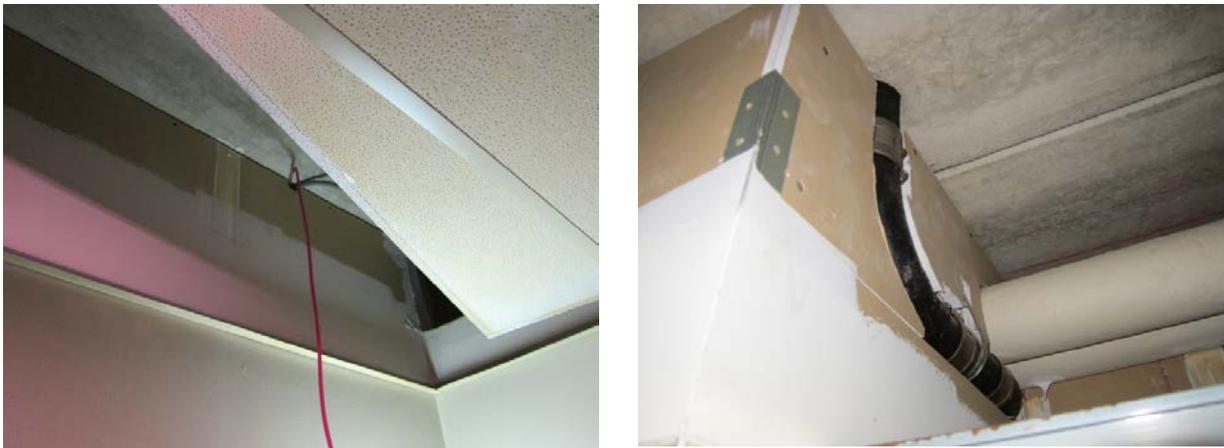
Figure 47. Lack of air sealing at demising wall to concrete plank (L) and pipe penetration (R)

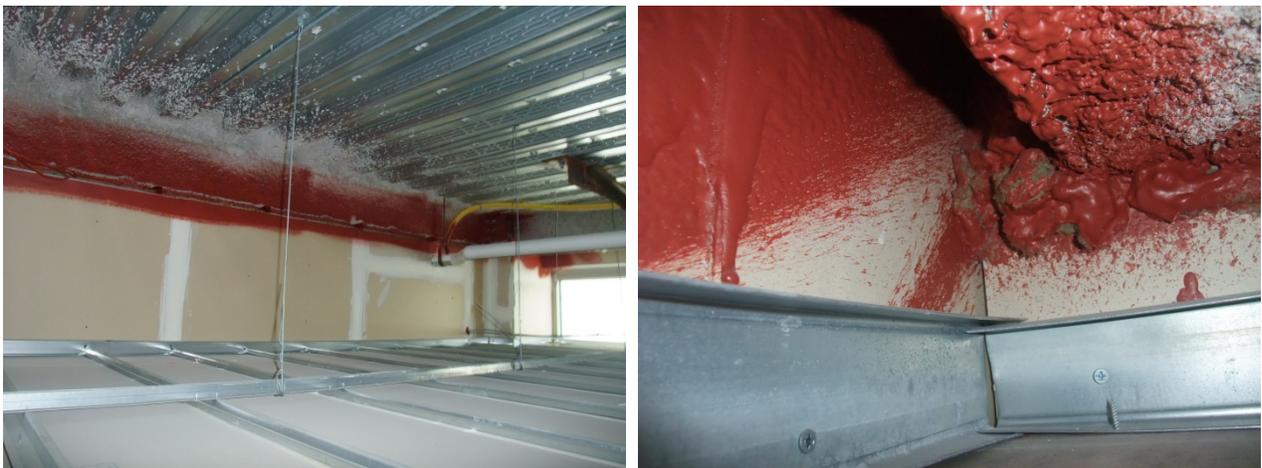
Figure 49. Liquid spray-applied fire-rated sealant

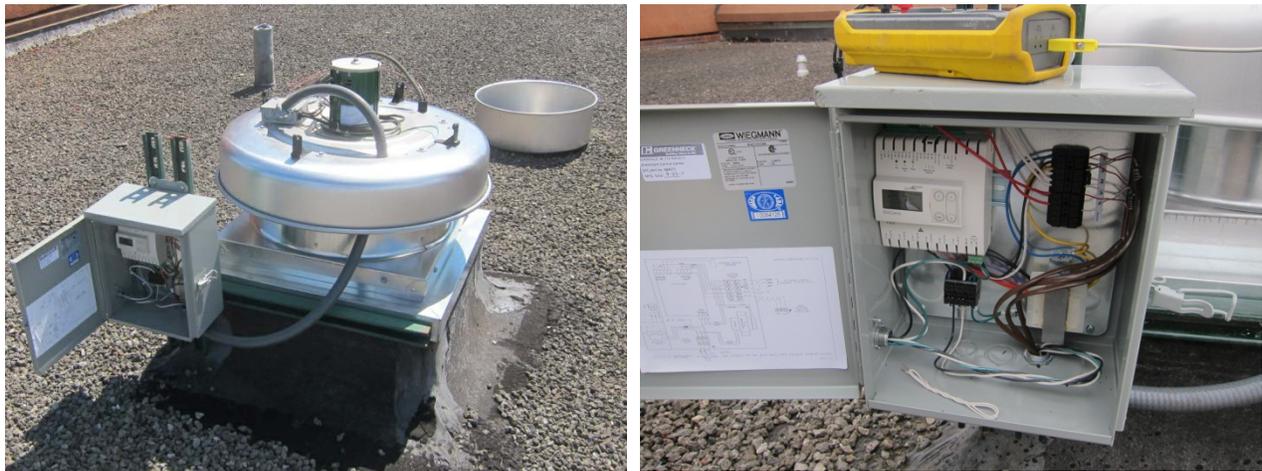
Figure 50. Variable-speed exhaust fan with cover removed (L), with controller box (R)

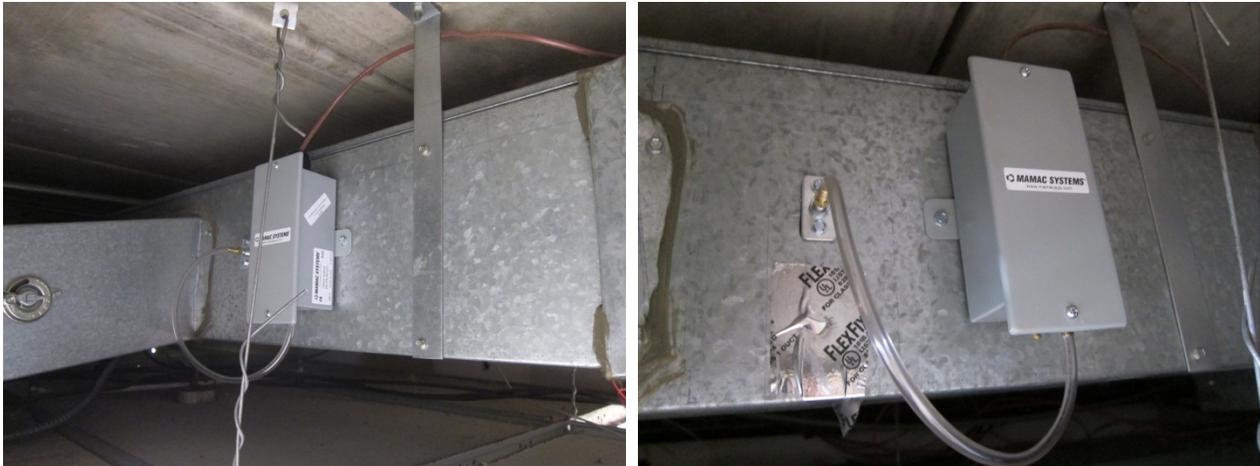
Figure 51. Duct pressure transducer and static pressure probe on top floor trunk duct

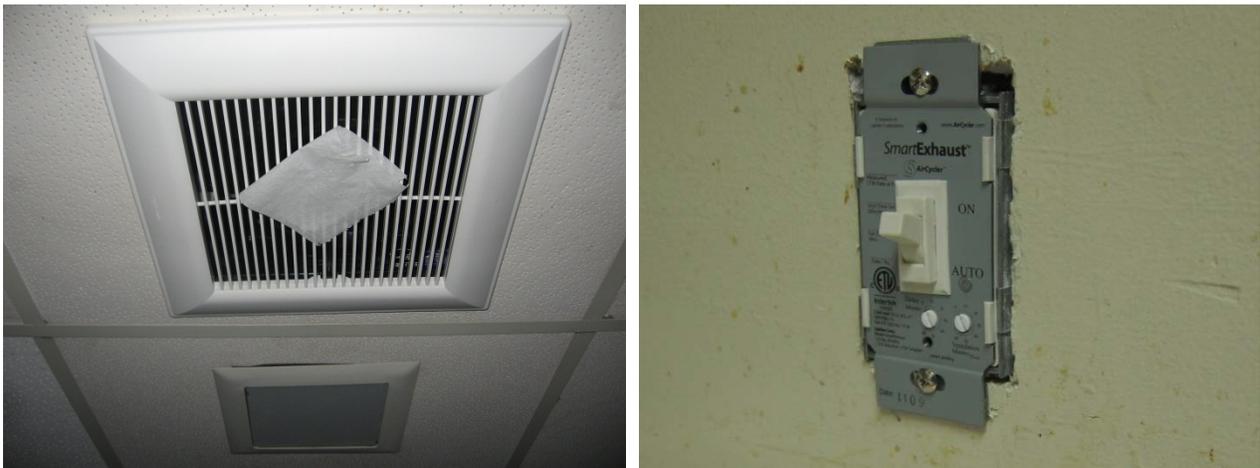
Figure 52. Bathroom dwelling unit exhaust fan (L) and controller timer switch (R)

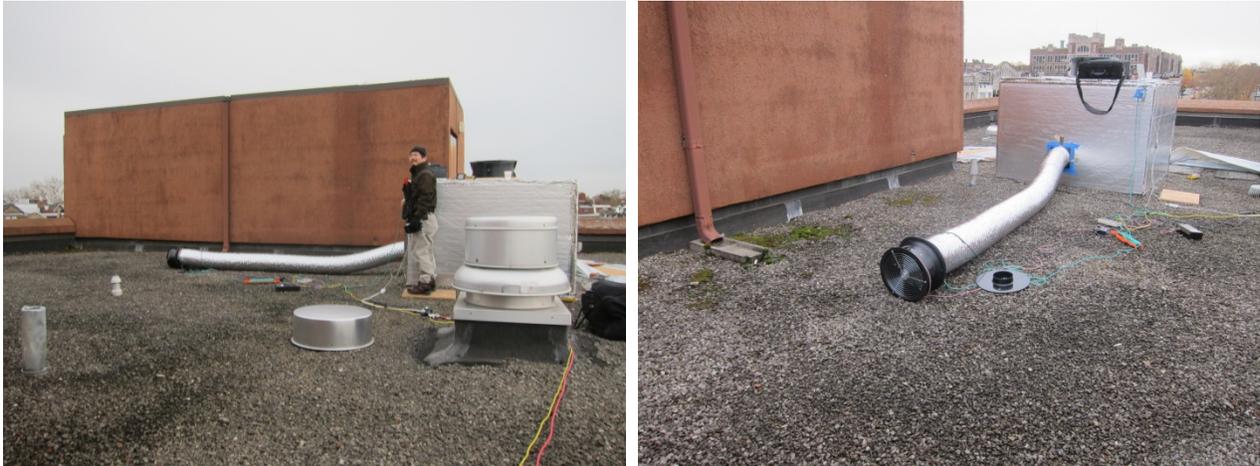
Figure 53. Powered flow capture hood, showing duct testing fan

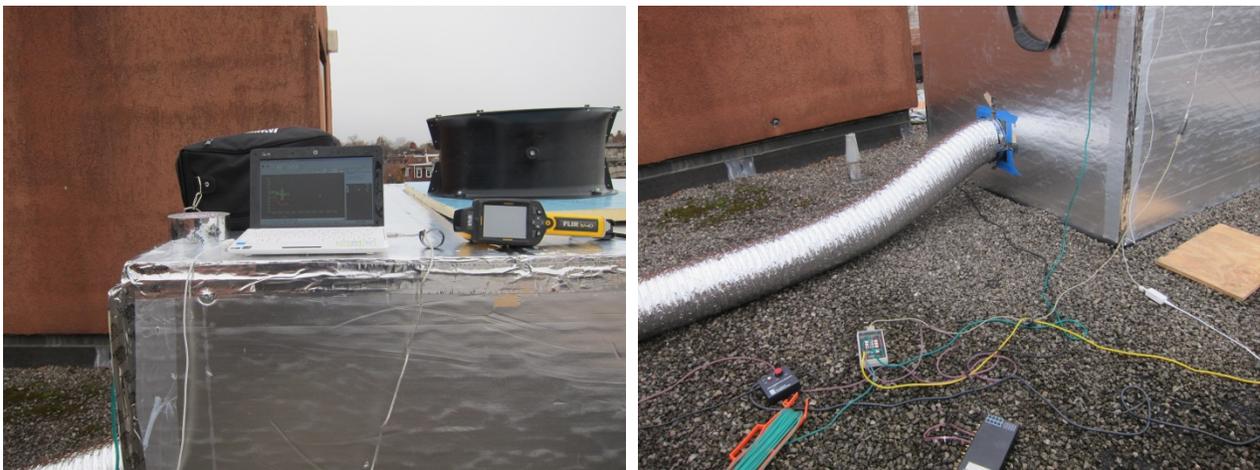
Figure 54. Computerized flow capture hood testing (L), showing manometer (R)

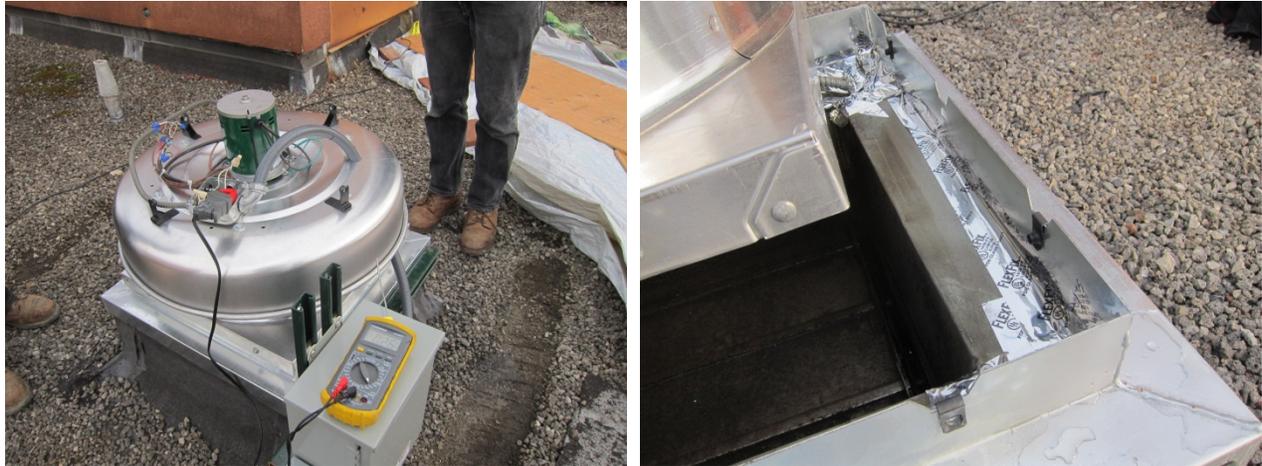
Figure 61. Amperage measurements at rooftop exhaust fan (L); temporary seal of roof curb (R)

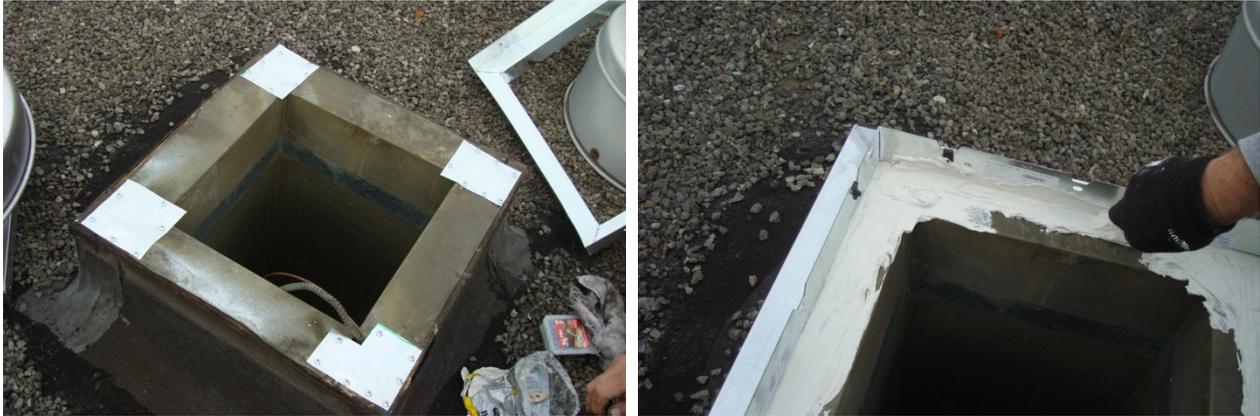
Figure 71. Mastic and sheet metal retrofit air sealing of exhaust shaft roof curb

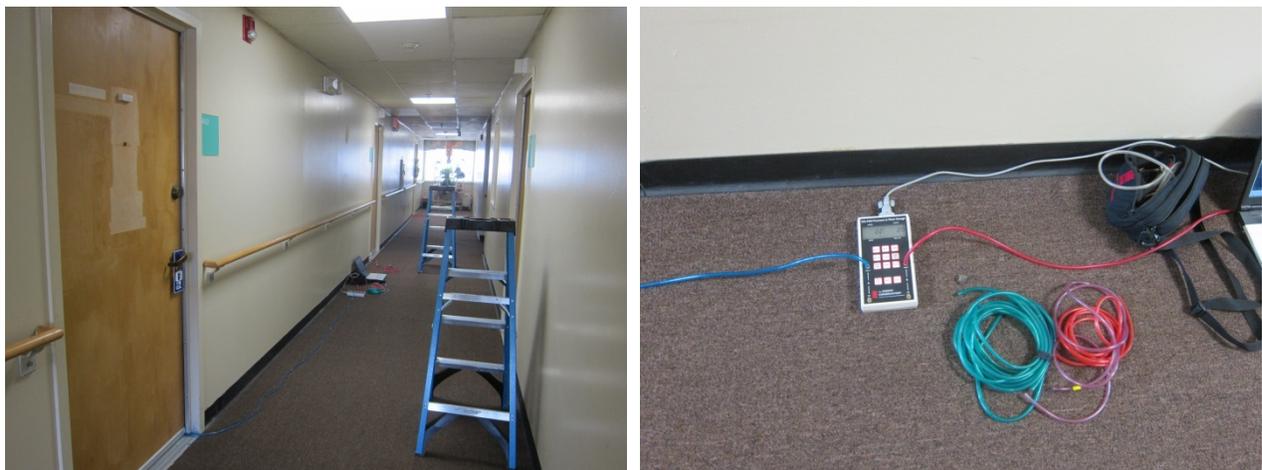
Figure 74. Interunit pressure difference measurement

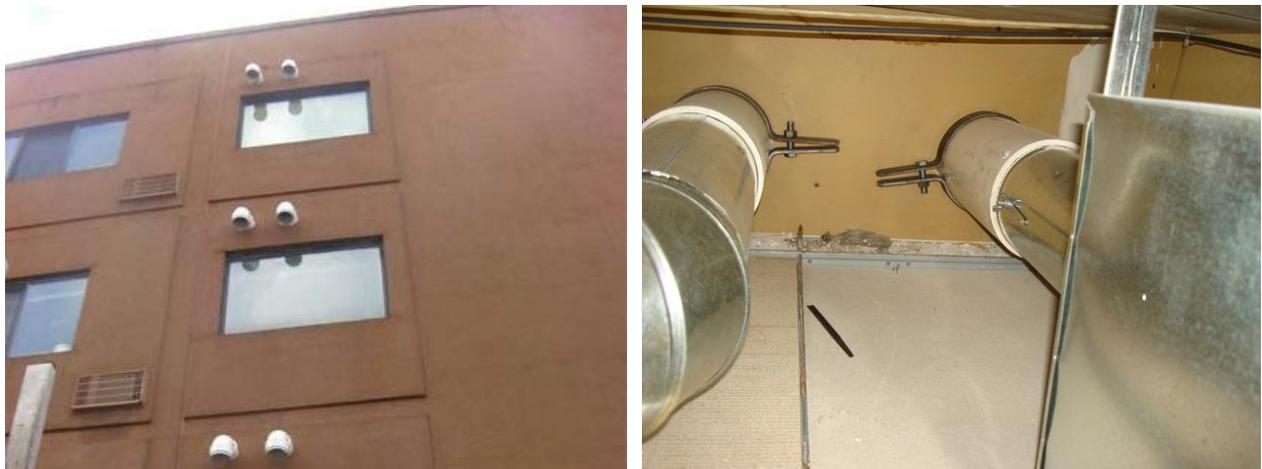
Figure 87. Corridor ventilation exterior view (L) and connections above suspended ceiling (R)

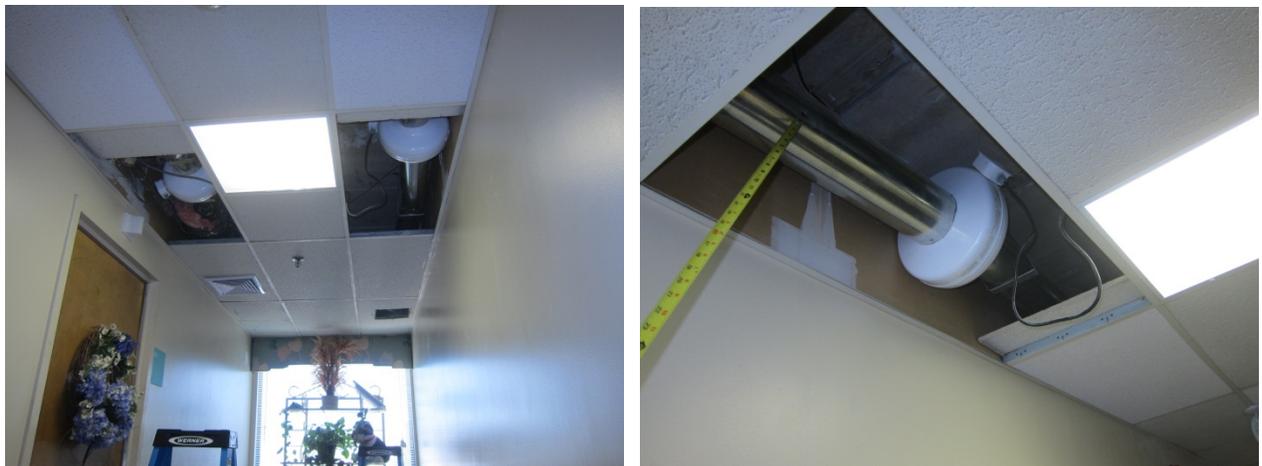
Figure 88. Inline fans and registers in suspended ceiling

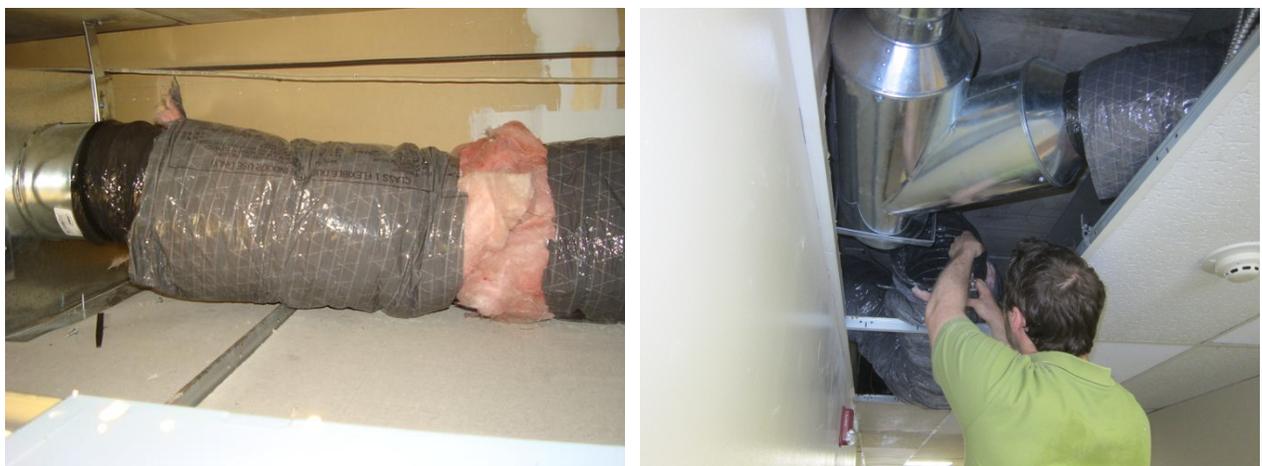
Figure 89. Flexible duct connection (L) and wye connection (R)
