# Case Study National Grid Deep Energy Retrofit Pilot Program: Clark Residence

Belchertown, Massachusetts

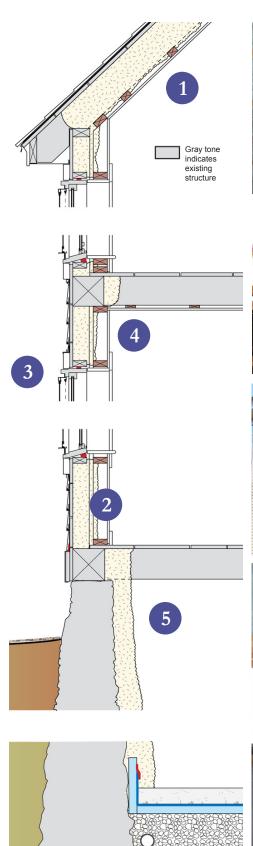
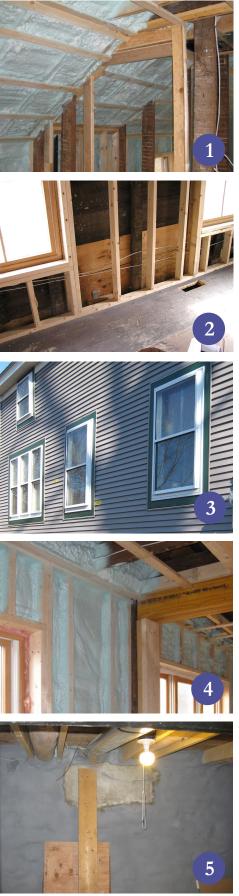
# **ENCLOSURE DESIGN**

● Roof Assembly: Compact (unvented) roof assembly with existing 2x8 rafter framing and 2x3 cross furring, framing cavity and portion of furring cavity filled with R-56 Demilec Heatlok Soy<sup>™</sup> medium density spray foam insulation.

**Wall Assembly:** 2x4 stud wall constructed to inside of original post and beam frame with 1" gap between existing and new framing. R-32 (~5") medium density spray foam insulation sprayed into wall cavities and over rim beam.

**Window Specifications:** New Harvey Tru Channel storm windows over existing wood-framed, double-glazed, low-E windows; approx. composite performance: U=0.25, SHGC=0.52.

Air Sealing: Continuous layer of medium density, closed-cell spray foam insulation provides air flow control in the field of the wall and roof assemblies. Spray foam insulation also applied at rim beams and in a floor assembly over a crawl space. Low-expansion foam sealant applied around windows and doors, and at any mechanical or electrical penetrations through the enclosure.

Conditioned basement with 3-5" medium density spray foam insulation applied directly to field stone and concrete foundation walls. Spray foam insulation painted with Blaze Lok 1B<sup>™</sup> ignition barrier paint. A 12" high strip of 2" XPS as the slab perimeter thermal break also allows foundation walls to drain to the sub-slab drainage system. Several trenches with drainage pipe connected to drain and filled with gravel manage bulk water. New cast concrete basement floor slab over 6 mil poly, 2" XPS and continuous bed of gravel.
