Proven Performance of Seven Cold Climate Deep Retrofit Homes

R. Osser, K. Neuhauser, and K. Ueno
Building Science Corporation

June 2012

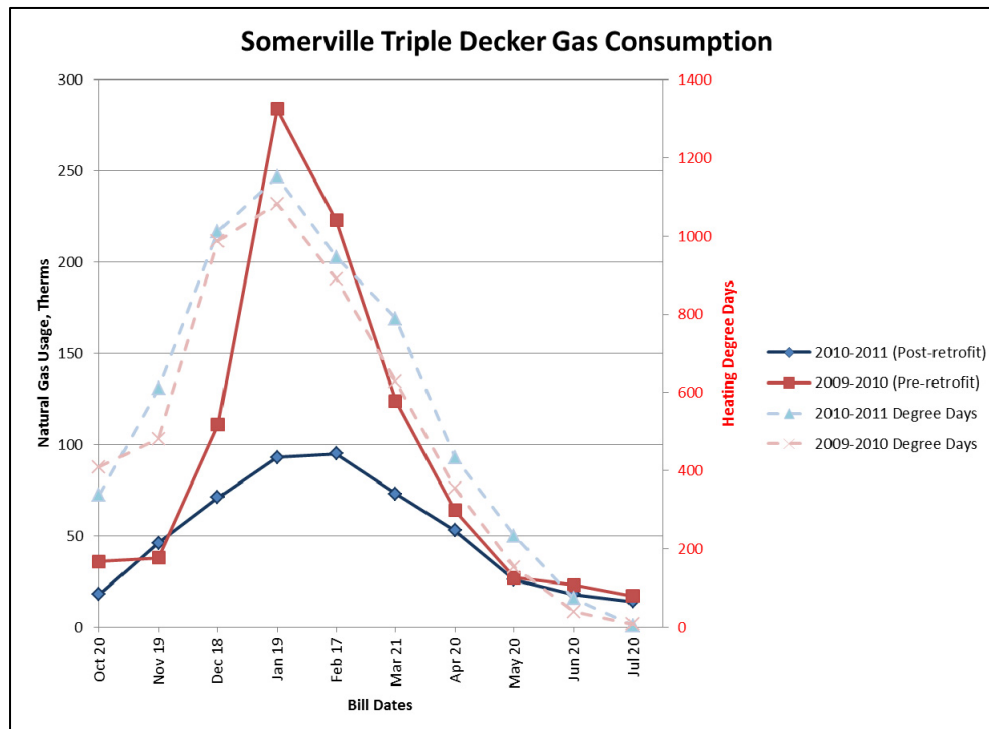
Figure 32. Somerville Triple Decker Gas consumption

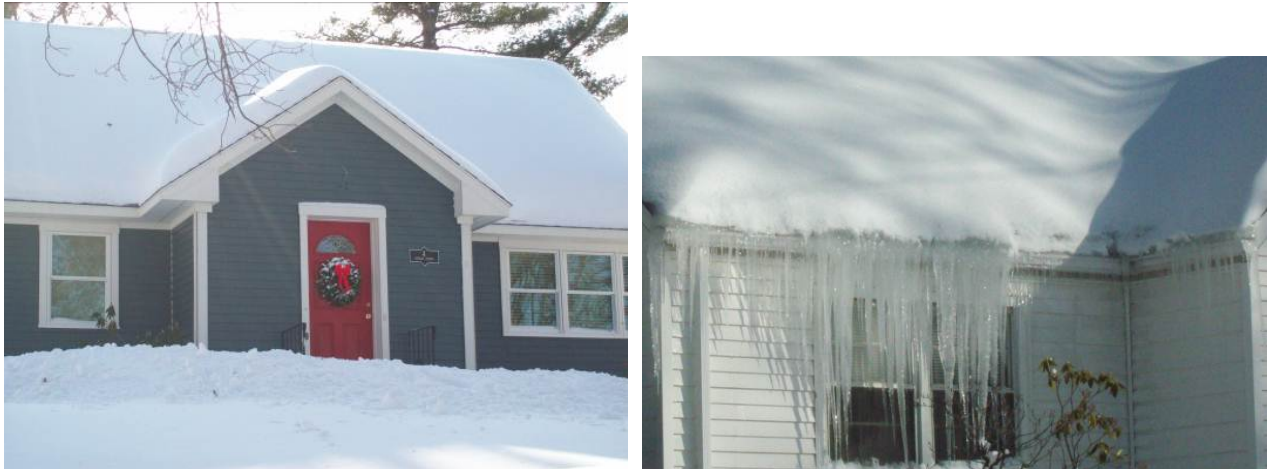
Figure 43. Left: Post-retrofit Millbury Cape; Right: Neighbor's home with ice dams

In addition to positive comments about thermal comfort, the owners of the Millbury Cape and Somerville Triple Decker, who had both lived in their homes prior to the retrofit, noted the lack of ice dams following the roof insulation and air sealing (Figure 43). Ice dams typically occur when conductive heat or warm air escaping the roof melts snow, which then refreezes after running down to the edge of the roof (Lstiburek 2011). Ice dams often lead to water leakage into building assemblies. Worse, when an ice dam gets too heavy it can snap off, sometimes taking a piece of roof with it. Ice dams can be prevented by keeping the roof surface as cold as possible. With a vented roof, this is done by insulating and air sealing the attic floor well and ensuring outside air ventilation under the roof. For the Millbury Cape, 2×4 s on the flat were inserted between the insulating sheathing and the outer layer of plywood, creating a vented roof capped by a ridge vent. In this case, the 2×4 s were attached to the existing roof rafters and the plywood sheathing was attached to the 2×4 s. This created a “vented over-roof,” successfully keeping the roof cold while still creating an attic space within the thermal enclosure.
