Smart Vapor Barrier CertainTeed DryRight – vs – Kraft-Faced Insulation

Objective

Monitoring Overview

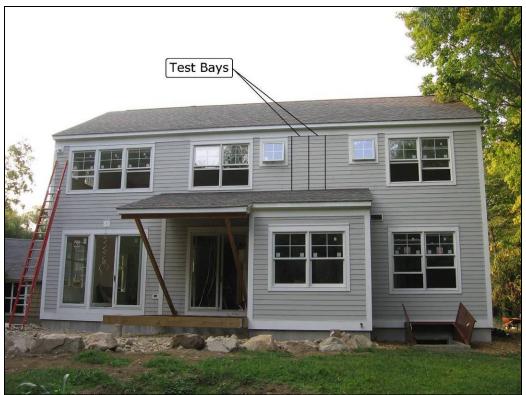
Figure 1: South side with test bays indicated.

Two adjacent bays in a second story, south facing wall of a new, modular home in Wilton, CT served as the field test section. Conventional 2x4 framing is used and both bays are insulated with CertainTeed R-21 fiberglass batts. Bay No. One uses CertainTeed's DryRight system and bay No. Two uses kraft-faced batts. Twelve Humirel temperature/relative-humidity sensors (six in each bay) have been strategically placed to track moisture movement in each bay. Interior walls are finished with conventional drywall. The exterior wall is OSB over which Typar HouseWrap, a layer of 15 lb. felt and fiber-cement siding was applied.

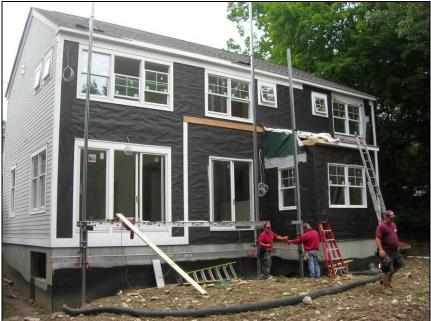
Figure 2: South side prior to installing fiber cement siding.

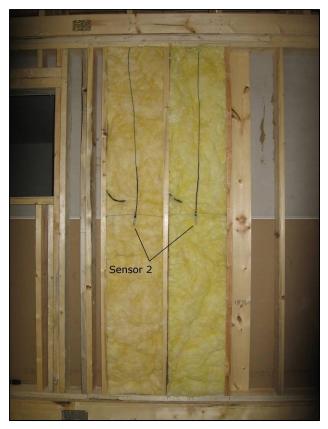
Sensor #2 is located on the interior side of the exterior sheathing. It is centered both vertically and horizontally and is shown here tied in place awaiting the installation of exterior sheathing.

Figure 4: Sensor 2, both bays, prior to installing exterior sheathing.

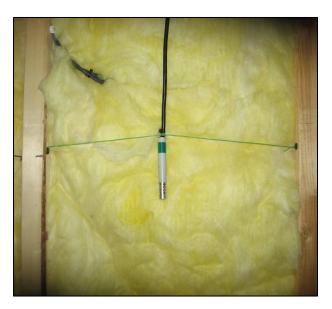
Sensor #2 located and awaiting the installation of the exterior OSB sheathing.

Figure 5: Close-up of sensor #2.

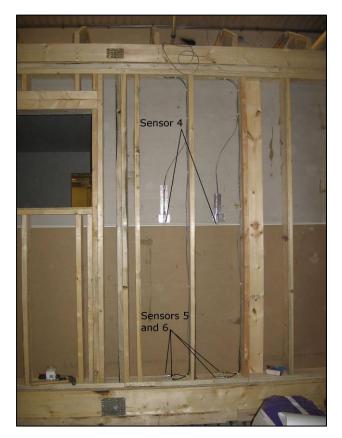
Sensor #4, located between the insulation's vapor barrier and the drywall, are secured with metal tape.

Figure 6: Empty cavity showing location of sensors #4-6.

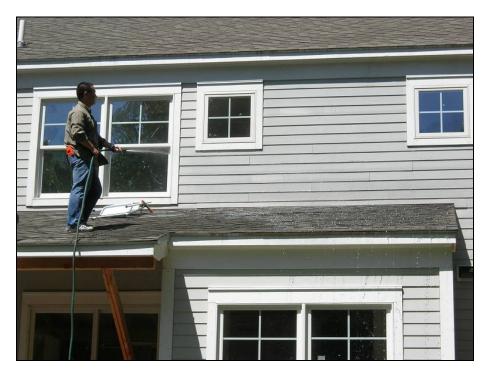
Figure 12: Spray wetting of the siding outside the test bay

The field test was initiated at noon on Aug 26th, 2008, a sunny day. The siding of the test wall sections was sprayed to simulate a "wind-driven-rain" effect. The spraying time was about 105 minutes.

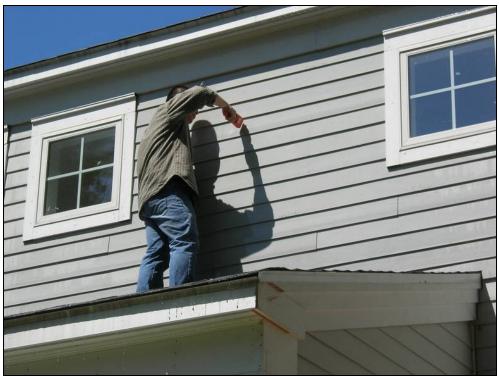
Figure 14 Testing the uniformity on the siding outside the test bay

In order to ensure that the fiber cement siding was uniformly wet; the Delmhorst hand-held moisture content meter was used. Overall there are 12 pieces of siding from the top to the bottom of the test wall assemblies which have been assigned Siding 1 (on the top) to Siding 12 (on the bottom). The test section is about 7.5 feet wide, which was evenly divided into 3 zones;
