West Village Community: Quality Management Processes and Preliminary Heat Pump Water Heater Performance

B. Dakin, C. Backman, M. Hoeschele, and
A. German

Alliance for Residential Building Innovation

November 2012

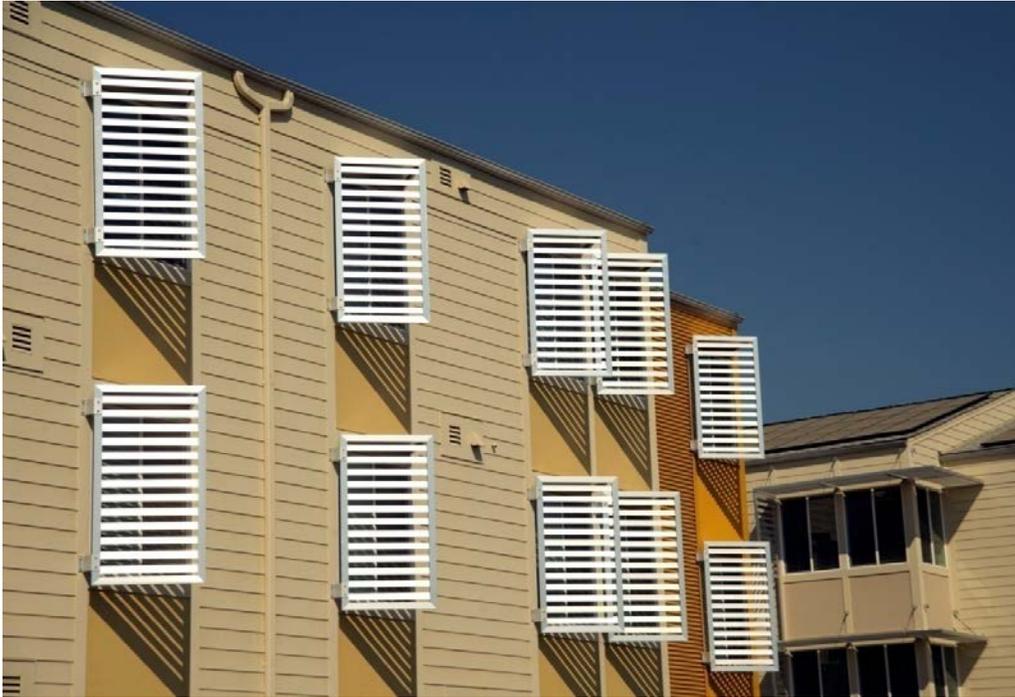
Figure 2. Exterior window sunshades on the student apartment buildings

Later iterations of the West Village Ramble building design included exterior window shading as both a building architectural feature and an energy efficiency measure. The horizontal and

vertical shading elements reduce solar gains entering the individual apartments (Figure 2). While the exterior shading elements were not cost effective as an efficiency measure alone, the developer chose to incorporate them in the south-, east-, and west-facing facades of the student buildings for aesthetics and comfort. The developer also felt that the exterior shades put a visual element to the buildings that celebrated the goals of the community.

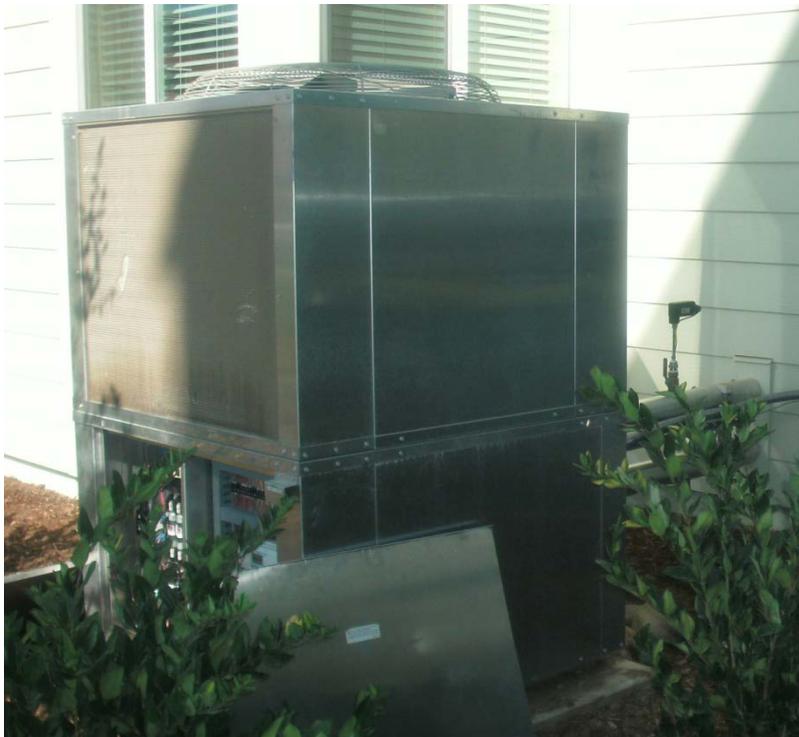
Figure 3. HPWH installed on Ramble Building #1

An A.O. Smith (formerly E-TECH) central HPWH system (nominal 127 kBtu/h capacity at 85°F ambient and 100°F inlet water temperature) is installed at each building. There are two, 120-gal storage tanks, both of which have three electric resistance elements totaling 54 kW. A hot water recirculation loop pump that serves the building is controlled by return water temperature and by a timer which shuts it off at night. See Figure 3 through Figure 5 for photographs of the water heating system and monitoring equipment.

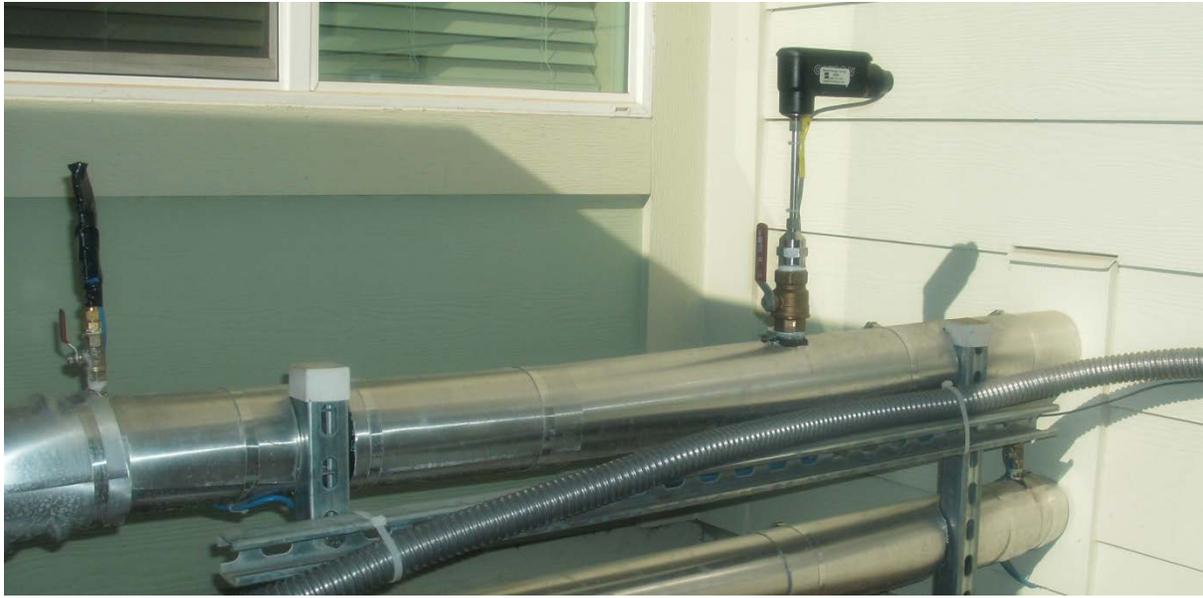
Figure 4. Flow meter installed on the hot water supply line leaving the heat pump unit

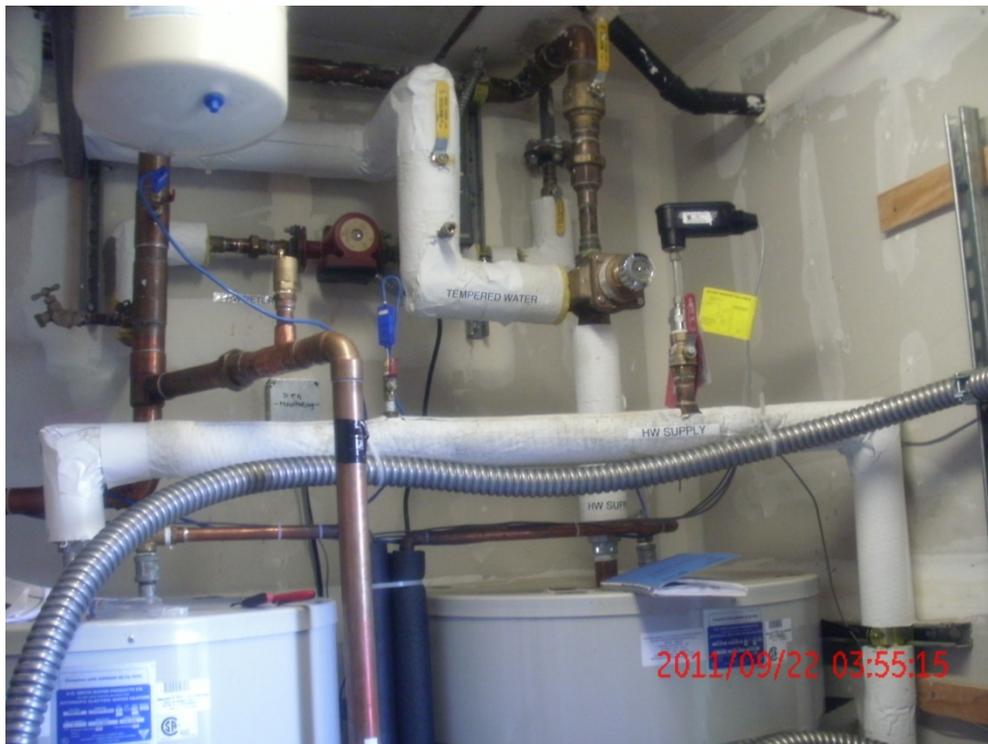
Figure 5. Two hot water storage tanks with electric resistance auxiliary heat and water piping. Flow meter and temperature sensor can be seen on the hot water supply line between the two tanks.

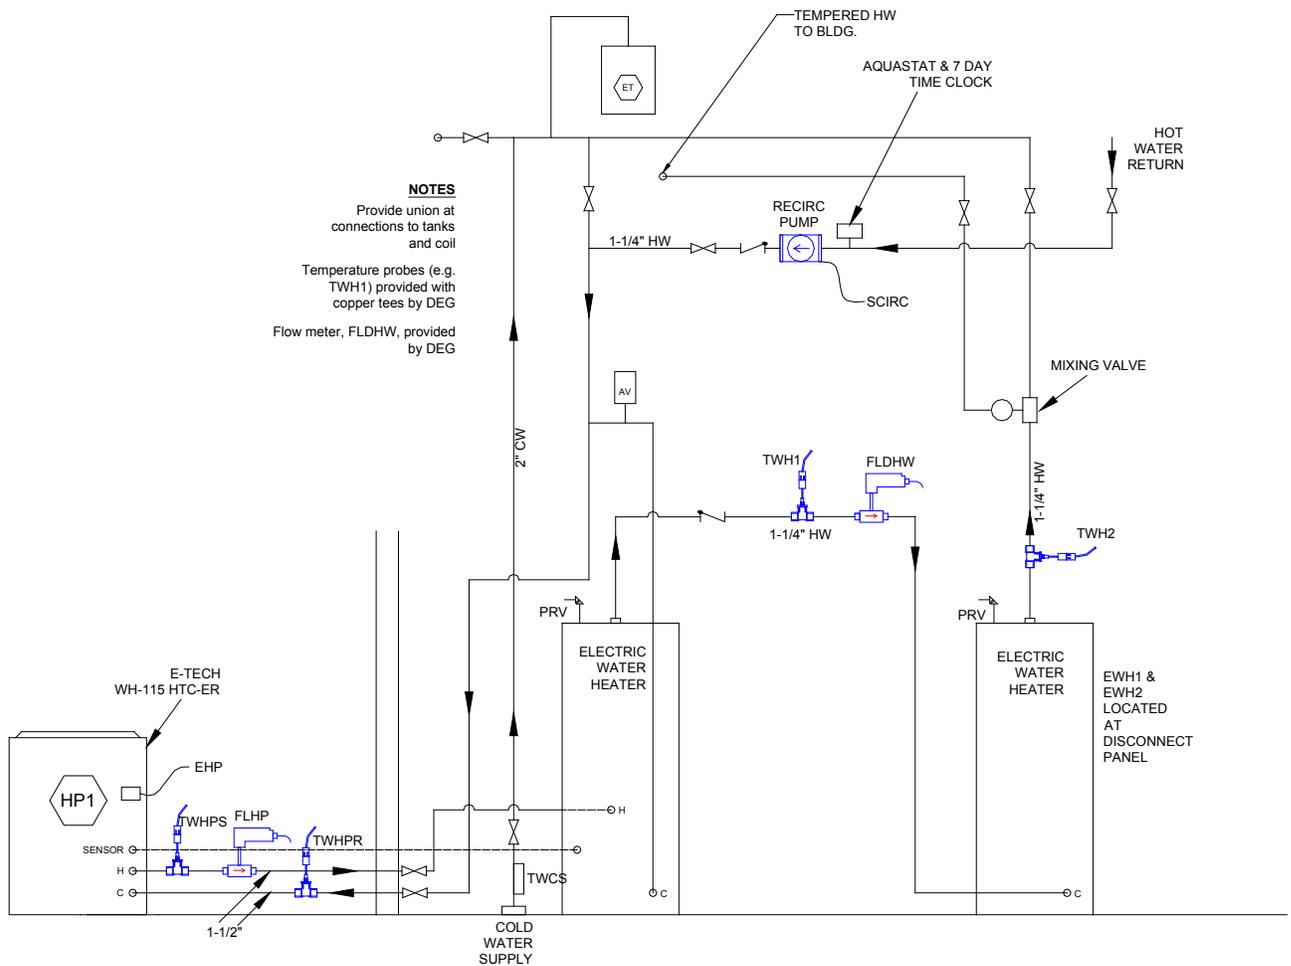
Figure 6. Water heating monitoring sensor locations

Point No.	Abbreviation	Description	Location	Sensor Type	Sensor Manufacturing/ Model
1	TAO	Temperature, air, outdoors	Outdoors, near heat pump	RTD, 4-20ma	RM Young 41372VF
2	RHO	Relative humidity, outdoors		RTD, 4-20ma	
3	TWRECIRC	Temperature, water, recirculation	Mechanical room—DHW	Surface thermocouple	Gordon Watlow
4	TWHPS	Temperature, water, heat pump supply	Mechanical room—DHW	Immersion thermocouple	Gordon Watlow
5	TWHPR	Temperature, water, heat pump return	Mechanical room—DHW	Immersion thermocouple	Gordon Watlow
6	TWH1	Temperature, water, electric heater inlet	Mechanical Room—DHW	Immersion thermocouple	Gordon Watlow
7	TWH2	Temperature, water, DHW supply	Mechanical room—DHW	Immersion thermocouple	Gordon Watlow
8	TWCS	Temperature, water, cold water supply	Mechanical room—DHW	Surface thermocouple	Gordon Watlow
9	FLHP	Flow, heat pump supply	Outdoors, near heat pump	Flow meter	Onicon F-1100
10	FLDHW	Flow, DHW	Mechanical room—DHW	Flow meter	Onicon F-1100

11	EHP	Energy, heat pump	Mechanical room—service panel	Power meter	Wattnode/WNB-3D-240-P
12	EWH1	Energy, electric heater	Mechanical room—service panel	Power meter	Wattnode/WNB-3D-240-P
13	EWH2	Energy, electric heater	Mechanical room—service panel	Power meter	Wattnode/WNB-3D-240-P
14	SCIRC	Status, recirculation pump	Mechanical room—DHW	Status	Hawkeye
15	FLRecirc	Flow, recirculation return	Mechanical room—DHW	Flow meter	Onicon F-1300

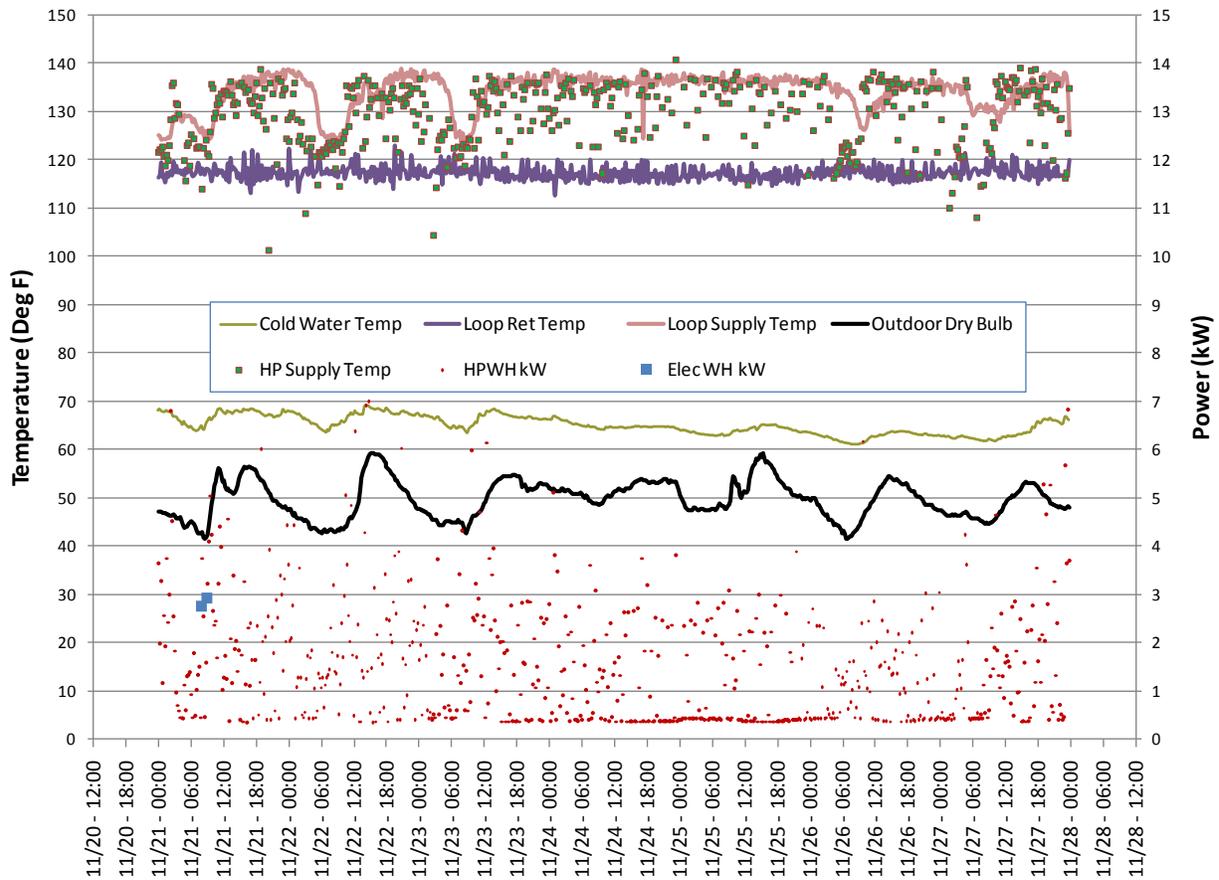
Figure 7 plots key monitoring data for November 21 through November 27. Fifteen-minute temperature data are plotted on the left axis; average power demand on the right. Water temperature of the supply to the tempering valve and the return from the recirculation loop are identified. All hot water demands, with the exception of a brief interval on the morning of November 21, were met solely by the HPWH.

Figure 7. West Village HPWH system monitoring data (November 21–27, 2011)

Preliminary performance data is being presented at this time as DEG works through the various HPWH system commissioning issues. Initial data collected in early October includes data when the system was operating solely in electric resistance heating mode. During this period, which also experienced the more favorable system operating conditions of early October (warmer inlet water temperatures, lower recirculation loop losses), the average daily electrical consumption was approximately 57 kWh/day. In November, with the HPWH operating reliably, average daily electrical consumption totaled about 42 kWh/day and daily hot water loads averaged roughly 340 gal/day, or less than 30 gal/day per apartment. The observed 30 gal/day load is lower than anticipated during the initial project modeling phase, but likely can be attributed to water-conserving appliances, including low flow showerheads, efficient clothes washers, and, perhaps, lower-than-expected hot water use for food preparation and dish washing.

A simplistic comparison of the 57 kWh/day electric heating use with the 42 kWh/day HPWH use does not take into account changes in hot water load, and colder November inlet air and water temperatures, which affect the energy comparison. A more thorough energy use study will be conducted as monitoring is completed in 2012.

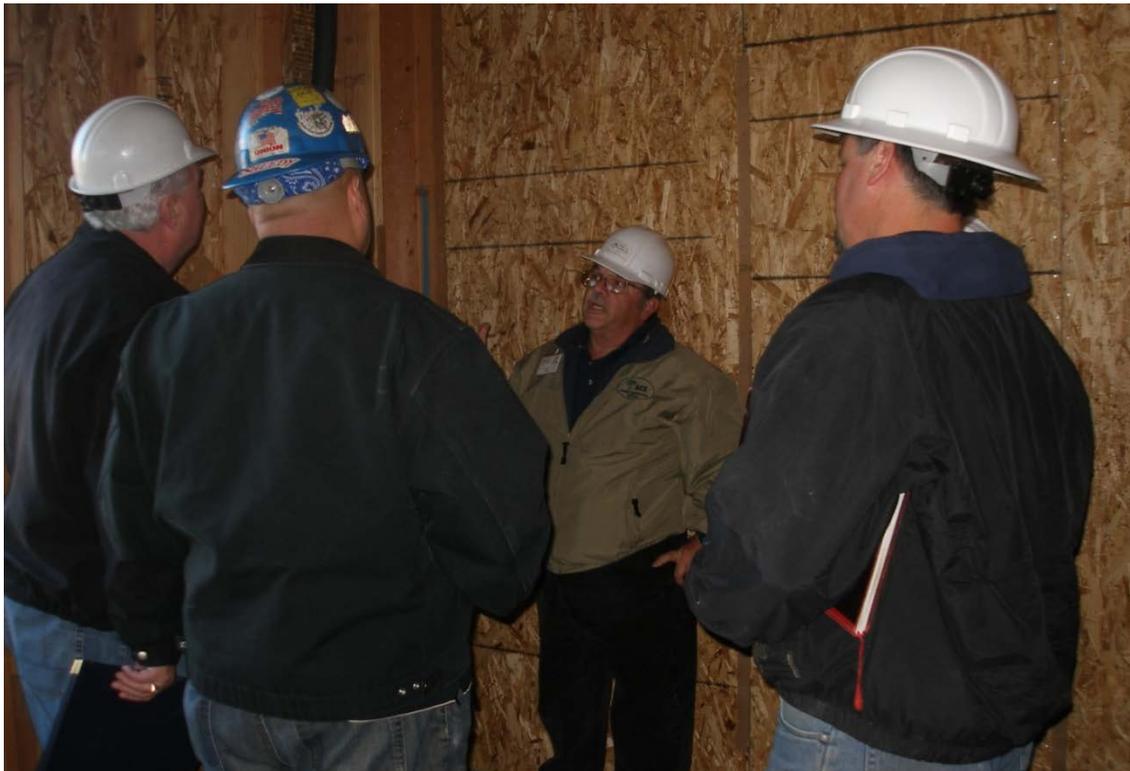
Figure 8. Initial QII training with subcontractors

During the first inspection, the rater trained representatives from all the pertinent trades (insulation, framing, mechanical, plumbing, electrical, and builder) on the QII verification process (see Figure 8). The rater defined what would be required of each contractor to pass the final inspection and explained the intent of the protocols and inspections. This initial training helped establish a working relationship between the rater and the trades and was an essential part of the process to create an understanding that the HERS rater was part of the team. In the typical process, HERS raters do not visit the project until after insulation is installed, at which point identified defects create extra work for the contractor and delays in the construction process. At this point, the insulation contractor and builder are often responsible for correcting issues and the other trades are not given any feedback about the defects. Because of the value of this initial meeting, DEG has written this initial QII training into all its LEED contracts.
