PNC Financial Services – Maximum Efficiency Bank Branch

The Singer Island branch was originally constructed in 1979; PNC acquired the property in 2008 and began a major renovation in March 2011. Construction was completed in January 2012. PNNL identified upgrades to the building envelope, lighting, and mechanical units as being the most effective means to increase the energy efficiency of the building. PNC used this retrofit as a pilot for new technologies that could be applied to future branch renovation projects.

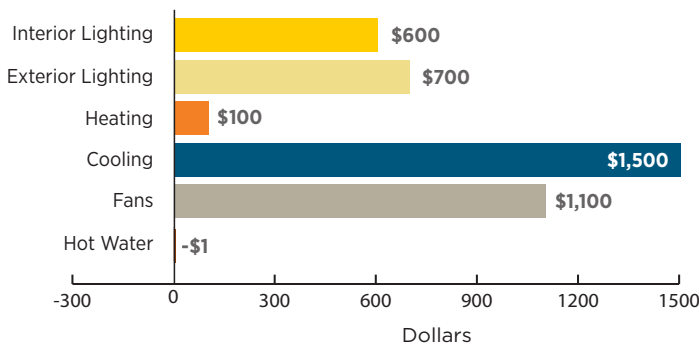
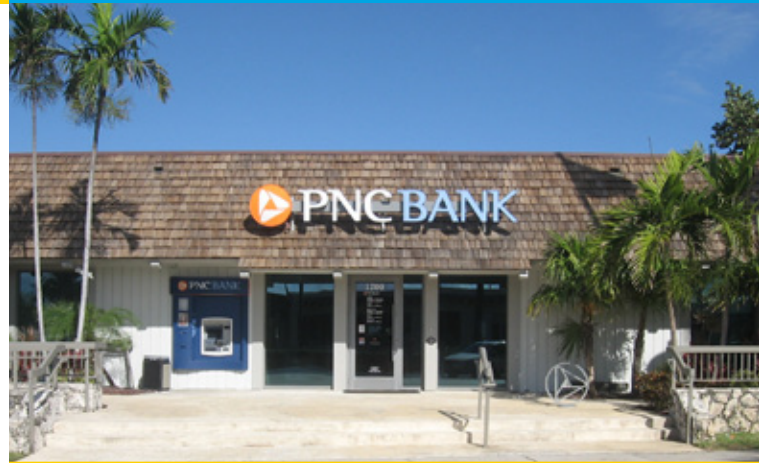
Expected Energy Cost Reductions

PNC renovated the Singer Island branch to upgrade branding, hurricane resistance, comfort issues, and energy efficiency

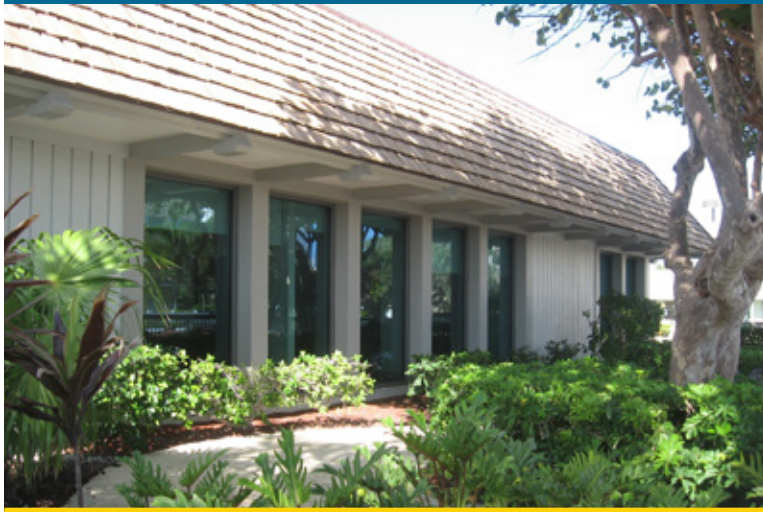
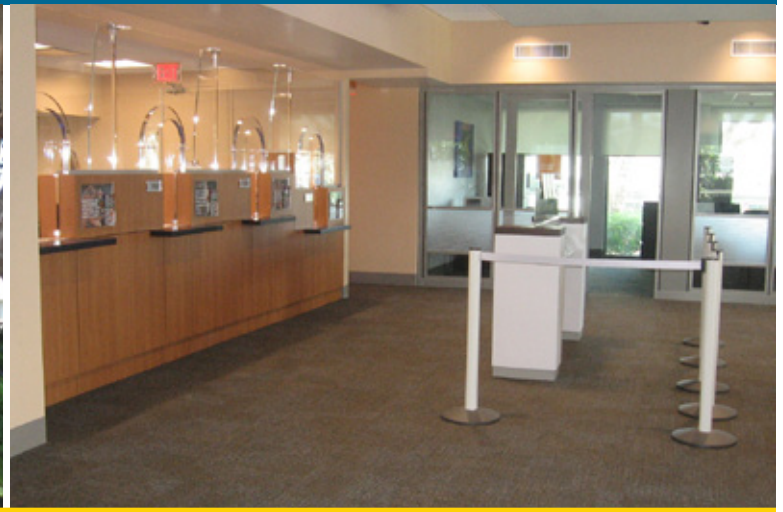
(left) Windows were replaced to improve hurricane resistance and control glare from sunlight. (right) Interior lighting and the ceiling were upgraded from fluorescents and light absorbing colors to reflective surfaces and light-emitting diodes.
