**Spectrally Enhanced Lighting Program  
Implementation for Energy Savings:**

***Field Evaluation***

Prepared by  
Pacific Northwest National Laboratory

August 2006

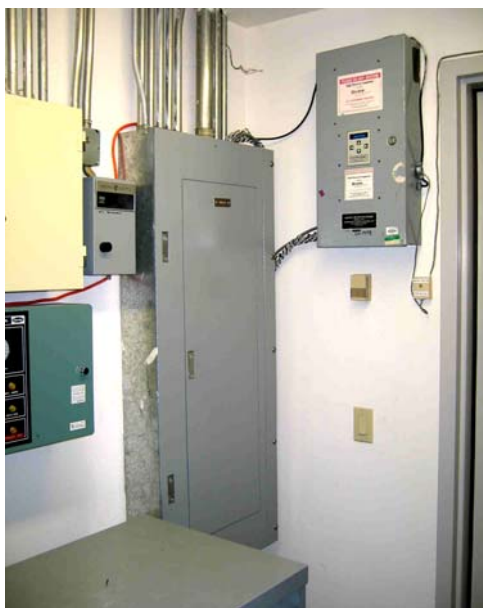
**Figure 3.1.** End Use Metering Logger. The box to the right of the control panel is one of two end use metering loggers used to measure current, power, and apparent power in Building A.

The fixtures affected by the retrofit are powered from eighteen 277-volt dedicated lighting circuits. Two end-use metering loggers were installed to monitor these circuits. One of the loggers is shown in Figure 3.1; the other logger installation is essentially identical. The pre-retrofit study period was August 10 to September 2, 2005, and the post-retrofit period was September 12 to October 15, 2005.

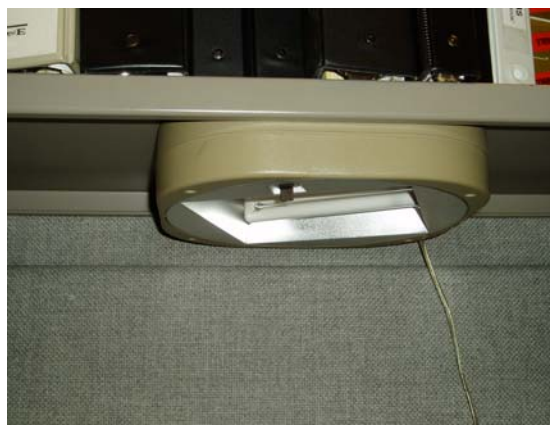
**Figure 3.11.** Building A Workstation Task Light

To assess pre- and post-retrofit task lighting use, individual data loggers were deployed at a sample of the building's workstations. Figure 3.10 and 3.11 show one style of task light and workstation/cubicle present in Building A. The lighting data loggers used were Onset Computer Hobo® H-8 models (see Appendix D for specifications). These were installed on or near 45 workstation task lights. The loggers were set to sense whether the task light was on or off by measuring the light intensity coming from the fixture at 10-minute intervals. Data were collected for more than two weeks in both the pre- and post-retrofit periods. The post-retrofit data were collected after the three-week adaptation period to allow for occupant adjustment to the new overhead lighting.

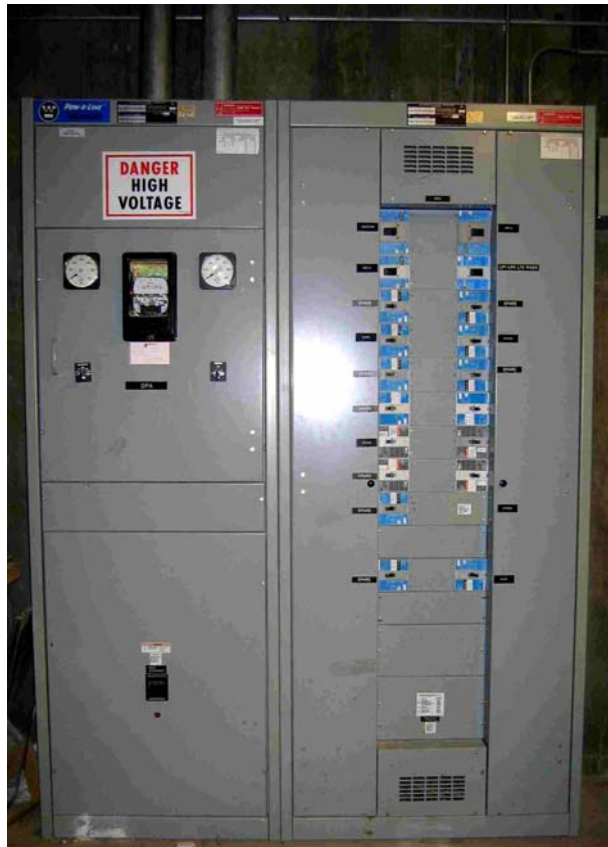
**Figure 4.2.** Building B - Distribution Panel with Three-Phase Lighting Riser Logger Installed in Right-Hand Compartment

The fixtures affected by the retrofit are powered from three 277-volt dedicated interior lighting panels on the second through fourth floors (one panel per floor) and a mixed lighting panel on the first floor. The first floor panel serves exterior and stairwell lighting as well as the overhead office lighting. Two loggers were installed to monitor lighting power. An end-use metering logger was installed at the first-floor lighting panel similar to the installation shown in Figure 3.1 for Building A. A four-wire three-phase power logger was installed on the lighting riser circuit of the distribution panel in the main electrical room as shown in Figure 4.2. The total overhead lighting load is taken to be the riser load minus the exterior and stairwell loads. The pre-retrofit study period was October 13 - November 4, and the post-retrofit period was November 7 – December 6, 2005.

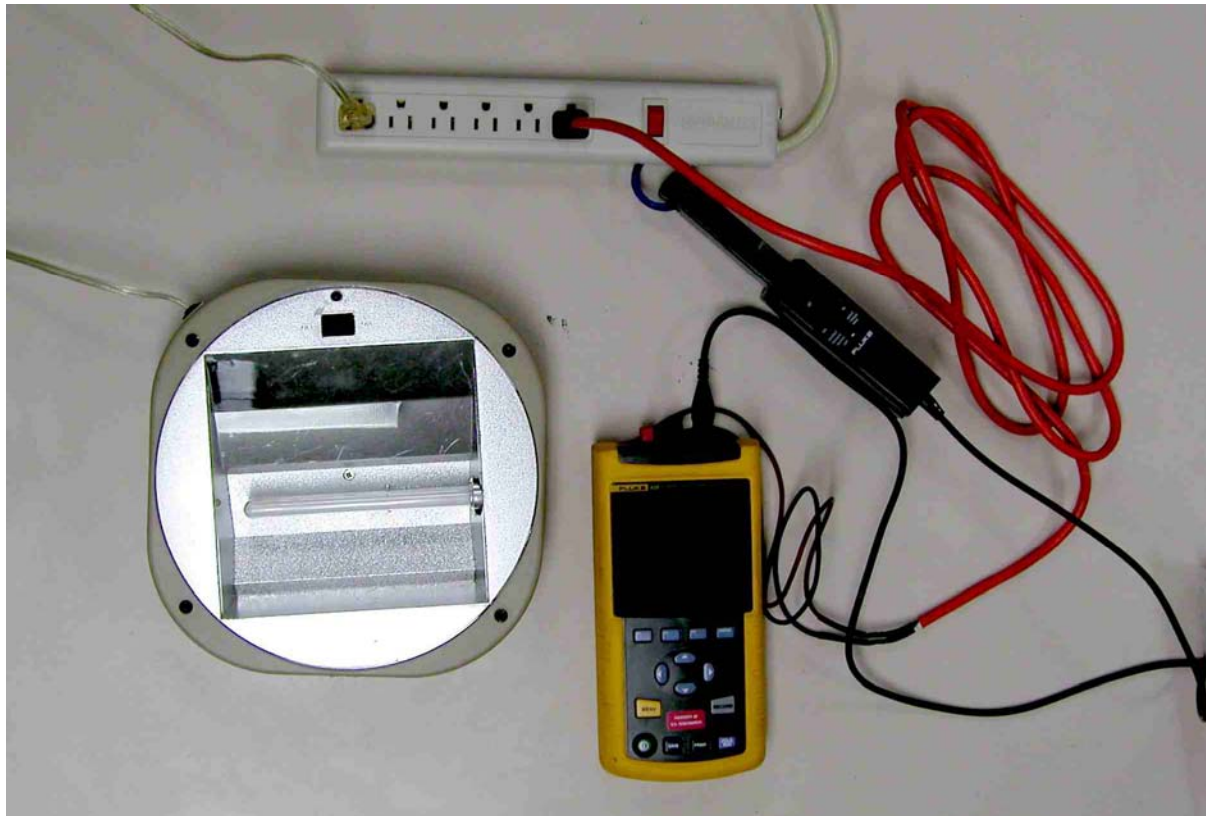
**Figure A.4.** One-Time Task Light Power Measurement Using 100A Current Probe and 10-Turn “Amplifier”

The Fluke 43B Power Quality Analyzer is intended to measure signals associated with 50- and 60-Hz power systems. It can measure true rms voltage and current and calculates real and reactive power at fundamental (60Hz) and harmonic (120, 180, 240, ...Hz) frequencies with sufficient bandwidth to measure up to the 51<sup>st</sup> harmonic as well as the ability to measure any dc components of voltage and current. Figure A.4 is a photo of the meter in use. The meter's performance specifications are provided below. For complete description see <http://us.fluke.com/usen/products/Fluke+43B.htm>.
