Case Study of Energy Project GGNRA Park Headquarters 2002 – 2006

Fort Mason Building 201
Fort Mason Historic District
San Francisco, California

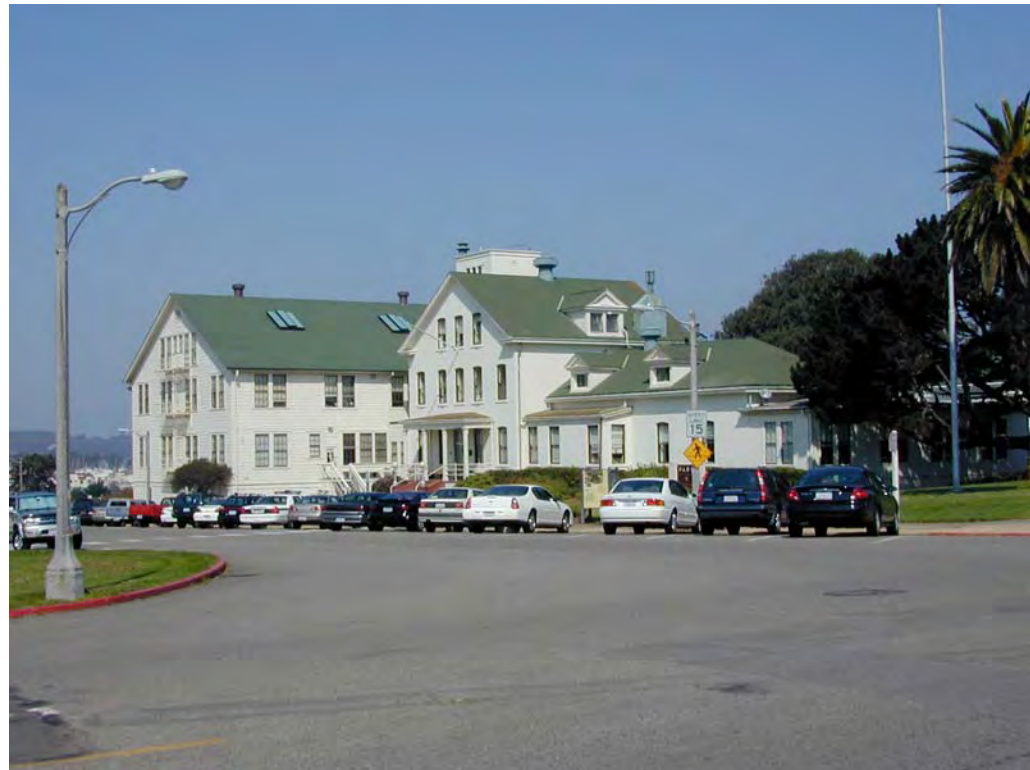
Building Location - (E) Mech System

East Wing - Has an existing historic functional hot water radiator system consisting of a furnace (circa 1950), piping and cast iron radiators.

West Wing, floors 1 and 2 - Existing heating system is an electric resistance heating system.

West Wing, 3rd floor - Modern HVAC system using roof-mounted equipment and interior ducting.

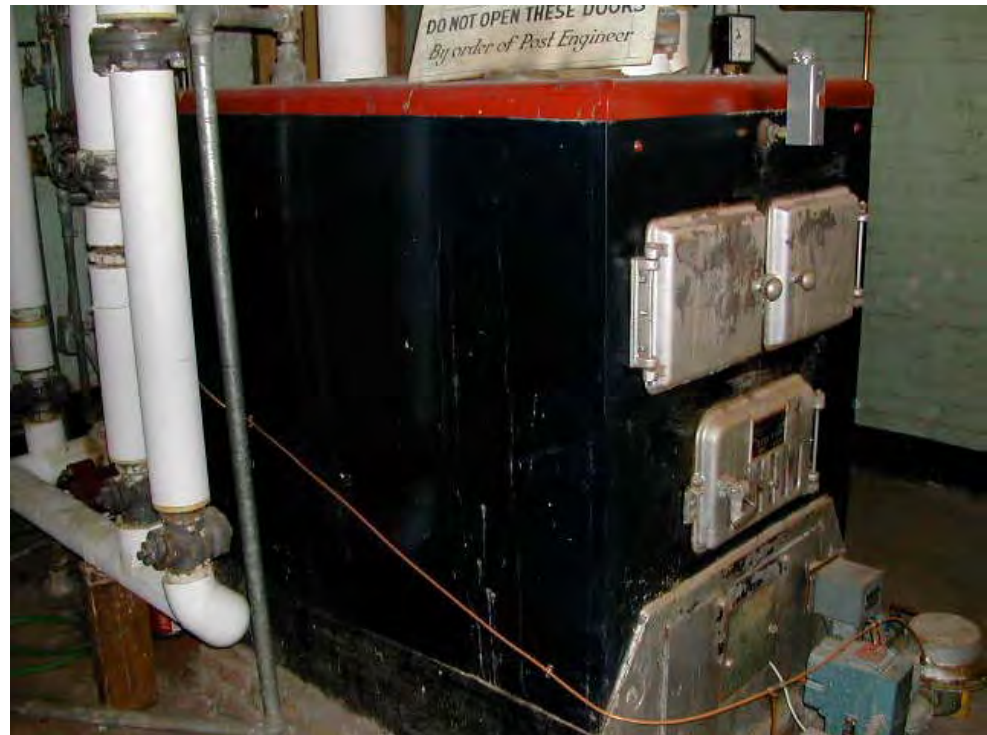
View of 1930s-era boiler

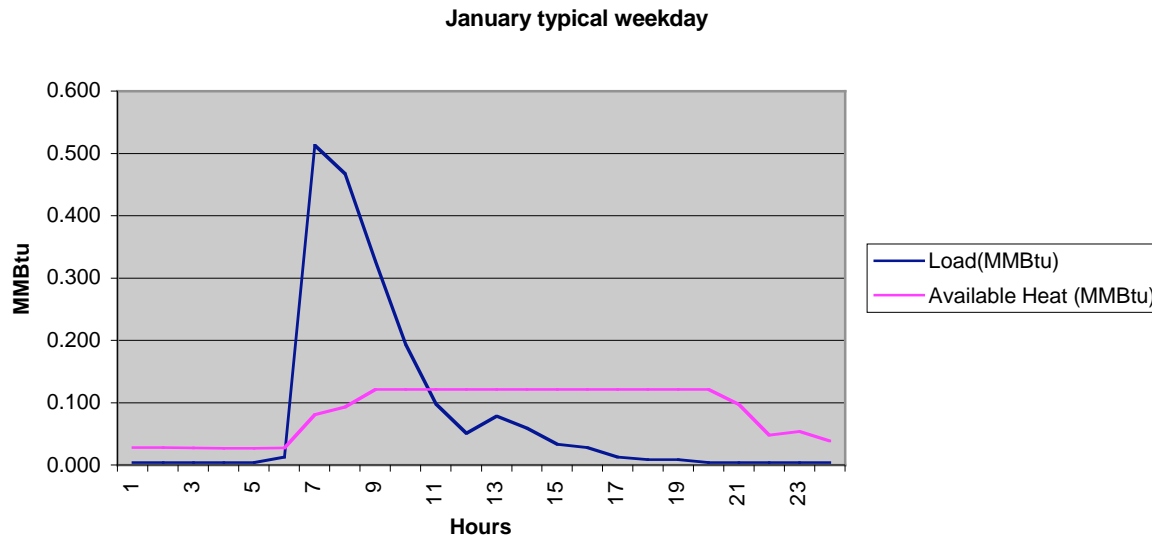
Figure 18. Electric and Gas Load Profiles for Building 201

Note asynchronization between the daily electric and thermal load profiles, which is reconciled by use of the hot water storage tank.

- *Best configuration: One microturbine installed and use of thermal heat storage*
- Uses the waste heat by storing it in a hot water thermal storage tank. The exhaust from the microturbine could charge the water tank and store the hot water until needed the following day as dictated by the thermal load. The maximum amount of stored energy required is 1.1 MMBtu, which could be stored by a hot water tank of roughly 500 gallons of capacity. This option increases the annual savings in 200 MMBtu, which represents \$1,220 per year.

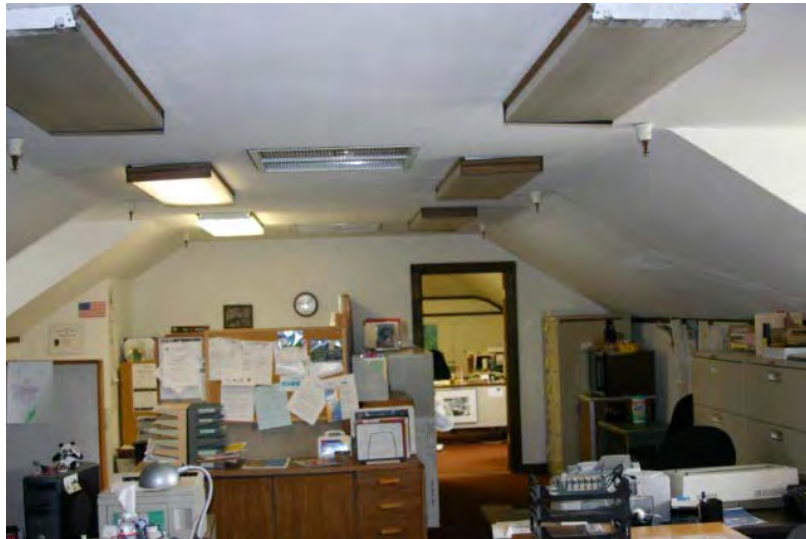
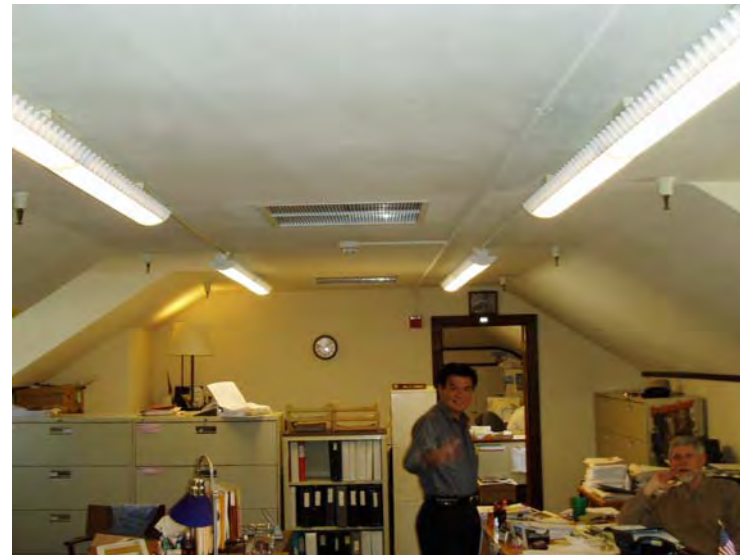
Lighting Before/After

- Project Construction Cost: \$560,000
- Mech: Disabled (e) ductwork was rebuilt to provide code-complying air changes at interior spaces without access to windows. This reversed an unintended consequence of poorly informed facility management.
- Elect: Office and Meeting Room interior lighting replaced with new contemporary compatible 4-foot suspended fluorescent fixtures.
- Elect: Primary historic hall and stair lighting replaced with new period-replica energy efficient light fixtures, based on historic evidence.
- Elect: Multiple generations of early modern light fixtures removed.
- Results: Safety conditions improved by incorporation of modern battery pack back-up lighting systems.
- Results: Light quality and indoor air quality was enhanced.
- Results: Energy efficiency improvements realized through at 50% reduction in wattage used for lighting.

- AE team compliance with modern code standards would have resulted in overlighting of interior corridors: project was modified during construction to reduce fixtures in these areas with a favorable overall result.
