**Corrosion Monitoring System (CMS)  
(135-00)**

**Materials Technology Institute**

**October 18, 2004**

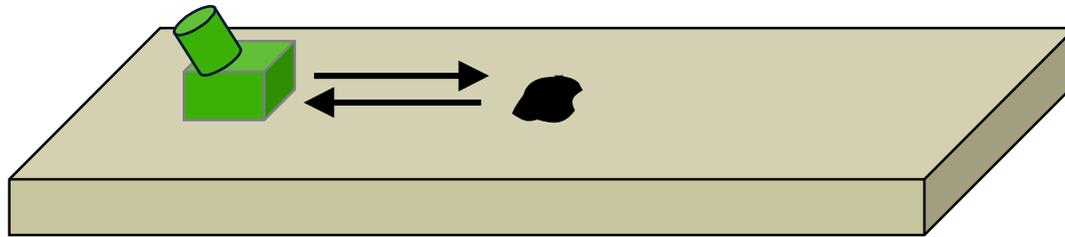
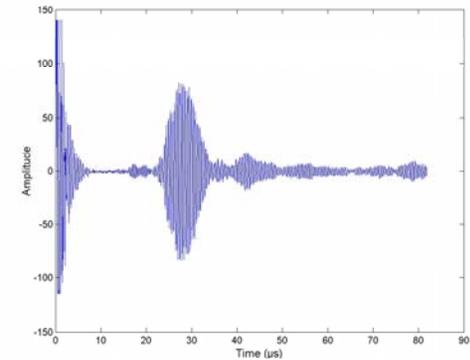
Single piezoelectric transducer

reflection from pit

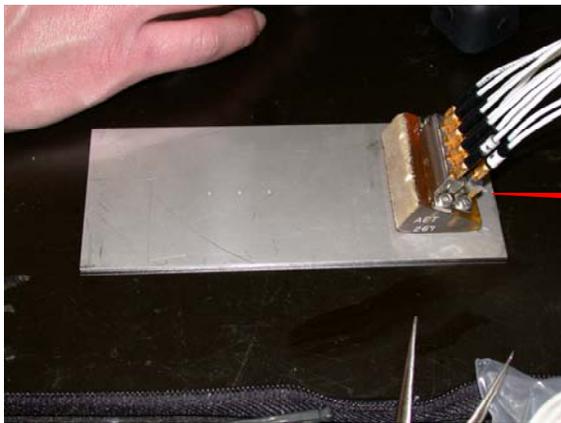
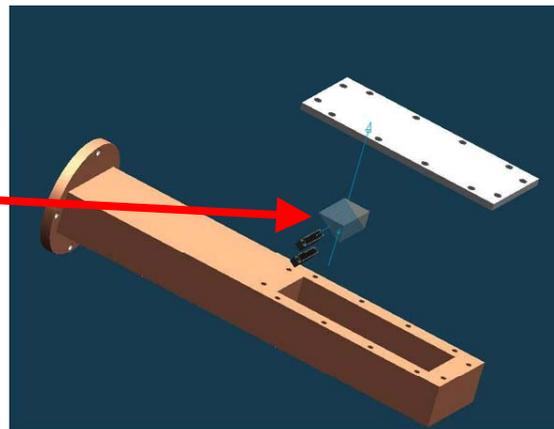
Using an array of piezoelectric transducers provides an image of the pits

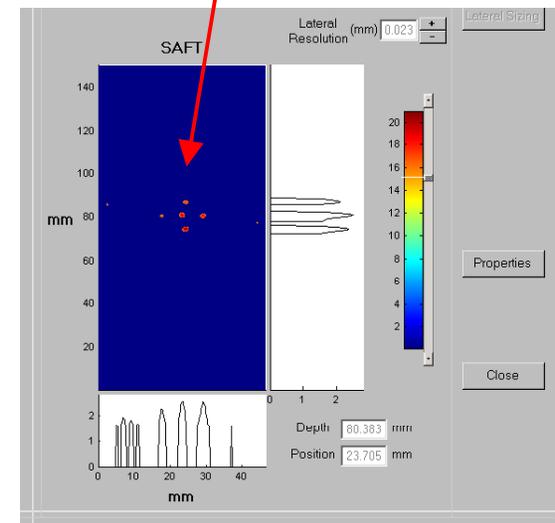
Image of clustered defects

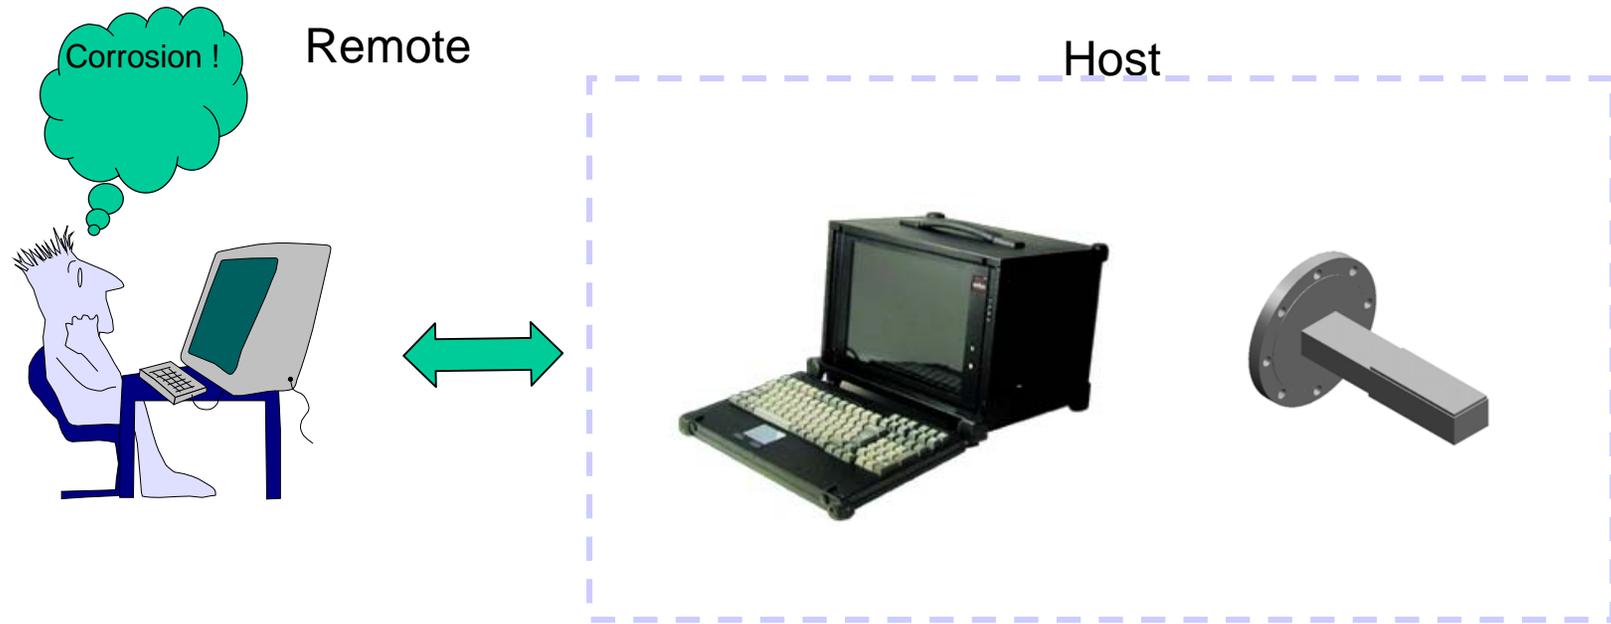
- The CMS remote computer connects to the host computer via internet
- The remote computer automatically downloads the array data and can remotely set system parameters
- The remote computer analyzes the data using our SAFT algorithms and provides an image of the defects

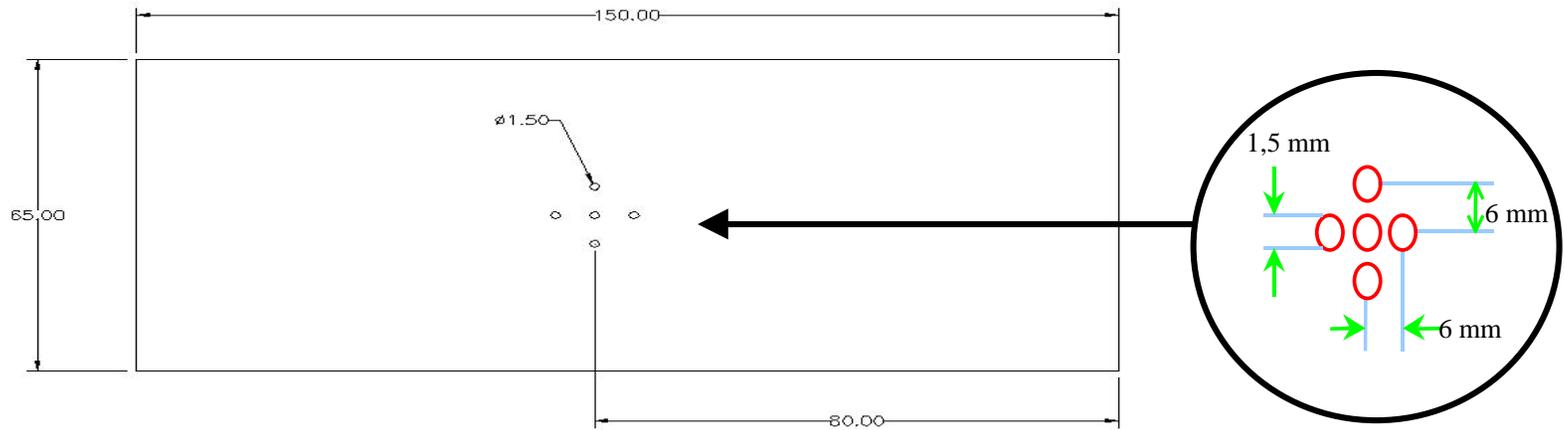
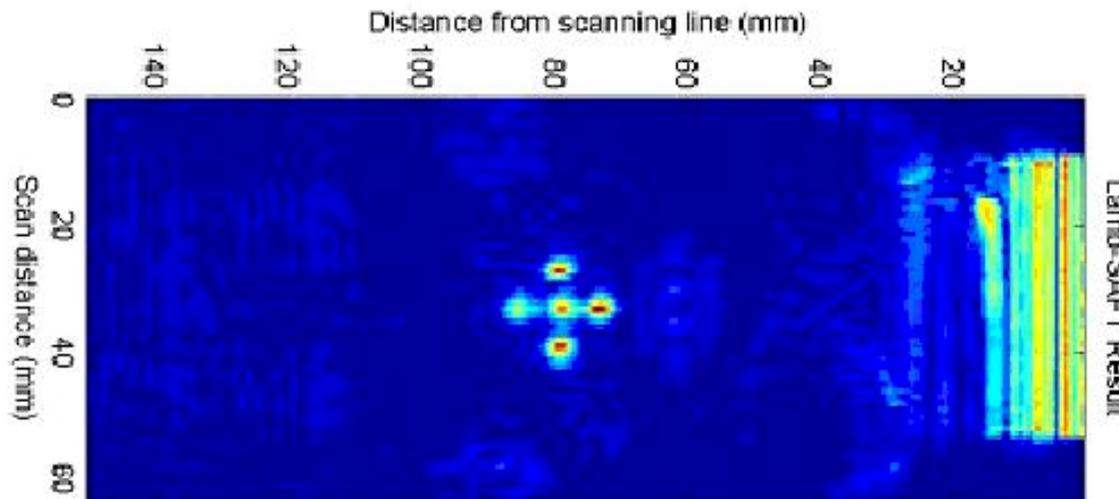
SS304 plate with **five simulated pits** (plate thickness = 1.895 mm, pit depth = 1 mm)

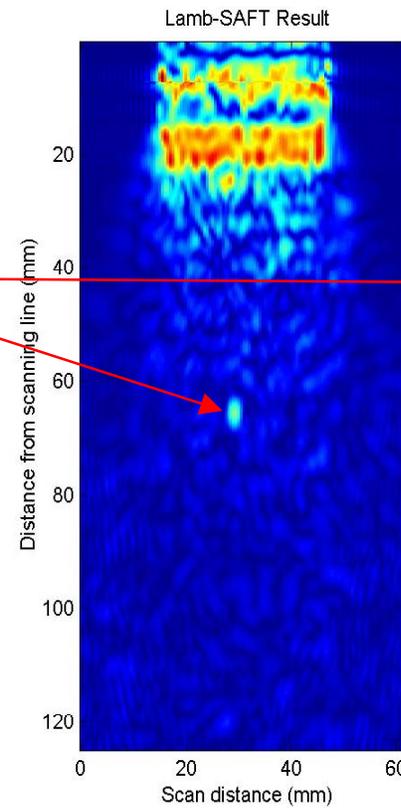
Manual scan

## SS304 real corrosion pit

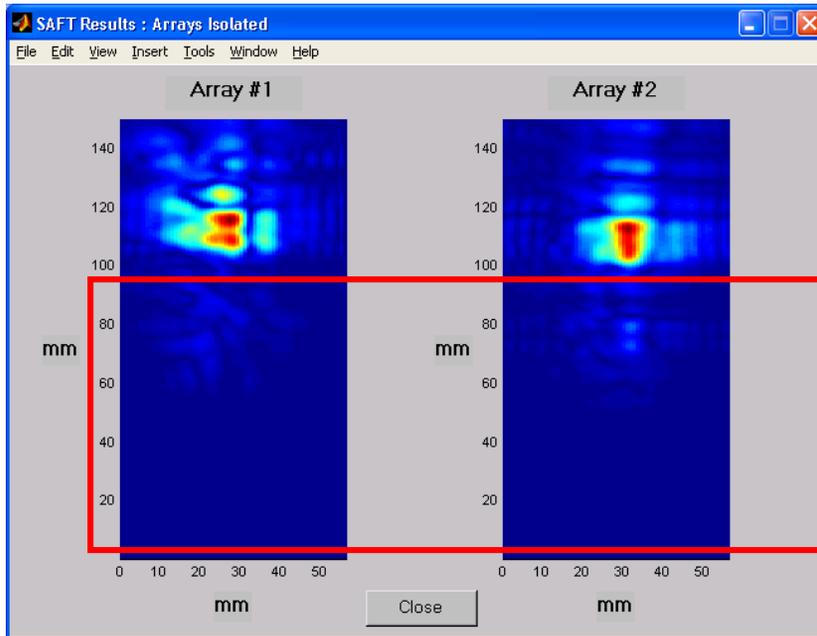
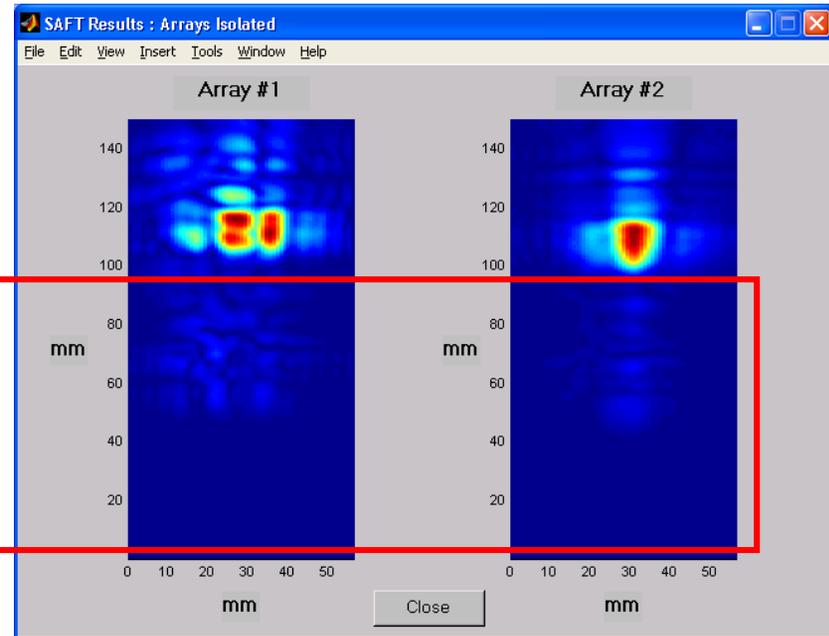
- Pitting did not occur during our Evadale tests
- Our sensors confirmed this result

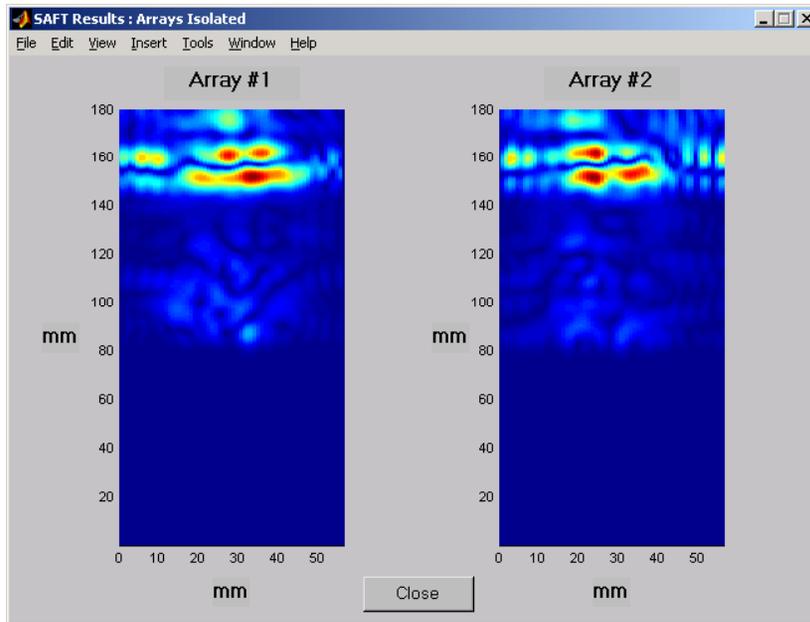
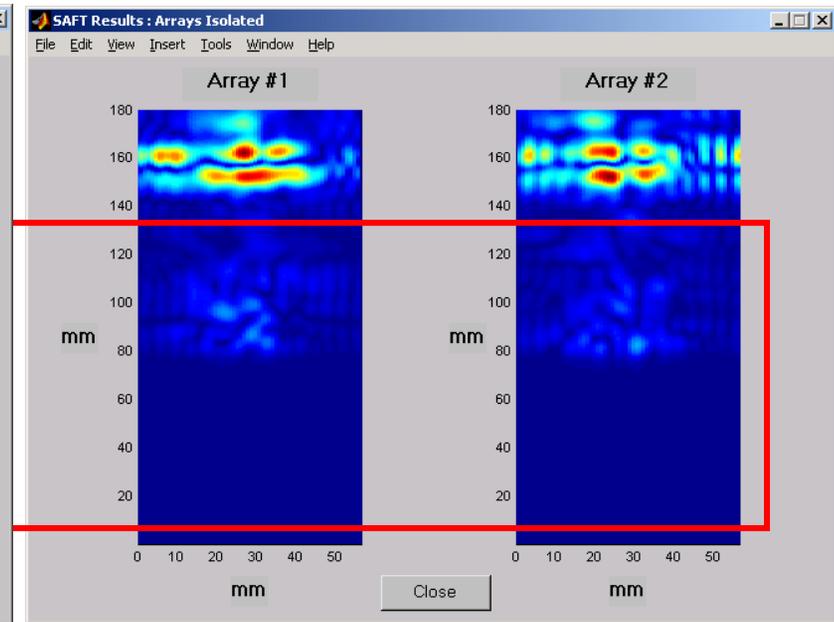
- No pitting
- Confirmed by sensor

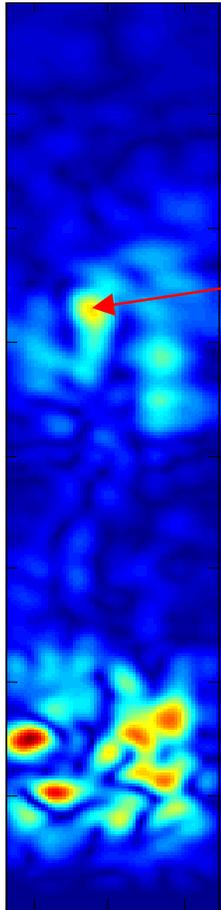
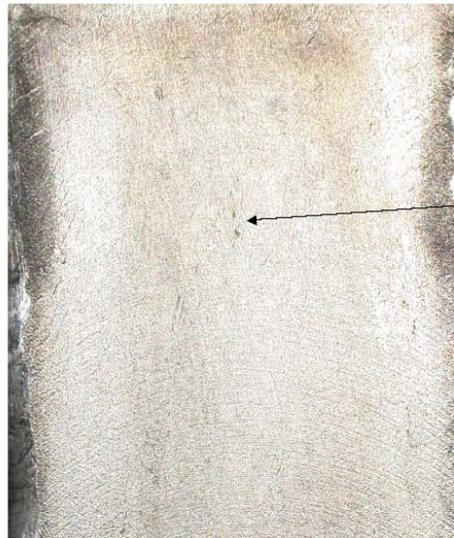
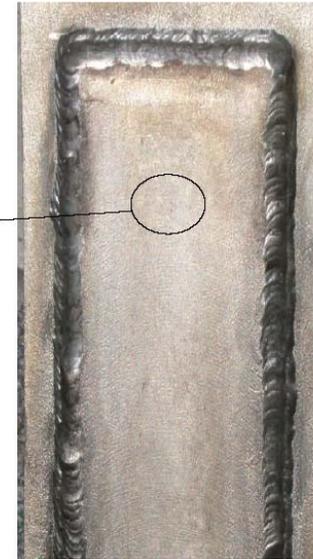
First pit formation!

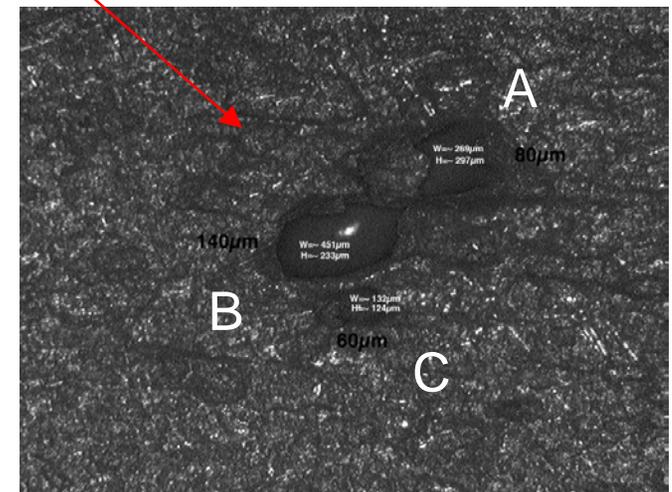
From SEM at ORNL

Width	Height	Depth
A	.269mm	.297mm	.08mm
B	.451mm	.233mm	.14mm
C	.133mm	.124mm	.06mm

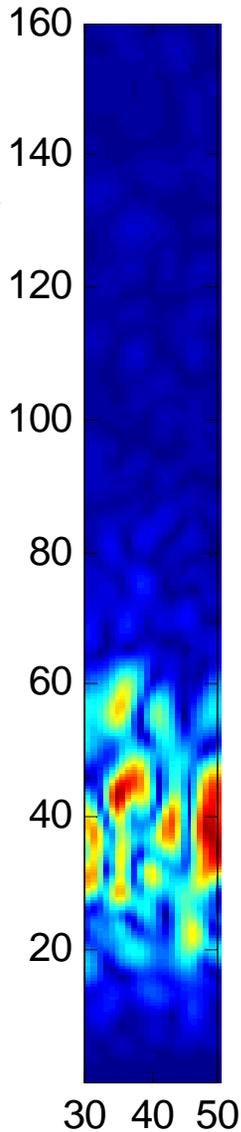
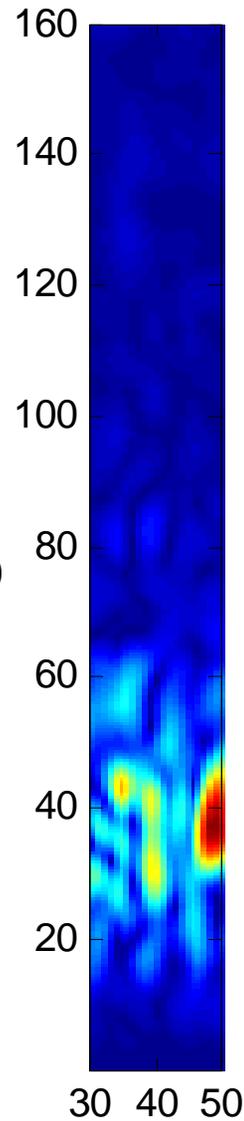
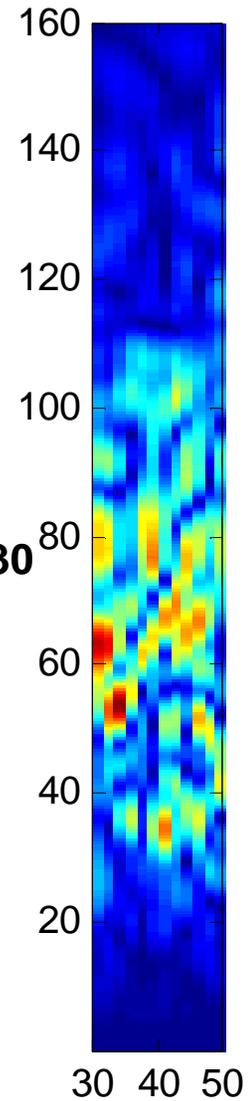
**Then pitting  
accelerated  
very quickly**

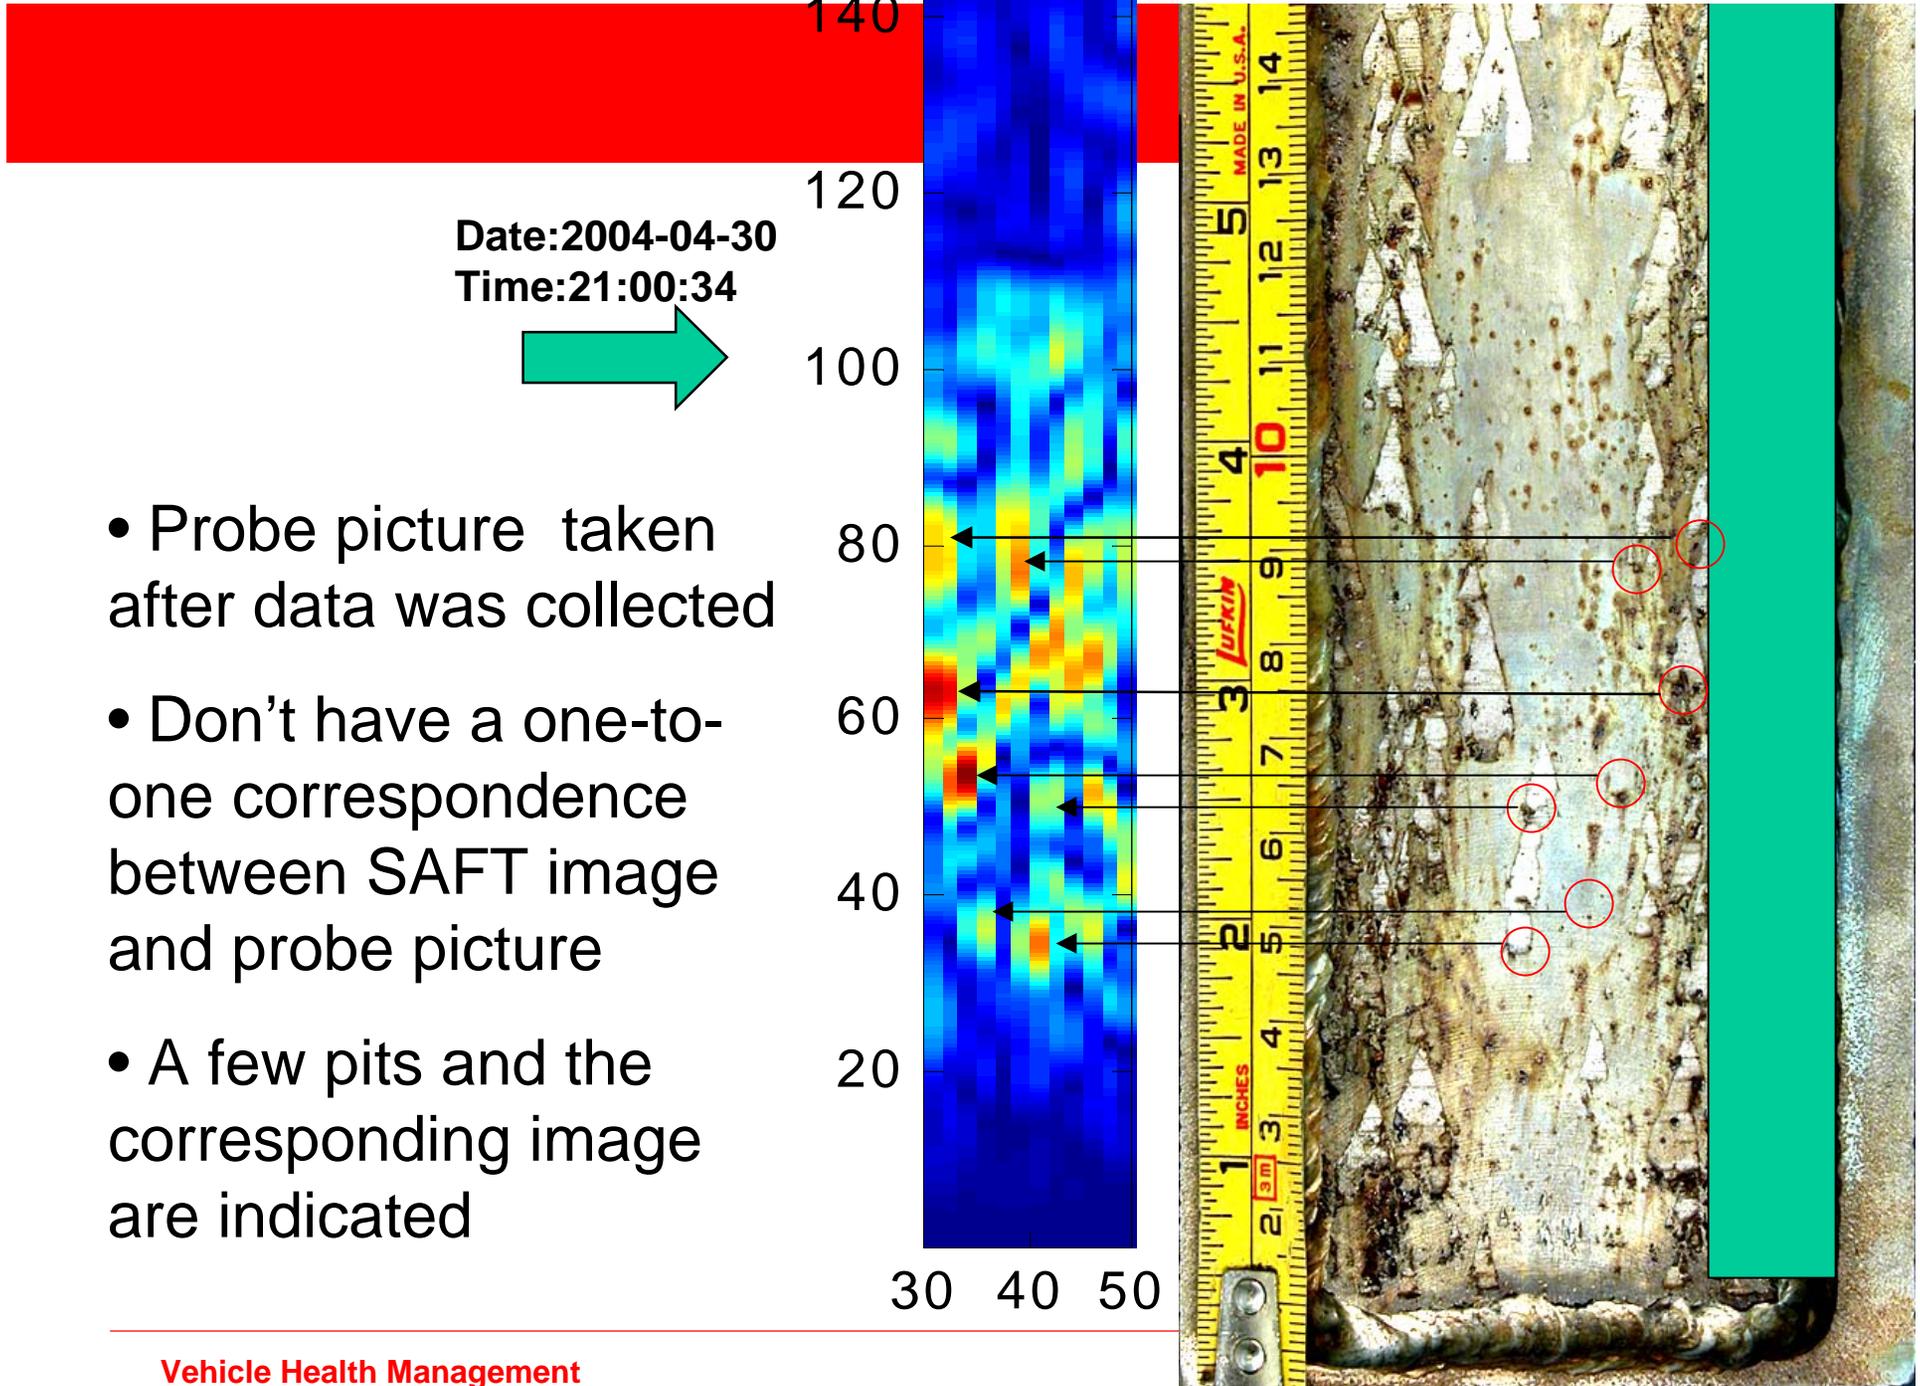
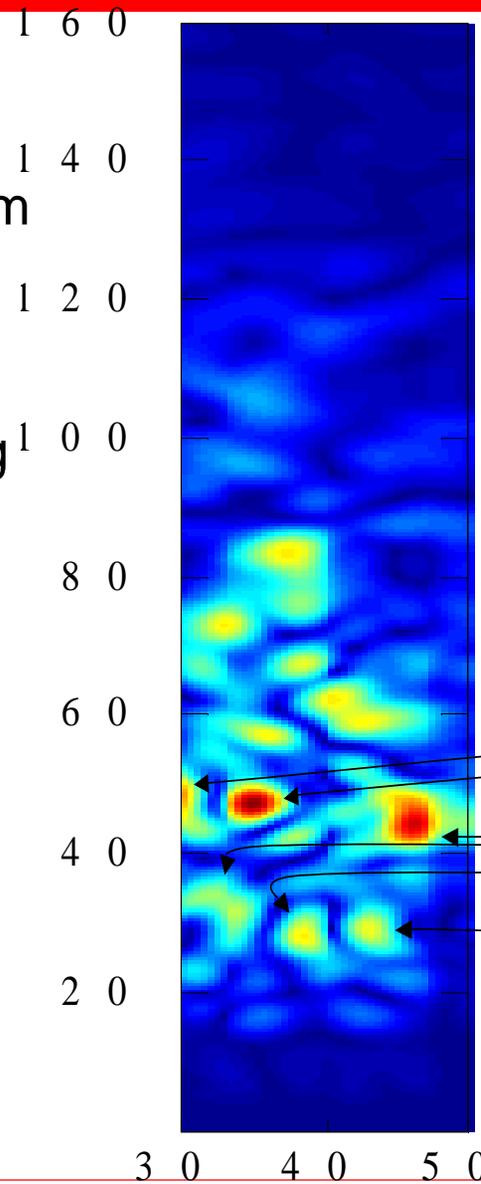
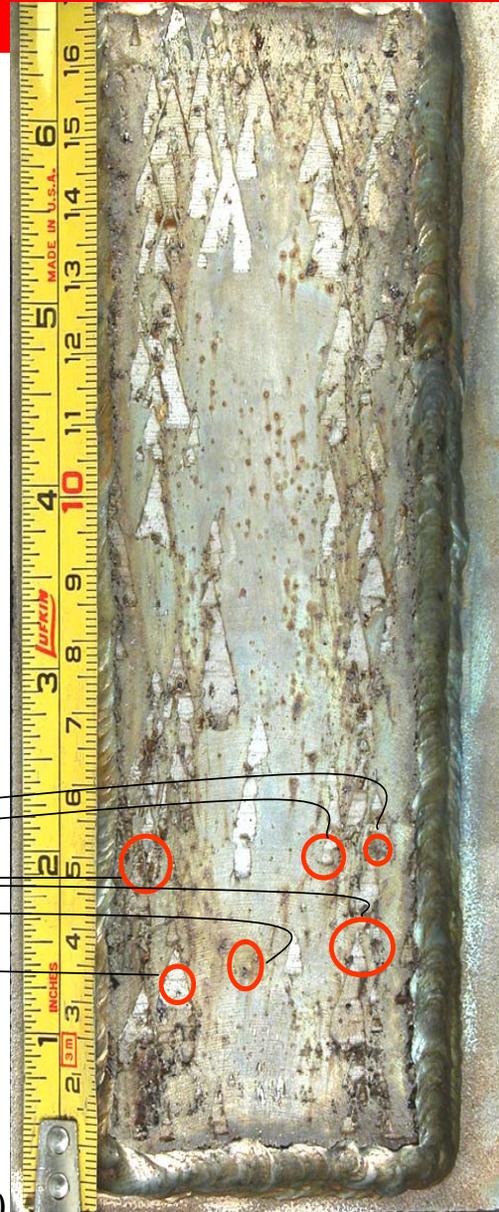
- Recent data from the ORNL probe
- A few pits and the corresponding image are indicated
