**DOE Sensors & Automation
2005 Annual Portfolio Review**

**The advancement in surface quality
assurance for hot rolled steel bars**

Tzyy-Shuh Chang, Ph.D.
Daniel Gutches
Howard (Hsunhau) Huang
OG Technologies, Inc.
Ann Arbor, Michigan 48108

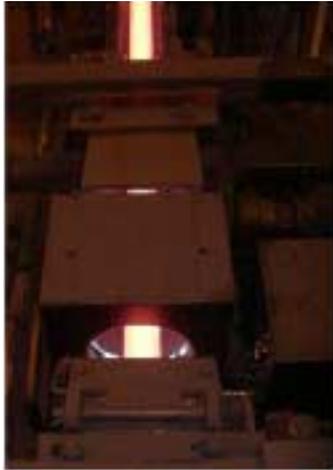
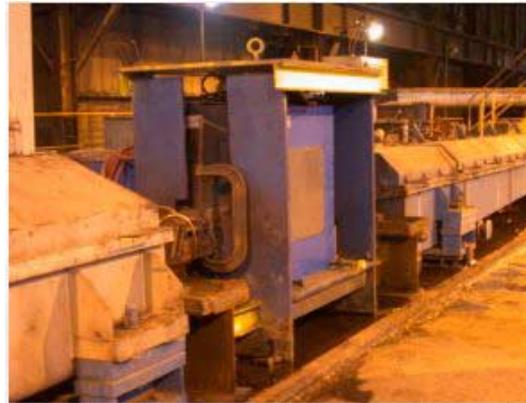
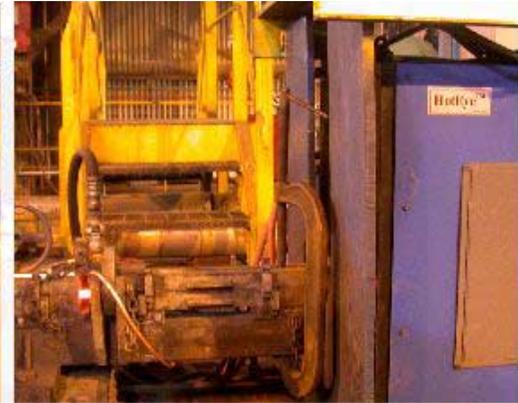
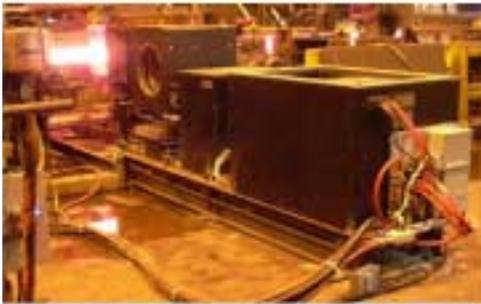
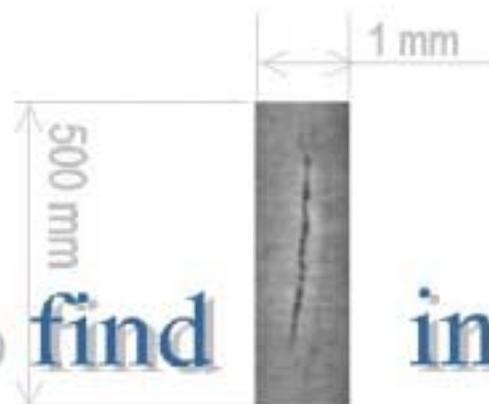
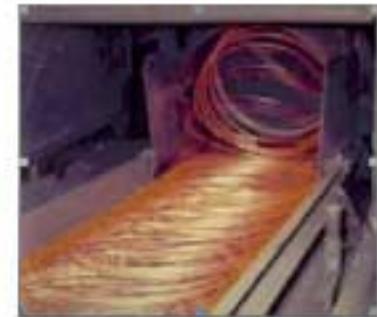
Surface Defect Detection Accuracy

Ability to detect and differentiate:

- Seams/laps
- Slivers/scabs/checking
- Overfills
- Scratches
- Roll cracks (periodic)
- Fluttering (periodic)
- Tool marks

Seam

Roll cracks

Overfill

Scratch

Heat crack

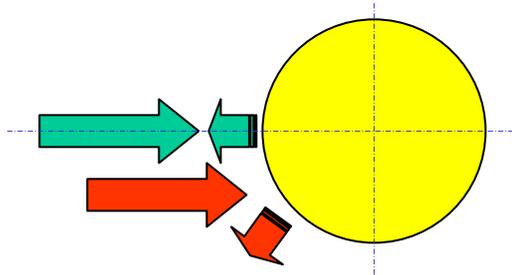
- Base technology: Laser Doppler Velocimeter
- Issue: Difficult to maintain perpendicularity to the surfaces of long products
- Solution: Special signal processing to extract the good measurements
- Tested accuracy: 0.02% of the speed

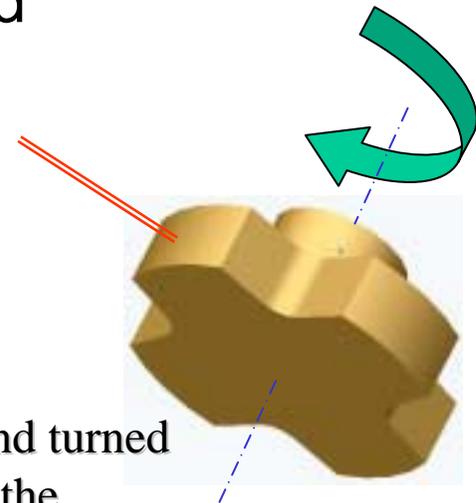
Part made and turned
on a CNC lathe

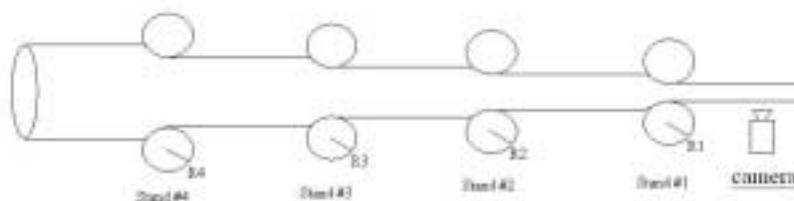
In-line Repeating Pattern Identification

Ideal Case

Symptom /
Problem
Location

Roll Pass Parameters

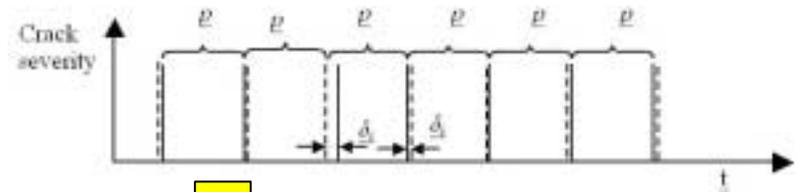
Repeating Pattern

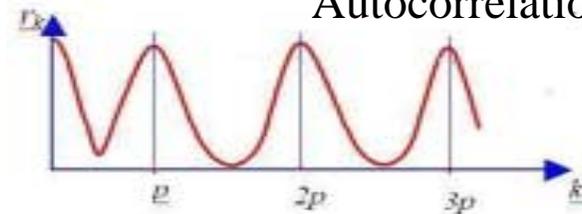
Autocorrelation

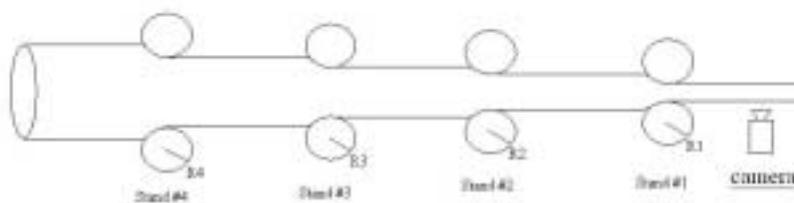
**Symptom /
Problem
Location**

- Contact/non-contact in subsequent rolling stands
- Quantization error due to fast computing needs
- Signals from multiple repeating sources
- Localized noise sources

Roll Pass Parameters
