# NDE DEVELOPMENT FOR ACERT ENGINE COMPONENTS

**Argonne National Laboratory**

**DOE Annual Merit Review, June 7-11, 2010**

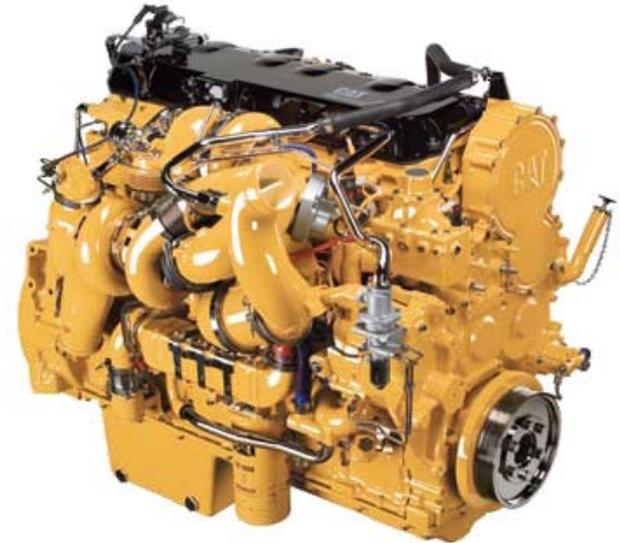
C-15 ACERT engine  
(image provided by Caterpillar)

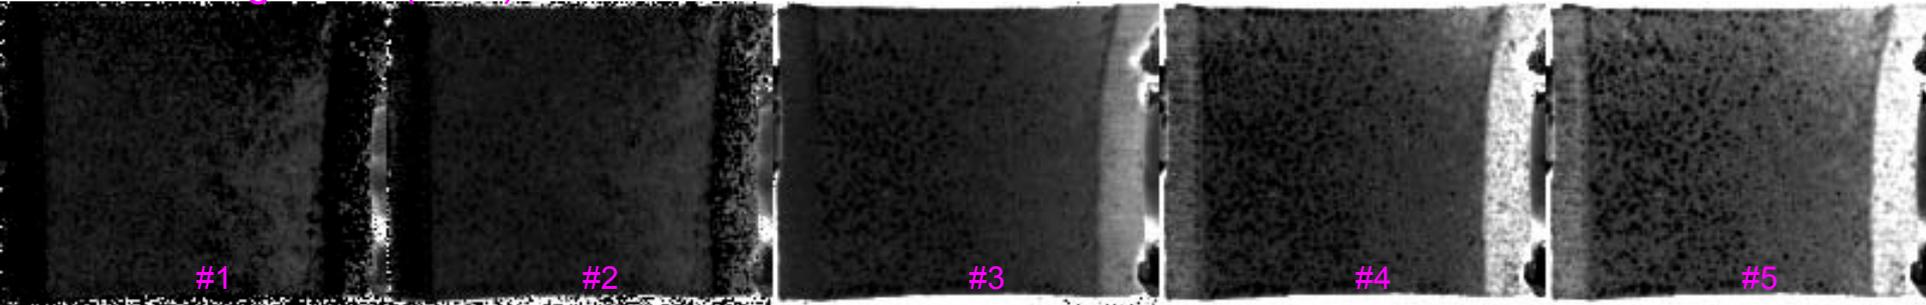
TBC coating slices (#1-5)

- Coating slices show spots of low effusivity that correspond to delaminations
  - Oxidized coating has better heat absorption in thermal imaging test, so data quality is little better (relatively lower noise in substrate)
